**Tree Condition Report**  
**Of Birch Tree**  
**at**  
**Deer Cottage**  
**Ansty**  
**Wiltshire**  
**SP3 5QD**

**February 2026**

**Ref: 02/DC26**

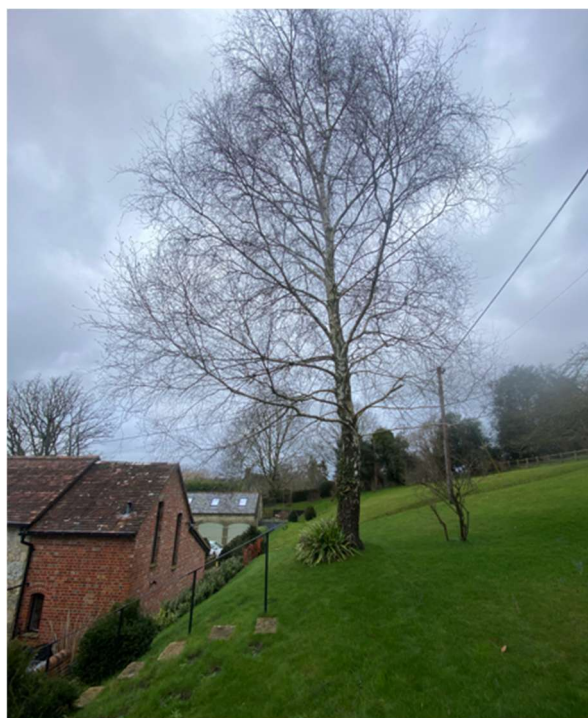
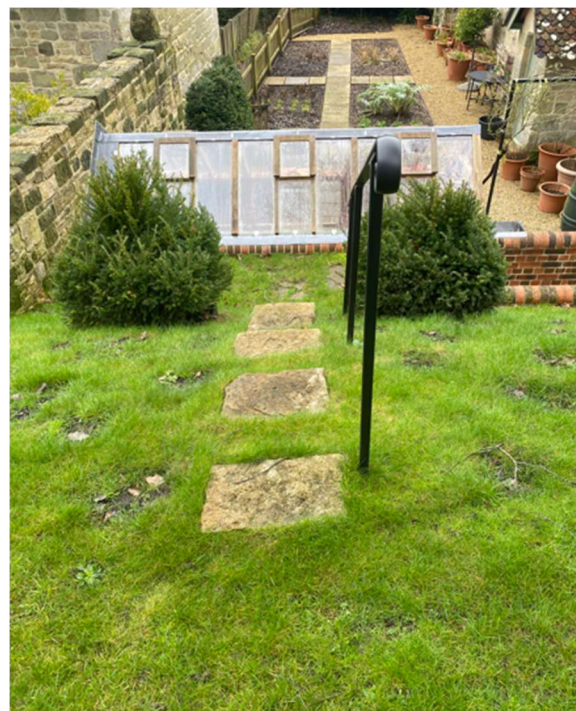
**2.1** The birch tree in question is located on the top of the slope approx. 2 meters to the west of the proposed works to change the slope angle and steps leading down to the greenhouse and house area.

In doing this the works will encroach significantly into the root plate of the birch tree to the point of making the whole tree potentially unstable.

**3.1.** In my opinion the works to make the approach steps to the green house and house area a much safer gradient, the birch tree should be removed to facilitate these safety works.
