## Photographic Record

**Existing outbuilding to the rear of The Carpenters Arms,  
Church Street, Lacock, Chippenham, Wiltshire, SN15 2LB**

**Ref: 2397      Written by: ARW      Checked by: JB      Date: 17/03/25      Revision: -**

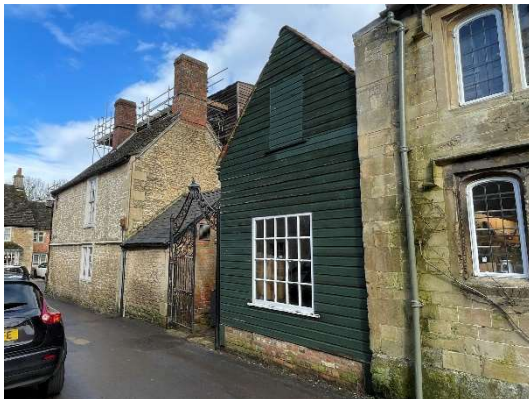
2.1) East St. Elevation with timber clad gable. The lower window is a modern casement. The high level window has been boarded over, and a modern casement remains behind the cladding boards.

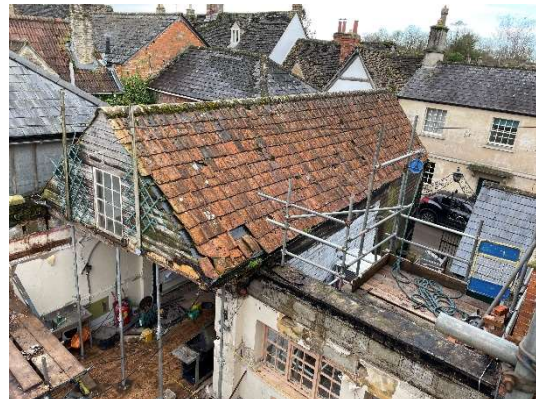
2.2) Roof and East facing gable, illustrates poor condition of pantile roof. The gable is clad with shiplap cladding with a modern casement window. Timber cladding and window frame are in poor condition.

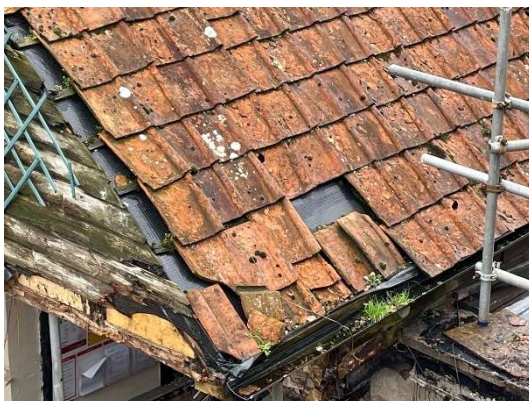
2.3) Detail photo showing the degraded pantiles, modern roofing felt and PVC guttering. The degraded timber cladding is also visible.

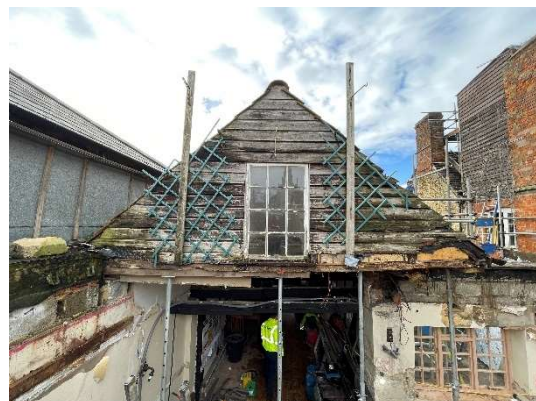
2.4) East facing gable, the gable was supported on the flat roof structure that has been removed in the photo and is to be replaced.

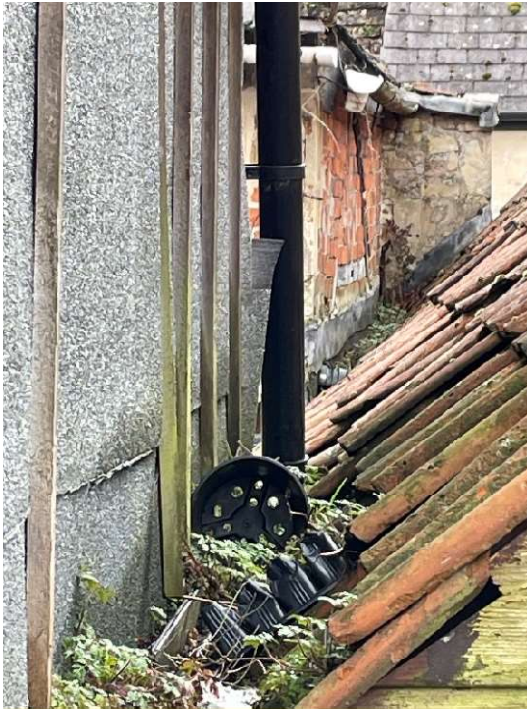
2.5) The valley gutter above the party wall is blocked and appears to be formed from loose bitumen felt. The guttering to the neighbouring building is also in need of attention.

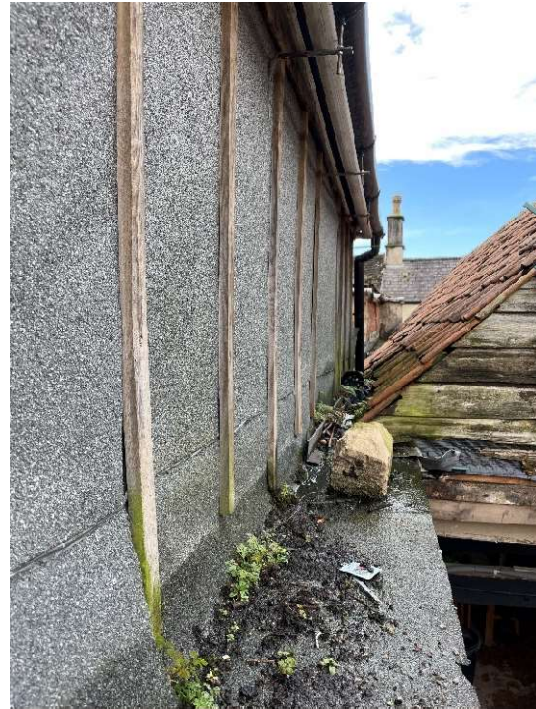
2.6) The side wall of the neighbouring building has bitumen felt secured with timber battens that is in need of a permanent repair.

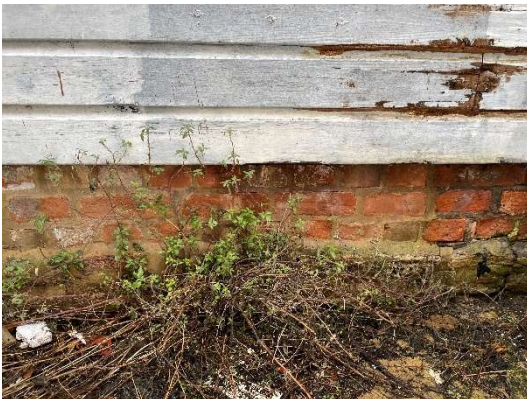
2.7) The brick plinth wall is visible on the courtyard facing elevation, there is a course of stonework at the base with brickwork above laid in English bond. Timber cladding shows signs of degradation and poorly applied white paint.

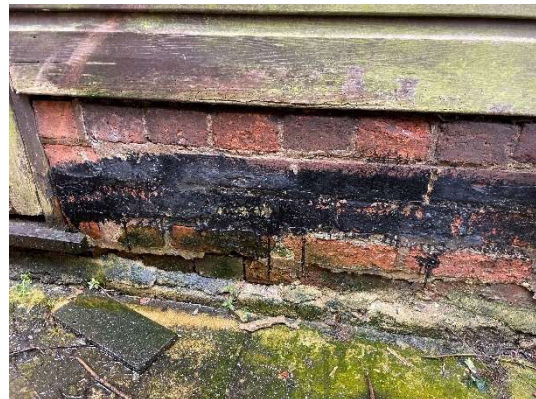
2.8) In places the brickwork facing the courtyard is spalling and has been painted with what appears to be bituminous paint.

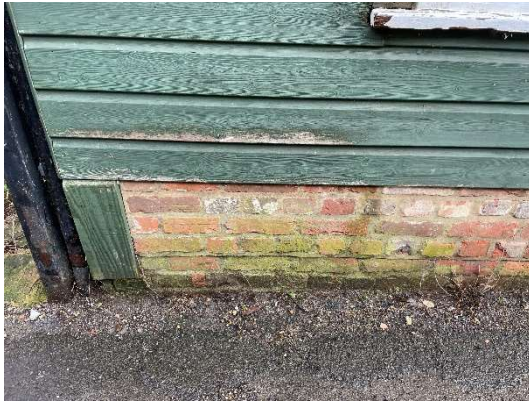
2.9) The gable facing East Street has a brick plinth in modern brickwork with cement mortar and a dpc.

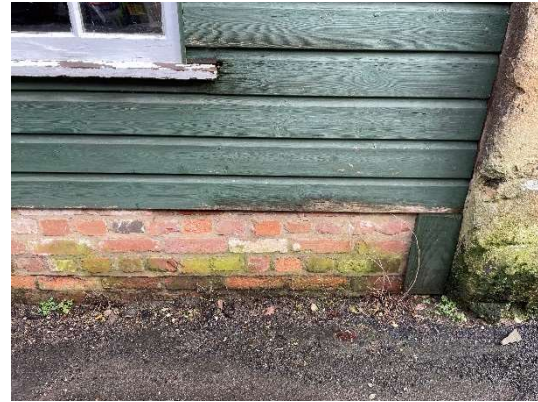
2.10) Window frames and cladding showing signs of degradation.

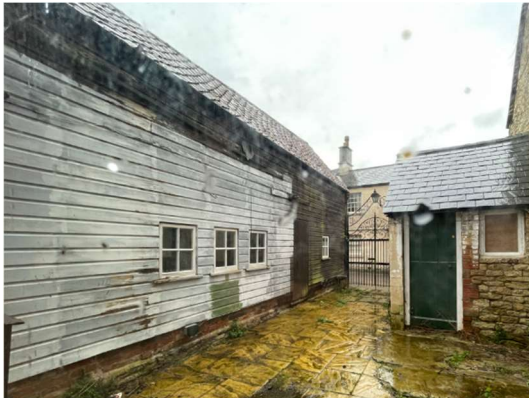
2.11) The timber clad wall facing the courtyard has shiplap cladding, showing signs of degradation and with poorly applied paint finish.

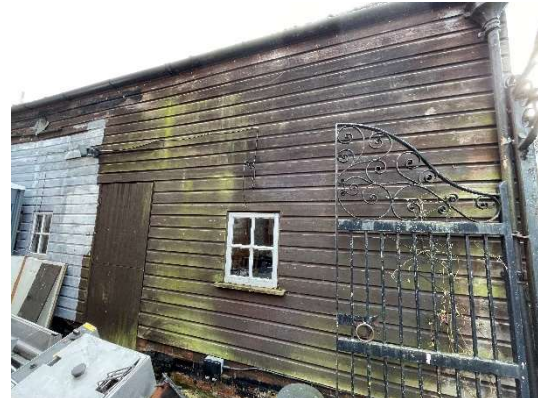
2.12) Modern fixed casement windows and a modern close boarded stable door.

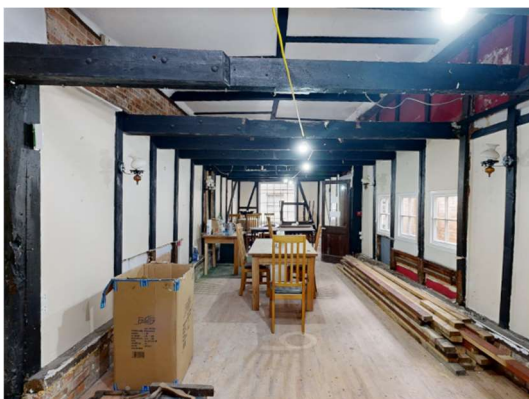
3.1) Interior view looking West towards East St. Plasterboard ceiling above the intermediate joists with applied faux timber detailing.

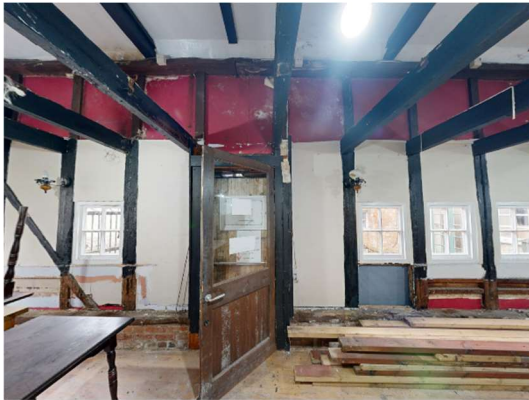
3.3) Fixed casement window and glazed door. Effects of water ingress at eaves evident on upper part of the wall.

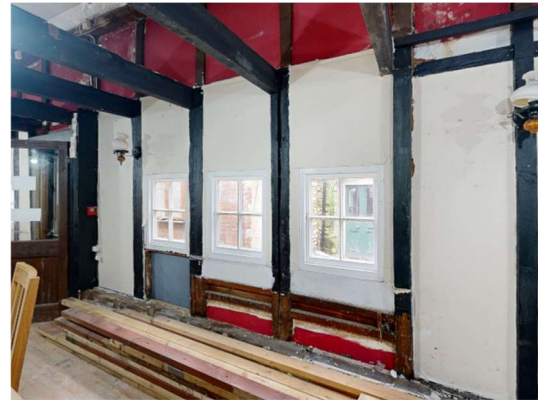
3.4) Fixed casement windows.

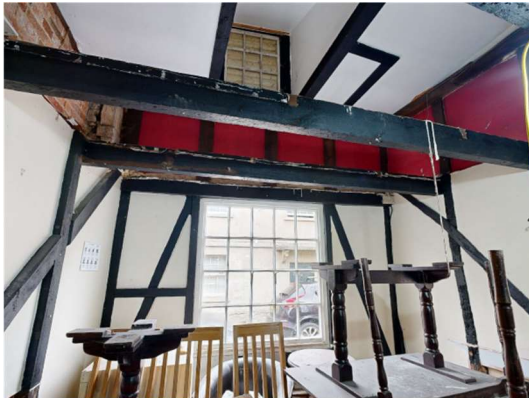
3.5) Fixed casement window to gable and high level window overboarded externally.

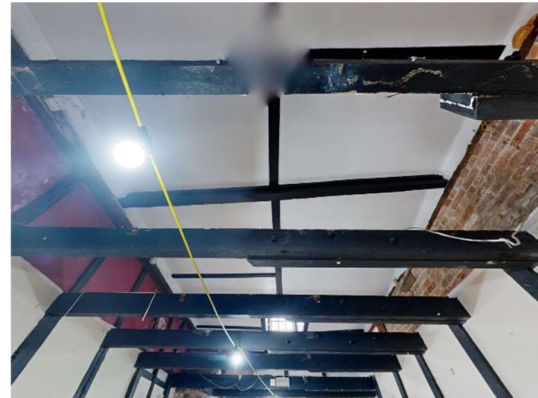
3.6) Plasterboard ceiling with truss chord visible and applied timber decorative detail.

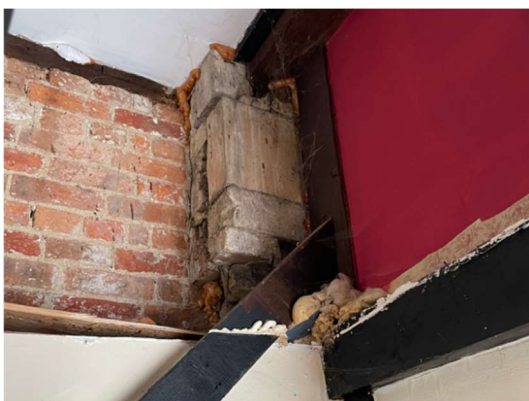
3.7) Abutment to neighbouring stone building. Modern block and foam seen.

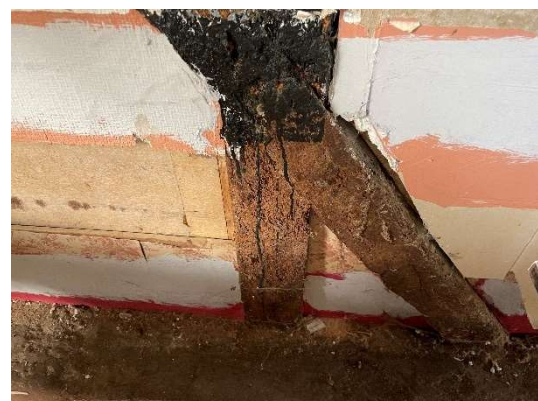
3.8) Where radiators have been removed, some historic timber framing is visible with modern materials used for infill panels.

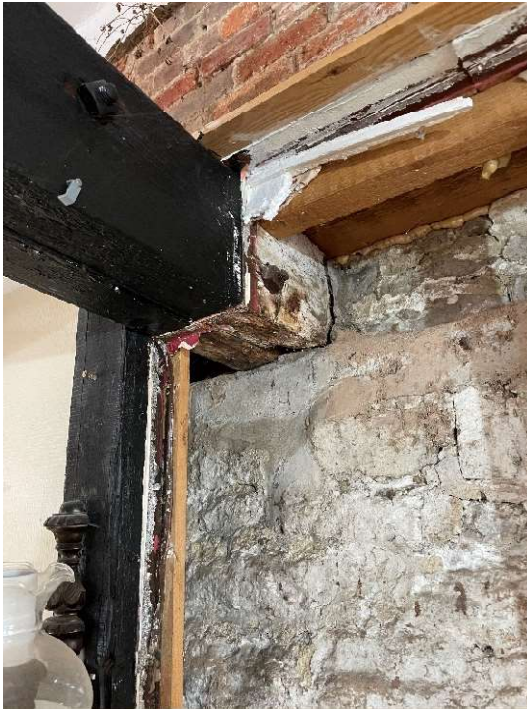
3.9) The South wall has been lined with plasterboard on softwood framing. A section of plasterboard has been removed to expose the party wall, this reveals the floor joists bearing onto the stone wall. Joist ends have rotted in the past and these have been repaired with new timber supports.

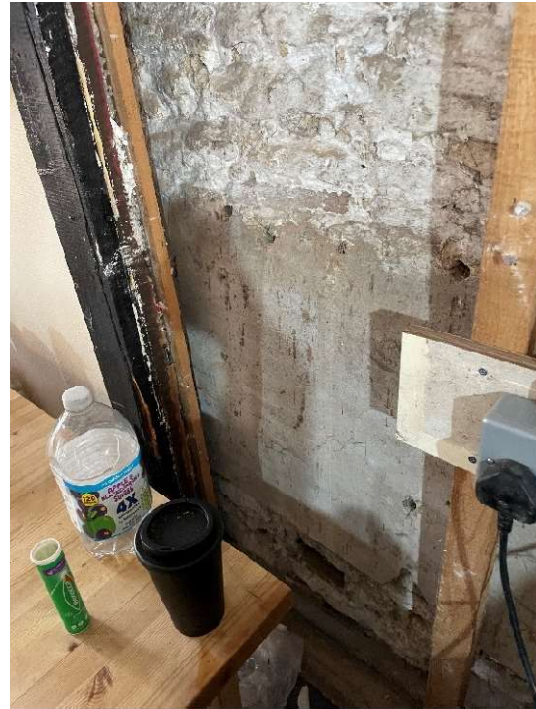
3.10) Painted stone wall with cementitious render at low level behind plasterboard lining. Extent of cementitious render unknown at present.

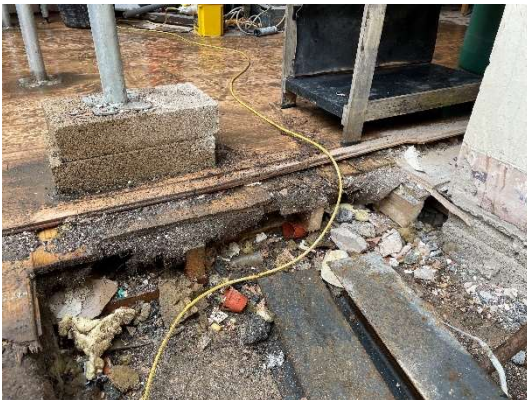
3.11) The floor is a modern engineered timber board on tongue and groove floor boards that are laid over a fibrous material over chipboard on joists. There is no evidence of a cement floor at the western end of the building (as should have been installed as part of the previous permission works).

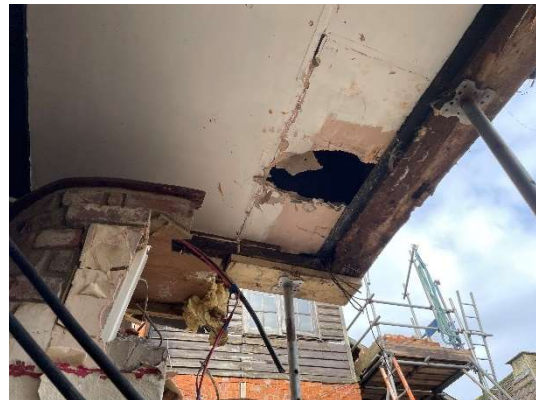
3.12) Modern plasterboard ceiling.

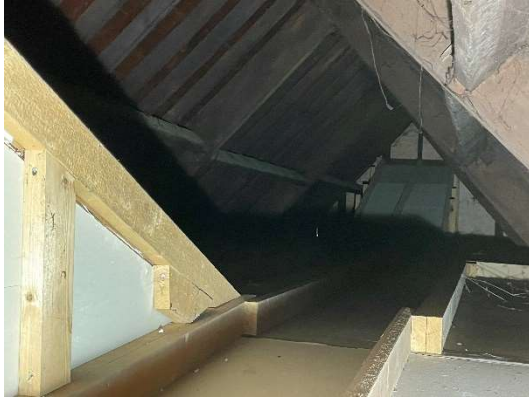
4.1) The roof is formed of simple trusses with purlins spanning between, supporting rafters. Access to the roof void is limited and further investigation is needed to ascertain the age of the roof timbers. Rafters are over-boarded with timber sarking board.

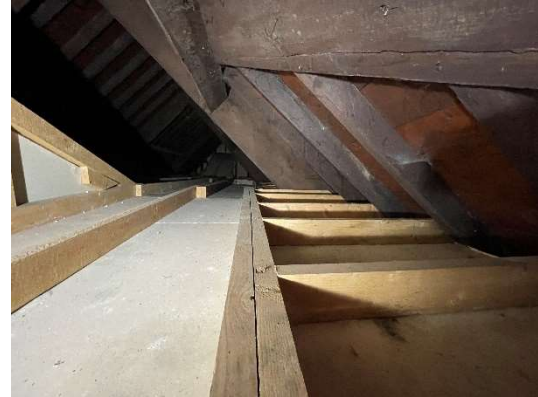
4.2) The ceiling is modern plasterboard on softwood framing between the trusses. At each end there is a hood formed in plasterboard around the high-level windows.
