| SITE DETAILS | | W0299, Drews Park |
| Survey/inspection summary | | 30/07/2025 RN - A total of 62 trees have been plotted on site, including individuals and groups. Approximately 75% are large mature specimens, with the remainder being newly planted trees. Overall, the tree stock is in good condition with no widespread issues observed. |

| <b>TREE INSPECTION DATA</b> | W2010, Ilex sp. |

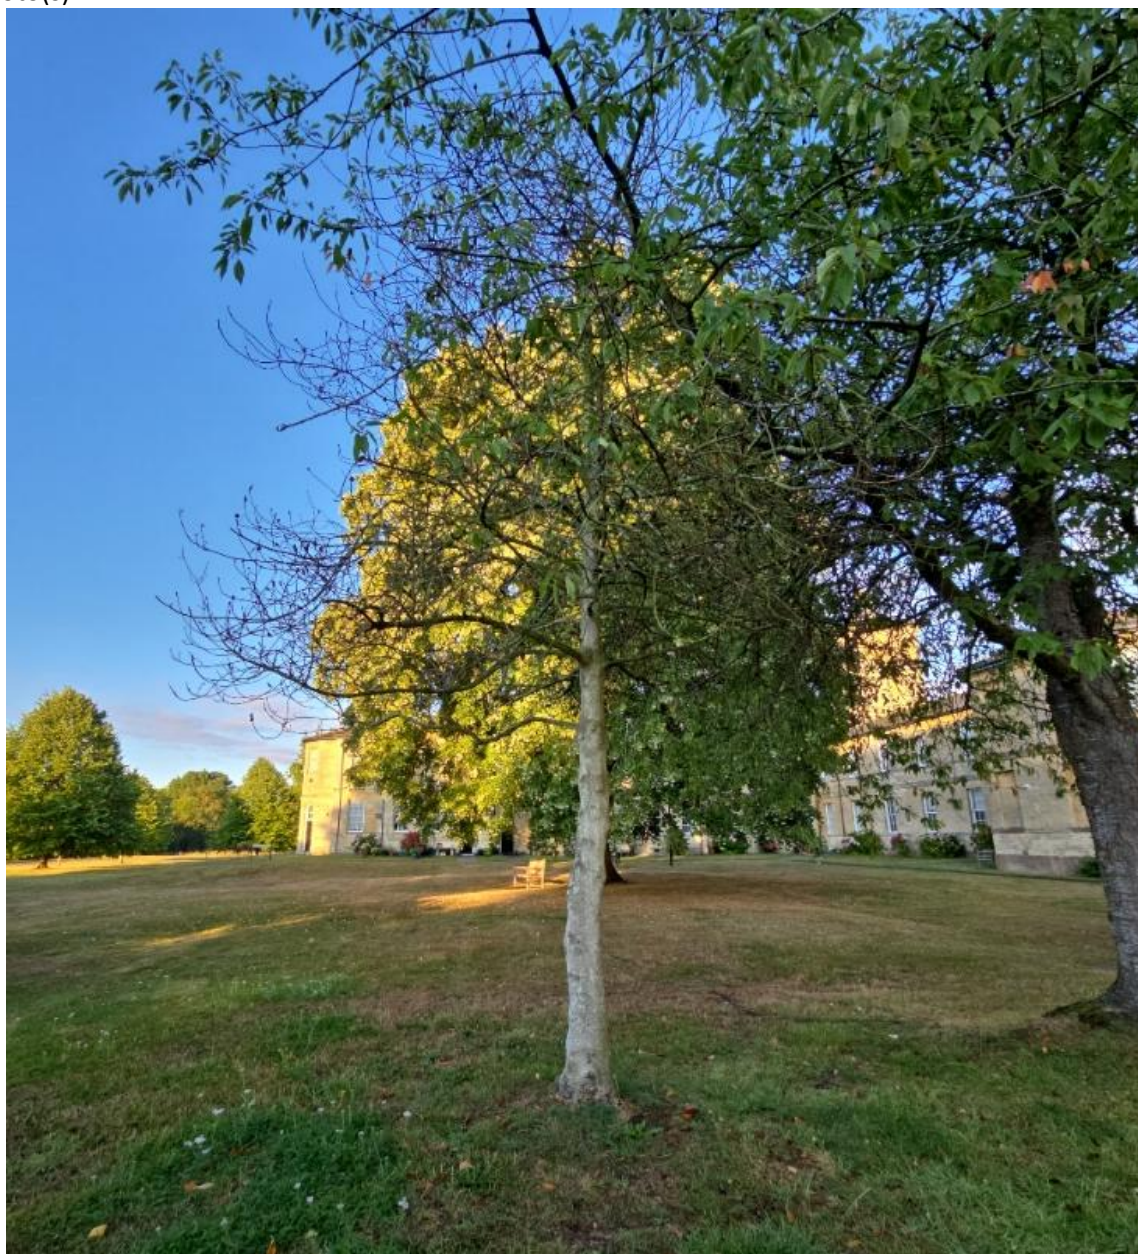
W2010, Ilex sp.

| <b>TREE INSPECTION DATA</b> | W2010, Ilex sp. |
|---|---|
| Condition | Dead |

| <b>TREE INSPECTION DATA</b> | W2010, Ilex sp. |
|---|---|
| Recommendations | Fell remove. |
| Priority score (1 most severe) | 2 - work within 3 months |

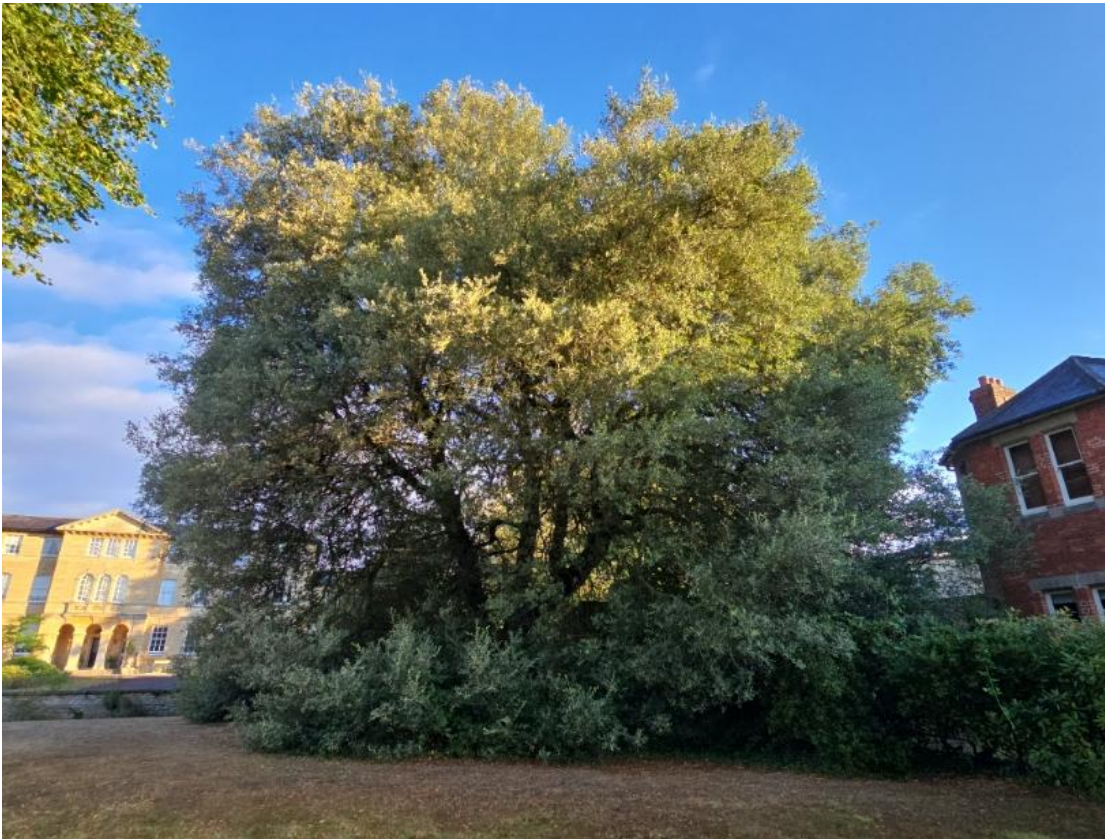
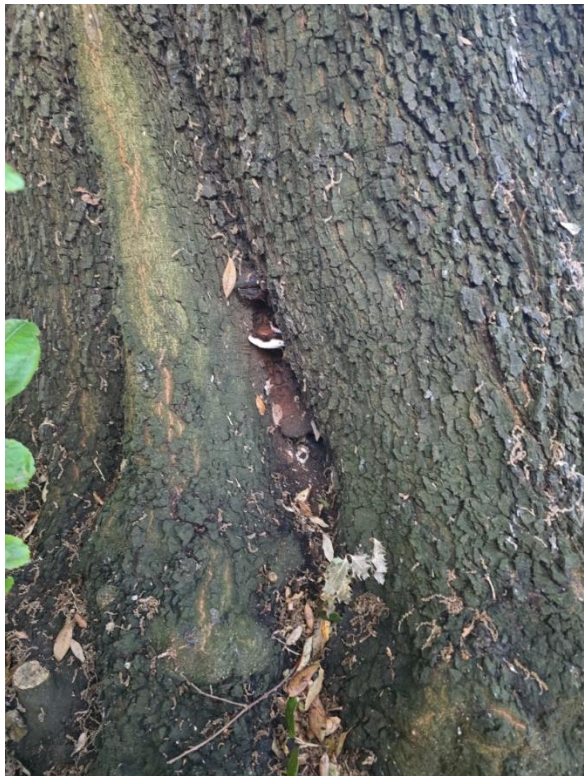
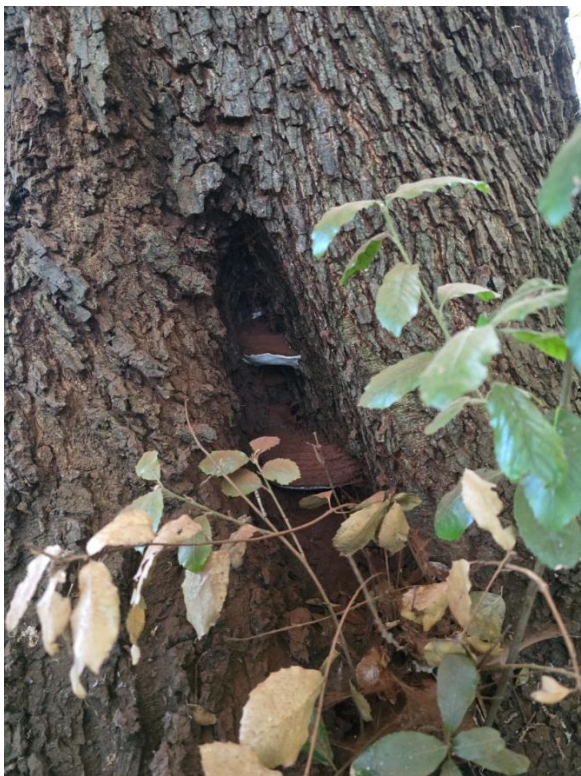
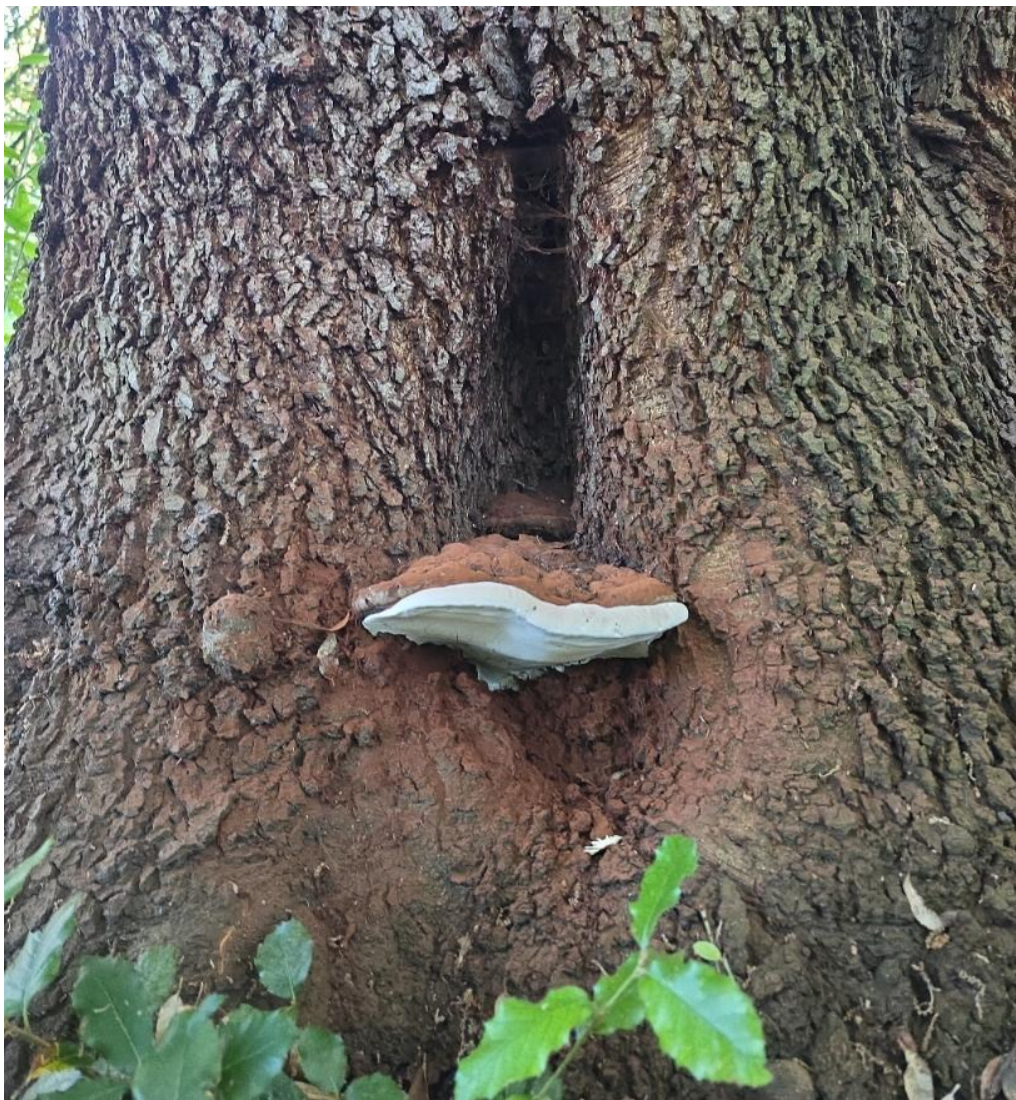
| TREE INSPECTION DATA | |
|---|---|
| Condition notes | <p>30/07/2025 RN - Multiple Ganoderma spp. fungal brackets (likely Ganoderma australe or G. applanatum) are evident in several basal and stem cavities.</p> <p>Presence of decay fungi at the base is a clear indicator of structural compromise, as Ganoderma causes white rot, degrading lignin and cellulose and potentially weakening the structural integrity of major roots and the lower stem.</p> <p>The tree has a dense crown and low branches.</p> <p>No immediate dieback or crown thinning is visible, but the internal decay may be advanced.</p> |

| TREE INSPECTION DATA | |
|---|---|
| Recommendations | Reduce crown by 3m. |
| Priority score (1 most severe) | 2 - work within 3 months |

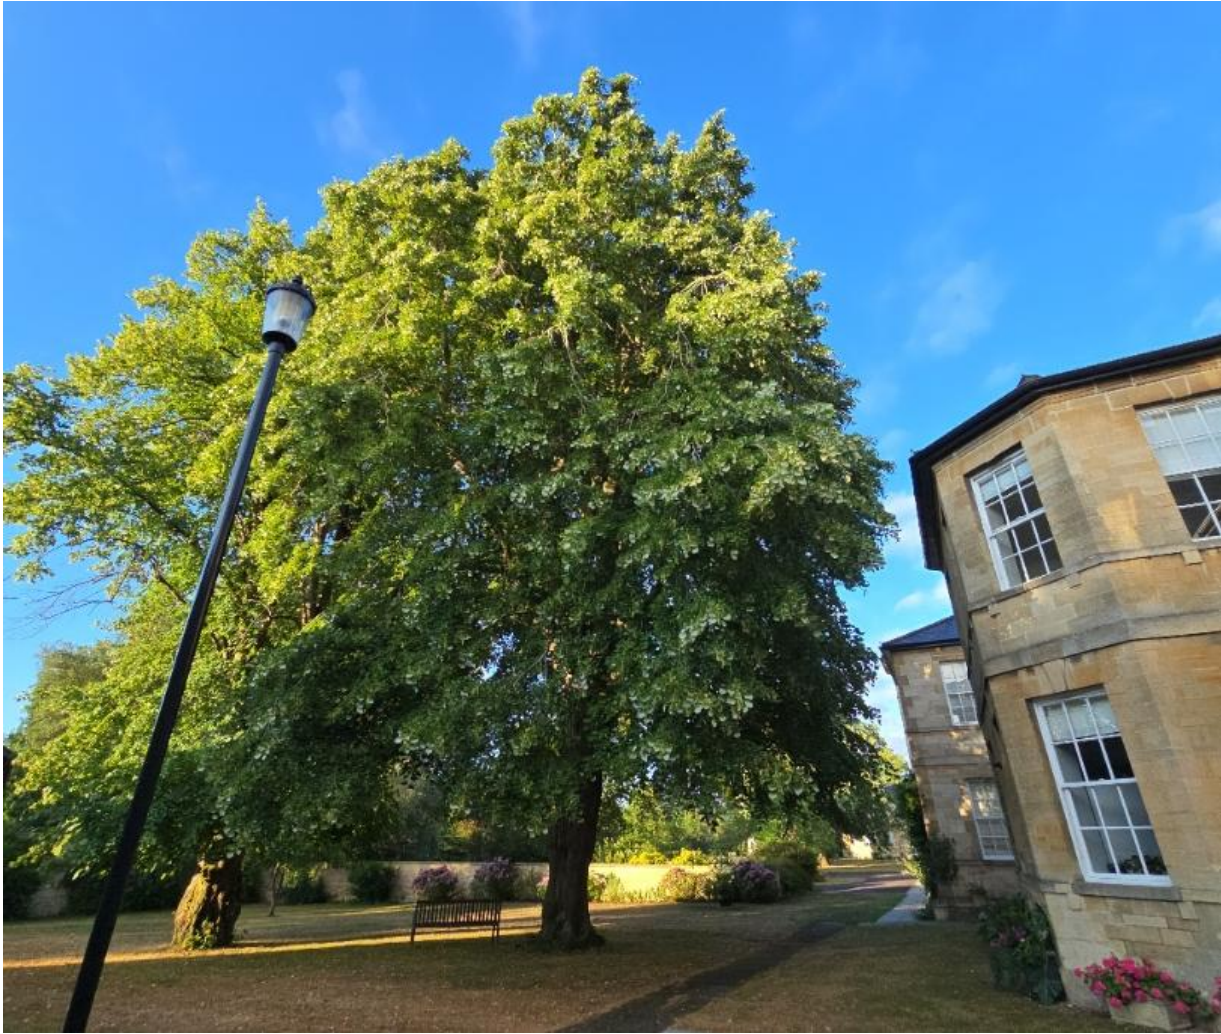
| TREE INSPECTION DATA | |
|---|---|
| W2006, Tilia sp. | |

| TREE INSPECTION DATA | |
|---|---|
| Condition notes | 30/07/2025 RN - Overgrown for is location and proximity to building. |

| TREE INSPECTION DATA | |
|---|---|
| Recommendations | Reduce crown by 3-4m. |
| Priority score (1 most severe) | 3 - work within 12 months |
