## **STRUCTURAL APPRAISAL**

**THE CARPENTERS ARMS, LACOCK, WILTS, SN15 2LB**

**MR ADRIAN GOTT**

**Project** : 2022.270  
**Date** : February 2024  
**Engineer** : G.Schofield C Eng, MI Struct E, MICE, MIEI  
**Issue No: 1** : 21.02.2024

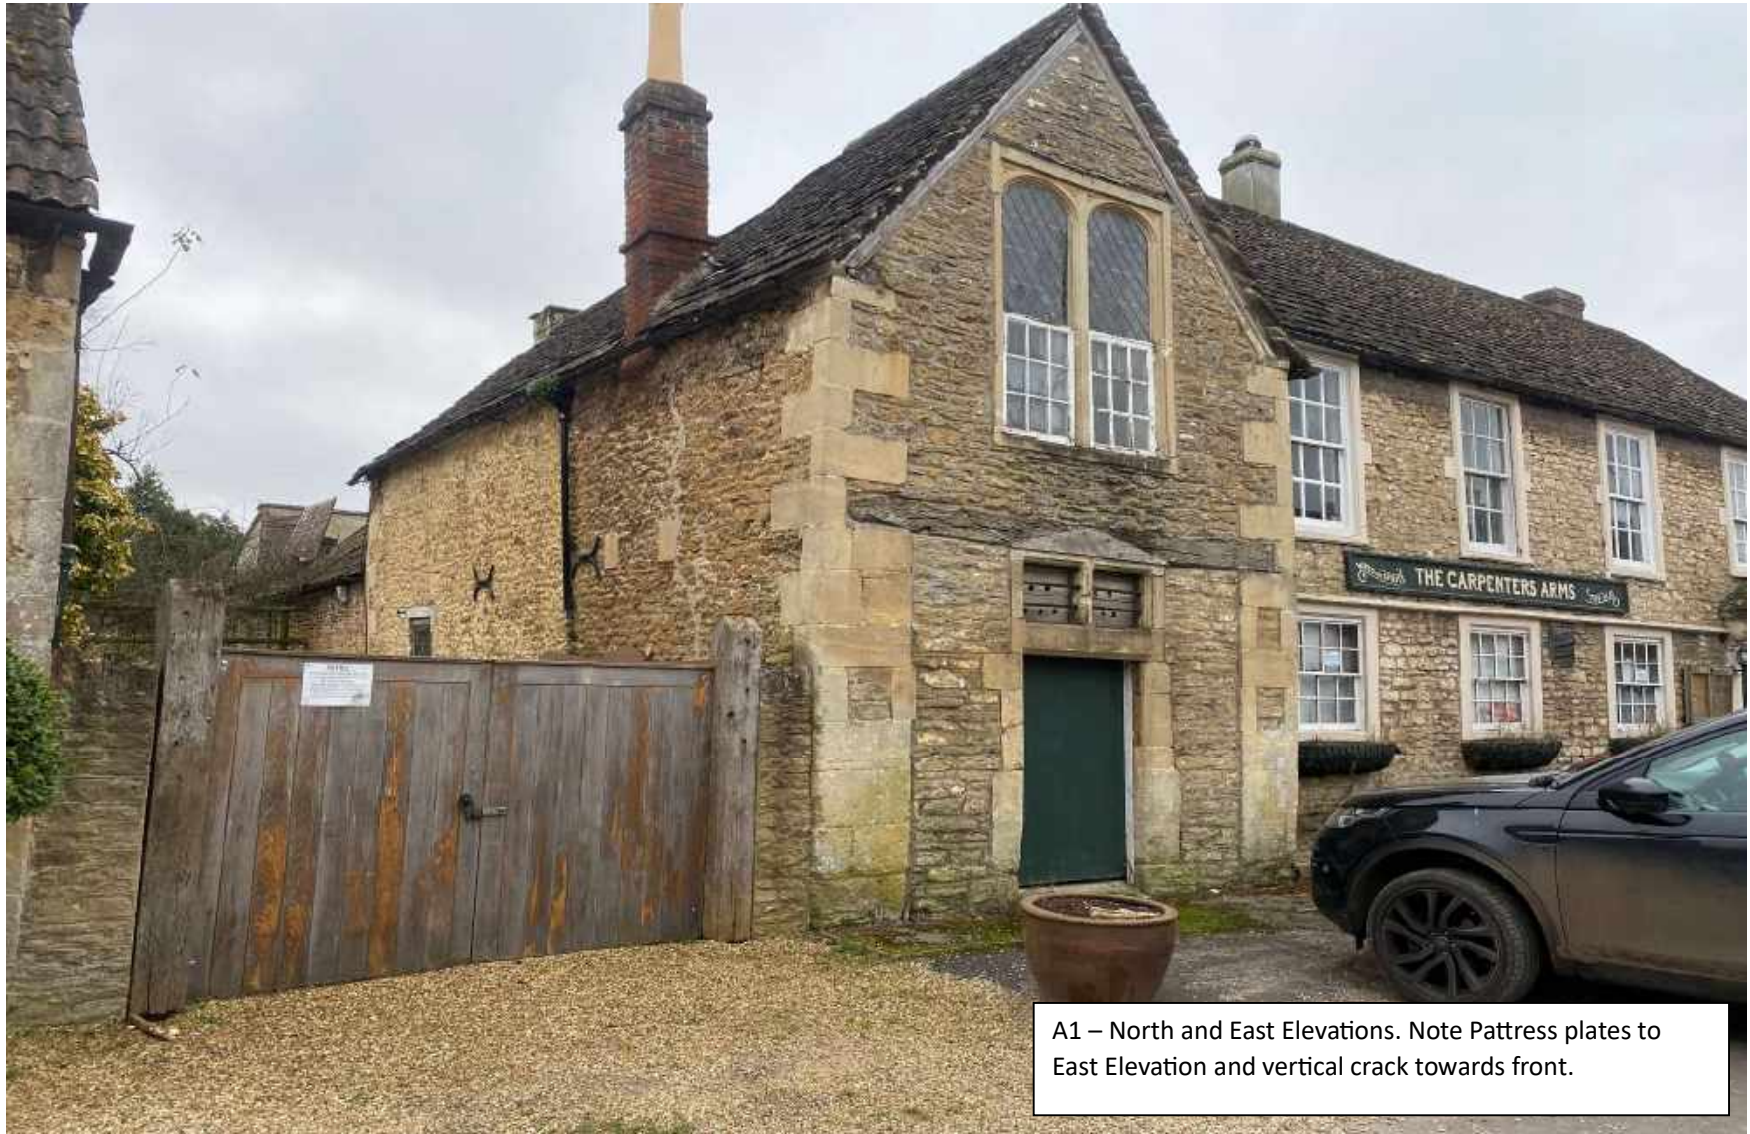
A1 – North and East Elevations. Note Pattress plates to East Elevation and vertical crack towards front.

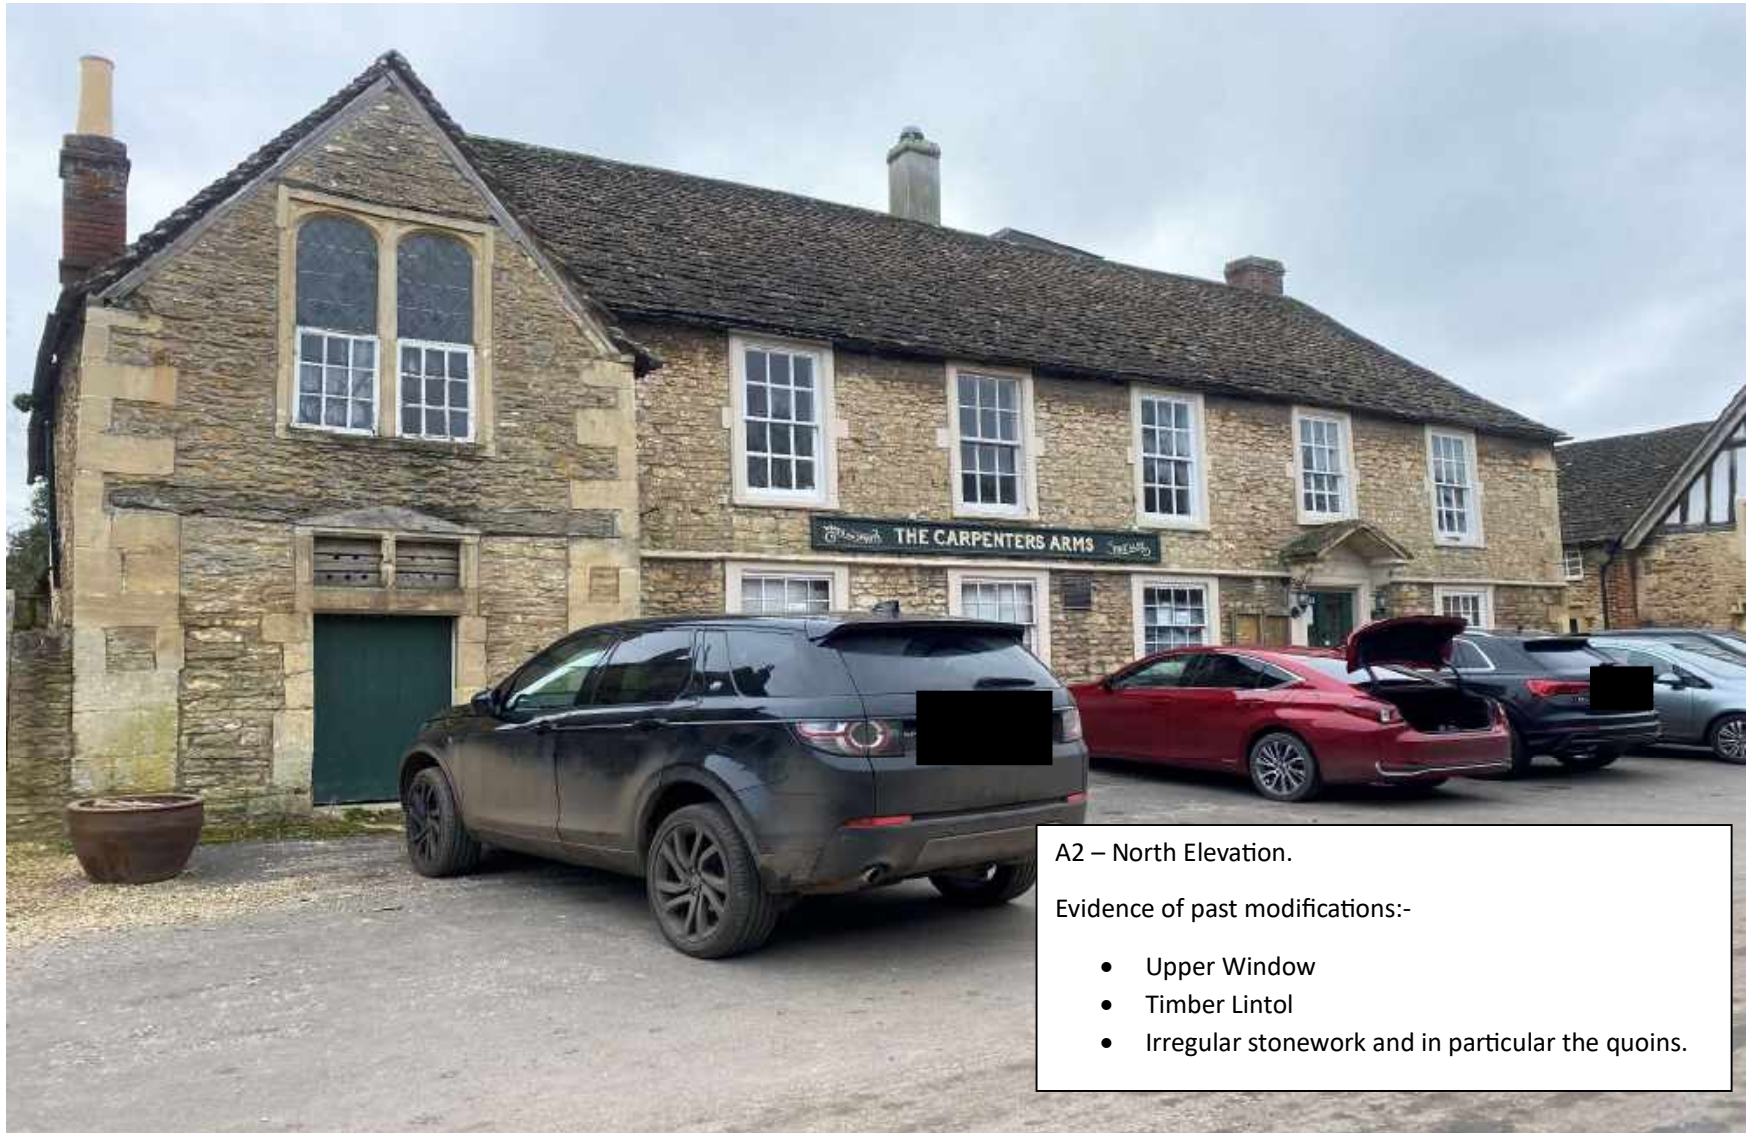
A2 – North Elevation.

Evidence of past modifications:-

- Upper Window
- Timber Lintel
- Irregular stonework and in particular the quoins.

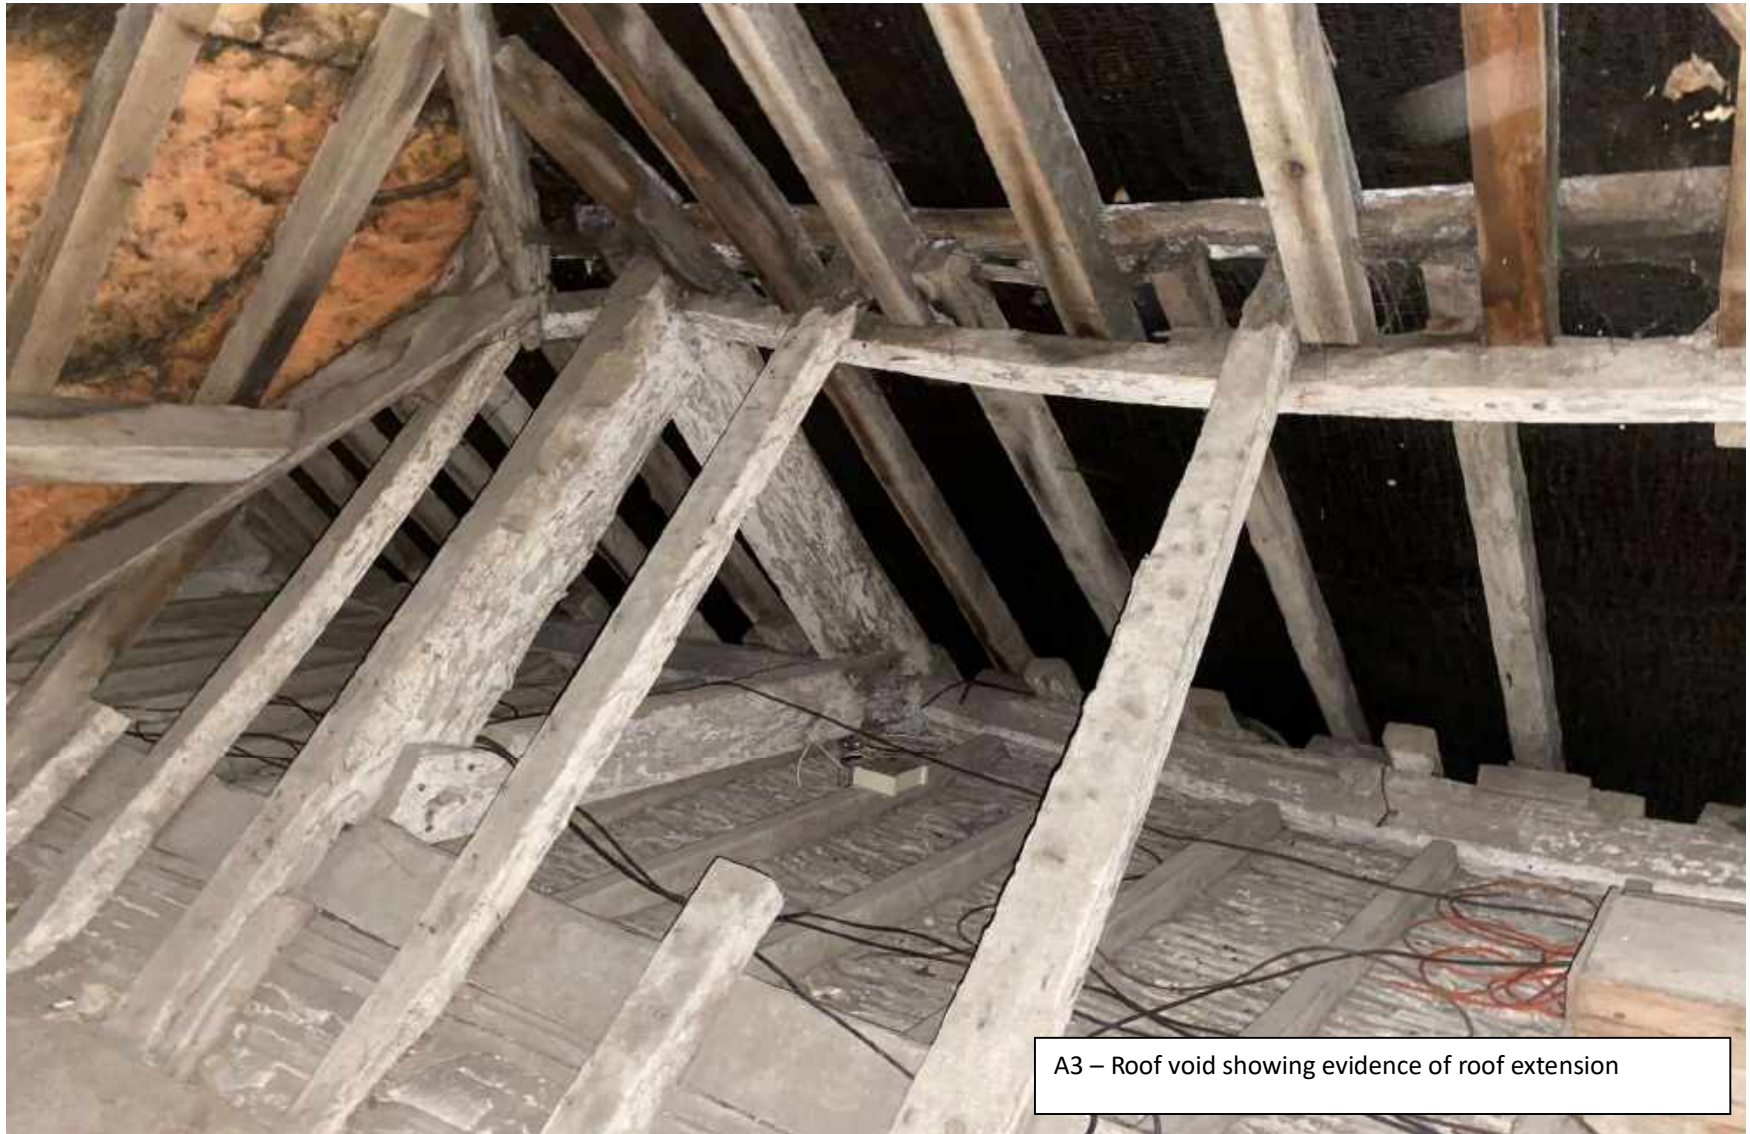
It is a two-storey building comprising stone slates on timber rafters, purlins and raised collar tie trusses. Internal viewing of the roof void (see photographs A3 to A5) clearly shows that the roof was raised, most probably during the Victorian era, to accommodate either the raising or introduction of a first floor. The height of the original eaves line is evidenced by the presence of the original timber wall plate being left in-situ (see photograph A10). Openings within the floor also show evidence of modifications to the first floor and the presence of a sub-floor.

A3 – Roof void showing evidence of roof extension

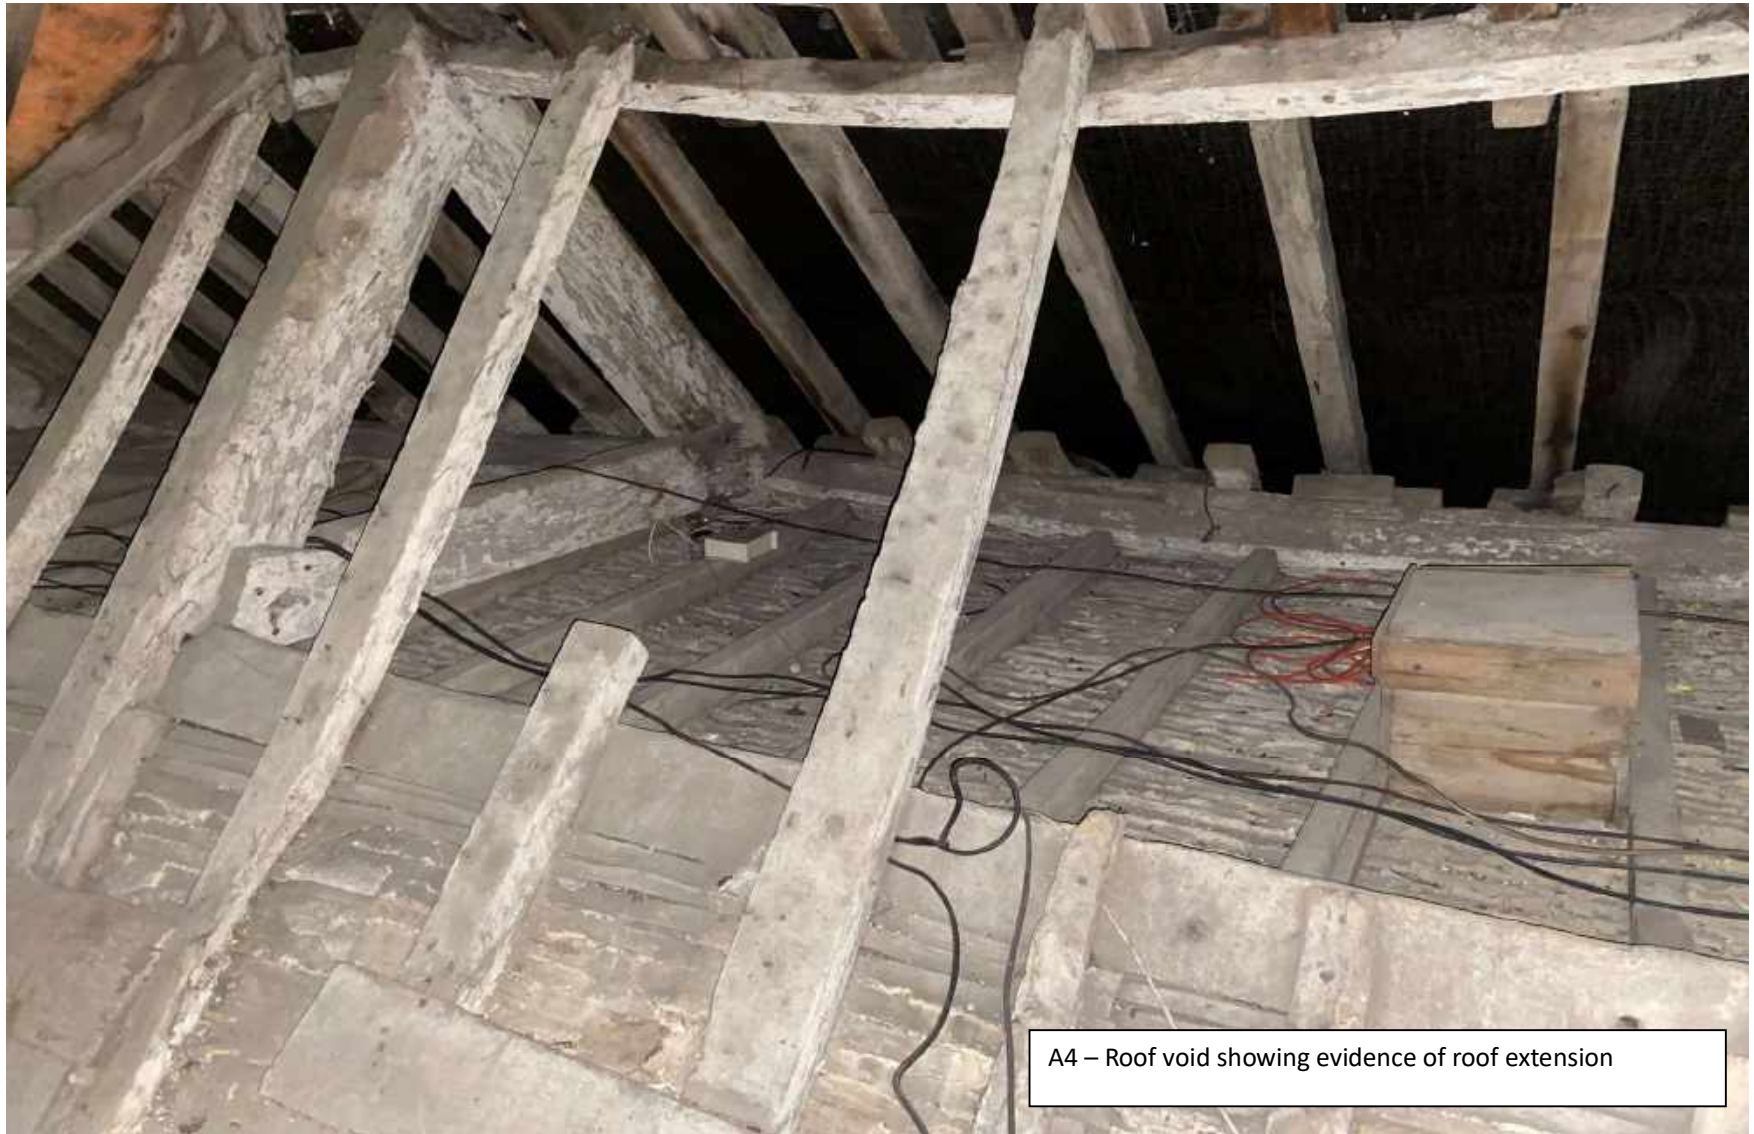
A4 – Roof void showing evidence of roof extension

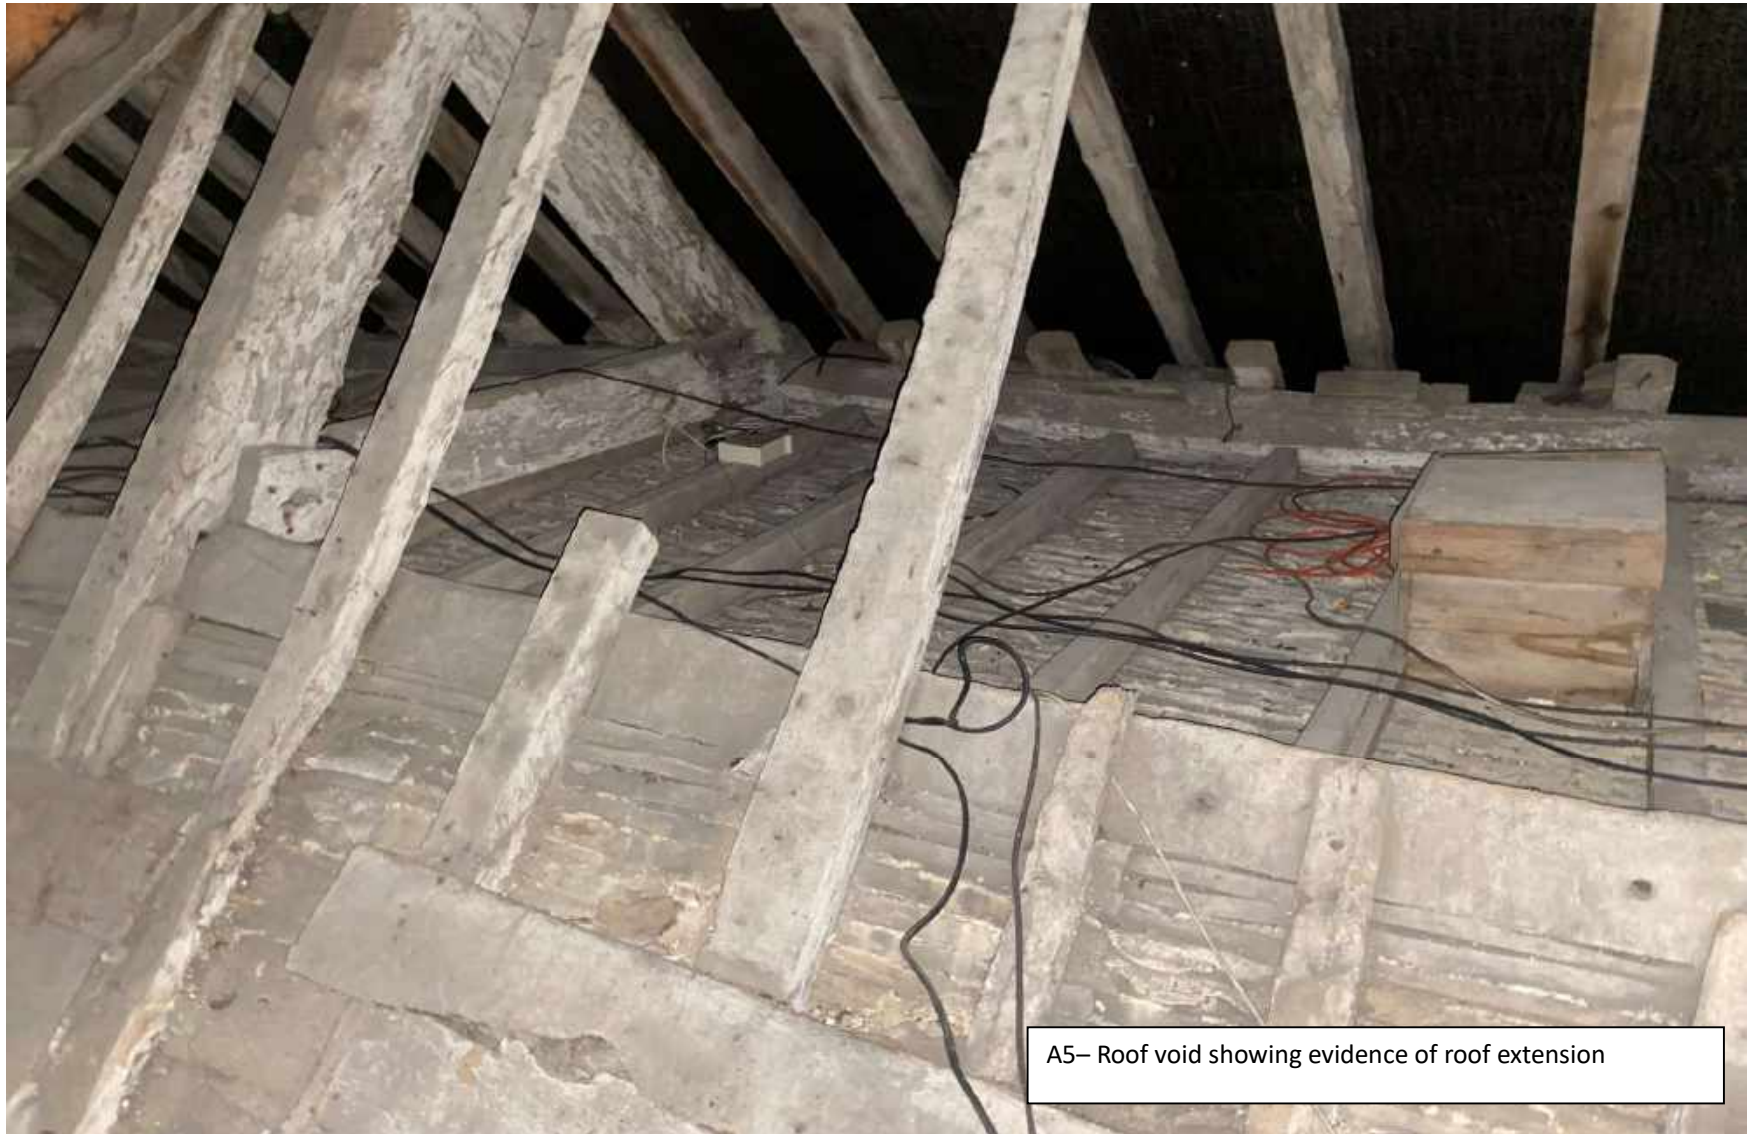
A5– Roof void showing evidence of roof extension

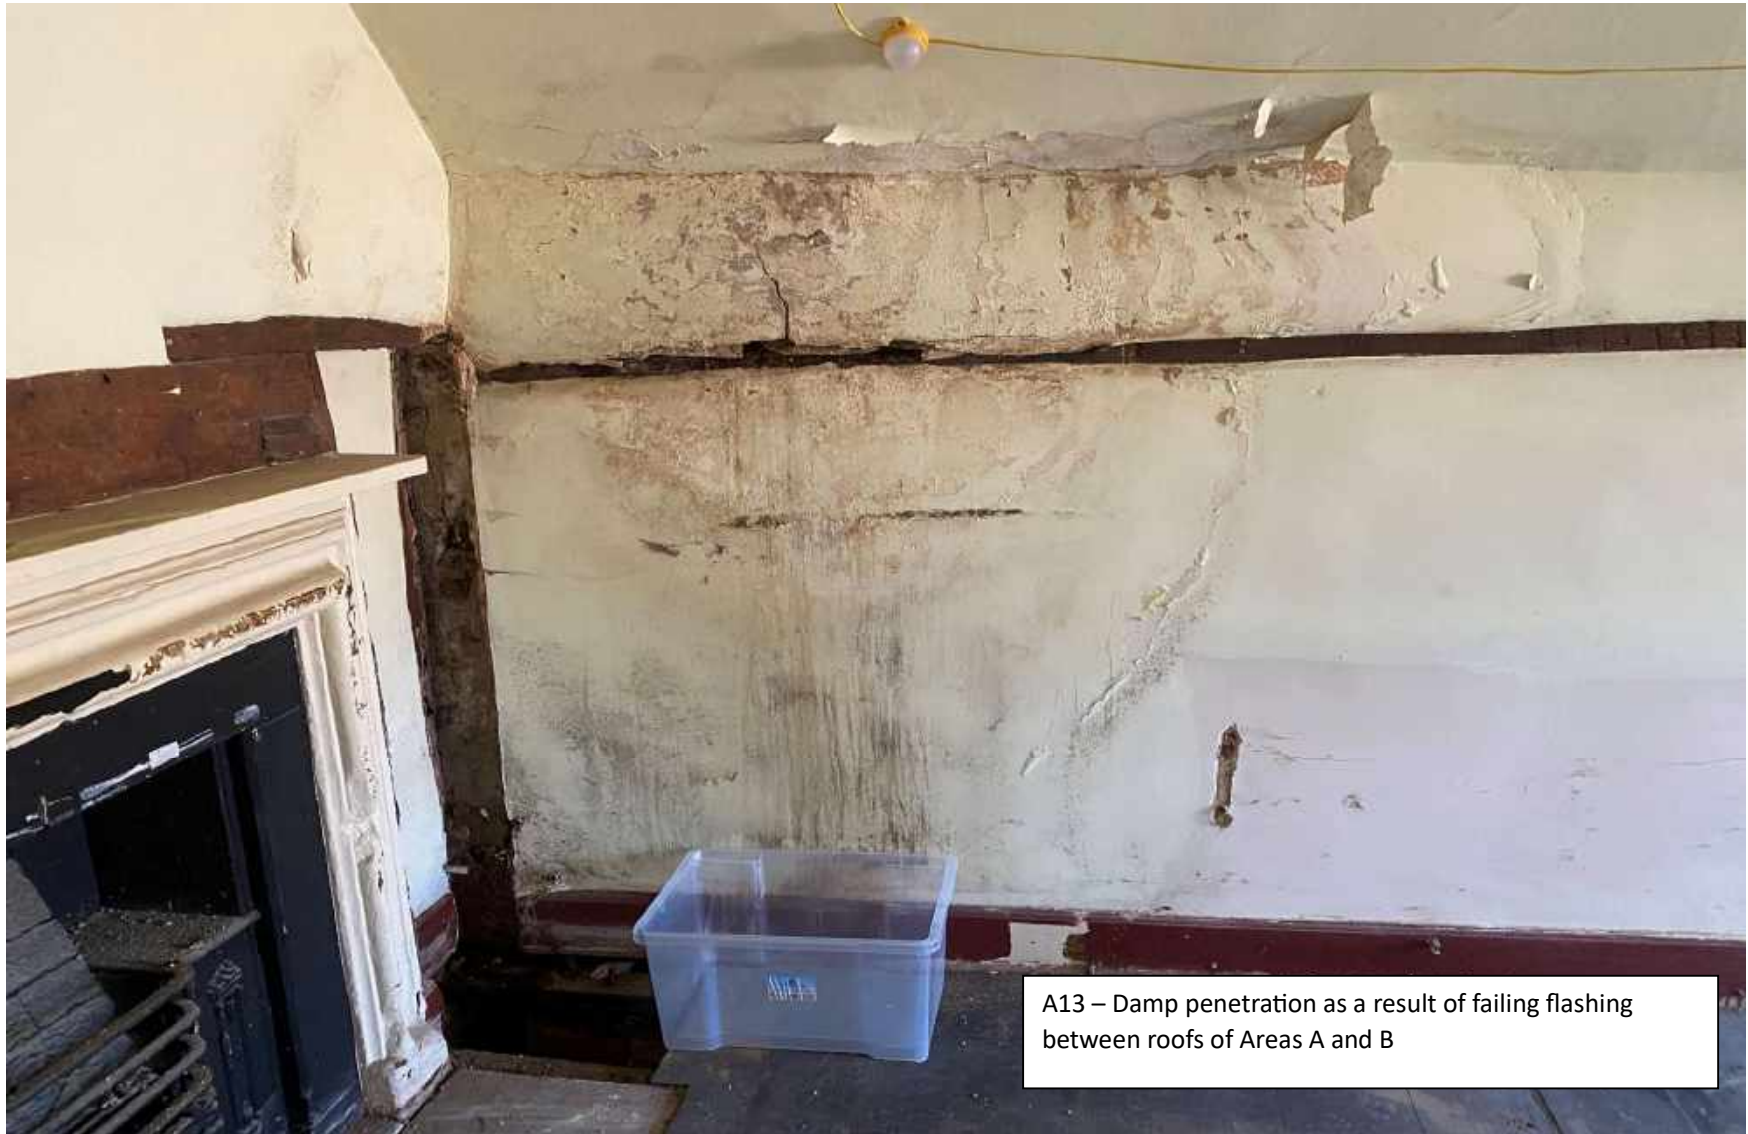
The damage to Area A is largely down to a water ingress and a general lack of regular maintenance.

A13 – Damp penetration as a result of failing flashing between roofs of Areas A and B

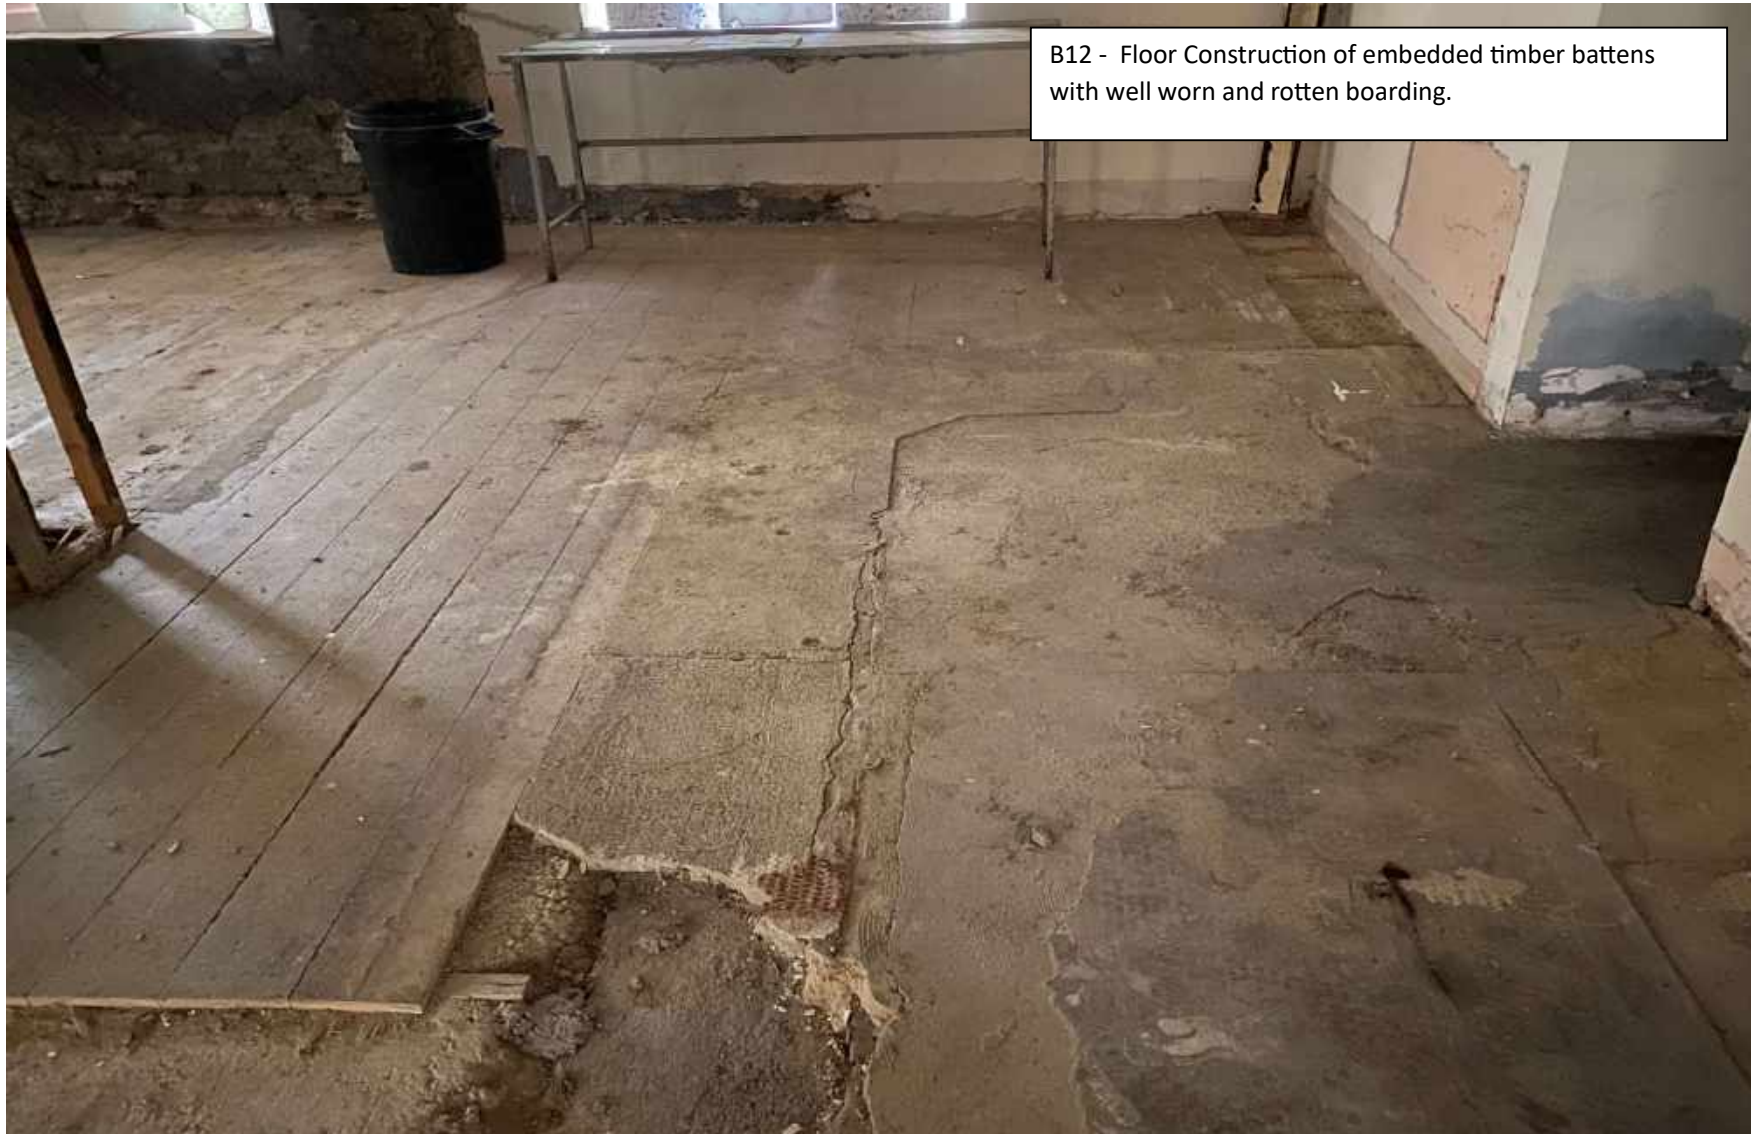
The timbers however are in poor condition and exhibit evidence of wet rot and deterioration from foot traffic. Quite a few areas have had the boards removed and replaced with a screed.

B12 - Floor Construction of embedded timber battens with well worn and rotten boarding.

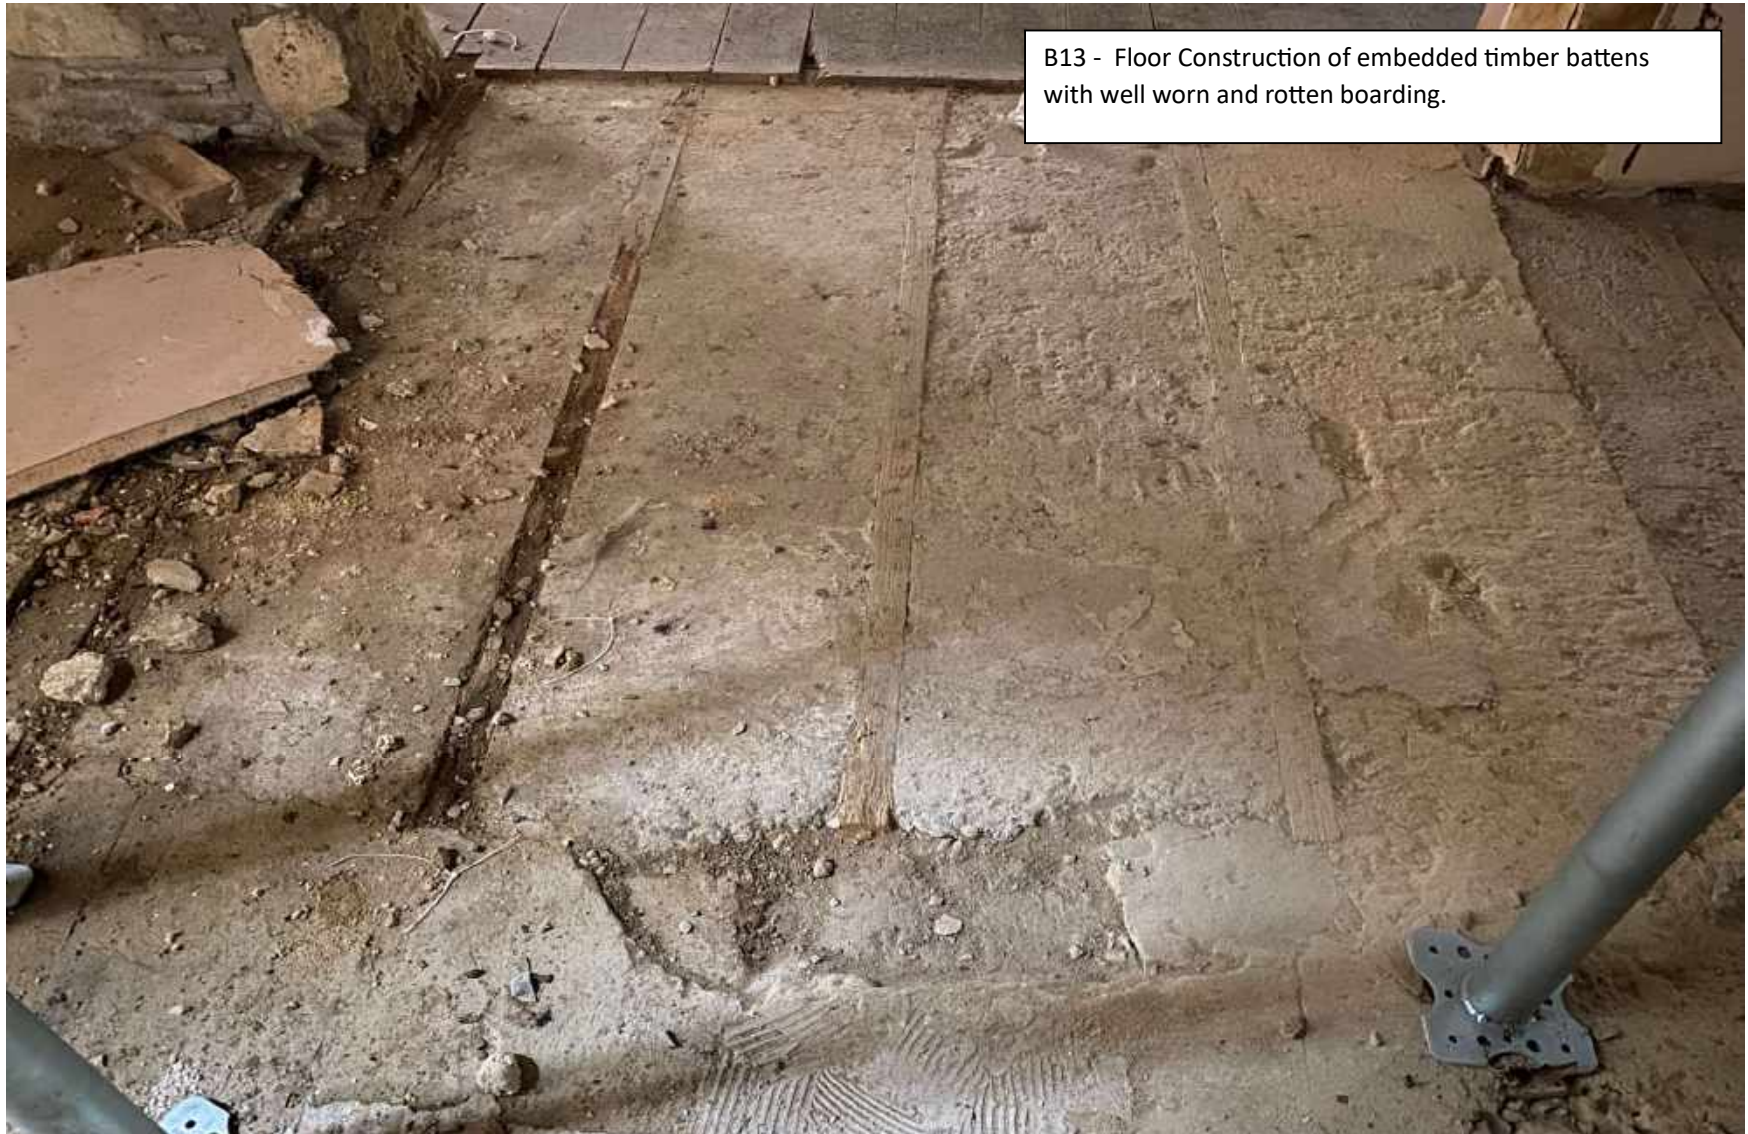
B13 - Floor Construction of embedded timber battens with well worn and rotten boarding.

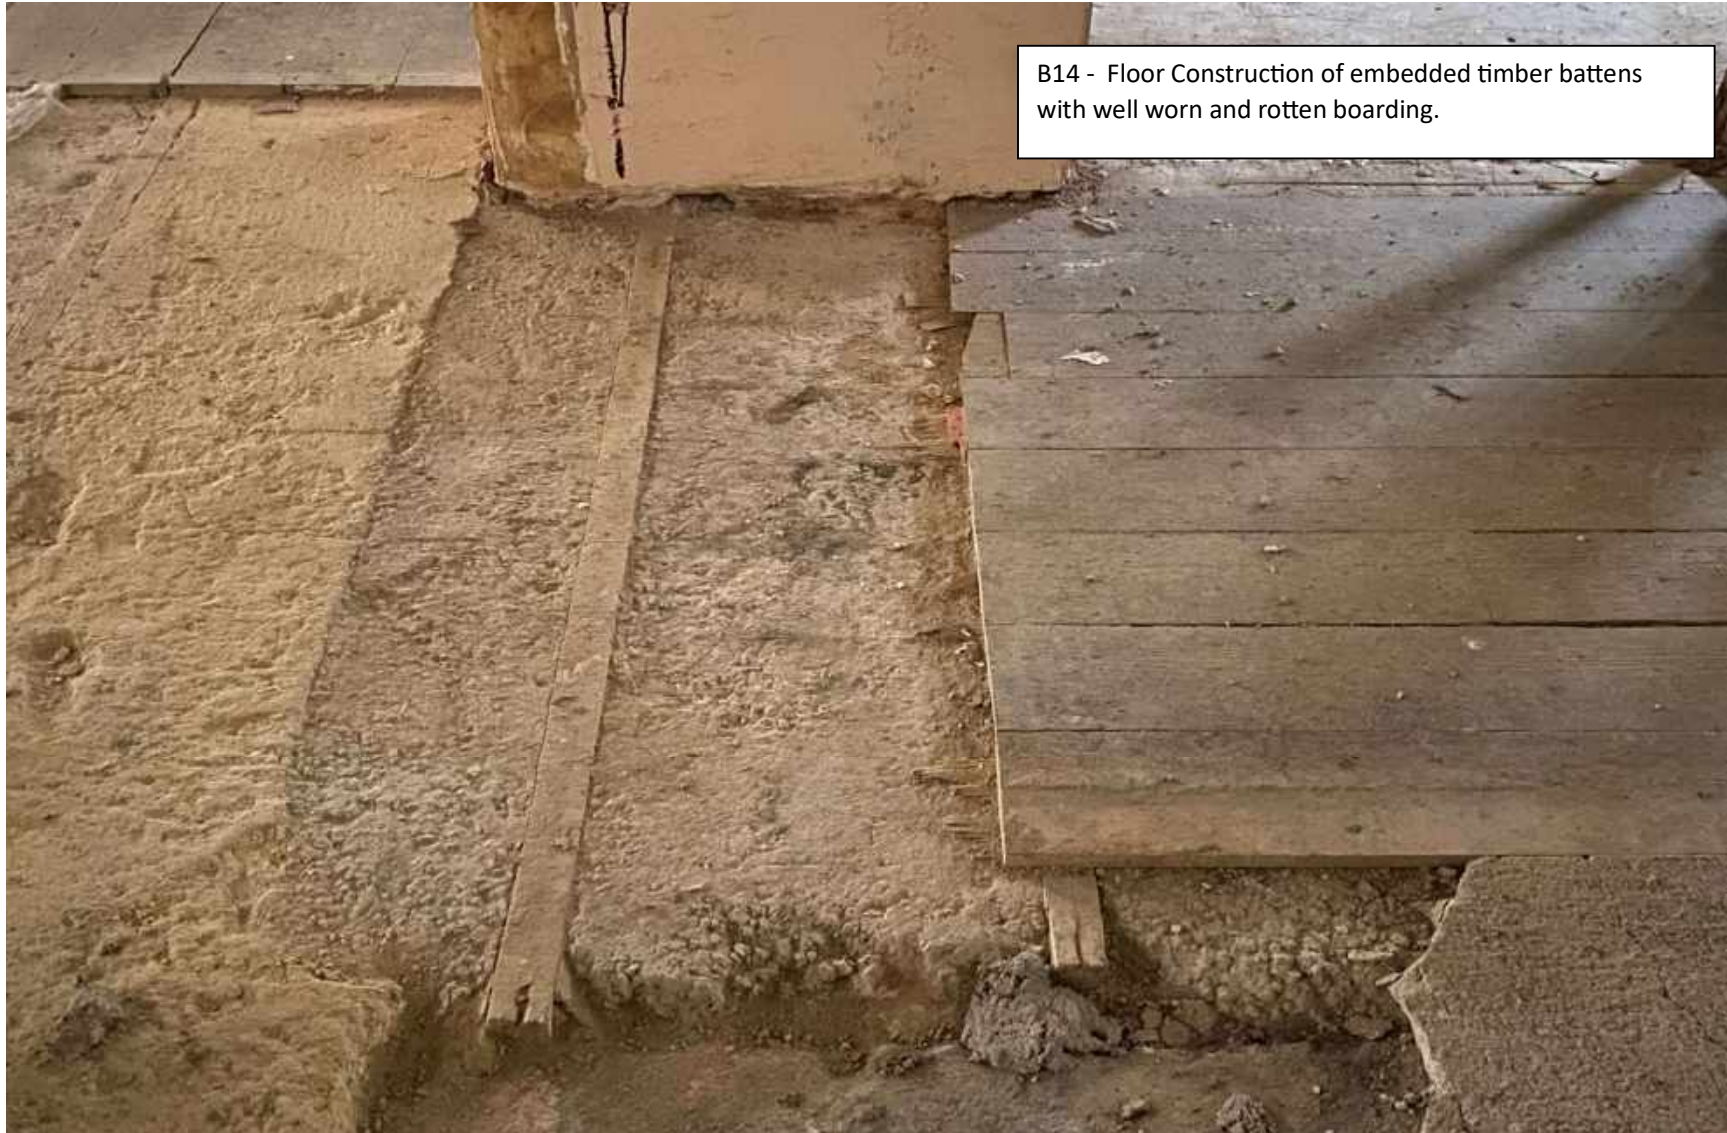
B14 - Floor Construction of embedded timber battens with well worn and rotten boarding.

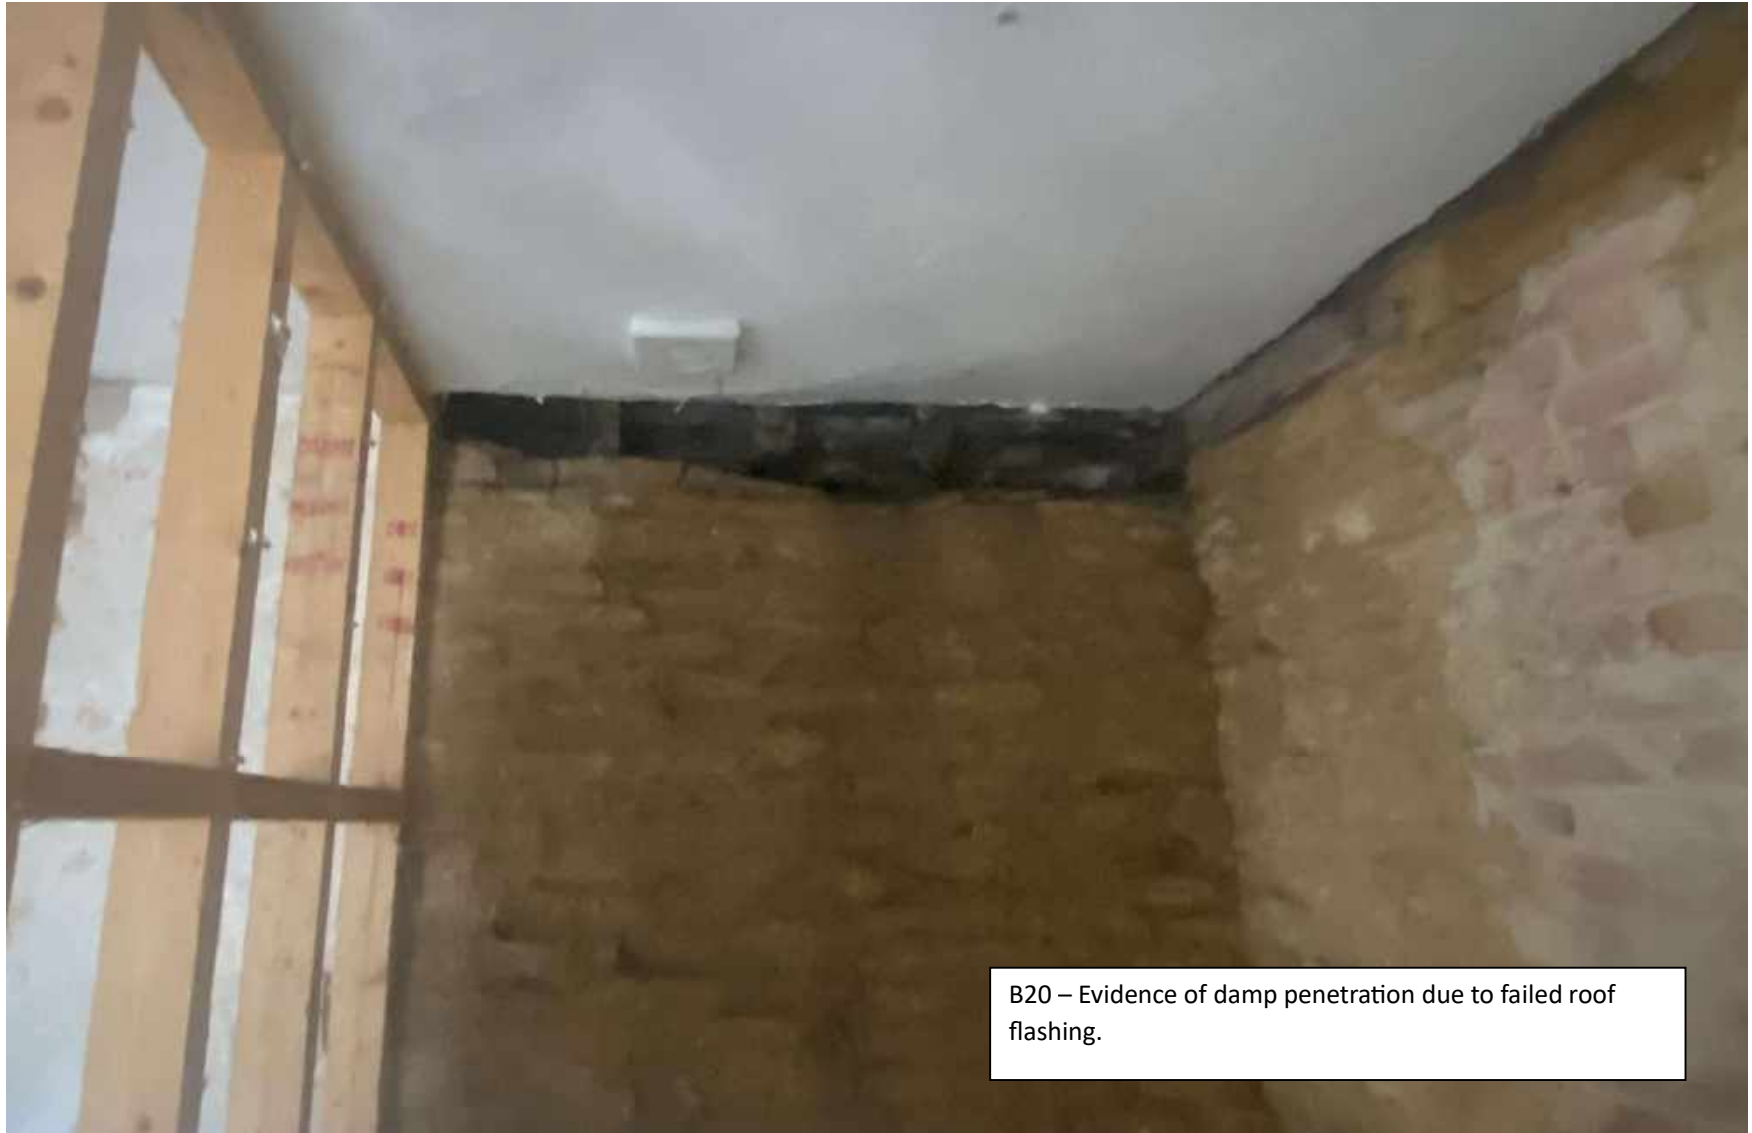
B20 – Evidence of damp penetration due to failed roof flashing.

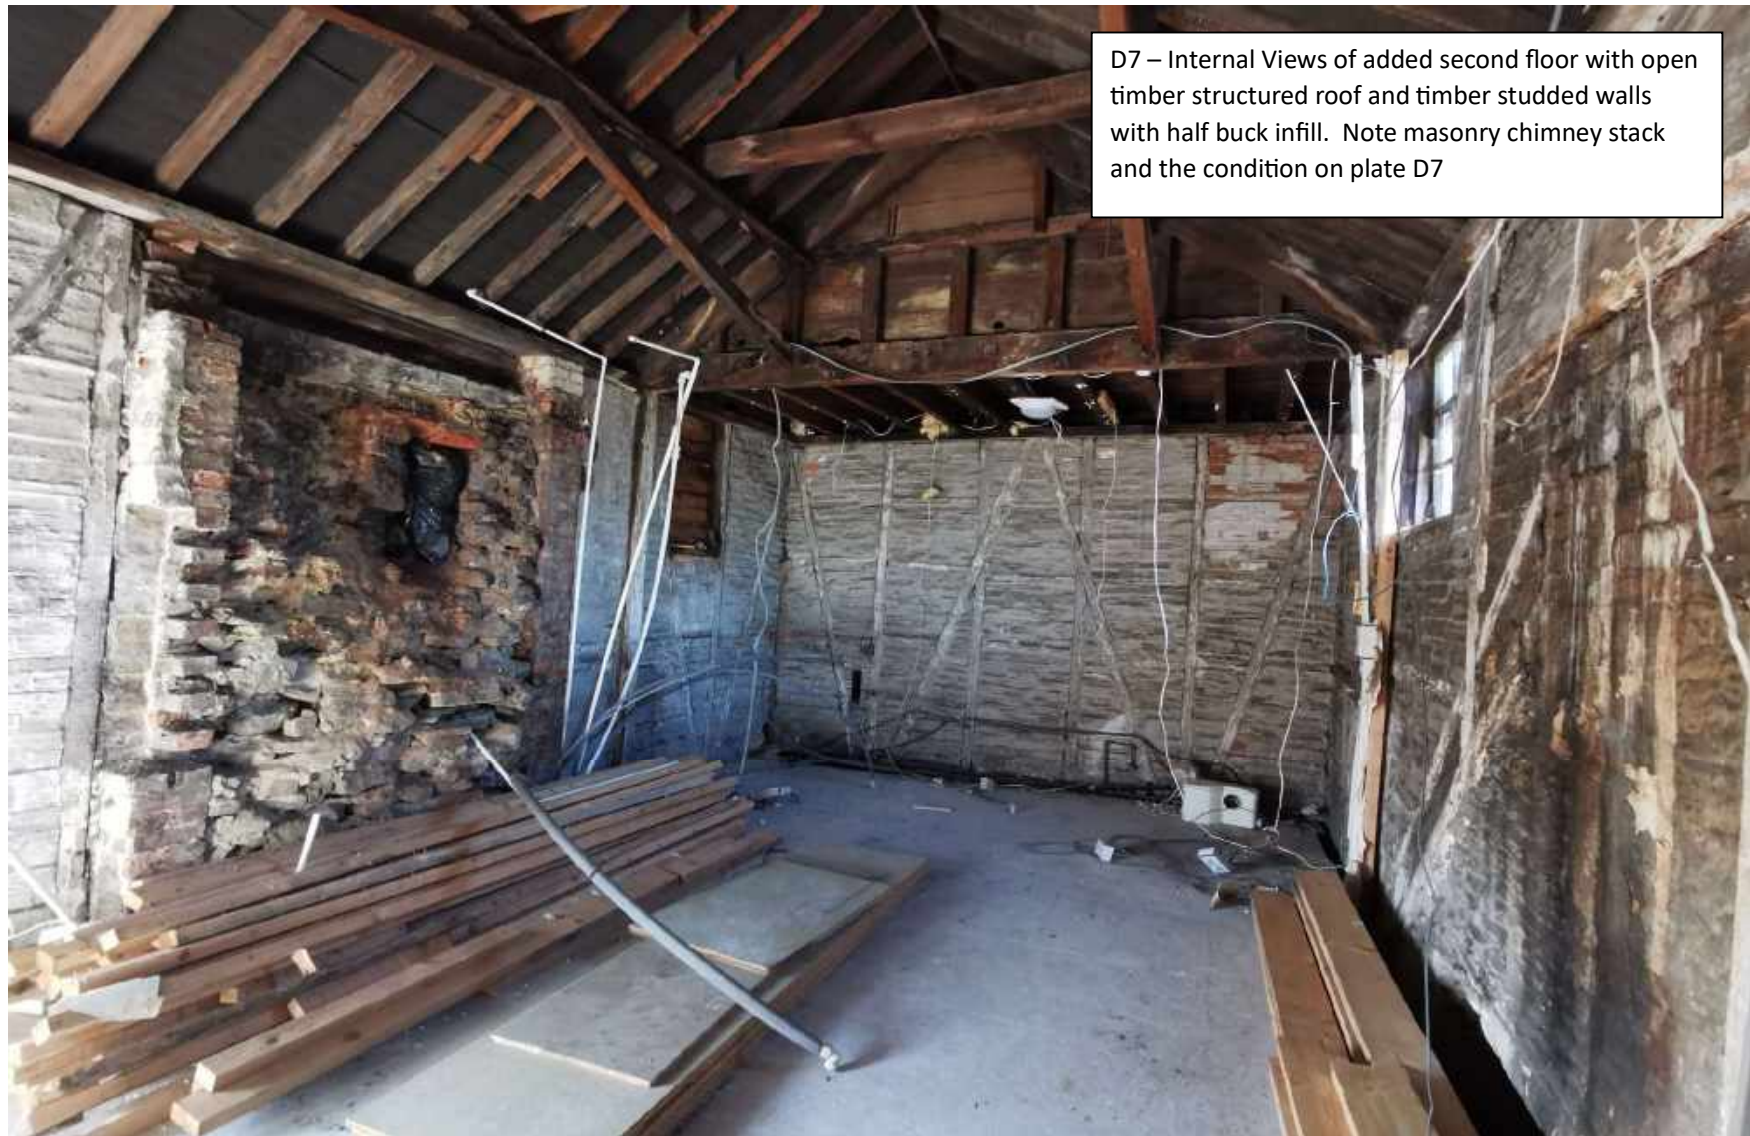
The chimney stack, as can be seen in photo no. D7, is composed of a 'mish mash' of loose and dry bound masonry.

D7 – Internal Views of added second floor with open timber structured roof and timber studded walls with half buck infill. Note masonry chimney stack and the condition on plate D7
