## **STRUCTURAL APPRAISAL**

**THE CARPENTERS ARMS, LACOCK, WILTS, SN15 2LB**

**MR ADRIAN GOTT**

**Project** : 2022.270  
**Date** : February 2024  
**Engineer** : G.Schofield C Eng, MI Struct E, MICE, MIEI  
**Issue No: 1** : 21.02.2024

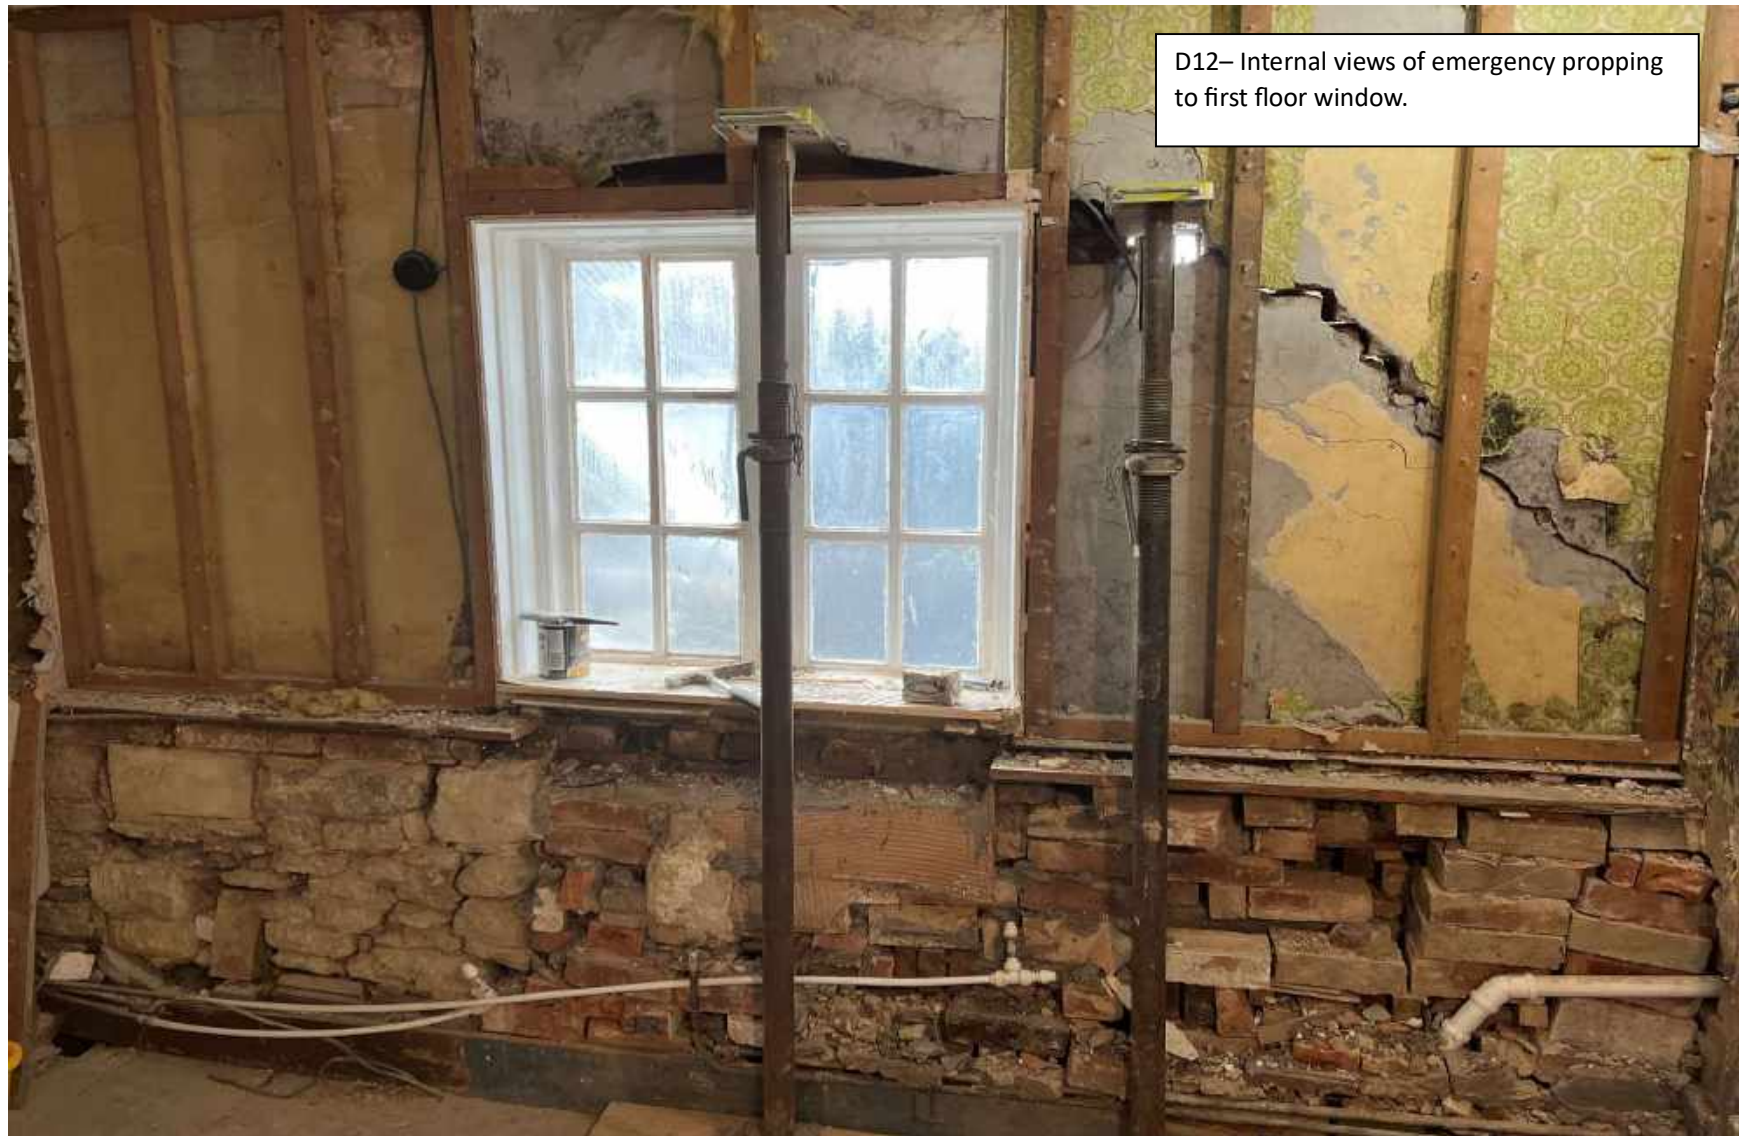
**The most serious and potentially dangerous structural deficiency to the Carpenters Arms is the rear wall at first floor, Area 'D'.** Referencing the Photographs D9 to D24 structural alterations in the past has been carried out to a very poor standard leaving a situation which could quite easily cause collapse. Emergency propping at first and ground floor has been carried out. Combined with the loose masonry (brick and stone) infill beneath the first-floor window (Photo D9) the first floor wall is supported off bressummer beams which are suffering from wet (Photograph D19 & D20) and possibly dry rot. This inadequate support arrangement has led to a partial collapse of the wall above as witnessed by the stepped crack leading from the head of the

window (Photographs D12 & D13). The crack penetrates the full wall thickness (Photographs D23 & D24).

D12- Internal views of emergency propping to first floor window.

**The condition to this area of the building is serious and we strongly recommend the situation be rectified with urgency.**

- Strip roof to Area D and replace, preferably with a pitched roof to marry with remainder of the roof.
- Walls to second floor, Area D to be replaced and strengthened or taken down and rebuilt.

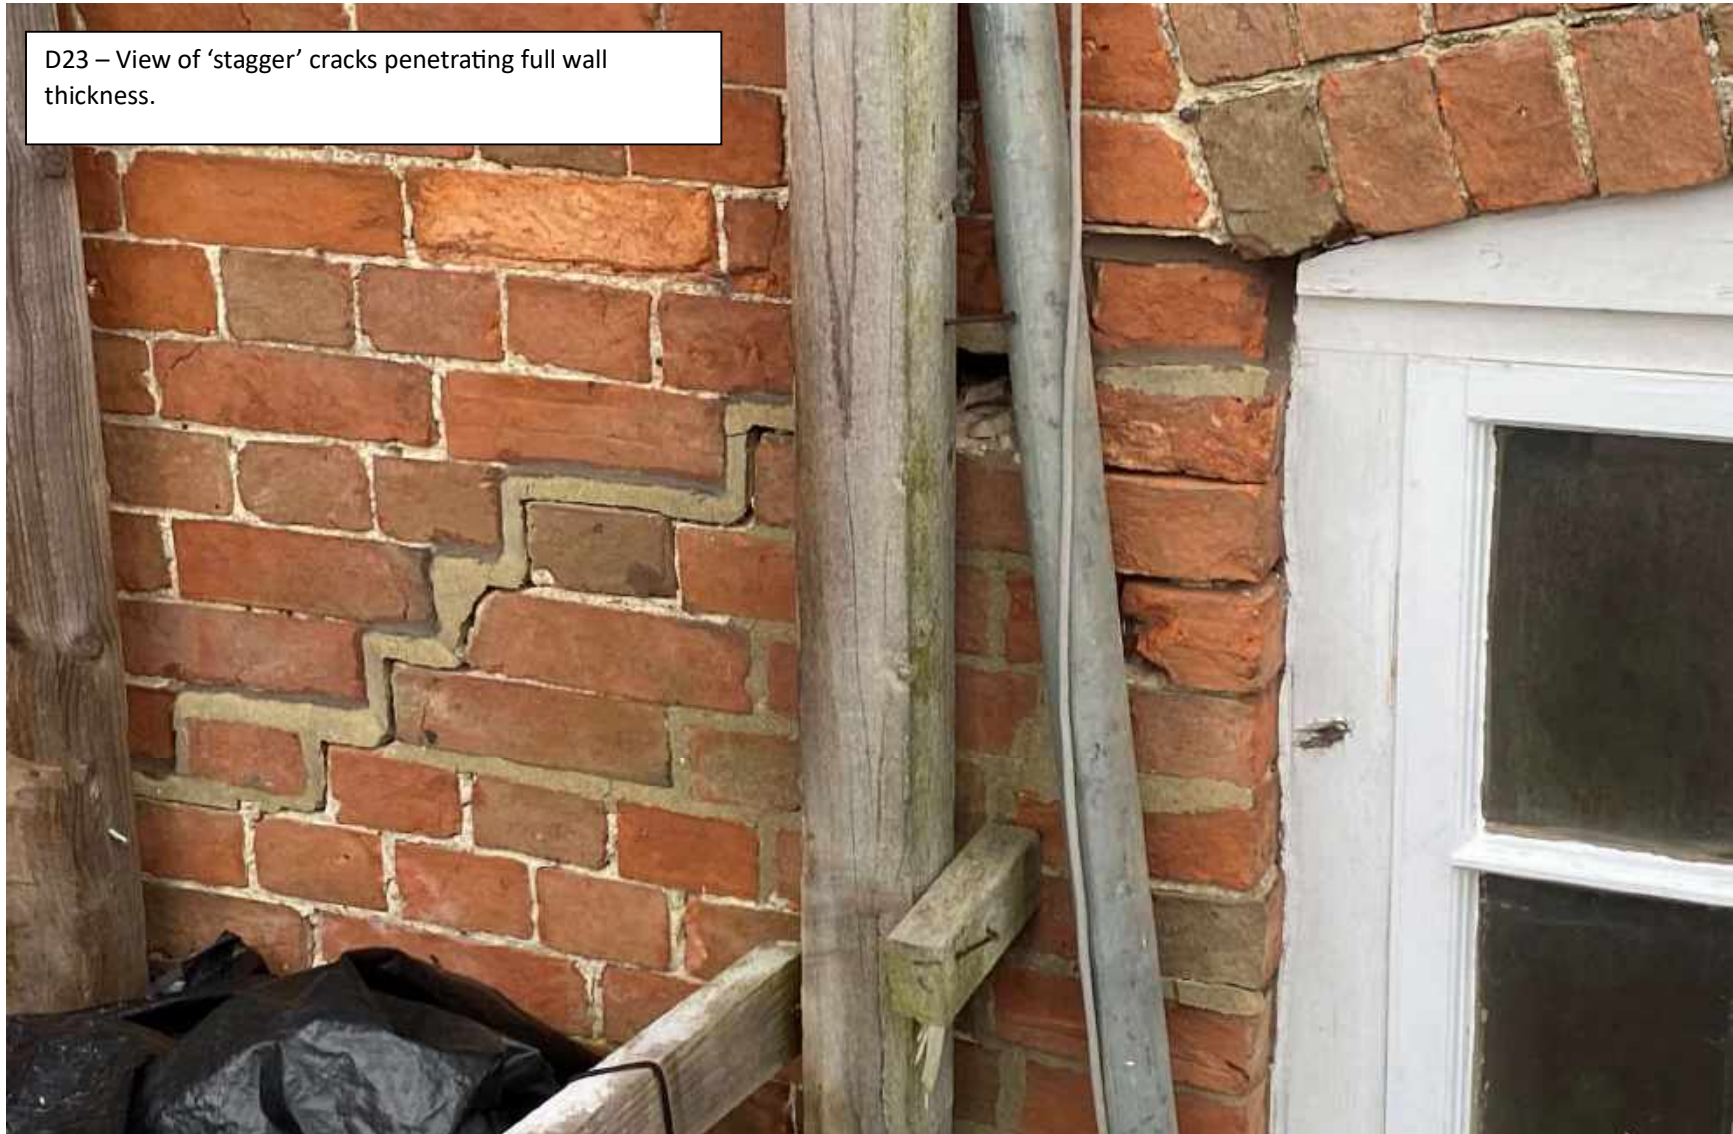
D23 – View of 'stagger' cracks penetrating full wall thickness.

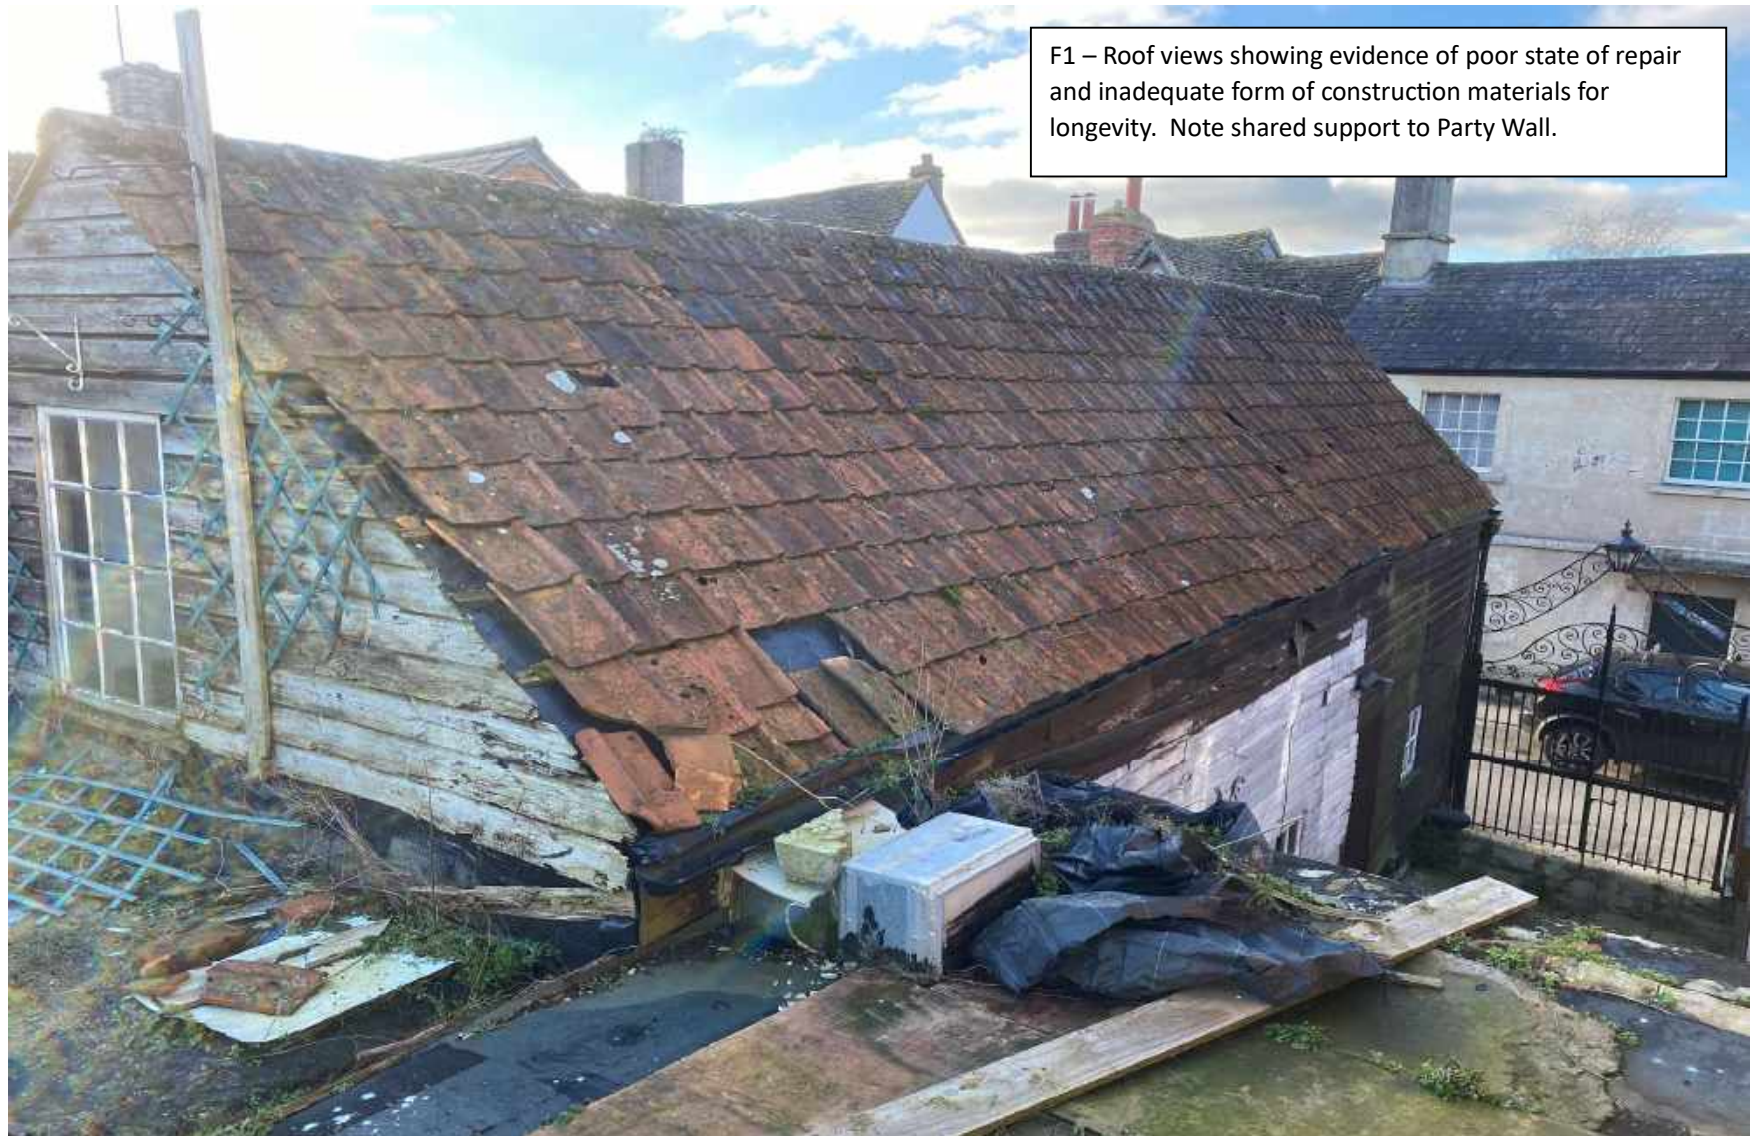
Photographs F1 to F3 show the poor condition of the clay roof tiling, gutter (warped plastic) and flashings. The weather boarding to the south pike has not been maintained and is serving no real purpose.

F1 – Roof views showing evidence of poor state of repair and inadequate form of construction materials for longevity. Note shared support to Party Wall.

- Area 'F' is of an "agricultural" standard and is therefore structurally inadequate for habitable personnel use. Its outer skin of weather boarding together with the timber support posts are particularly in poor condition.
- We recommend a Specialist Timber Survey be undertaken once consent has been given to open up areas for inspection.

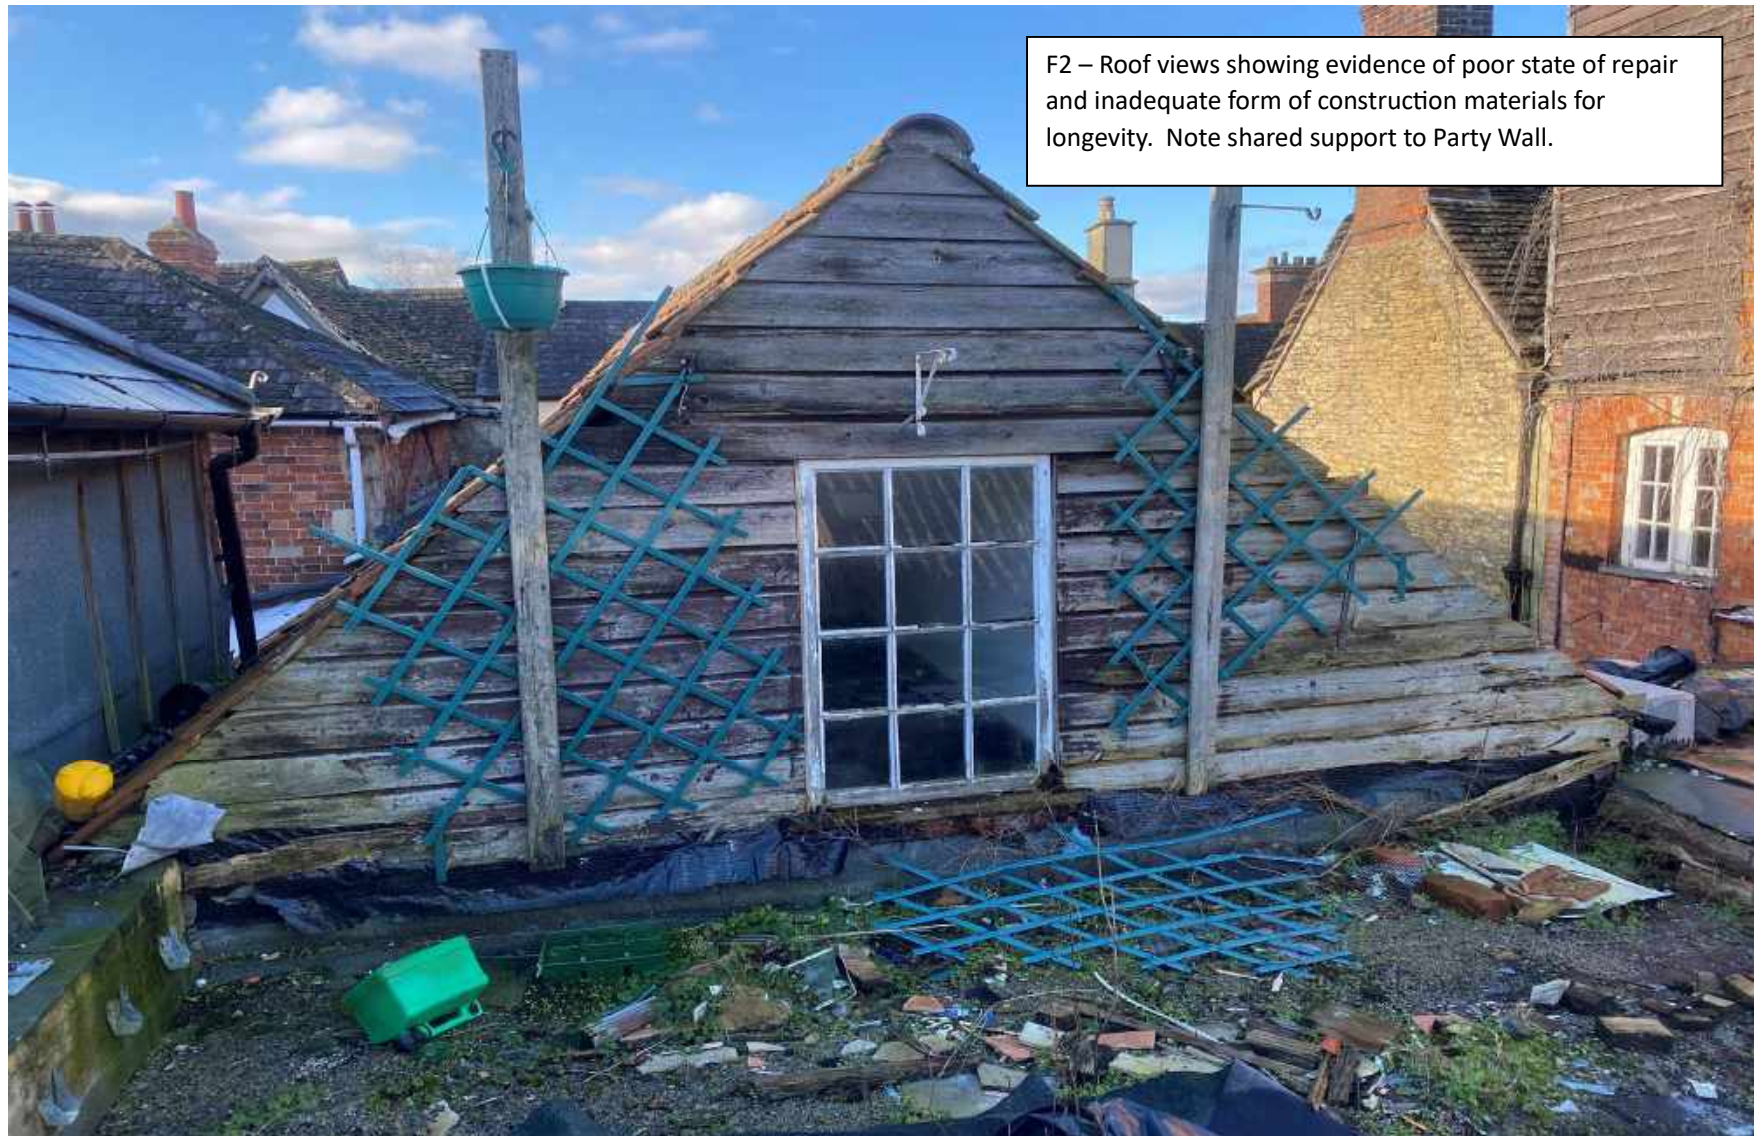
F2 – Roof views showing evidence of poor state of repair and inadequate form of construction materials for longevity. Note shared support to Party Wall.

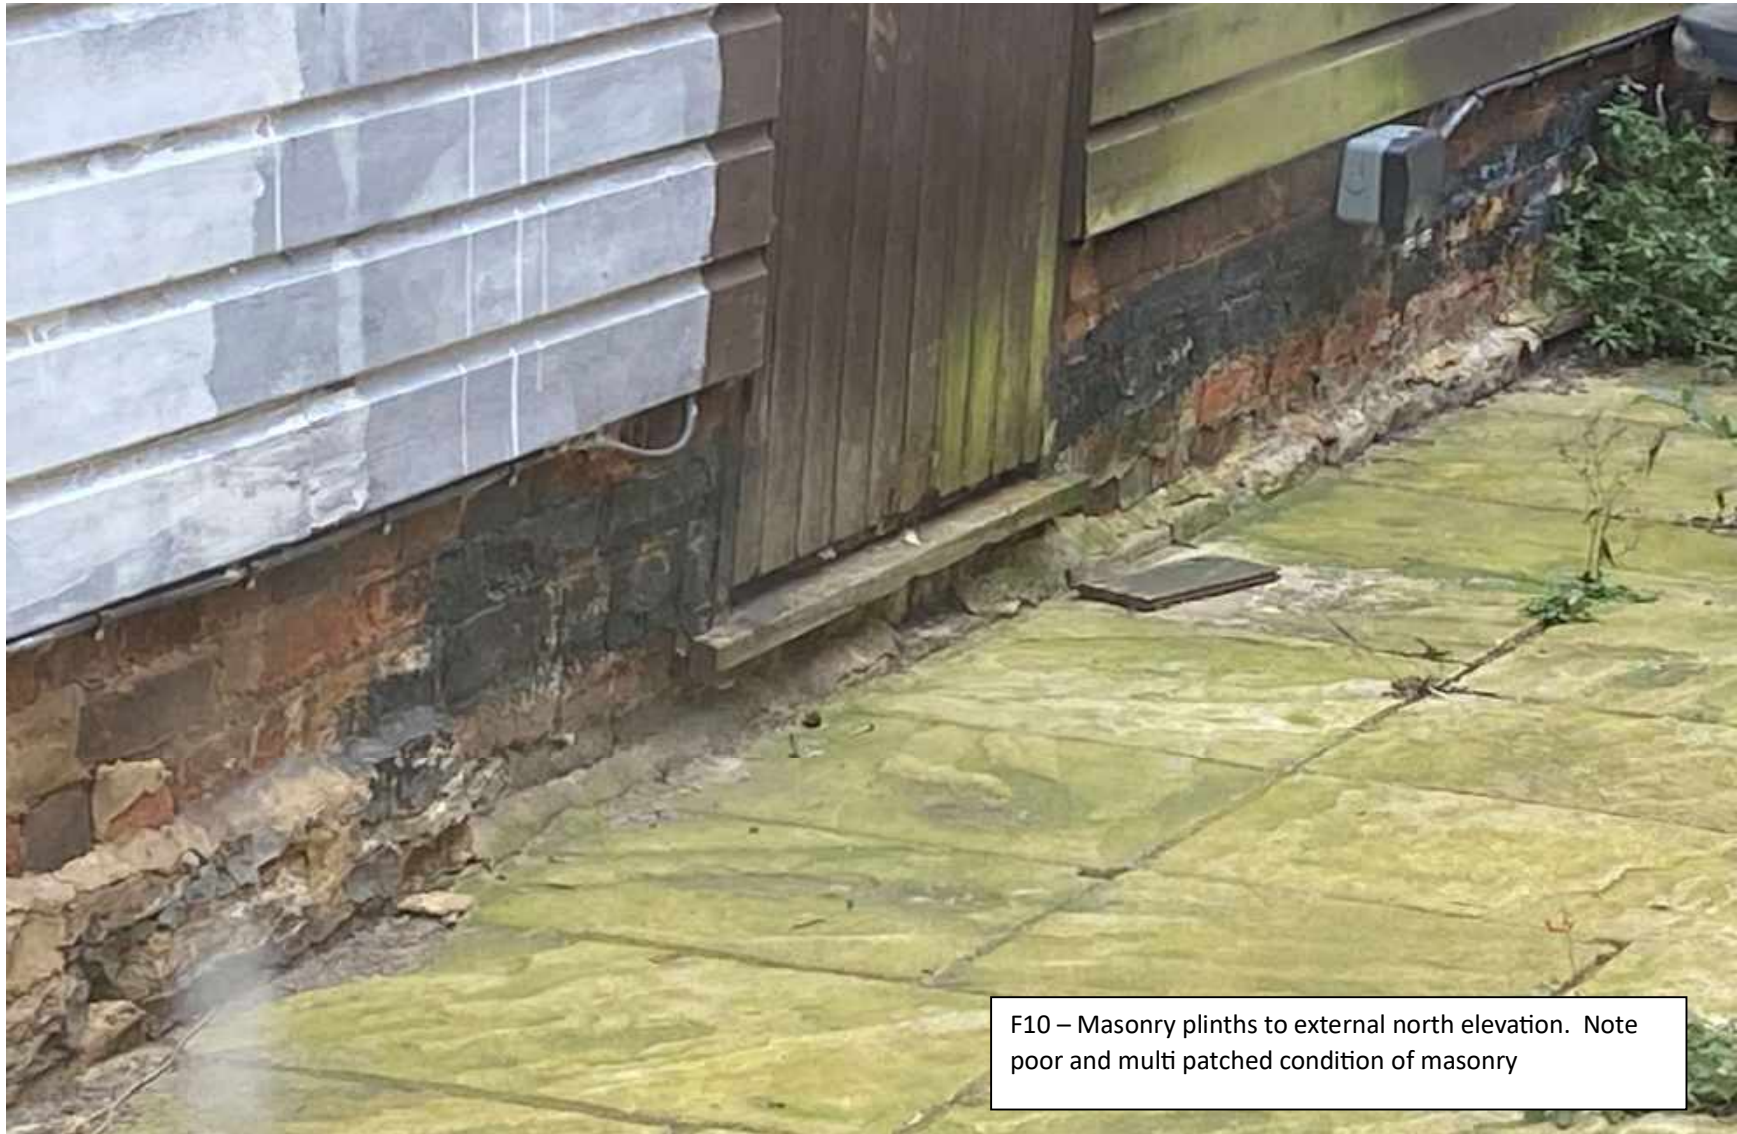
F10 – Masonry plinths to external north elevation. Note poor and multi patched condition of masonry

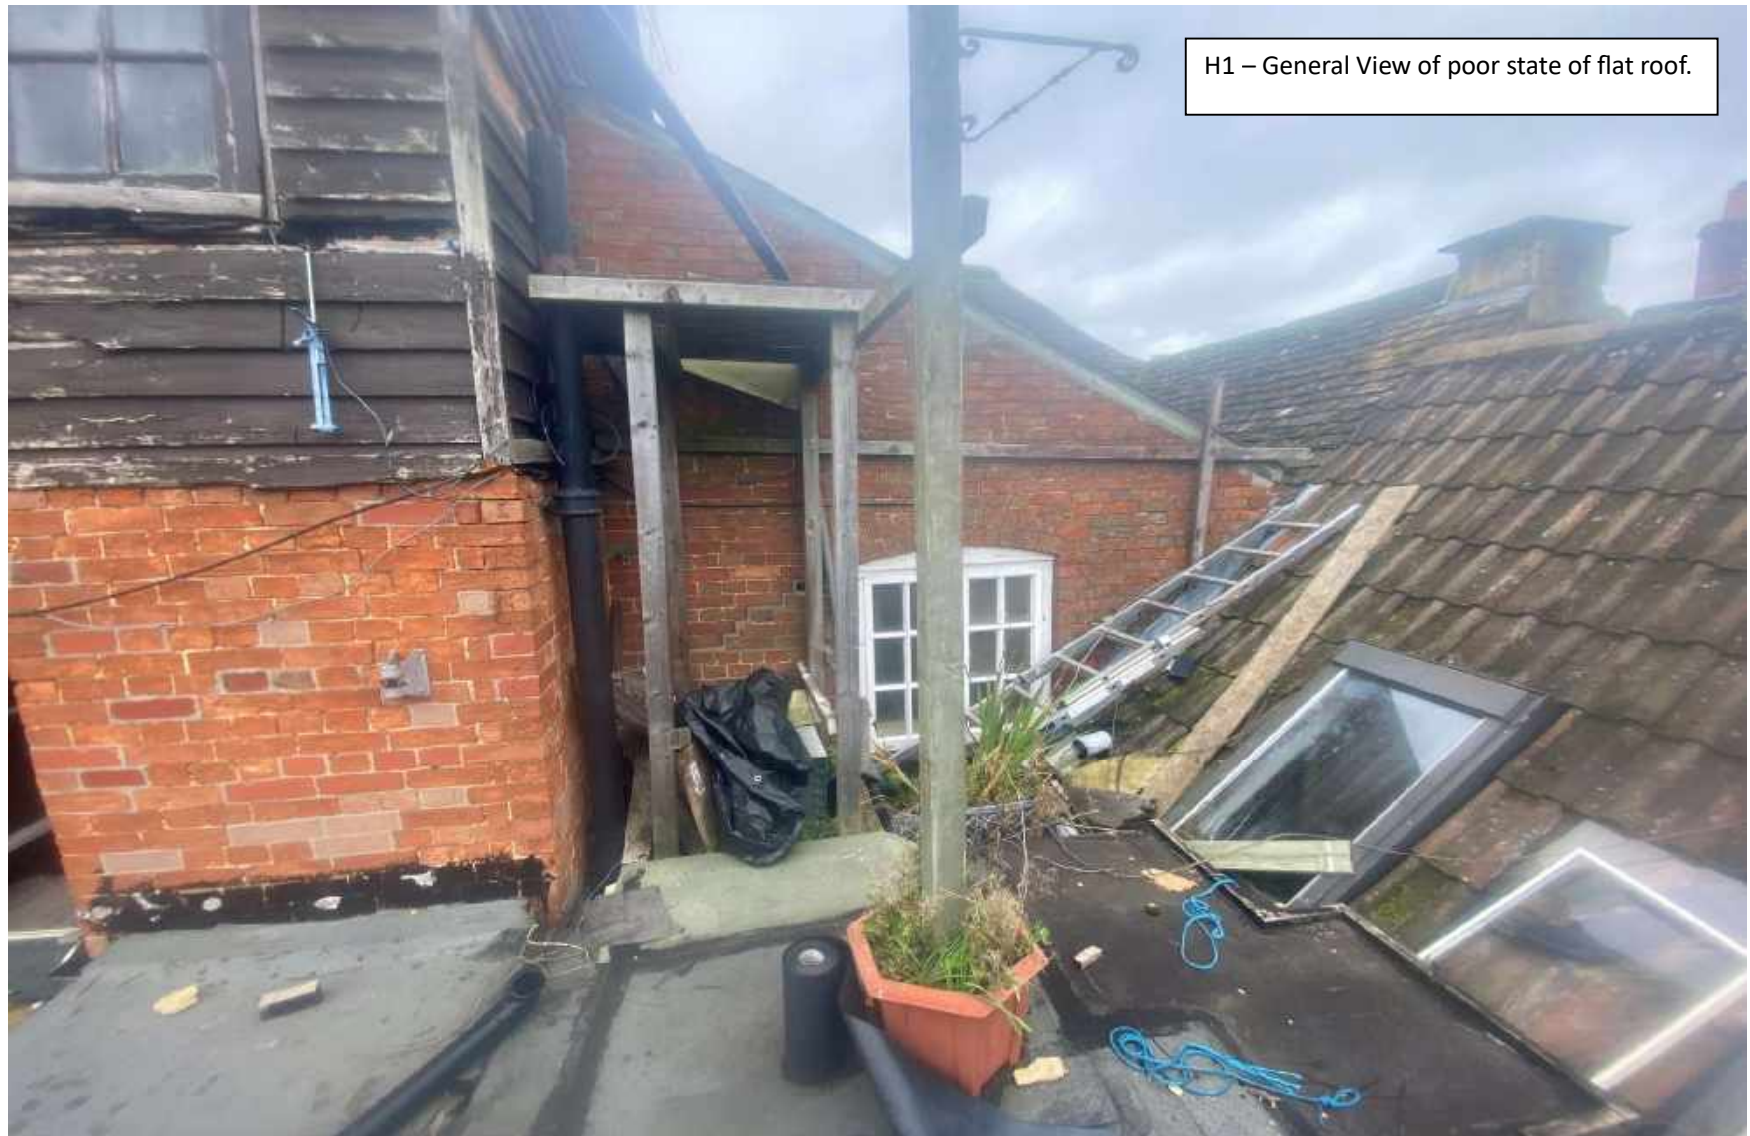
The 'built up' flat roof is on a poor state of repair and requires replacing. We would anticipate a large portion of the roof joists also require renewal due to the effects of rain penetration.

H1 – General View of poor state of flat roof.

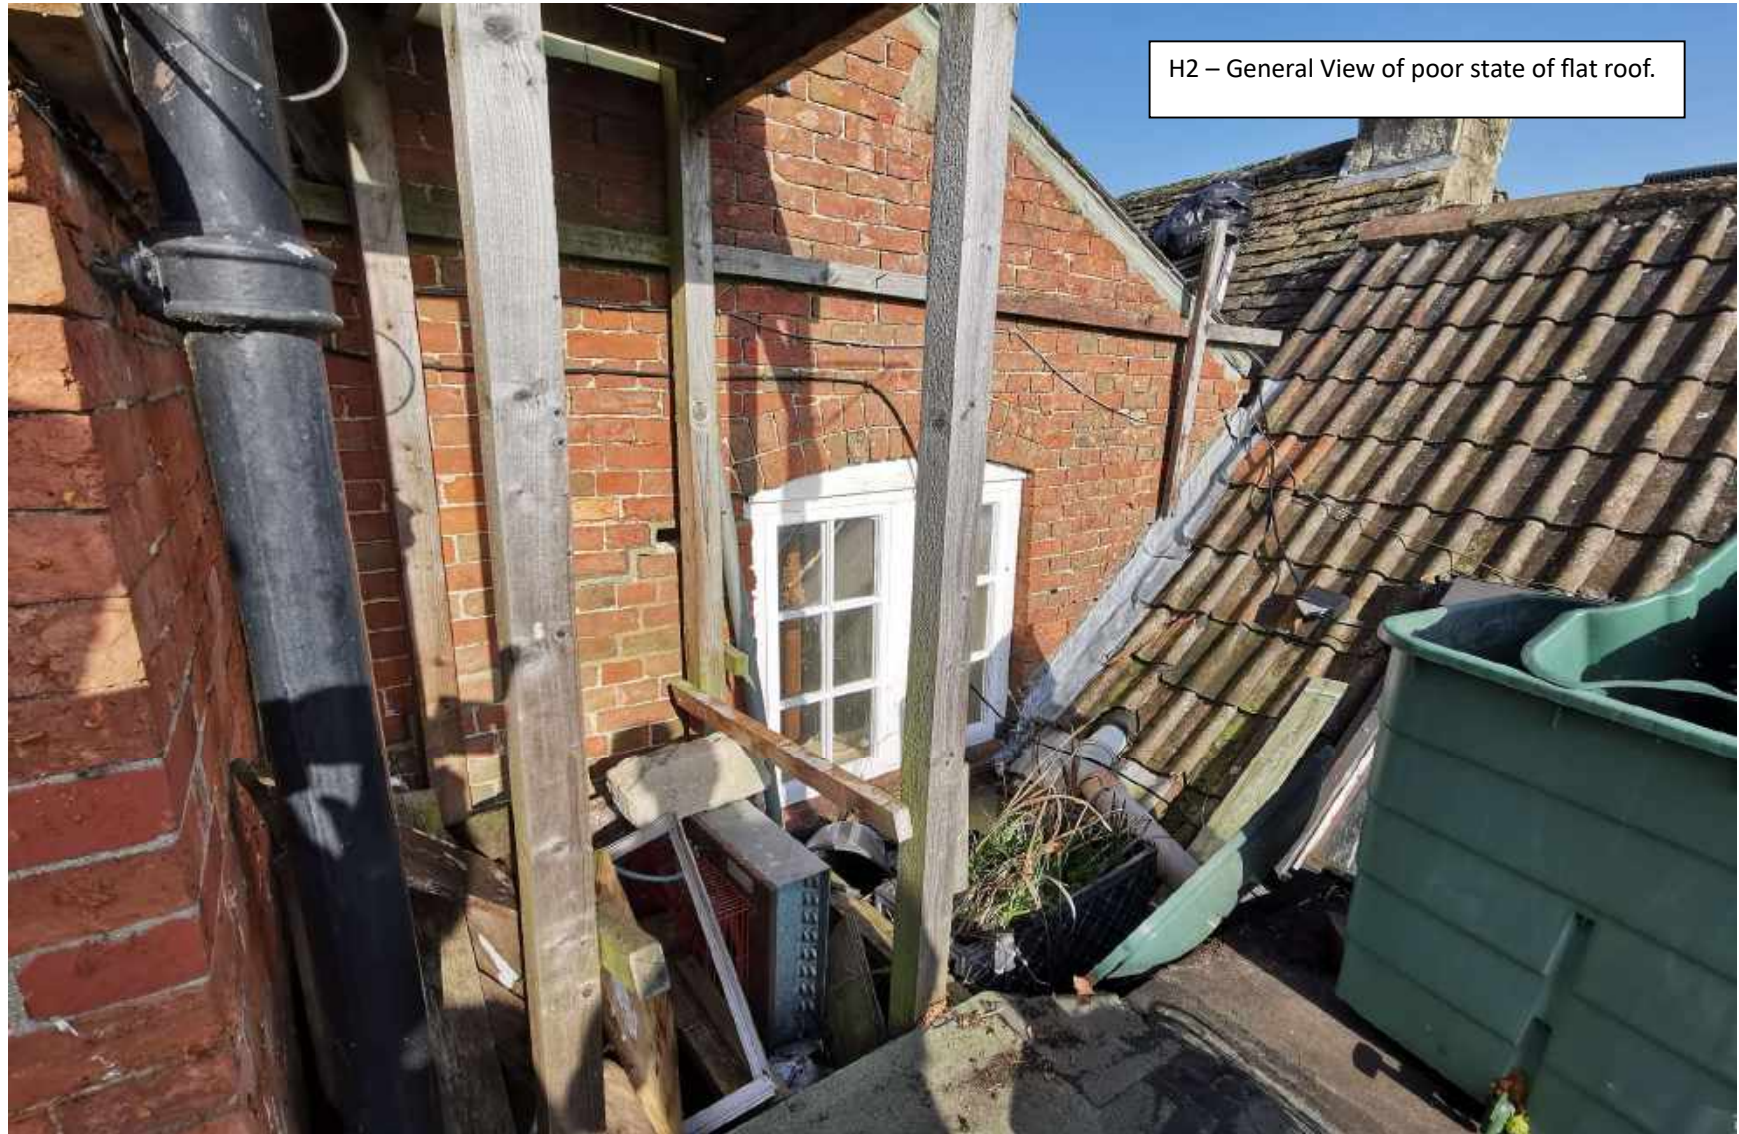
H2 – General View of poor state of flat roof.
