Mann Williams  
Consulting Civil and  
Structural Engineers

# Southview Farm Drynham Lane Trowbridge

## Inspection Report

| Job Number: | 11890 |

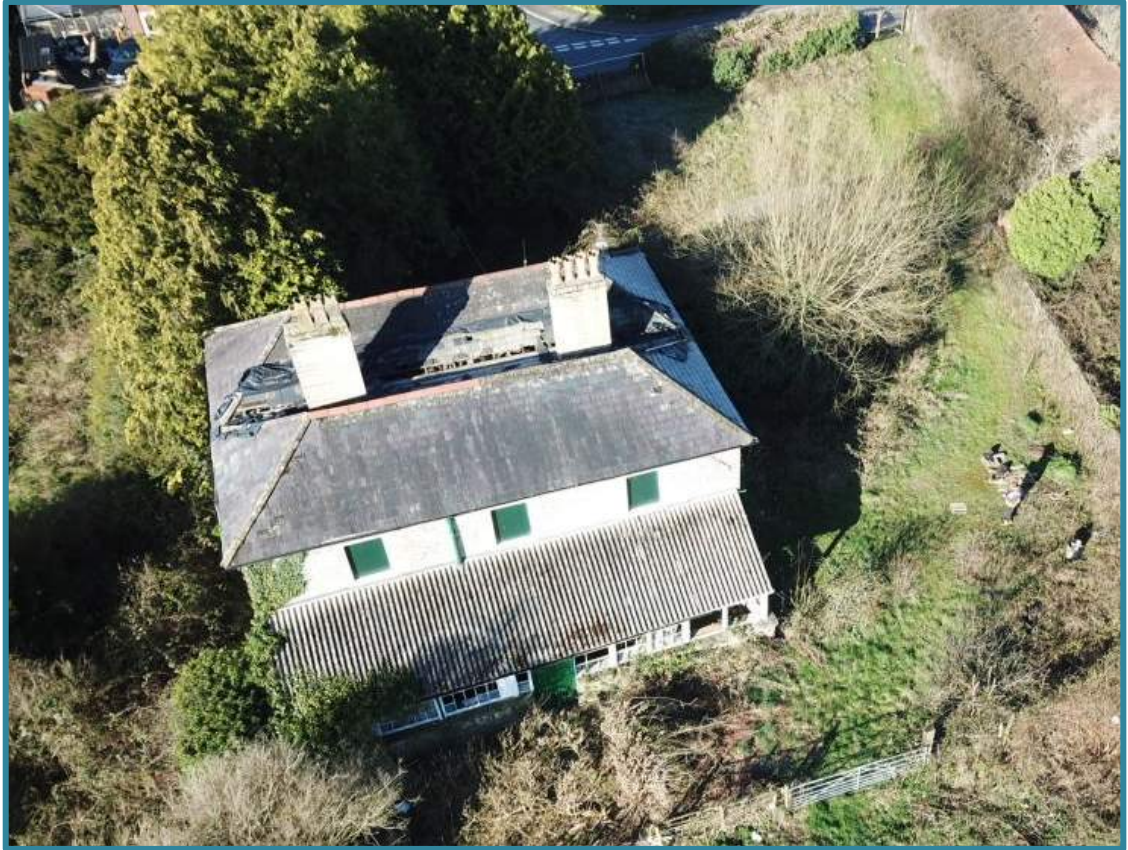
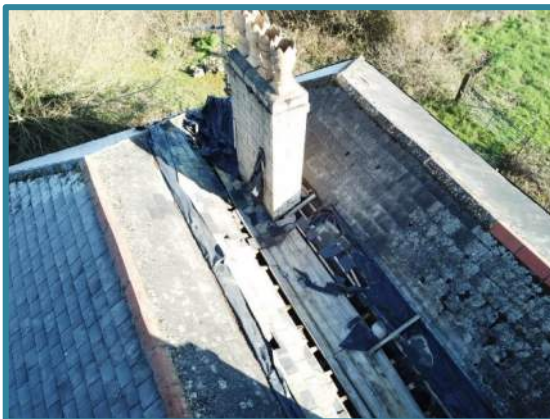
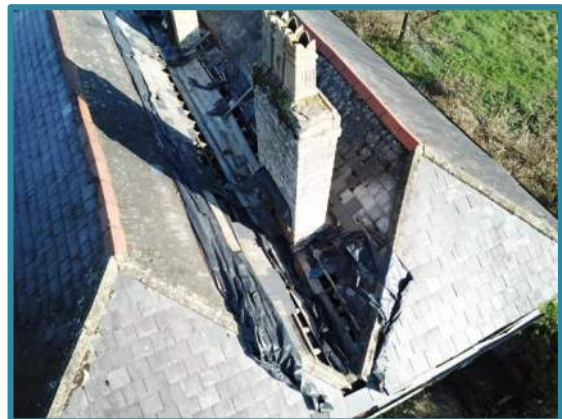
Figure 1 Farmhouse – aerial view from northeast aspect

Figure 2 – Central Valley Northwest

Figure 3 – Central Valley Southeast

- 2.1.2 As can be seen in figures 1, 2 & 3 the central roof valley has no lead flashing (presumably stolen) and the temporary plastic sheeting has displaced revealing the valley boards beneath and voids into the roofspace / centre of the property.

- 2.1.3 Due to the damage caused by the penetrating rainfall into the centre of the property there is a lot of localised damage and the structure immediately beneath the central valley was saturated at the time of the survey (refer below).

- 3.1.8 The roof finishes should be removed, roof timbers repaired where necessary, new underfelt provided and roof finishes and flashings replaced in order to prepare for drying out the building internally. It could take upwards of a year to fully dry out the saturated internal walls.

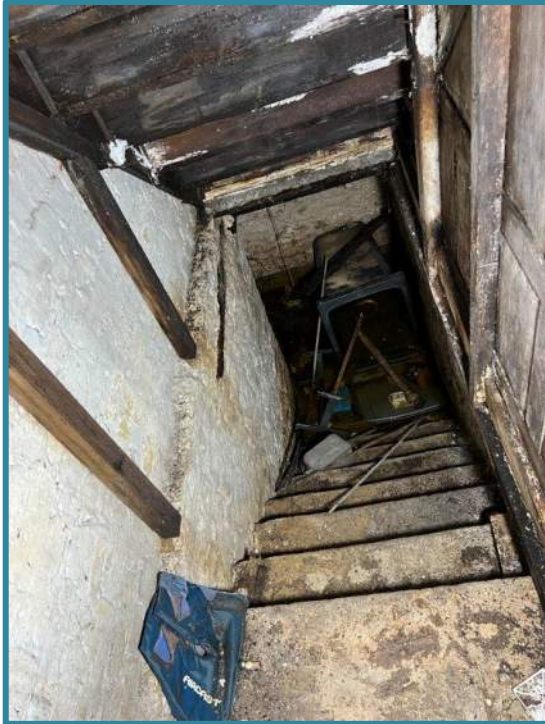
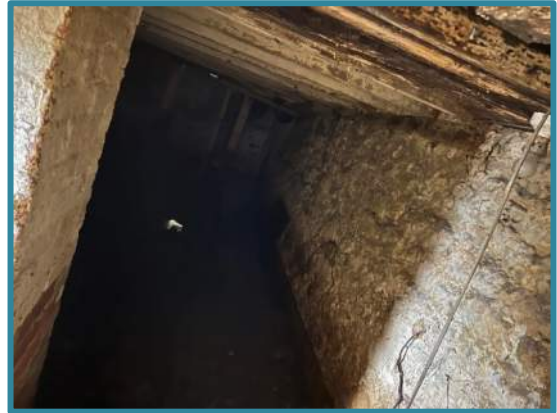
- 2.1.6 The property has a partial basement which sits under the south room (no. 4 on the key plan) of the property. As noted in the photos below, at the time of the inspection the basement was flooded and full access was not available.

- 2.1.7 From what could be seen of them, the basement walls appeared to be of rubble stone construction and the line of the walls appeared good.
- 2.1.8 It was not clear whether the water in the basement was natural ground water or accumulated water from the leaks in the roof. We would suspect the latter, and that in general the basement would be clear of standing water. However the building needs drying out and the basement emptied of water to prove one way or another. There may be a drain in the basement floor that is currently blocked or has a restricted outlet.

Figure 8 – Steps to (partial) basement

Figure 9 – Flooded Basement

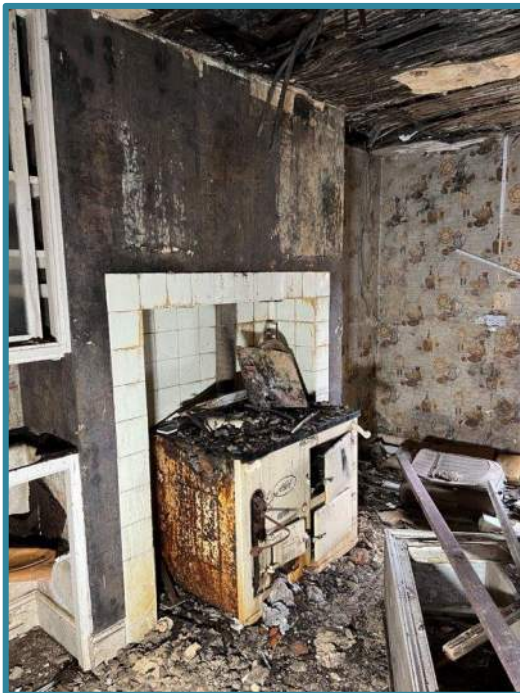
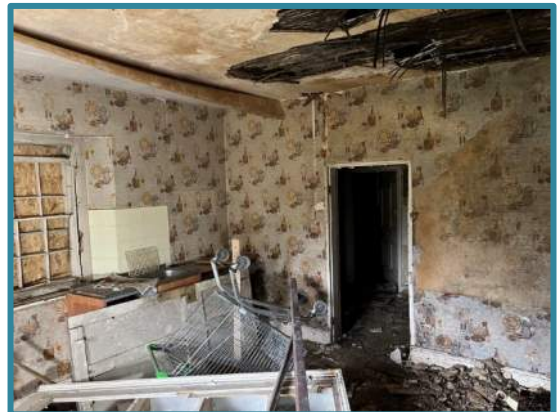
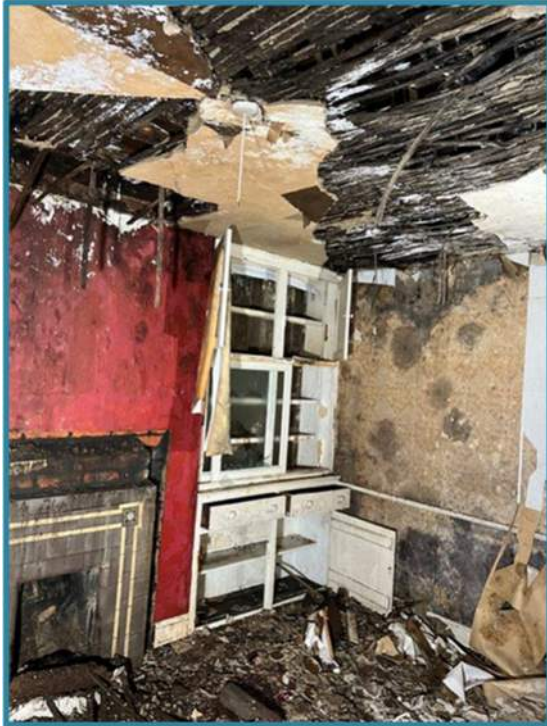
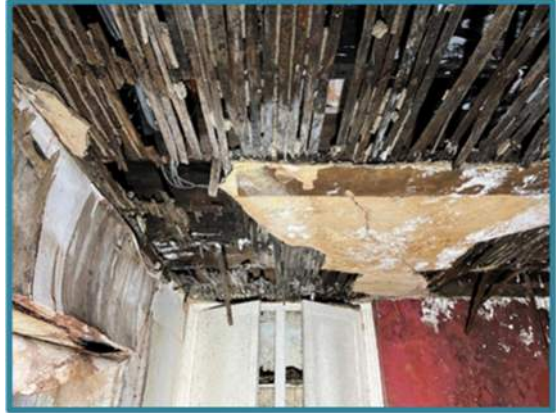
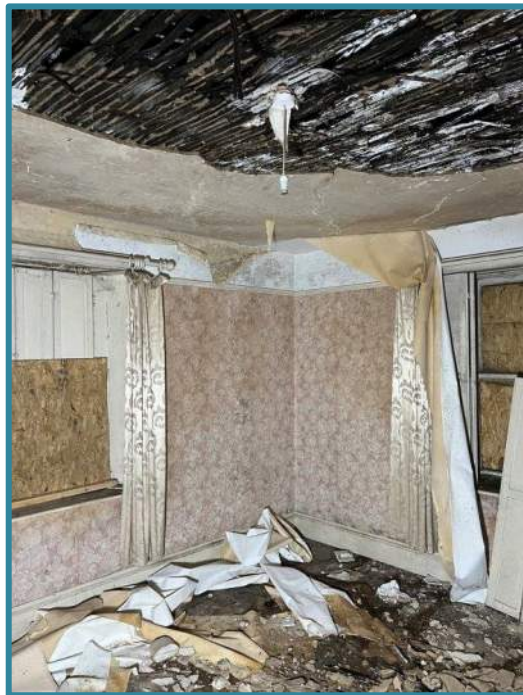
Figure 10 – G.F. Room 1 (North) Kitchen

Figure 11 – G.F. Room 1 (North)

- 2.1.9 Rainwater has cascaded through the property damaging floors and ceilings throughout. The worst of the damage is centred beneath the central north-south valley line that no longer has any finishes in place to channel water off the roof.
- 2.1.10 The original lathe and plaster ceilings have largely failed throughout the property and should be removed to allow a full inspection of all timbers to roof and floors.

Figure 12 – G.F. Room 2 (East)

Figure 13 – G.F. Room 2 Ceiling

Figure 14 – G.F. Room 3 (West)

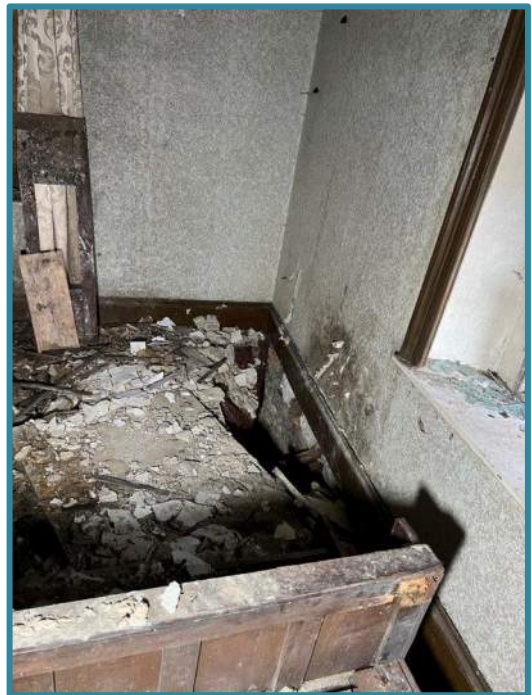
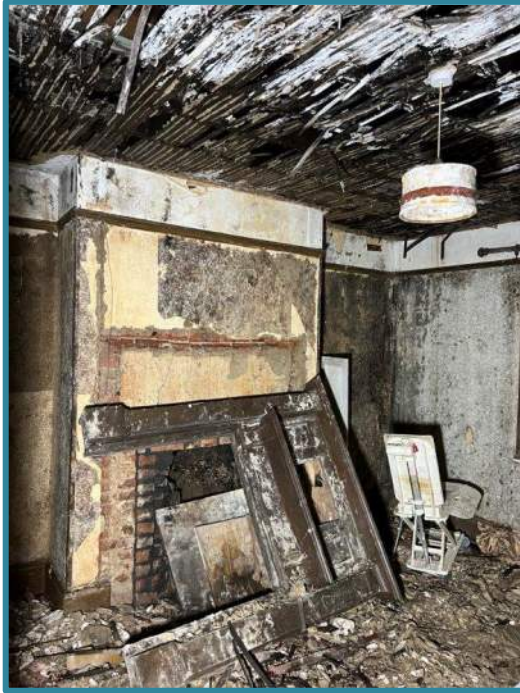
Figure 15 – G.F. Room 4 Failed area of suspended floor

- 2.1.11 Due to the amount of debris in the building, it was not safe to access all areas of the property or to carry out localised inspections. There are air bricks in the building façade externally which would suggest the ground floor of the property comprises a suspended timber floor. Certainly over the basement this is the case, but some site clearance would be required to establish if this was the detail throughout the ground floor.
- 2.1.12 In the southern corner of room 4 at ground floor level the floor joist bearings have failed locally. It is quite likely that as part of any refurbishment project a new suspended ground floor with adequate cross ventilation will be required throughout the property.

Figure 16 – G.F. Room 4 (South)

- 3.1.3 Is it likely though any suspended timber floors at ground floor level will need replacing and properly ventilating to ensure a sound structure is provided going forwards.

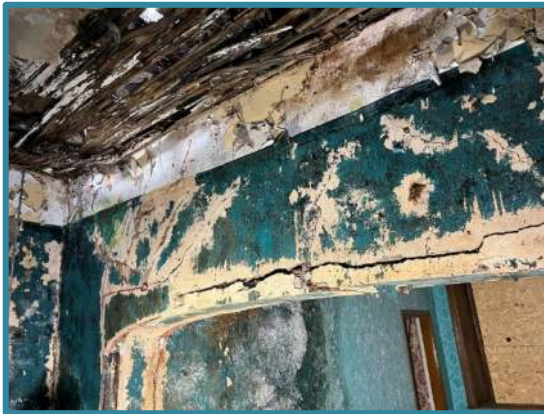
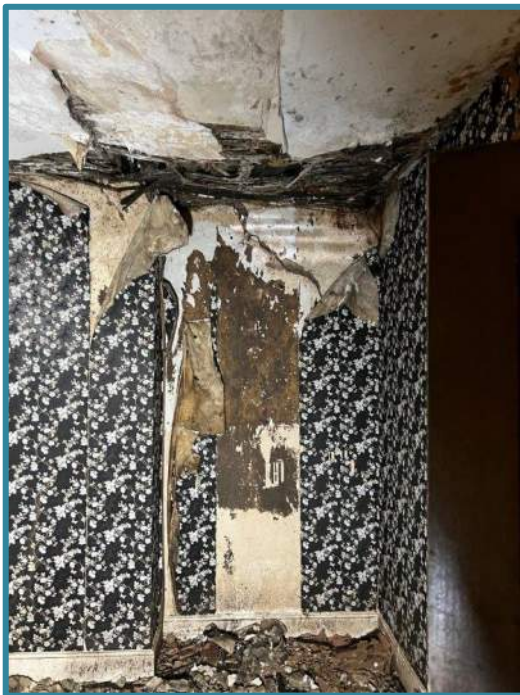
Figure 18 – Plaster fracturing to F.F. landing arch

- 2.1.14 The staircase sits in the middle of the property giving access to basement and first floor. The landing at the head of the stair has been affected by long term water penetration but it is likely that a considerable proportion of the floor, and the floors to the first floor rooms, should be able to be retained as part of the conversion.
- 2.1.15 The timber joists are vulnerable at their bearing end, particularly where they bear into saturated walls, but we would imagine localised repairs rather than wholesale replacement would be the likely remediation strategy.

Figure 22 – Plaster fracturing to F.F. landing arch

- 3.1.2 We were not able to access the roof structure, but from our cursory inspection we believe localised timber repairs, rather than wholesale timber replacement will be appropriate to remediate the current structural issues with the upper internal floor and roof.

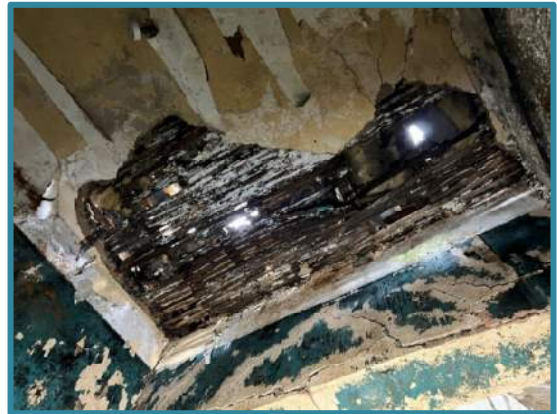
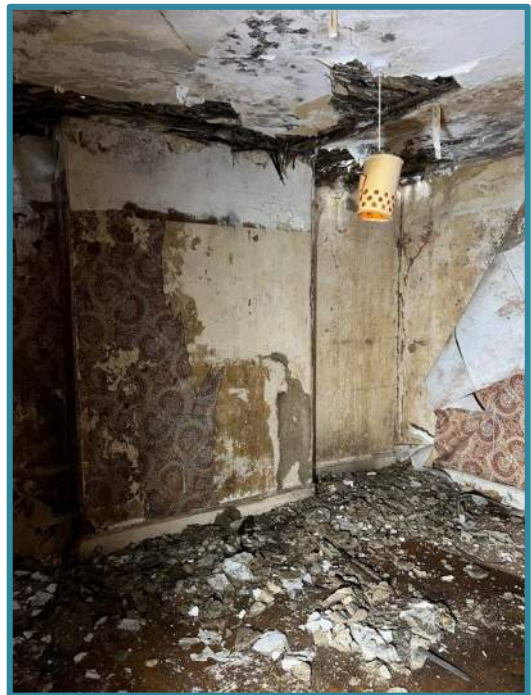
Figure 19 – Daylight visible through central valley soffit

Figure 23 – Daylight visible through central valley soffit

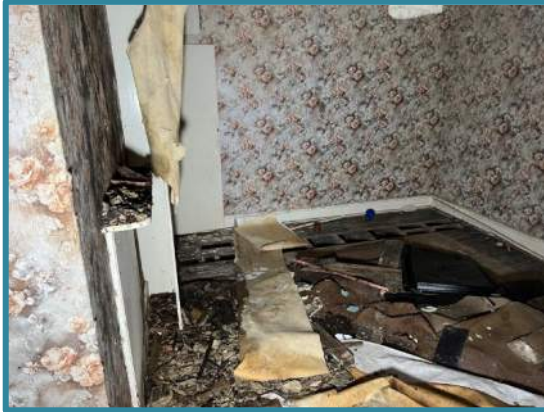
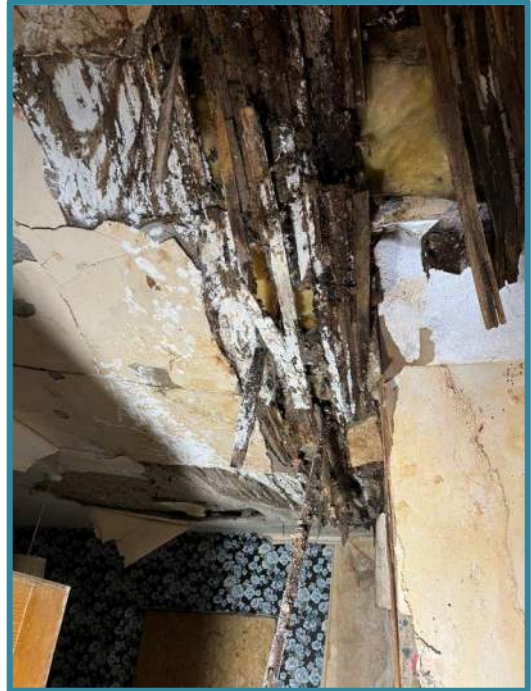
- 2.1.16 As with the ground floor the first floor lathe and plaster ceilings are badly damaged and need replacing.

Figure 20 – F.F. Bedroom 1(North)

Figure 21 – F.F. Bedroom 2(East) Failed Ceiling

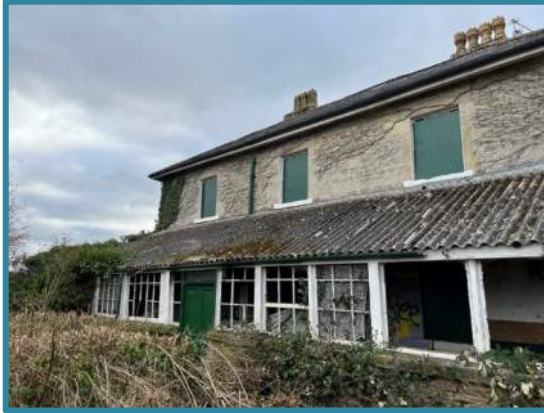
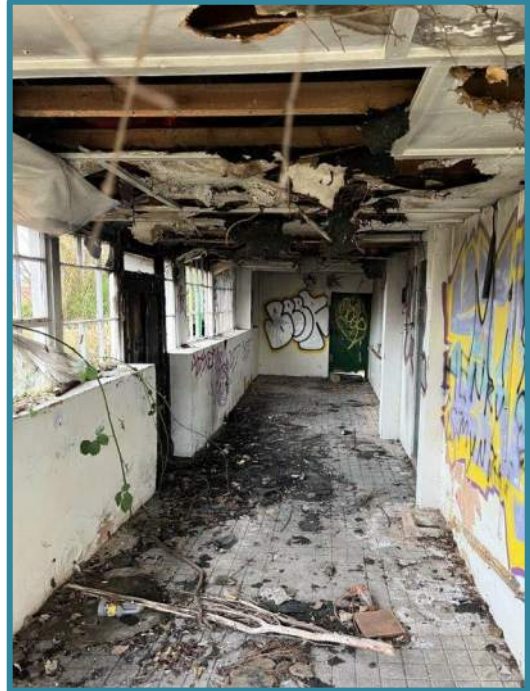
Figure 24 – Northeast lean-to

Figure 25 – Lean-to internal

- 2.1.20 Along the northeast elevation a single storey extension with corrugated asbestos sheeting mono pitch roof has been added. At the east end there is an external lavatory structure that was completely covered in ivy at the time of our inspection.

- 2.1.21 Whilst this structure could be retained and refurbished, it may well be worth removing it and replacing it with something more appropriate and fit for a modern purpose.
- 2.1.22 There is a slight bulge in the external face of the southeast elevation at the upper level. This wall is finished externally in rubble stone and most likely comprises an inner and outer leaf of large section rubble stone with the heart, or core of the wall filled with smaller stones and mortar. It is quite possible the outer leaf of stonework is becoming delaminated from the core and inner leaf of the wall. This can be remedied by installing some discreet ties, localised grouting of voids and repointing the wall.

- 3.1.5 The lean-to building appended to the northeast elevation ought to be removed and reconfigured if required, as the corrugated roof finishes are not fit for purpose and the roof structure is rudimentary.

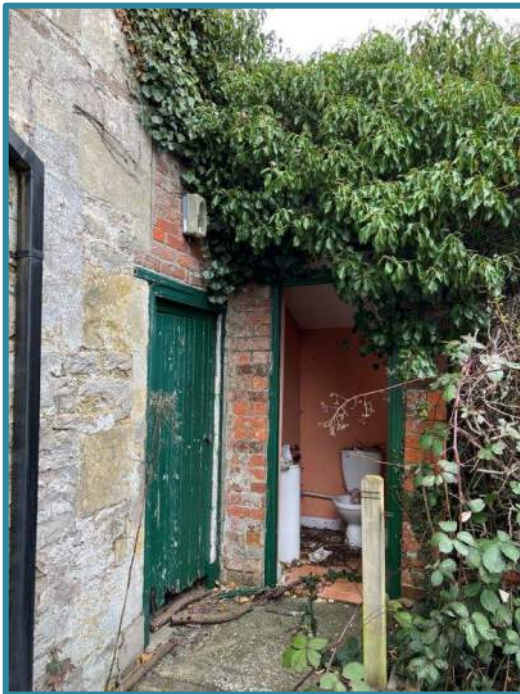
Figure 26 – External lavatory

- 3.1.6 The external lavatory structure could not be fully inspected, but again it is not fit for purpose as presently configured and should be removed.

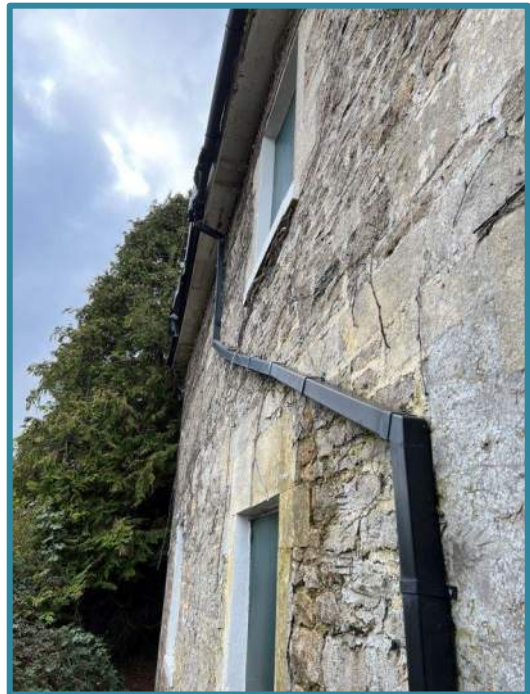
Figure 27 – Slight bulge to southeast elevation

- 3.1.4 The delamination noted on the southeast upper wall needs further investigating, but will most likely need some localised consolidation anchors installed (Cintec or similar) to stabilize the wall.

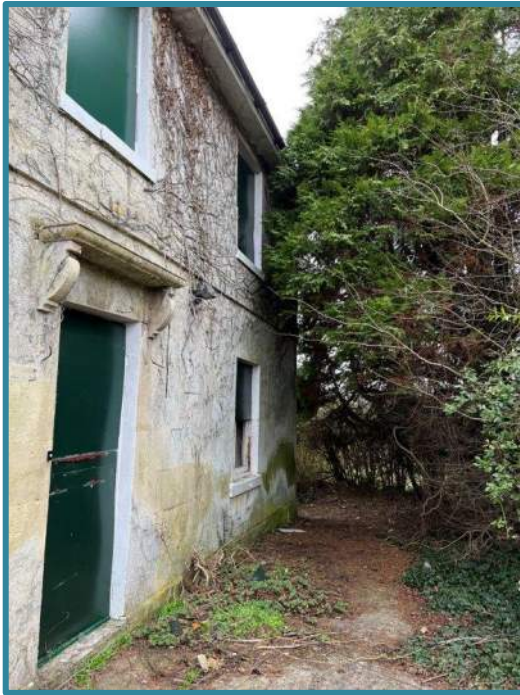
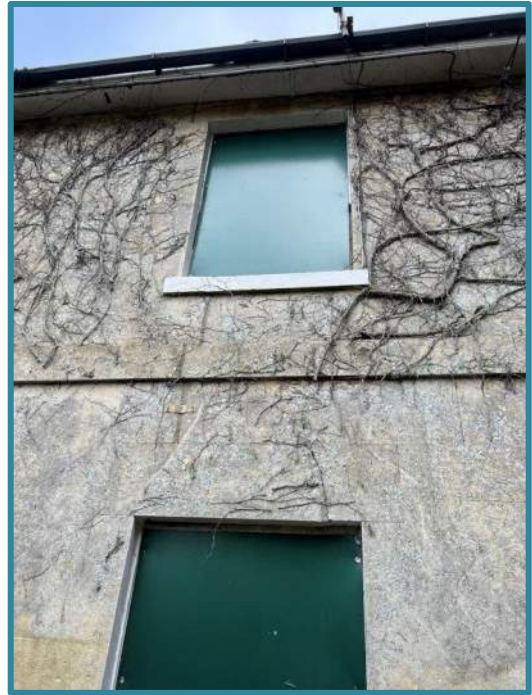
Figure 28 – Front ashlar façade (southwest)

Figure 29 – Fractured lintel SW elevation

- 2.1.23 Unlike the rubble stone facades to sides and rear, the southwest facing front elevation of the property is finished in ashlar stonework. This wall generally appears to have a good line but has suffered from a small degree of movement in the past evidenced by fractured lintels to the central doorway and fractured cills and lintels to the windows on the façade.

- 2.1.24 The nearby trees may have been a contributing factor in this movement and it would be wise to remove the closest trees to prevent any ongoing damage occurring; note - by removing trees the ground water content in the ground can recover potentially triggering small foundation movements until a new equilibrium is reached.

- 3.1.7 Any trees close to the building should be removed in a timely fashion to allow the ground to recover its natural moisture content before extensive refurbishment works are undertaken.

- 3.1.9 The fractured lintels on the northwest and southwest elevations can be retained insitu but need stitch repairs to hold the masonry units in their current locations.

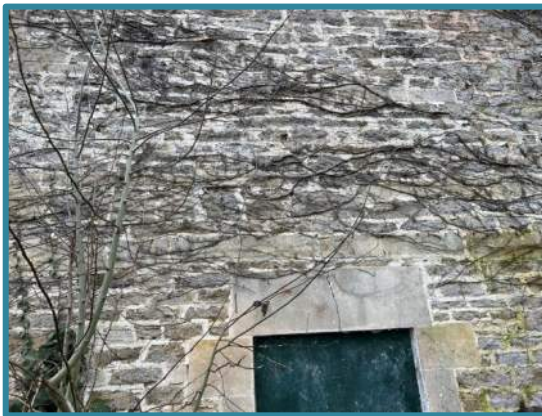
Figure 30 – Fractured lintel NW elevation

- 2.1.25 Overall though the wall appears in good structural order.
- 2.1.26 The northwest elevation is finished in coursed rubble stone. This elevation appears in good structural order, but again there are fractures in the ground floor stone lintels to the window openings suggesting a small amount of movement in the walls.

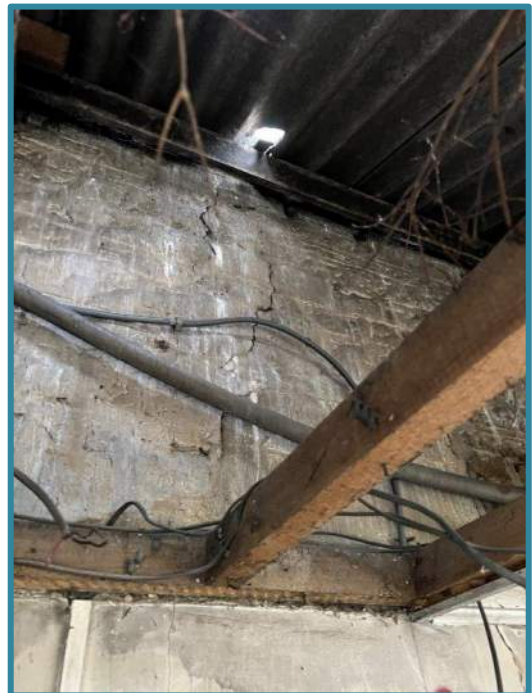
Figure 31 – Fracture NE elevation

- 2.1.27 The lower portion of the northeast elevation is partially obscured by the single storey appendage. A small fracture was noted in this elevation above ceiling level, but again this is localised and small in nature and not indicative of any more widespread structural issues.

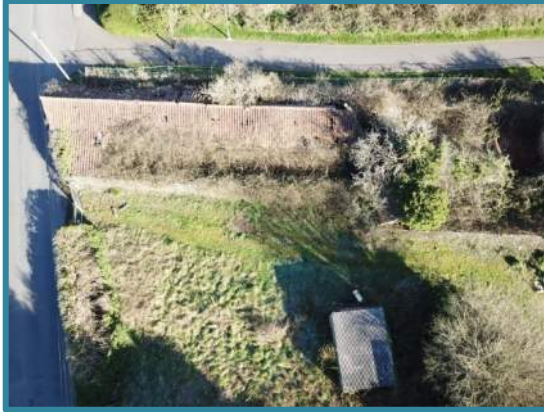
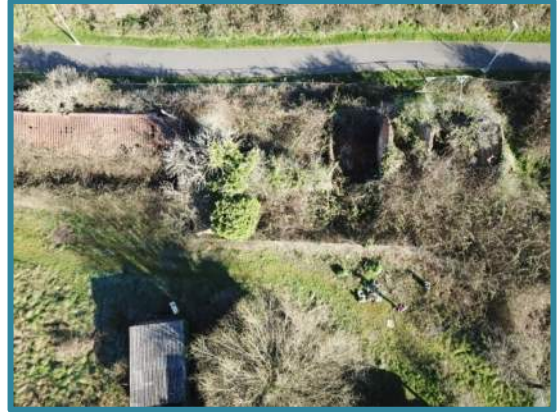
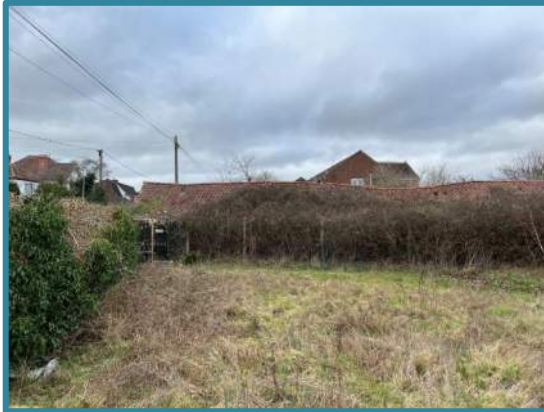
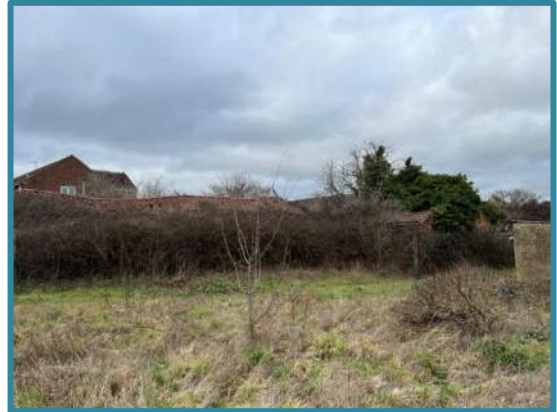
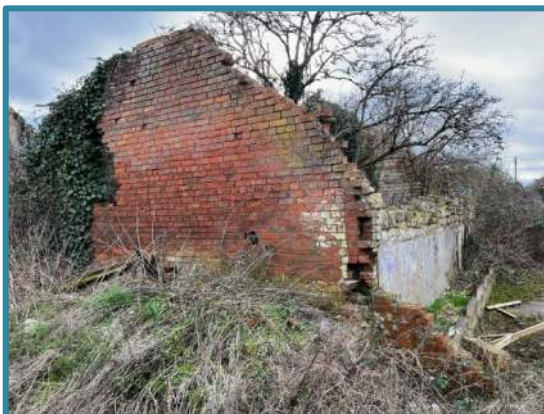
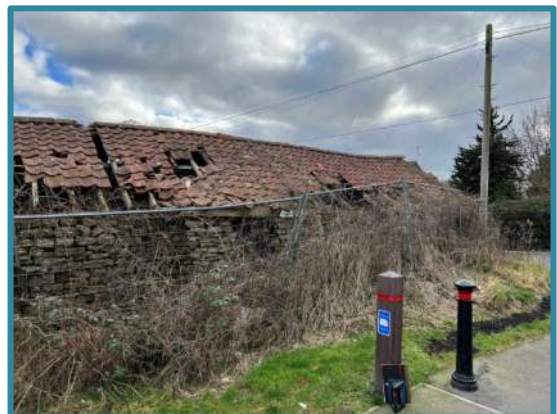
Figure 32 – Barns west end aerial

Figure 33 – Barns east end aerial

Figure 34 – Elevation west end

Figure 35 – Elevation east end

Figure 36 – East gable

Figure 37 – North elevation (part)

- 2.2.2 The barns are in a very poor condition and are currently fenced off on the north side and have a large bank of vegetation concealing the south elevation.
- 2.2.3 The barns appear to have a natural rubble stone wall to the north and west sides with red brick walls elsewhere. Strangely the upper gable on the west side has been built in a crazy paving style with reclaimed stone masonry units.

- 2.2.5 The imagery clearly shows that the roofs are largely missing in areas and have large holes in the finishes where some semblance of roof still remains. It is clear though when observing the roofline from a distance that the purlins and ridge beams, that most likely span between internal timber trusses, have all largely failed as the ridge line dips significantly between what we believe are the principal truss locations.

- 2.2.6 Where visible the stone walls to the barns have delaminated and collapsed over significant lengths and where still standing are in poor condition with the mortar that binds the masonry units badly decayed from prolonged exposure to the weather conditions.

- 3.1.10 The barn structures to the north of the site are in very poor condition and are not structurally competent enough to be retained for any future use.

- 2.2.7 We do not feel there remains any section of the barn that can be practically retained and repurposed for a new use. It may be possible to reclaim a proportion of the masonry units for reuse elsewhere, but in our opinion the remaining barn structures should be demolished as at present they present a health and safety risk to anyone accessing the site.

- 3.1.11 The remaining barn structures should be demolished as they present a health and safety risk to anyone accessing the site.
