## **ATWORTH ARBORICULTURE LTD**

### **Decay detection on Beech tree at Hightown Aldbourne.**

Hightown,  
21 The Green,  
Aldbourn,  
SN82EN.

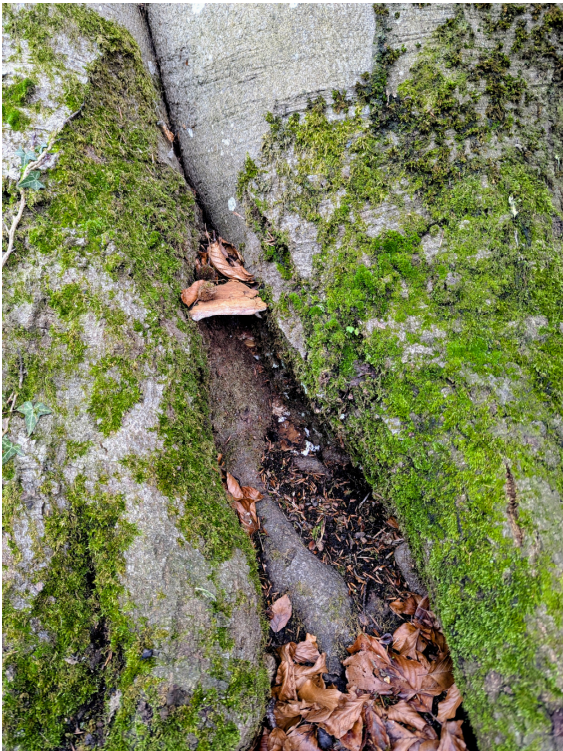
Photo 2

There are several fungal brackets of *Ganoderma adspersum* erupting at 30cm (agl) to the north (Photo 2), with a further bracket at 3m to the northeast (Photo 3) and again at 2.4m to the south. (Photo 4).

The structural integrity of the tree at just the crown break is compromised with a higher risk of failure. We considered option to retain the tree in some form by reducing and bracing. For this tree this isn't a viable option. Healthy beech trees are not good with heavy reductions. This tree has problems and a reduction would likely kill the tree. Even if the tree were reduced, the decay would continue to spread and further weaken the structure. Taking these considerations, we would recommend the tree be felled as soon as practically possible. This work to be carried out by a fully insured and qualified arborist working to BS3998 (2010) tree work. Necessary permissions will be needed from the local authority as the tree is covered by a TPO.

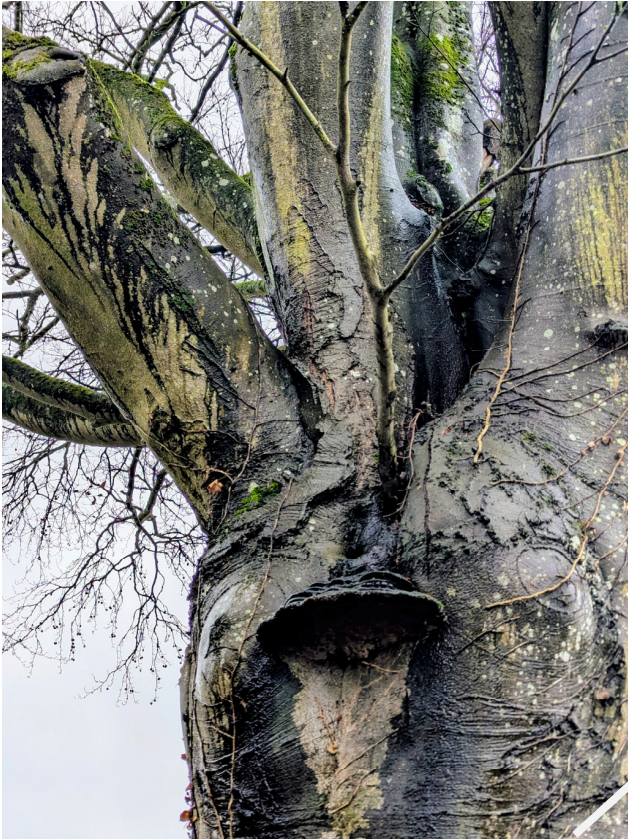
Photo 3.

The tree is situated on a slightly raised bed 30cm east of the boundary wall and entrance. The main property is 11m to the south. The crown is biased towards the south, with a long low lateral limb extending 15m to the southeast. This crown shape is due to the competition from a neighbouring beech tree that was situated 5m to the north. The crown break is at 3m above ground level (agl) with a congested mix of ascending limbs that have several narrow included forks. (See arrow on Photo 3).

The Picus tomography image taken at 30cm agl indicates predominantly sound wood coloured brown, with an area of decay coloured green adjacent to the fungal bracket. The Resistograph tests carried out at 2.4m show a substantial area of decay just under the crown break, with only between 12 and 20cm of sound wood remaining around 180 degrees of the trees circumference. The fungal pathogens are likely to have been introduced through the inclusions and wounds within the crown break. The large low lateral limb mentioned, is attached with the narrow included fork shown in Photo 3, with further limbs immediately above it.

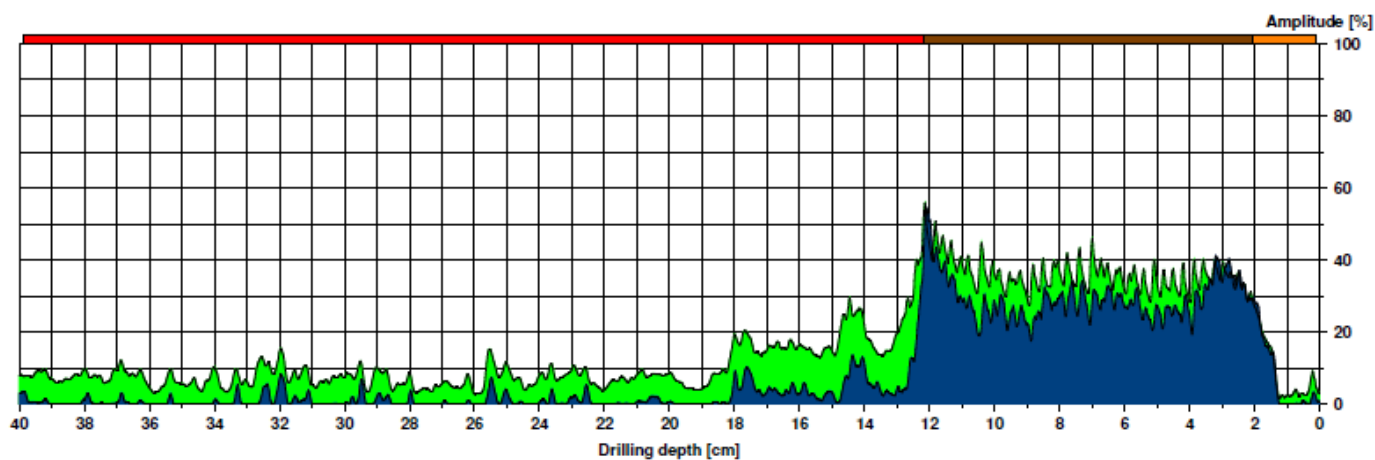
HIGHTOWN 2.4m EM003

| <b>Direction</b> | <b>Height</b> | <b>Results</b> |
|---|---|---|
| East | 2.4m | Good – 12cm, remainder decay |

| From 12,17 cm to 39,90 cm : Decay |

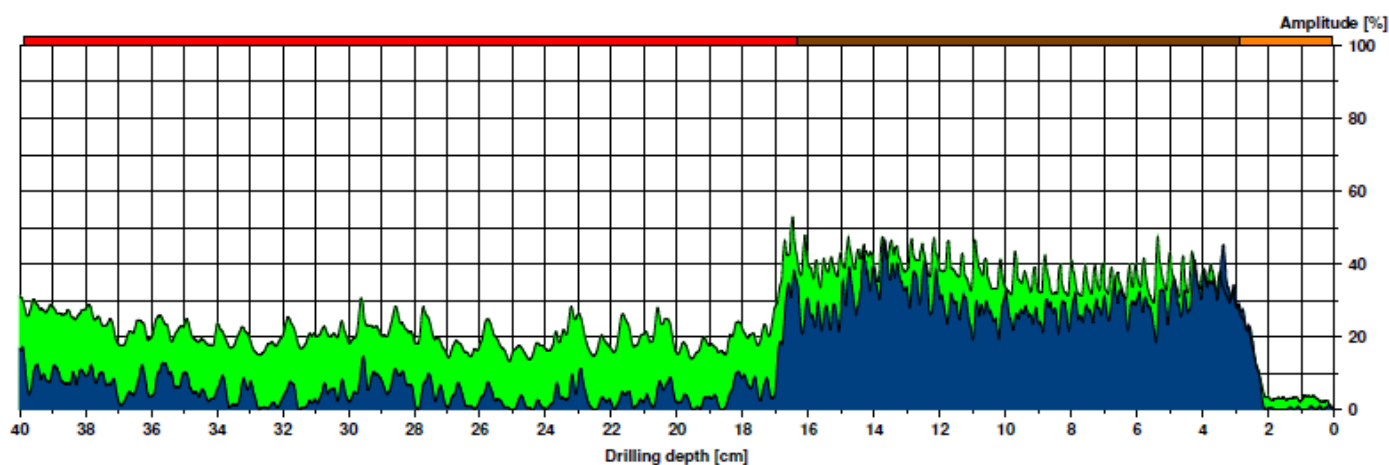
HIGHTOWN 2.4m NM004

| <b>Direction</b> | <b>Height</b> | <b>Results</b> |
|---|---|---|
| North | 2.4m | Good – 13cm, remainder decay |

| From 16,36 cm to 39,90 cm : Decay |

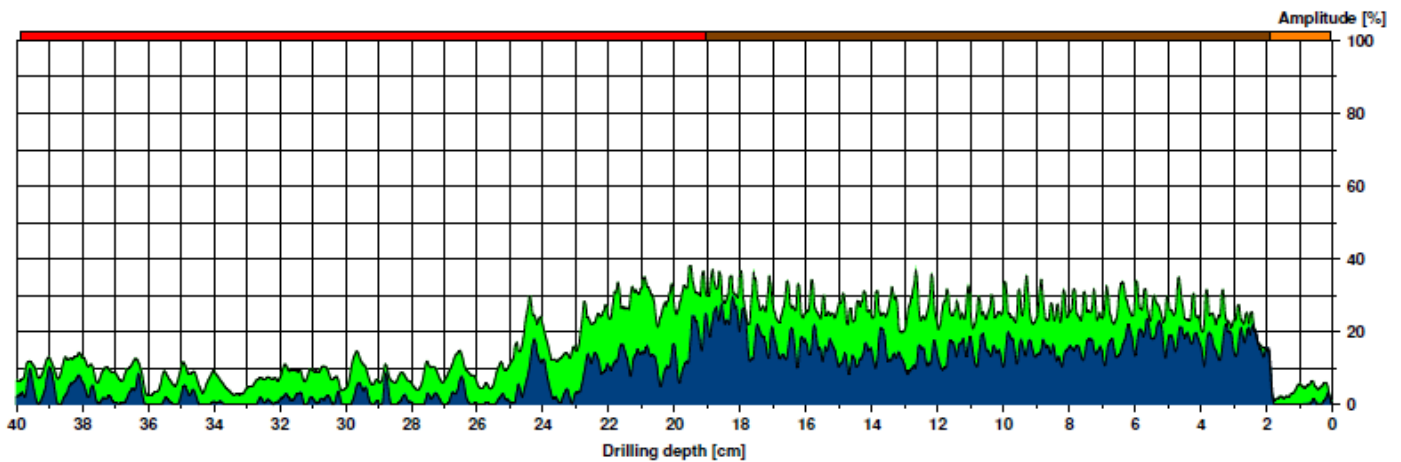
HIGHTOWN 2.4m SEM002

| <b>Direction</b> | <b>Height</b> | <b>Results</b> |
|---|---|---|
| Southeast | 2.4m | Good – 14cm, remainder decay |

| From 19,03 cm to 39,90 cm : Decay |

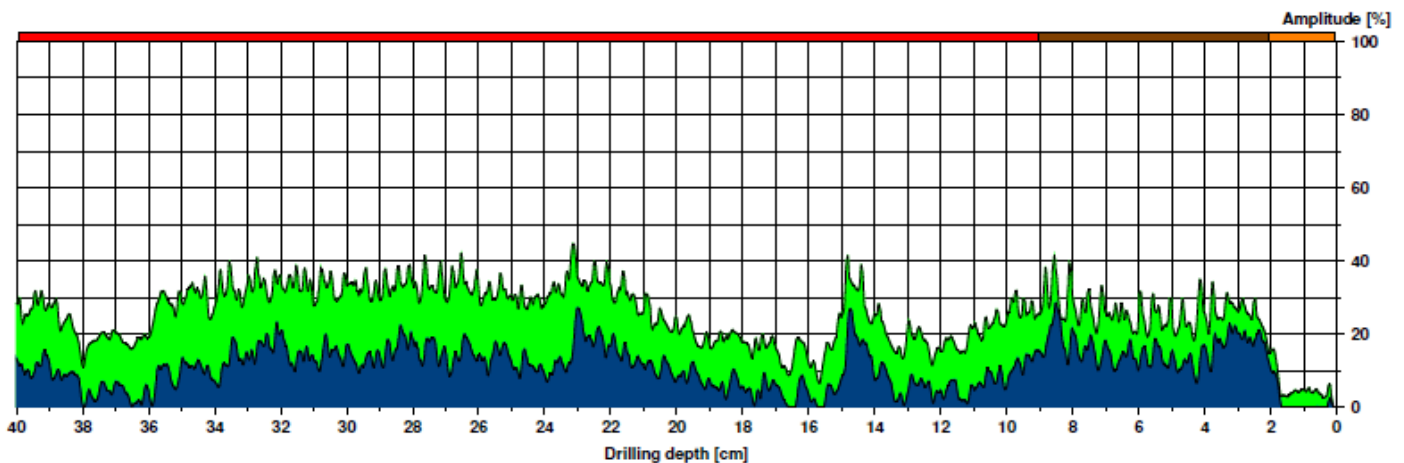
HIGHTOWN 2.4m SM001

| <b>Direction</b> | <b>Height</b> | <b>Results</b> |
|---|---|---|
| South | 2,4m | Good- 9cm, remainder decay |

| From 9,02 cm to 39,94 cm : Decay |
