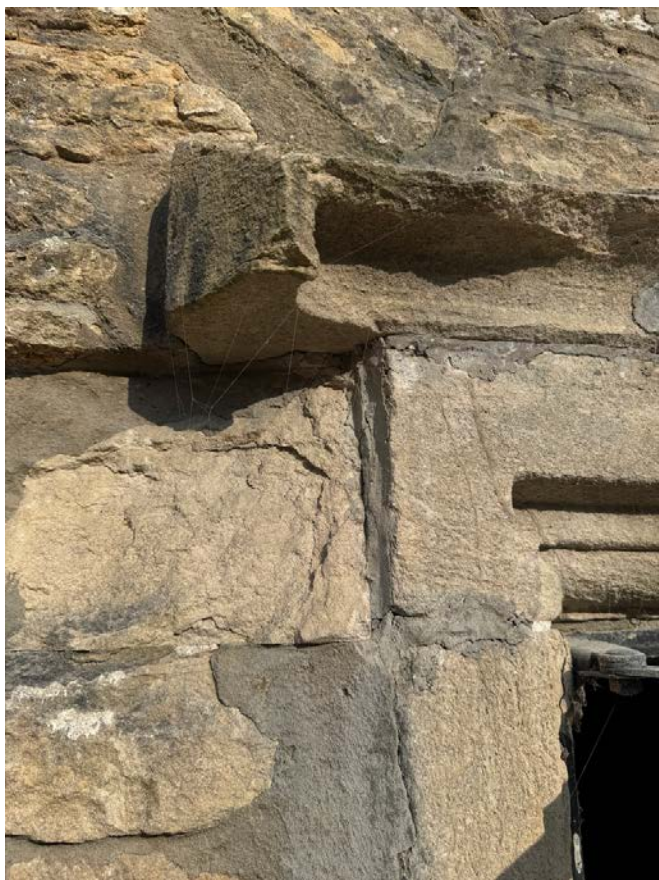
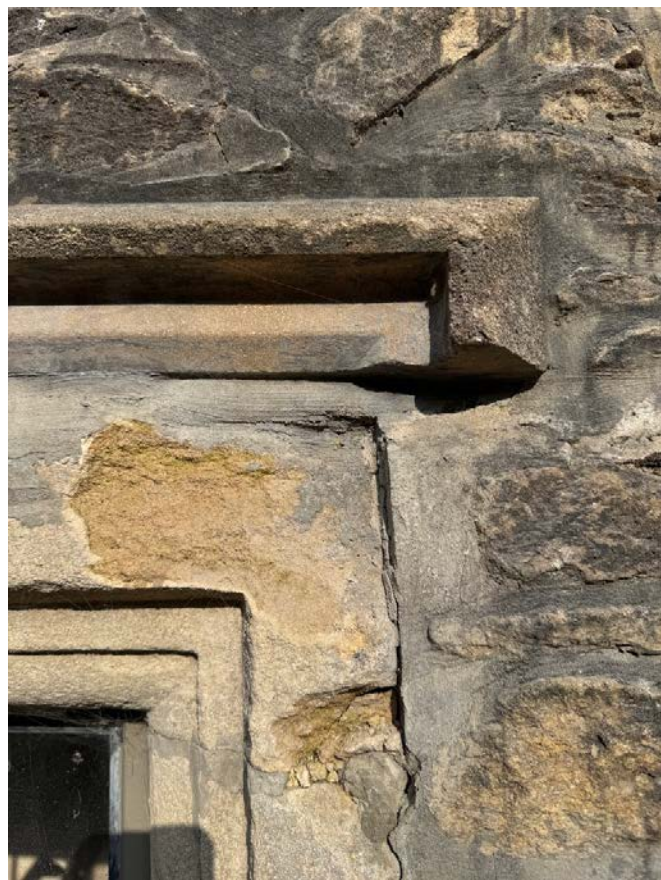
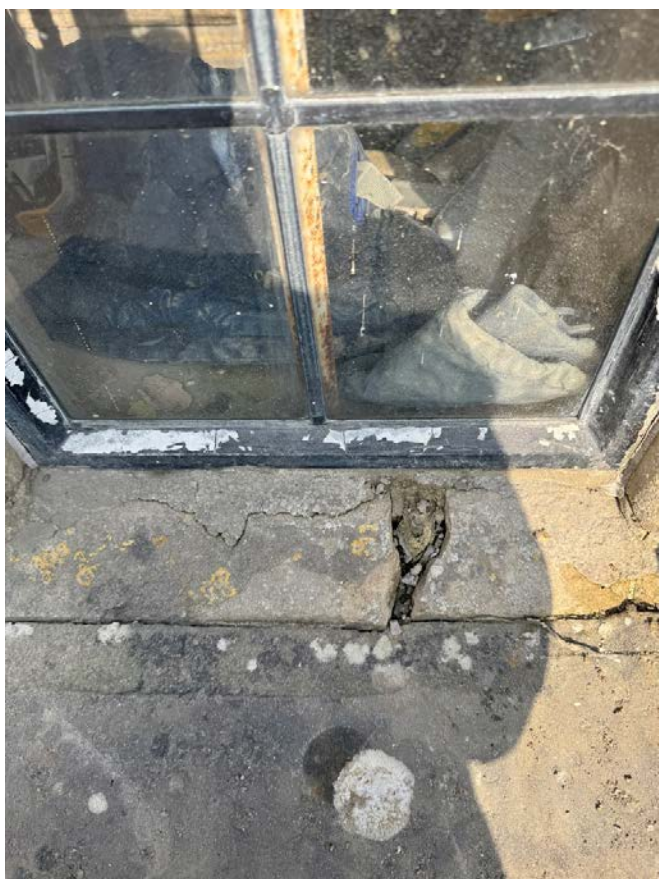
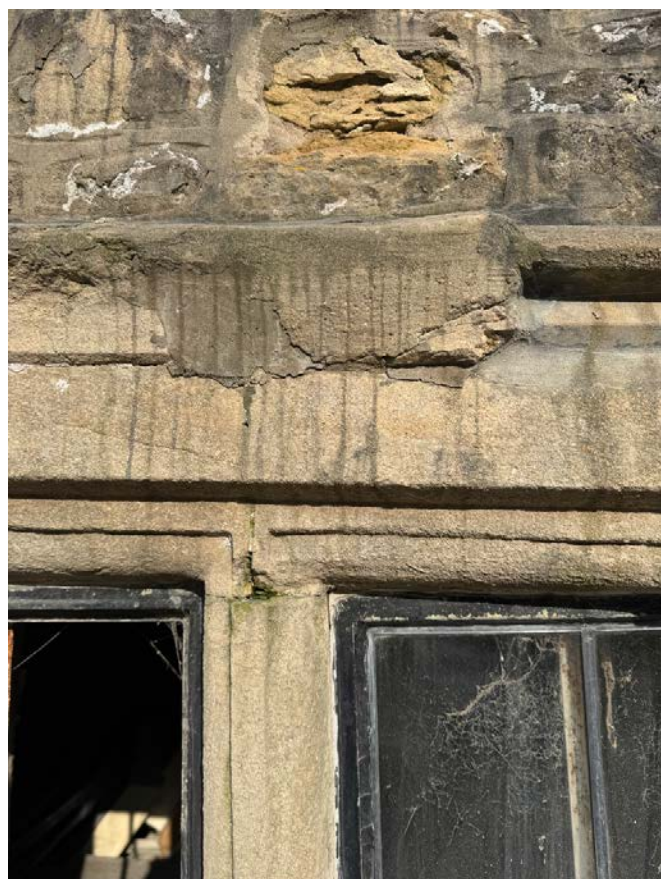
Existing window surround showing Bath stone deterioration associated with historic cement-based pointing and patch repairs, and further damage to the sill and lintel
