Pockeridge House

**Structural Report for Property  
Facades.**

**Project No 5424435**

M.O.D. Corsham  
Wiltshire

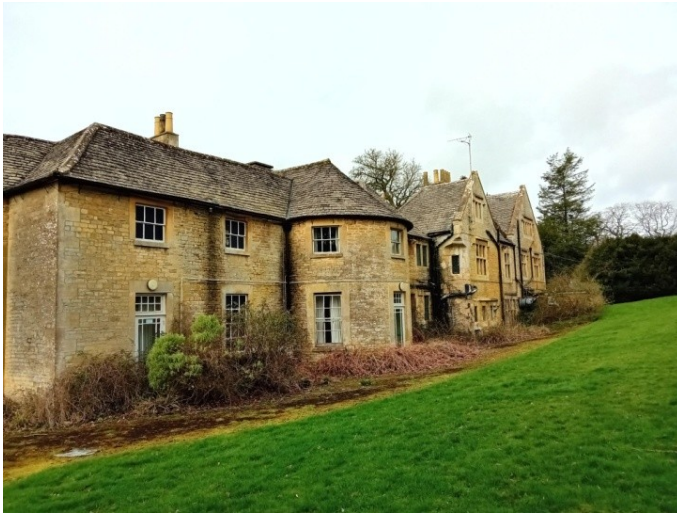
### East Elevation

The substantial sized building appears to be in a sound condition and has no visible structural issues in the roof structure or external façade walls.

Vegetation primarily ivy is starting to attach to the wall. Other vegetation has been allowed to grow up to the façade.

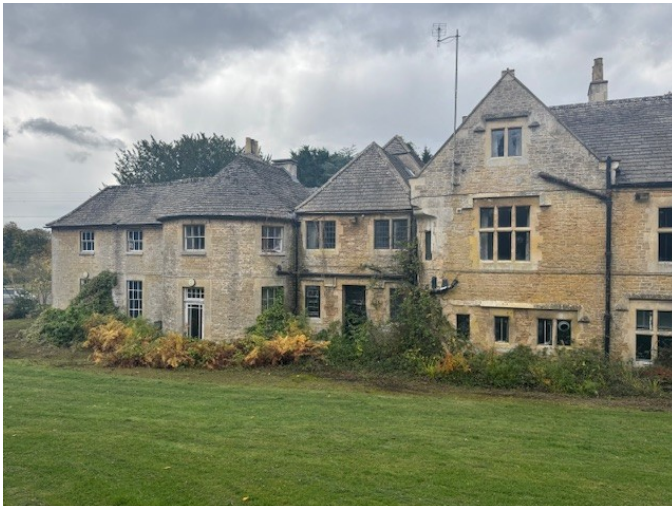
### South End

On closer inspection the external façade has deteriorated due to water staining and especially where services have been fixed.

The fixings have caused the outer surface of the dressed bath stone to absorb water and has delaminated due to freeze / thaw action during the winter months.

As highlighted in the observation section of this report, the East elevation façade has deteriorated due to water staining and especially where services have been fixed. The fixings will allow water to penetrate the outer surface of the dressed stonework and absorb water which has delaminated the outer face due to freeze / thaw action during the winter months.

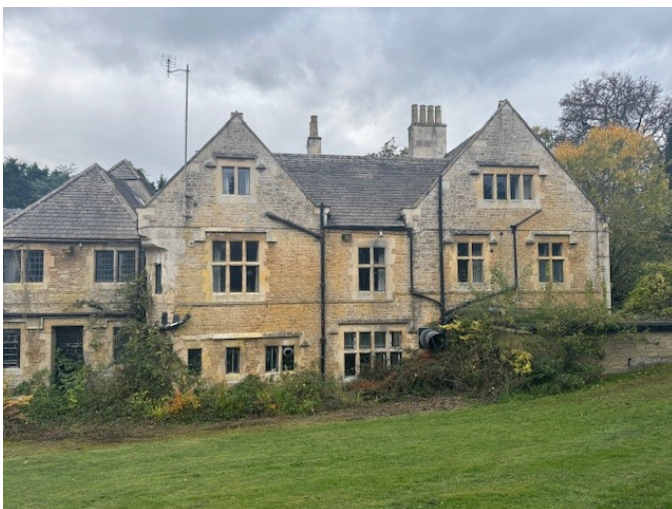
### North End

The building appears to be in a sound condition and has no visible structural issues in the roof structure or external façade walls.

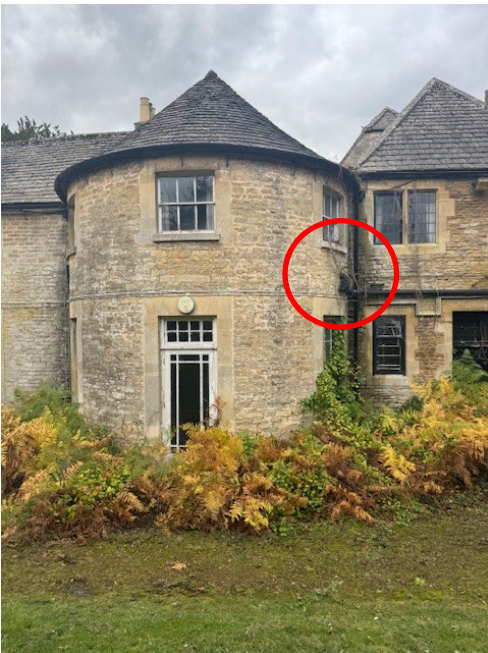
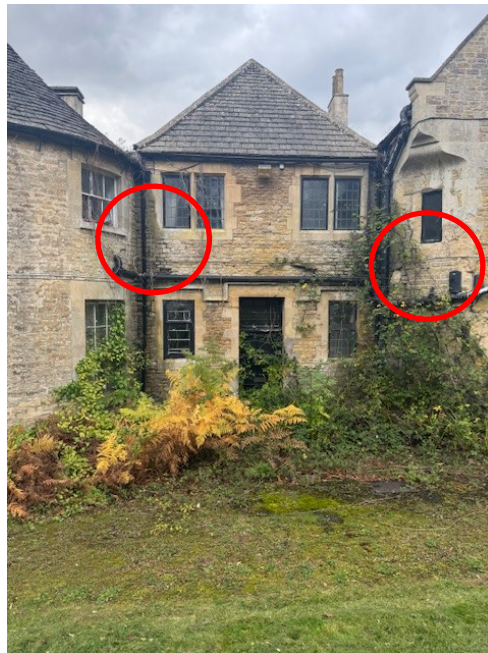
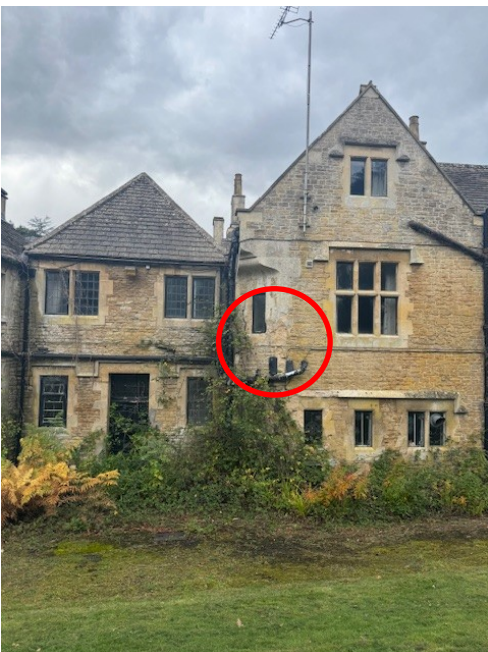
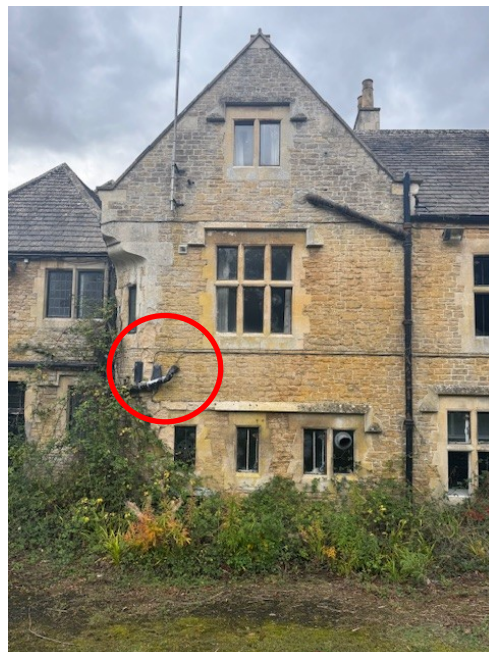
## South End

The elevation has a roof tile missing, vegetation and water staining damage together with the damage caused by service fixings. All are circled in the following photographs.

The overall general impression of the elevation appears to be in a good condition.

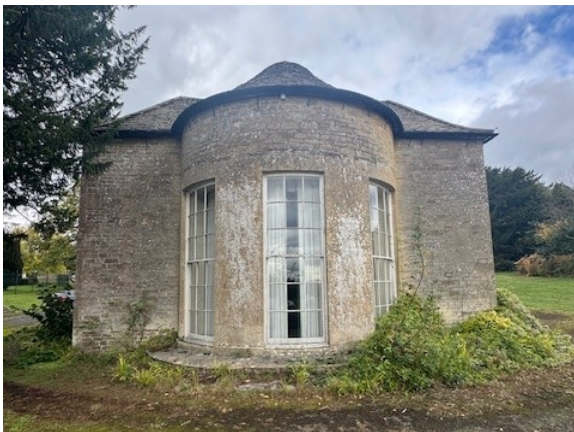
## South Elevation

Vegetation is growing alongside the building  
The building appears to be in a sound condition and has no visible structural issues in the roof structure or external façade walls.

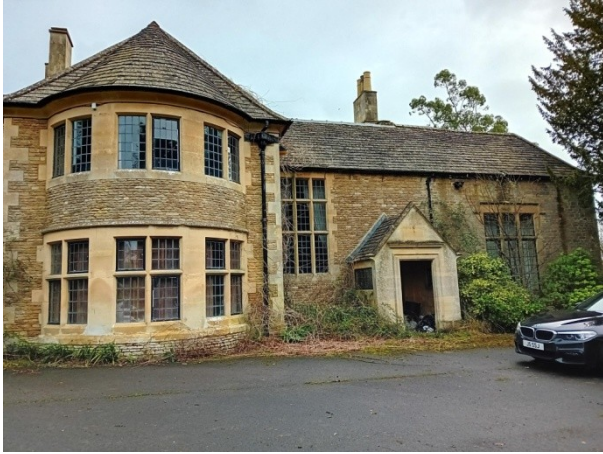
## South End

Vegetation is growing alongside the building and is primarily ivy attached to the wall and now at roof level. Other vegetation has been allowed to grow up to the façade.

The building appears to be in a sound condition and has no visible structural issues in the roof structure or external façade walls.

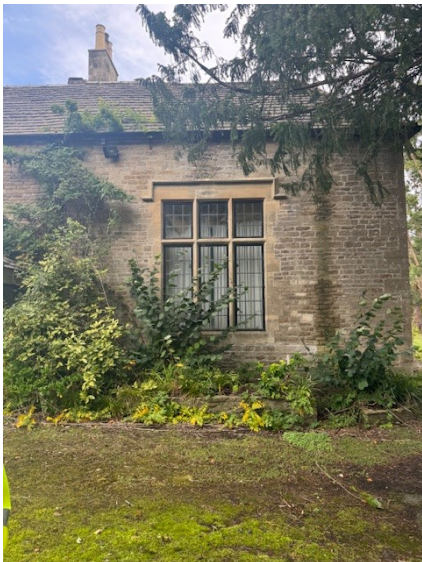
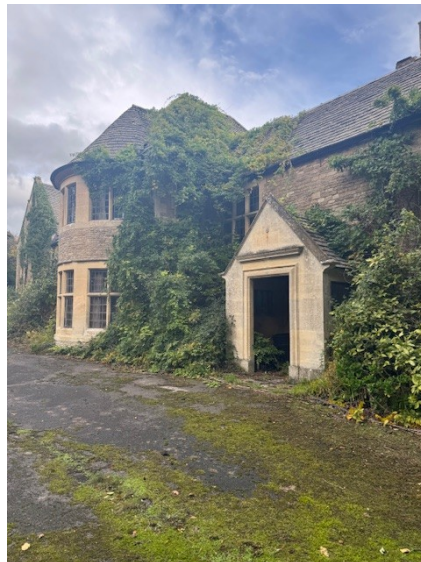
## South End

Vegetation predominantly ivy is attached to the façade and continues over the roof level the bedroom area at first floor.

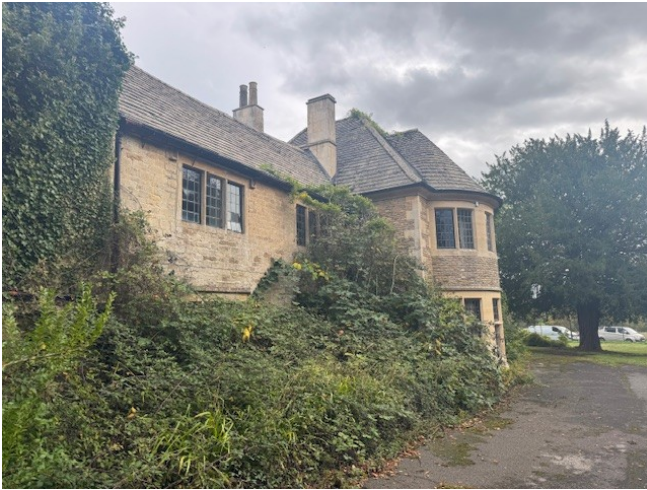
## Middle Section

Vegetation is primarily ivy attached to the wall and at roof level over the bedroom area at first floor level.

The building appears to be in a sound condition and has no visible structural issues in the roof structure or external façade walls.

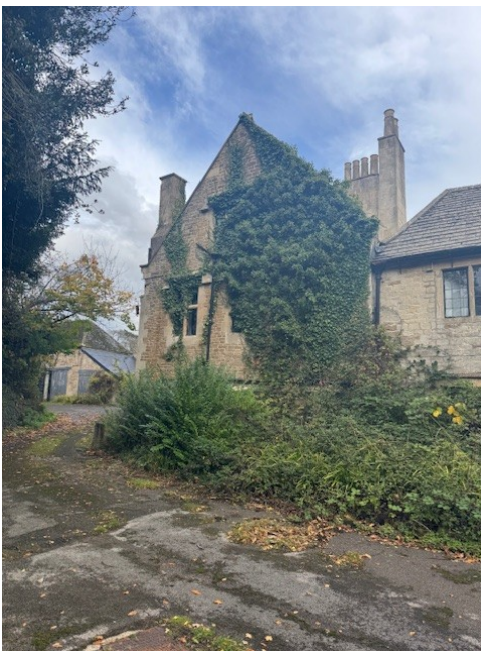
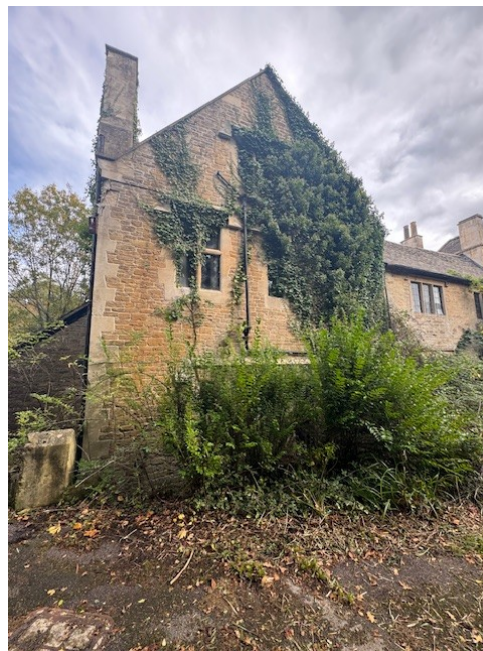
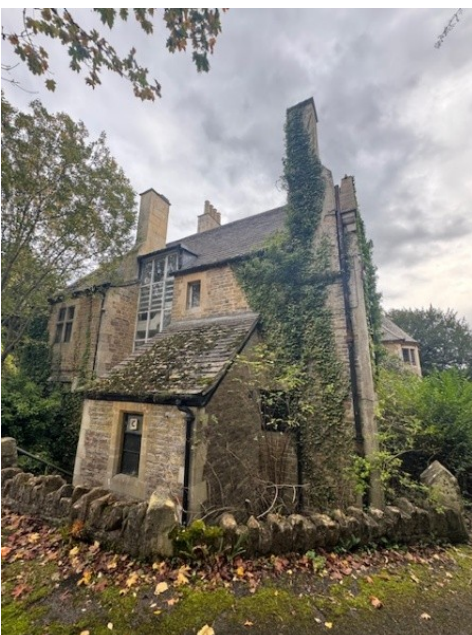
## North End

Vegetation primarily Ivy has grown over the façade and roof.

The building appears to be in a sound condition and has no visible structural issues in the roof structure or external façade walls

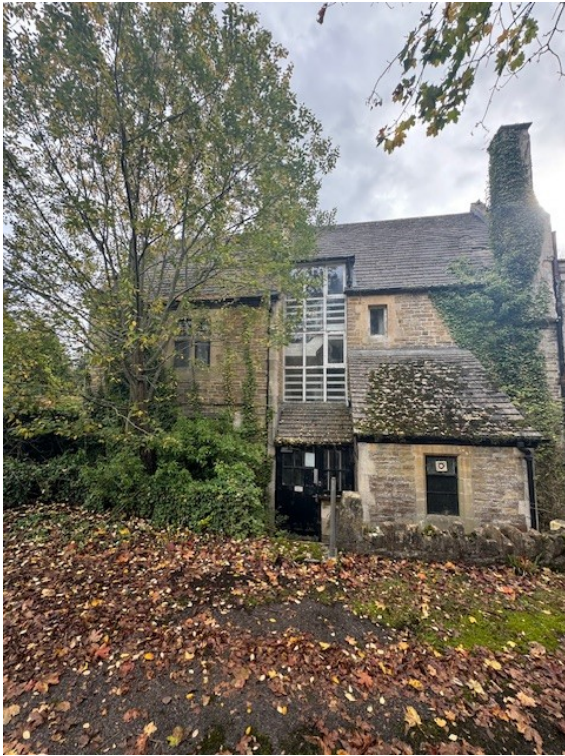
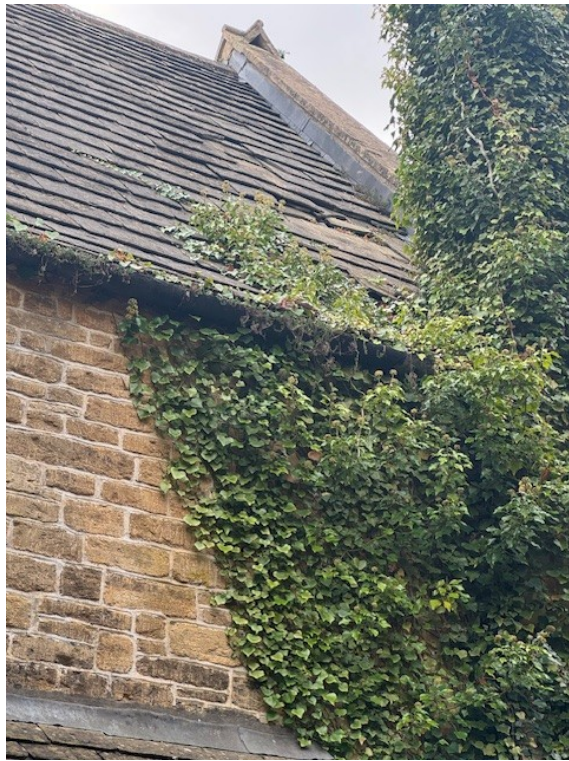
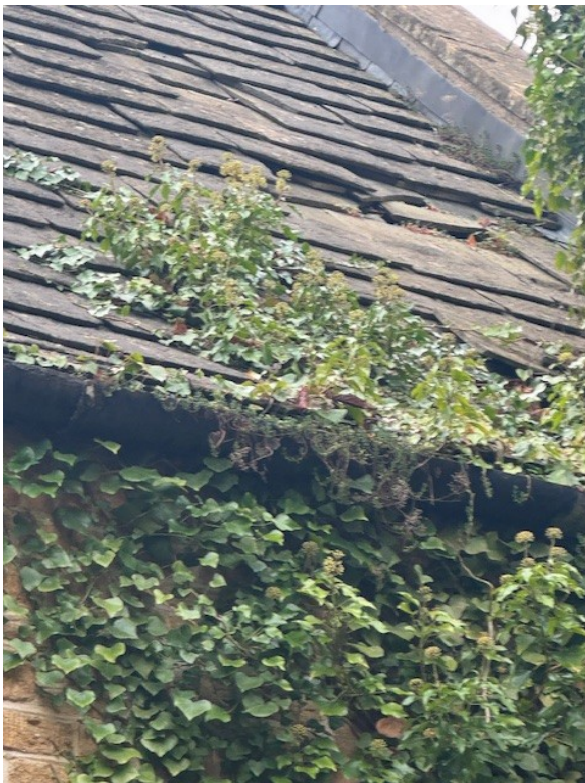
## North Elevation

The building appears to be in a sound condition and has no visible structural issues in the roof structure or external façade walls

Vegetation, predominantly ivy is attached to the chimney stack and over the roof level which is causing damage to the roof covering. Slates are dislodged or missing.

Another concern is Ivy damage, Ivy is detrimental for all types of buildings, especially if the structure is old, vulnerable, or has existing damage. Ivy can dislodge mortar, lift slates, and get into cracks.
