## Proposed Elevation C-C 1:50

Client • Aspire Defence Services Ltd  
Job • Proposed Works to the Garrison Church of St Patricks & St George, Tidworth.  
Ref • AT 0 083 Job • F1870  
Title • Proposed Elevation C-C

Scale • 1:50 @A1  
Date • August 2025  
Drawn • WT  
Drg No • F1870/108/E

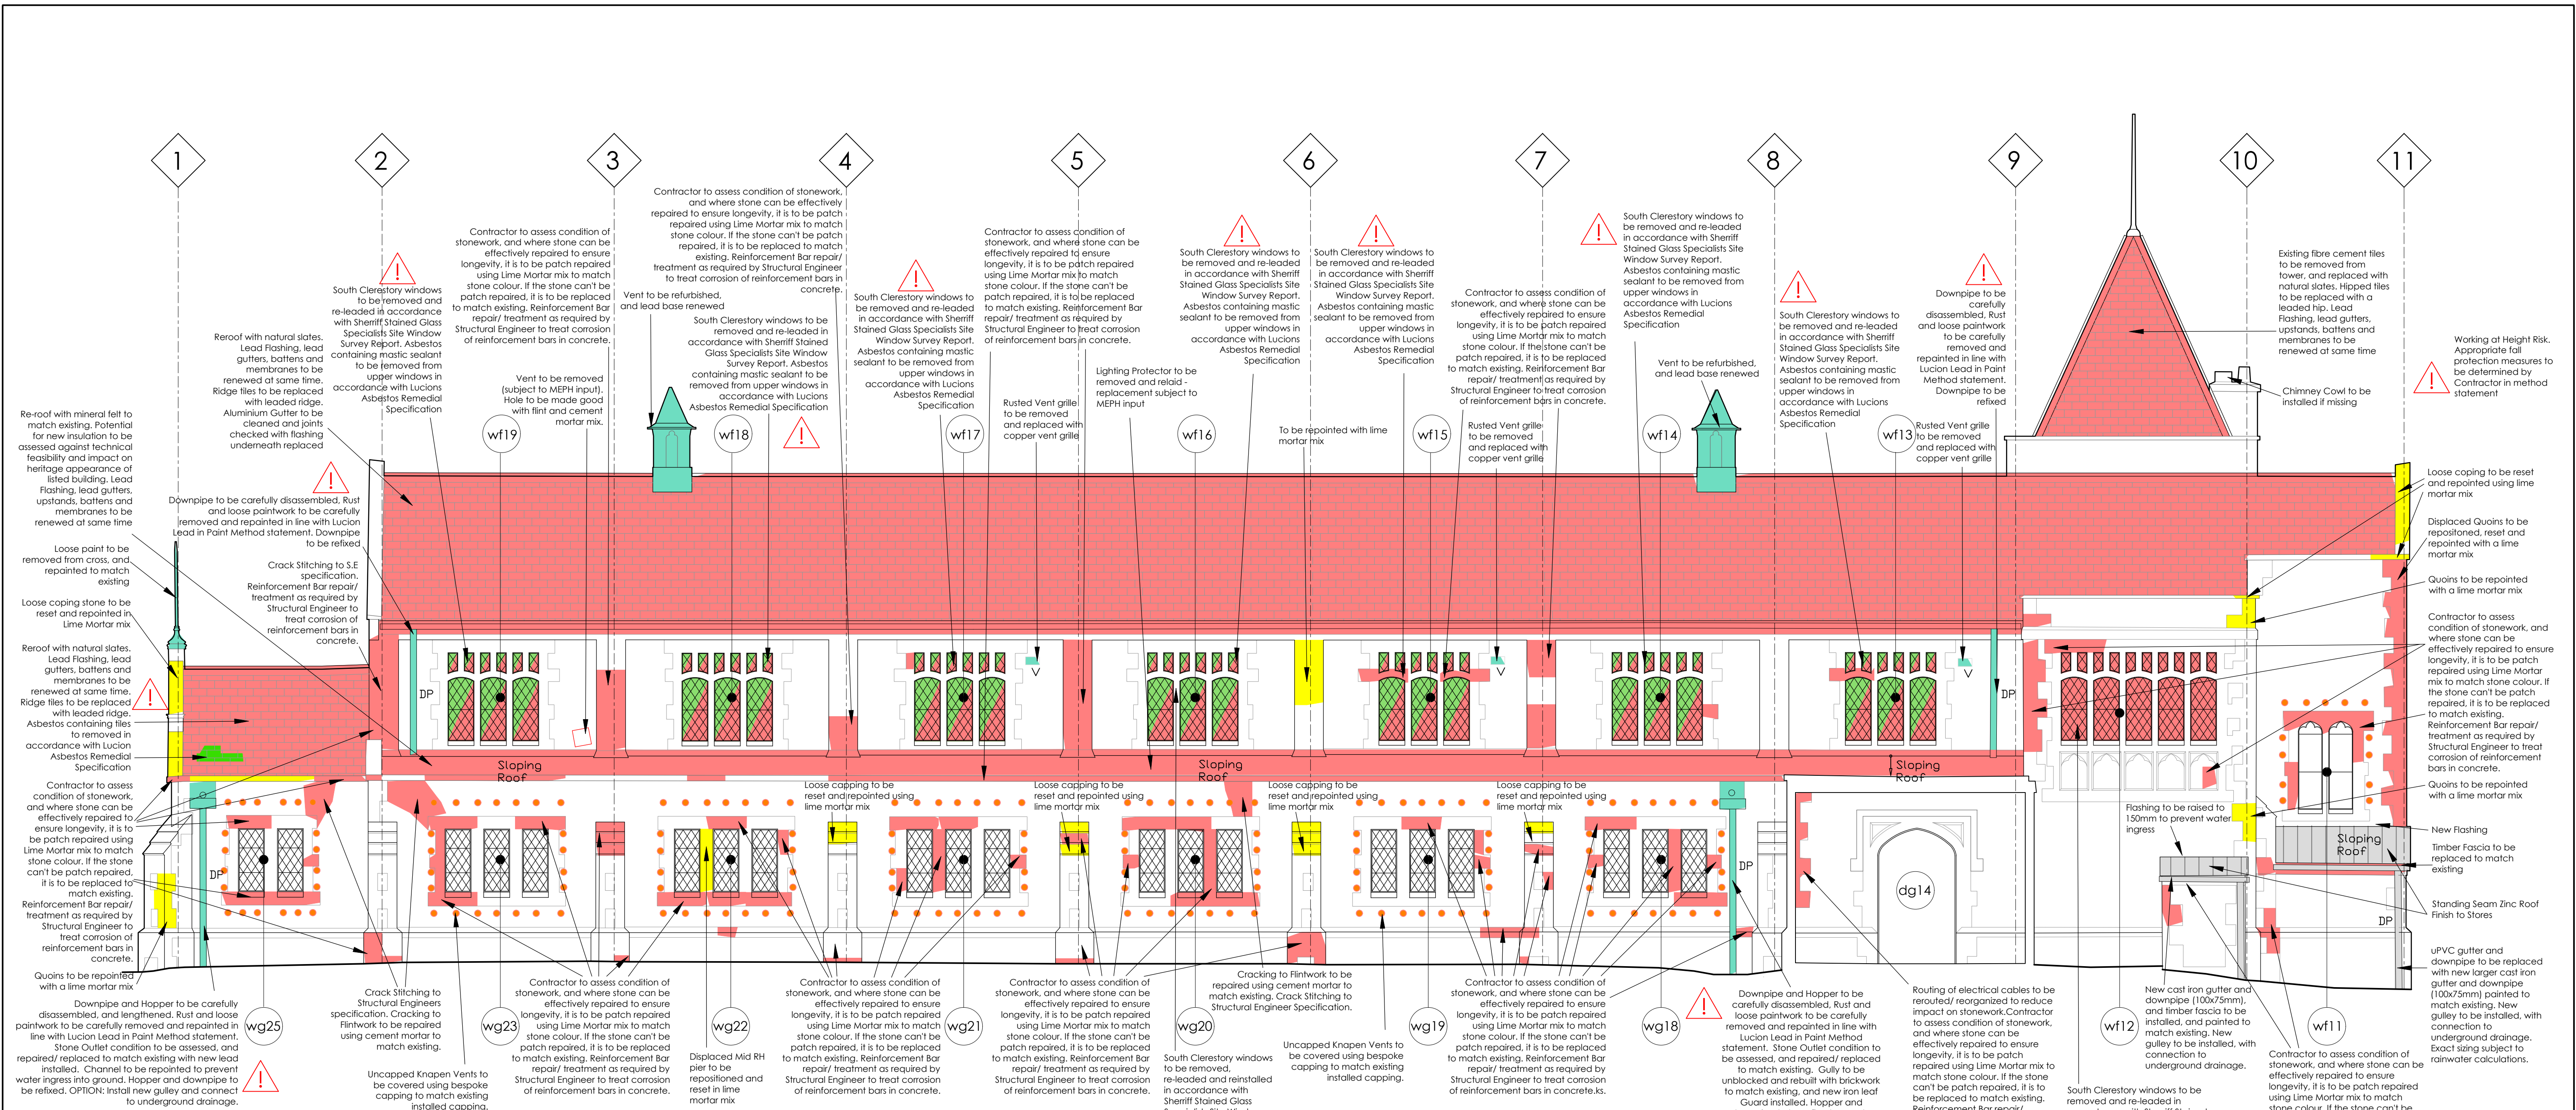
- Degraded Finishes to be refurbished
- Building Fabric to be repaired/ patched, or replaced to match existing if repair is not possible
- Loose Stonework to be reset and repointed
- Asbestos (Refer to Lucion Asbestos Remedial Specification)
- Proposed New Fabric
- Knapen Vent to be capped

- Dark Staining to dressed sloping stone sills on windows, and under parapets to be removed using laser abrasion

- Moss build-up to buttress capping stones to be carefully removed
- Asbestos Sealant to all upper windows and two of the lower windows to be removed in accordance with Lucion Remedial Works Specification.

- Knapen Vents to be capped using fabricated lead caps to match existing
- Lead present in the paint to grey cast iron rainwater goods. The concentration of lead in the rainwater goods is higher than that permitted in domestic materials and for the general public as noted in Lucion's Lead in Paint Testing Report. A risk assessment and other precautions as detailed in the Lucion report should be carried out.

- All damaged dressed stonework to be assessed by the contractor/ stone mason to determine if it can be patch repaired using lime mortar, or if it requires replacement. The Lime Mortar mix for repairs to dressed stonework is to be determined by the Contractor through consultation with The Lime Centre. The mix is to be agreed with ADSL, Wiltshire Council and the SHHC. The Compatibility of the Lime Mortar mix with the existing flint and cement mortar is to be assessed and confirmed by a specialist. Replacement stonework is to be matched to the existing (Quarry and stone to be agreed with ADSL).

- Mismatched colour cement pointing to be carefully removed to dressed stonework throughout. The Lime Mortar mix for repointing to dressed stonework is to be determined by the Contractor through consultation with The Lime techniques. The mix is to be agreed with ADSL, Wiltshire Council and the SHHC. The Compatibility of the Lime Mortar mix with the existing flint and cement mortar is to be assessed and confirmed by a specialist.

- Battens, membranes and Lead Flashings to be renewed throughout when roofs are replaced. Roof structure to be assessed, treated and only replaced where essential, with traditional jointing techniques.

- Stained glass windows will be repaired following asbestos removal works in line with the site window survey report 2023 by Sheriff stained glass specialist, by a suitably qualified professional
