Job • Proposed Works to the Garrison Church of St Patricks & St George, Tidworth.

Title • Proposed Basement Plan and Window/ Door Schedule

Drg No • F1870/100/D

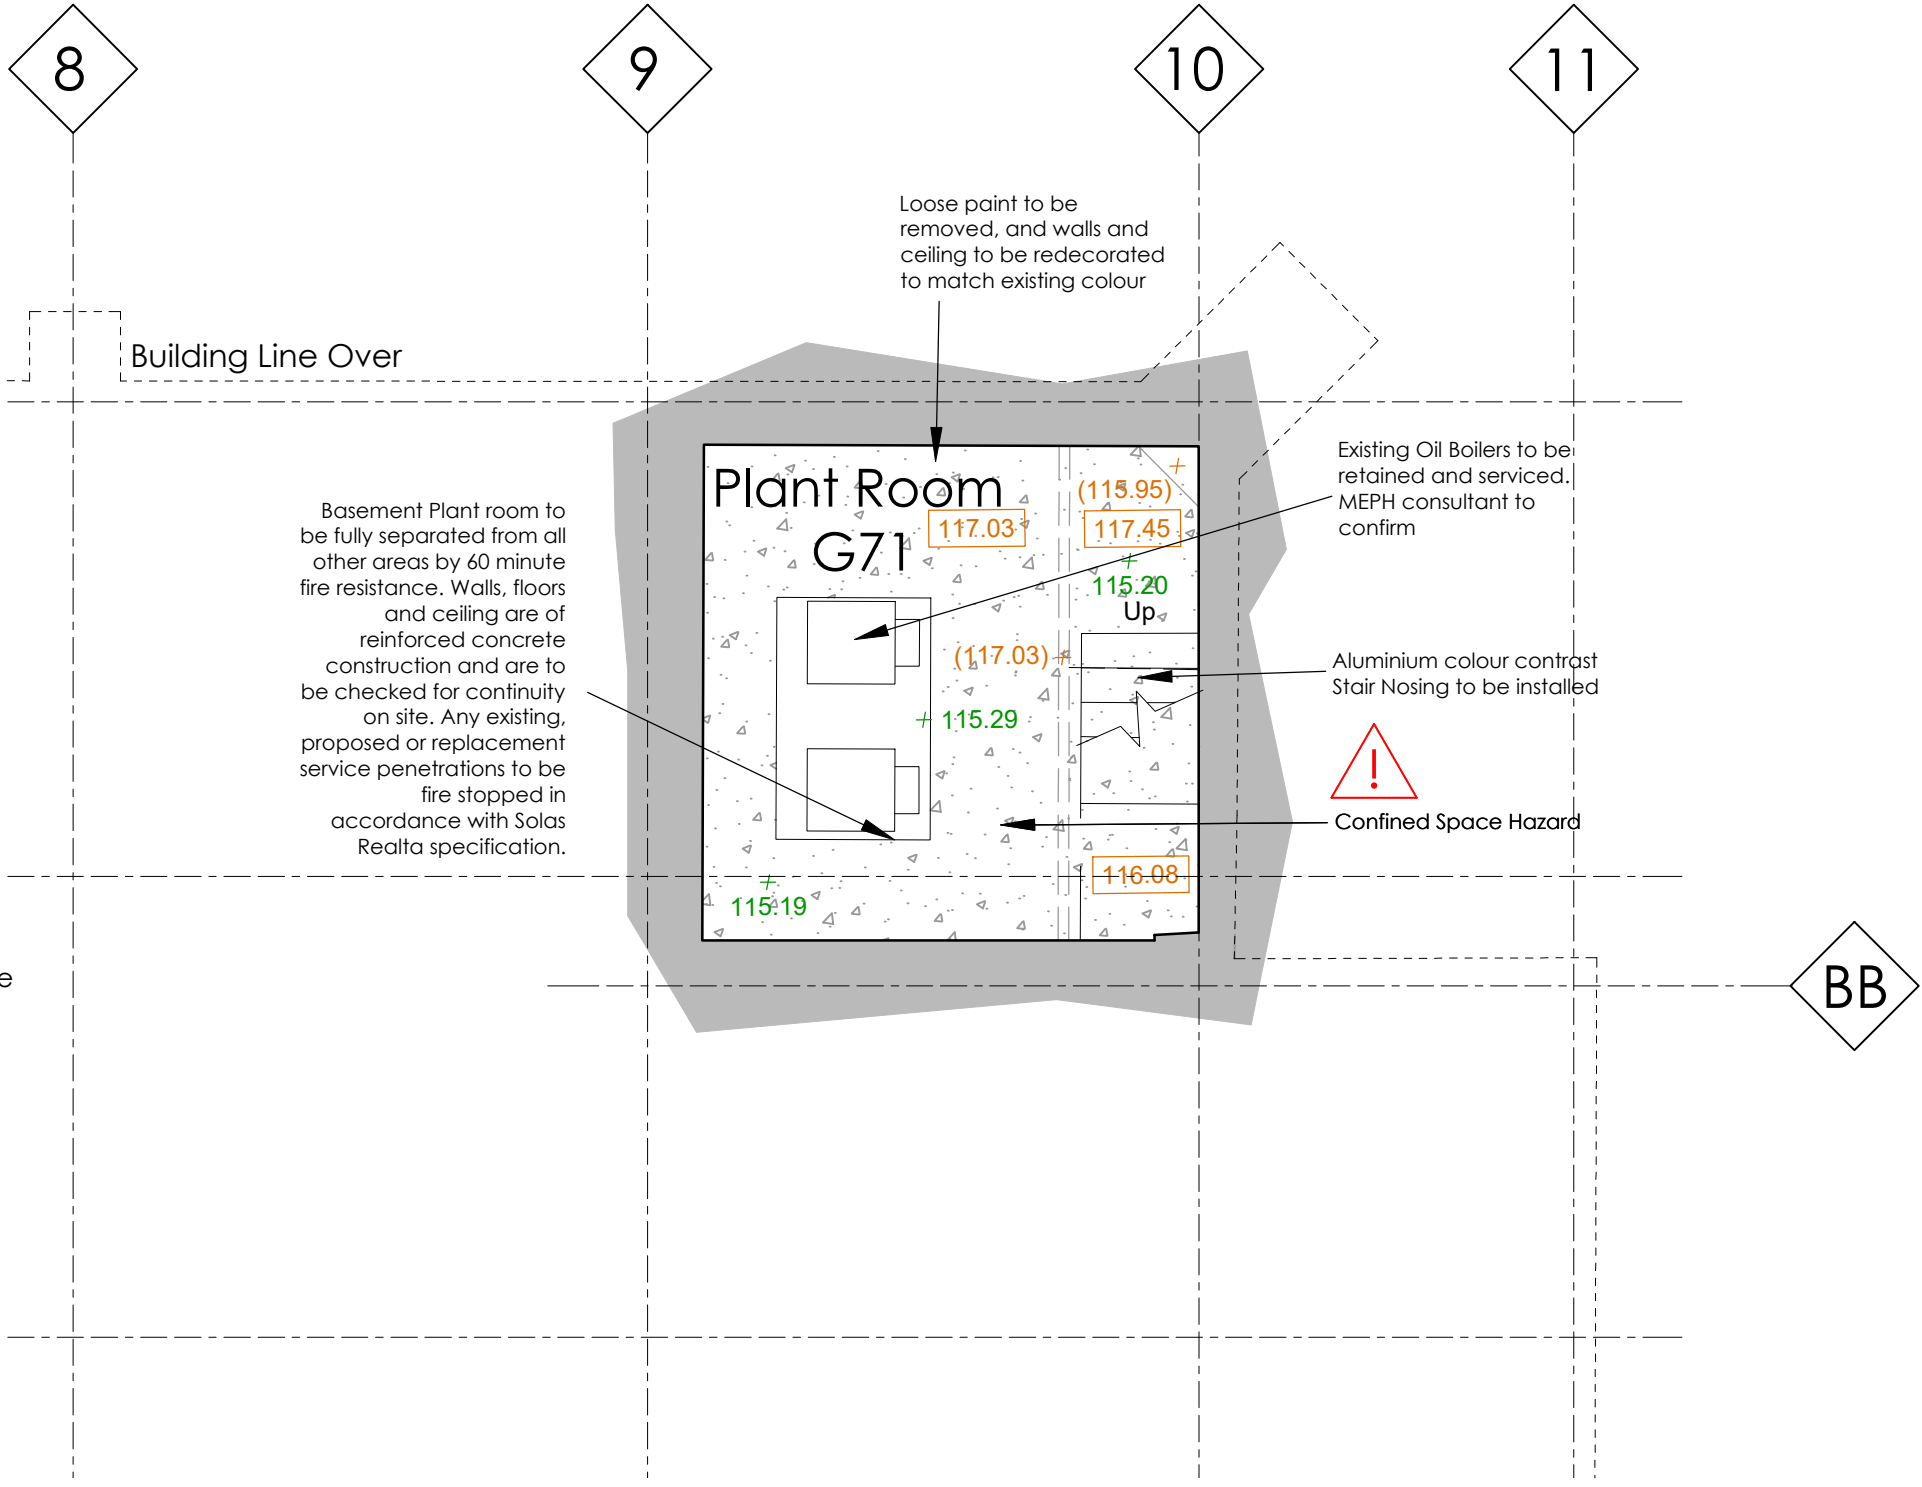
Proposed Basement Floor Plan 1:50

| Window Schedule | | | | | | | |
|---|---|---|---|---|---|---|---|
| wg09 | Basement | Crack to window cill. | | | | | |

| Door Schedule | | | | | |
|---|---|---|---|---|---|
| dg04 | Basement | Hole in header to be filled with lime mortar mix (to be matched by Contractor) | To be replaced with grey PPC aluminium door with louvres and intumescent seals | | |
