## Quinquennial Inspection Report

**St Patricks Garrison Church  
Tidworth  
Wiltshire  
SP9 7BS**

**Job Ref: 14470  
ID: 592114**

19 September 2025 Rev A

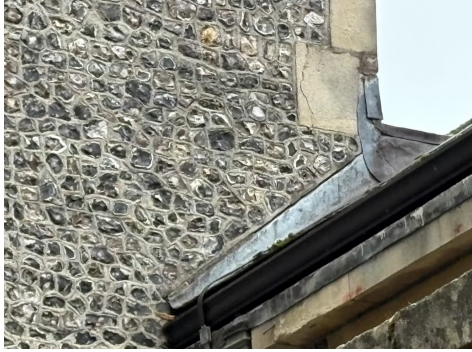
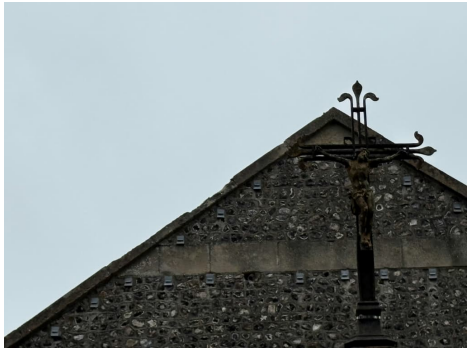
| 1.2 | <p>Lead flashings are present to the raised parapet gables. Leadwork in fair condition although exhibiting signs of weathering and staining. "Lead Mate" or a silicone-type material has been used to point in the lead flashings below the copings. The copings are noted to be badly weathered with spalling stonework in a number of locations, especially to the left-hand gable of elevation 1. What appears to be a gap is visible between the lead and mortar to the flashings to the flank elevation of the tower. We were unable to get a clear inspection of the lead valley behind the tower, however, the limited area of lead that we were able to observe was heavily stained and weathered.</p> | |

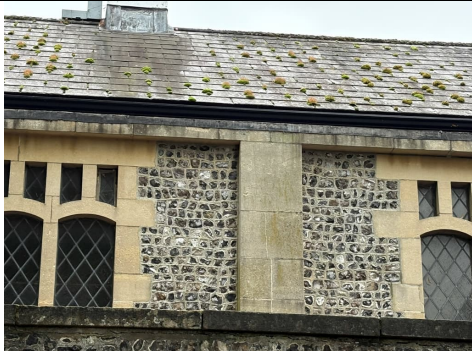
| 1.3 | <p>Natural slates appear to be in fair condition when observed from ground level. However, a small number of missing and cracked slates were observed during the inspection. Quite extensive moss growth and weathered joints are present to the ridge tiles.</p> | |

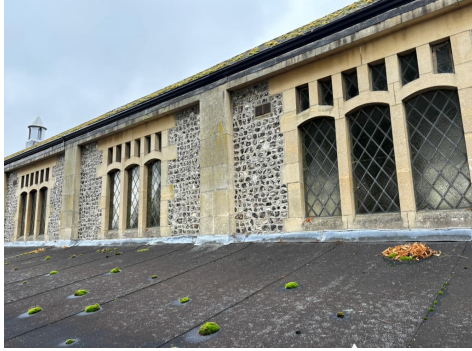
| 2.1 | <p>Lean to pitched roof over the southern aisle of the church covered with built-up bituminous felt. When viewed internally it is evident that this roof slope is formed of an in situ cast concrete slab. We assume that the original roof covering would have been built up asphalt beneath the felt and is likely still in place beneath the felt. The roof is fully enclosed with a raised parapet wall, with stone copings draining towards the roof.</p> | |

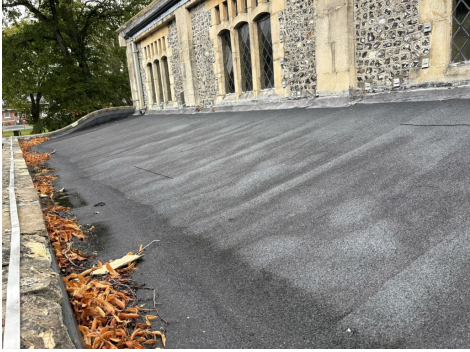
| 2.2 | Whilst the felt appears to generally be in fair condition in its physical state, there are extensive areas of blistering indicating trapped moisture and air between the layers of the built-up felt. | |

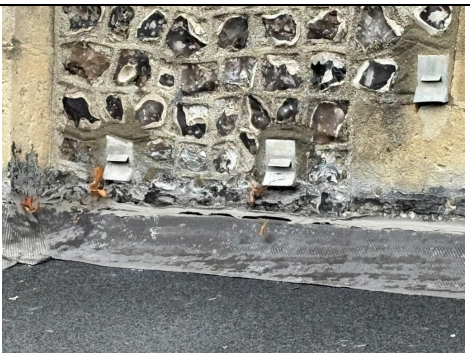
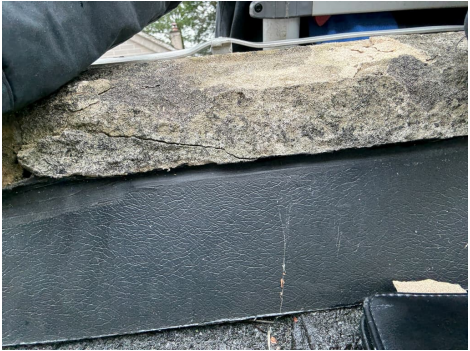
| 2.3 | At junctions with the main flank wall of the church the flashing detail is formed of lead alternative material Ubbink-style flashings, with GRP trim flashing details beneath the copings. | |

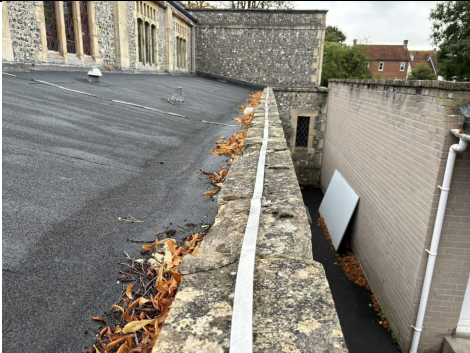
| 2.4 | The stone copings to the parapet walls are badly weathered with spalling stone noted in a number of locations. In addition, the joints were noted to be weathered and cracked. | |

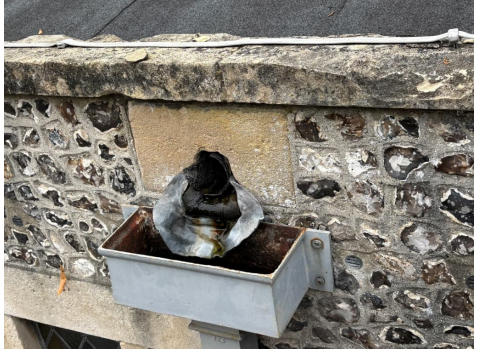
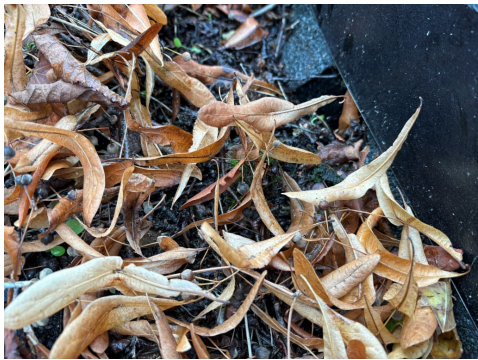
| 2.5 | <p>The roof is served by a single rainwater outlet to the eastern end of the roof which was found to be generally blocked and obscured with leaf debris and mulch at the time of inspection.</p> | |

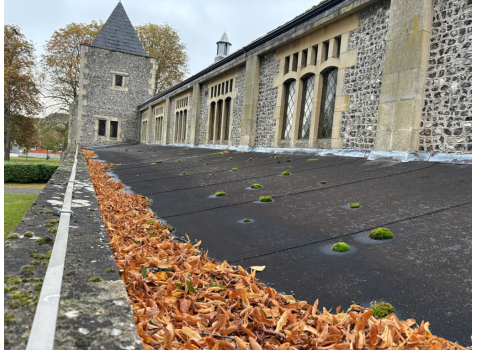
| 3.1 | <p>Lean to pitched roof over the southern aisle of the church covered with built-up bituminous felt. When viewed internally it is evident that this roof slope is formed of an in situ cast concrete slab. We assume that the original roof covering would have been built up asphalt beneath the felt and is likely to be still in place beneath the felt. The roof is fully enclosed with a raised parapet wall, with stone copings draining towards the roof.</p> | |

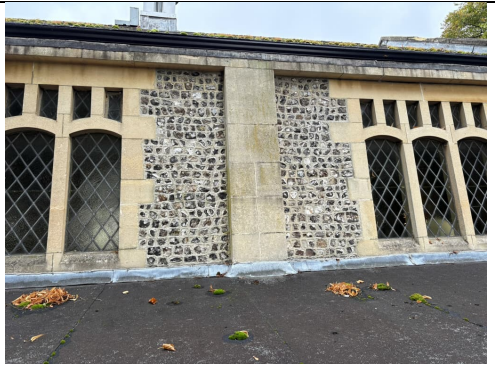
| 3.3 | At junctions with the main flank wall of the church the flashing detail is formed from lead. The lead is weathered and stained. | |

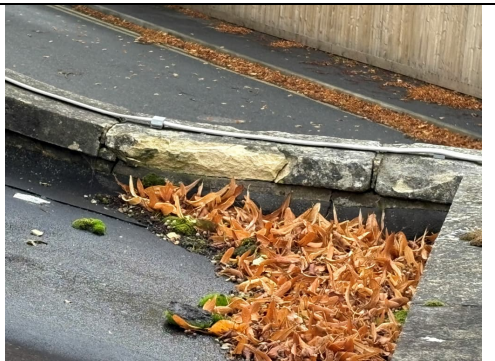
| 3.4 | The stone copings to the parapet walls are badly weathered with spalling stone noted in a number of locations. In addition, the joints were noted to be weathered and cracked. | |

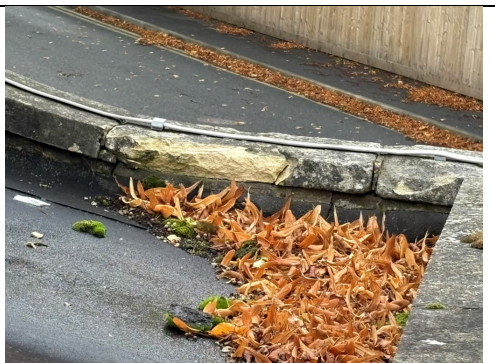
| 3.5 | The roof is served by a single rainwater outlet to the eastern end of the roof which was found to be generally blocked and obscured with leaf debris and mulch at the time of inspection. | |

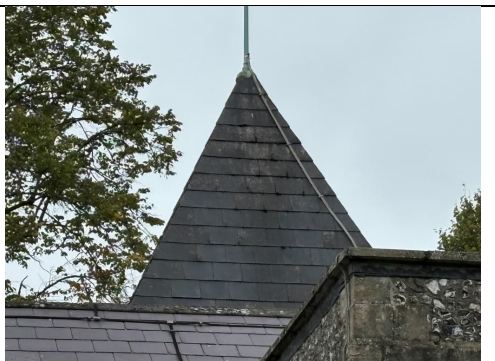
| 4.1 | Pyramidal roof covered with replacement artificial slates enclosed with a raised parapet wall. We were unable to access this part of the roof, therefore, are unable to comment on the condition of the parapet walls and parapet gutters. | |

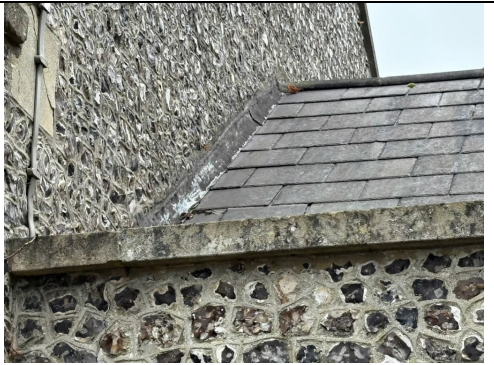
| 5.2 | Lead flashings are present at the junction with the porch roof and the front wall of the church. The flashings are weathered in nature and covered with what appears to be a bitumen-style coating, again indicating potential historic failure of the lead in this location. | |

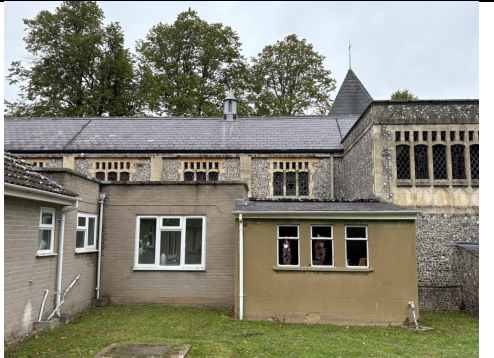
| 7.1 | Lean to mono pitched roof covered with natural slates above the extension to the Vestry. Low level pitch, likely cause of water pentation through this roof. | |

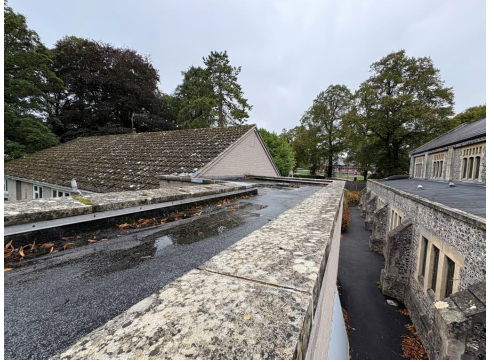
| 8.1 | Flat roof forming the link from the presbytery to the church. Roof covered with built-up bituminous felt, fully enclosed with raised parapet walls with stone copings. An aluminium perimeter trim forms the weatherproofing detail to the upstand of the parapet wall directly beneath the copings. | |

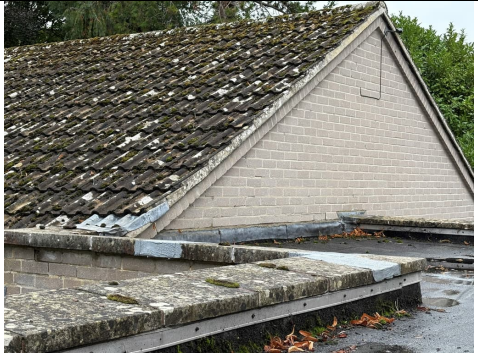
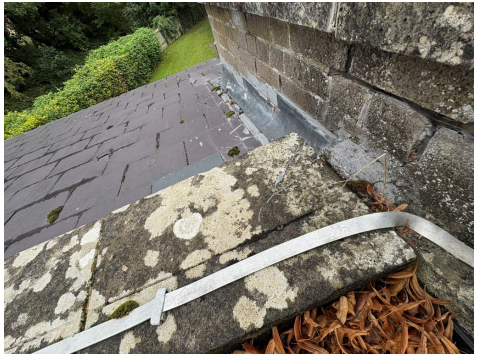
| 8.2 | The stone copings drain inwards towards the roof and are exhibiting signs of weathering, extensive moss build-up along the joints, and in addition there are patches that have been covered with liquid repair system such as "Aquapol" indicating historic leaks in these locations. | |

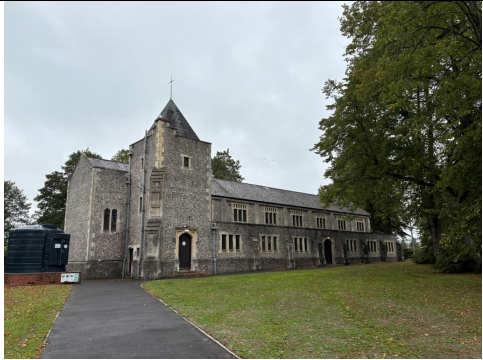
| 9.2 | The majority of the walls are formed from knapped flint set in a cement mortar, with vertical dressed stone columns to the nave, stone window surrounds and mullions, with the aisles and tower supported with buttresses and stone quoining to the corners of the towers and the church and aisles. | |

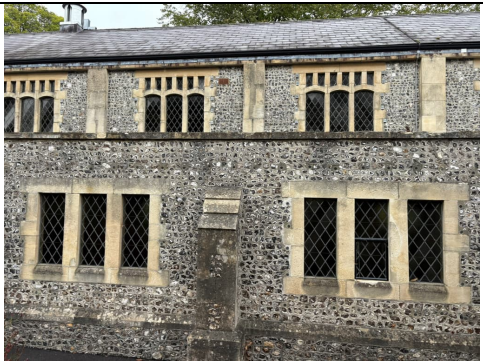
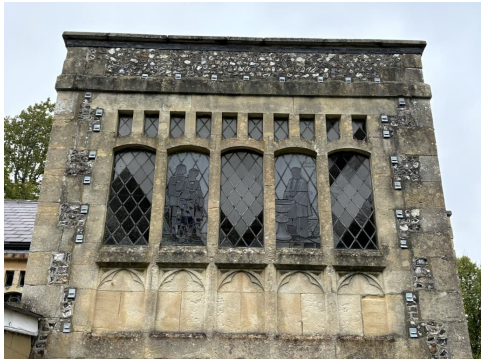
| 9.4 | The stone window surrounds and mullions are of varying degree of weathering and condition with eroded and spalling stonework evident in numerous locations. | |

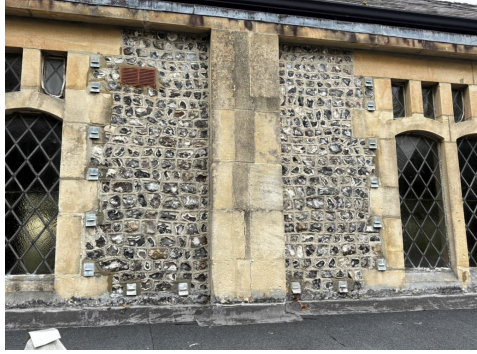
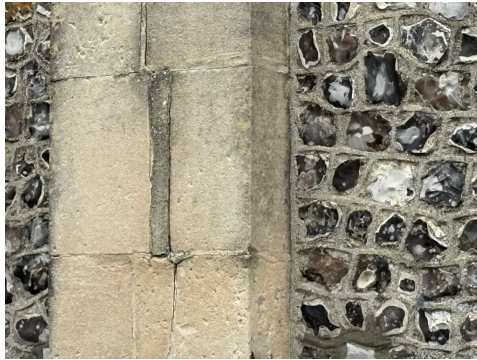
| 9.5 | <p>The vertical stone columns which we assume from the known form of construction will be formed of stone ashlar cladding around the concrete frame to the upper half of the nave walls above the aisle roofs, beginning with the eaves detail to the nave roof comprising of a string course of projecting stonework on which the guttering sits. Vertical cracking ranging from hairline to 1mm in width is present to a number of these columns, located approximately 100-150mm in from the outer edge.</p> | |

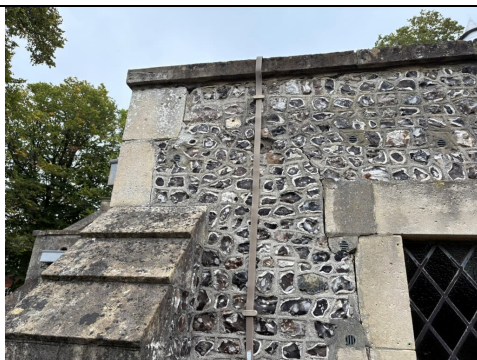
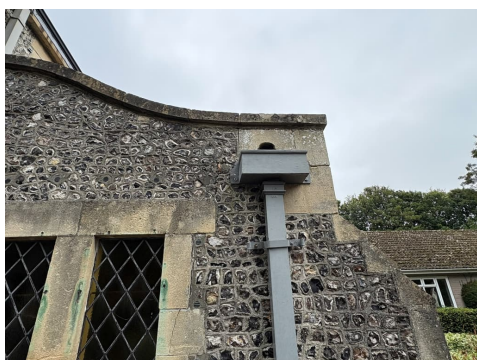
| 9.6 | <p><u>1 on plan</u></p> <p>High level cracking is present above the buttress to the stonework quoining and parapets. The cracking is running along the horizontal bed joints of the quoining and between the coining and the knapped flint walls. The cracking then continues down the side of the window to the south elevation.</p> | |

| 13.3 | The pattern of cracking visible to the walls is in our opinion indicative of expansion cracking caused by corrosion of the steel frame within the structure. Intrusive investigations will be required to determine the extent of corrosion and what remedial repair works will be required. | |

Prior to the proposed refurbishment works at the church including new roofs and works to the parapets and masonry, we recommend that intrusive investigations are undertaken to the walls to expose the steel frame to determine its condition and potential remedial repairs that may be required.

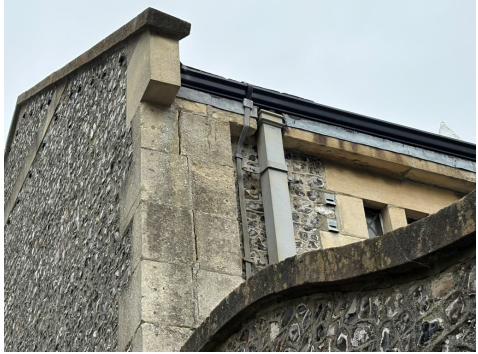
| 9.7 | <p><u>2 on plan</u></p> <p>Vertical cracking is present between the quoining and the first column where we assume it is encasing a steel beam to the south-west corner of the nave, running from eaves down to the parapet wall of the aisle roof. Cracking is ranging between hairline to 2mm in width.</p> | |

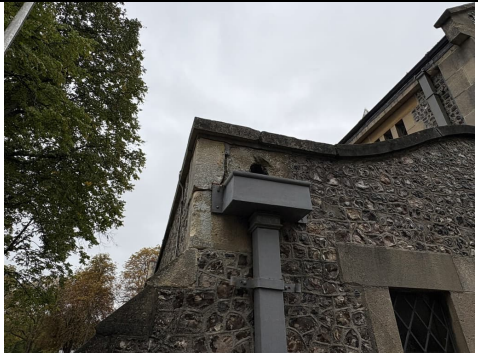
| 9.8 | <p><u>3 on plan</u></p> <p>North-east corner of the northern aisle. Adjacent to the rainwater outlet within the western elevation, the outside quoining stone has been dislodged and been pushed outwards forming a crack between that stone and the adjacent stone.</p> | |

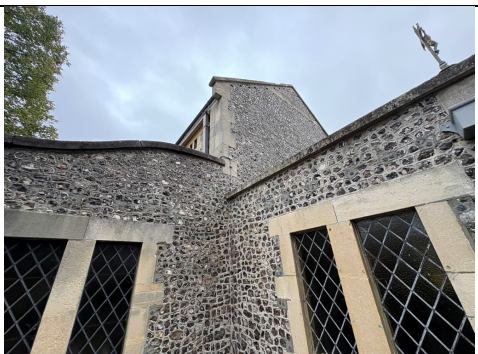
| 9.9 | <p><u>4 on plan</u></p> <p>Horizontal cracking is occurring in the bed joints to the quoining to the north-west corner of the nave, along with signs of evident repointing with junctions with the flint walling indicating historic repairs in these locations. Vertical hairline cracking is also present to the north elevation of the quoining.</p> | |

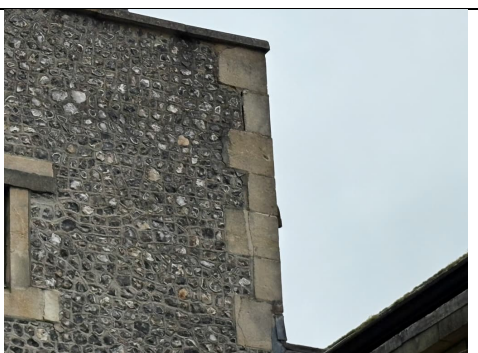
| 9.10 | <p><u>5 on plan</u></p> <p>Vertical hairline cracking is occurring to the south-west corner of the quoining to the tower running for the full height. Cracking is approximately 100-150mm in from the outward corner.</p> | |

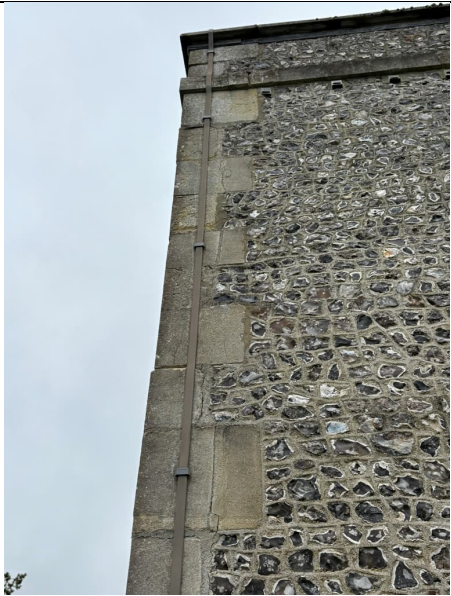
| 9.11 | <p><u>6 on plan</u></p> <p>Cracking is present to the top corner of the parapet and quoining stonework to the sanctuary, resulting in pushing out of the stonework at the corners.</p> | |

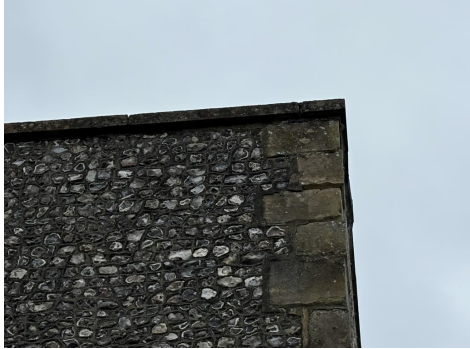
| 9.12 | <p><u>7 on plan</u></p> <p>Cracking is occurring to the stonework forming the corner quoining in this location at high level.</p> | |

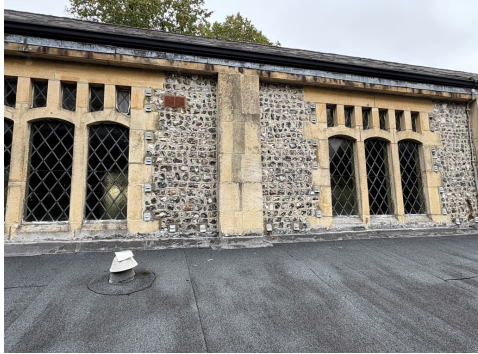
| 10.1 | The guttering serving the main roof to the nave is cast iron painted ogee-style resting on the protruding stone plinth for the full length of the eaves to both slopes. The gutters are served by square profile downpipes discharging onto the lower aisle roofs. Signs of corrosion and leaks are evident to the rainwater goods, and we understand that they are going to be subject to replacement/overhaul as part of the proposed works. | |

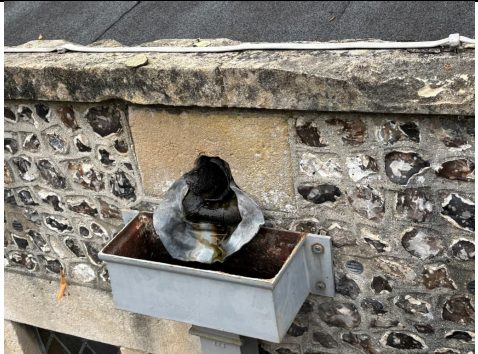
| 10.2 | The lower aisle roofs and the flat roofs are served by square profile metal downpipes and rainwater hoppers, water discharging into the hoppers via chutes through the raised parapet walls. | |

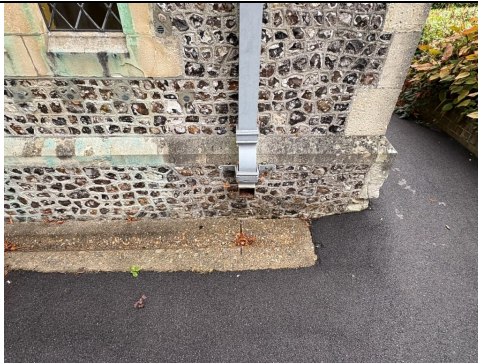
| 10.3 | The downpipes discharge directly onto the ground, and a number of the downpipes terminate a reasonable height from the ground into open concrete gulleys. Due to the height we anticipate that elements of splashback will be occurring as well as windblown water discharging directly onto the walls at low level exacerbating any potential dampness to the external fabric of the church. As a consequence, we would recommend that to any replacement rainwater goods the downpipes are lengthened to discharge close to the ground and gulleys via a shoe directing water away from the face of the wall. | |

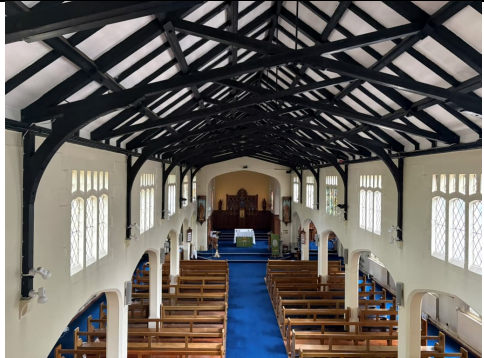
| 14.1 | <p>The roof and ceilings to the nave and chancel are supported by large scissor trusses supporting three purlins to each slope. Each truss in turn is supported by wall posts and curved brackets resting on projecting stone or concrete corbels with a painted finish. These line up with the columns directly below forming the openings to the adjacent aisles. We assume that this lines up with part of the overall frame structure of the building. Between the exposed roof timbers are laid asbestos cement ceiling panels, according to the Asbestos Management Plan, with a painted finish. Due to the present of ghost staining to the panels we anticipate that timber sarking boards are behind, beneath the slate roof covering.</p> | |

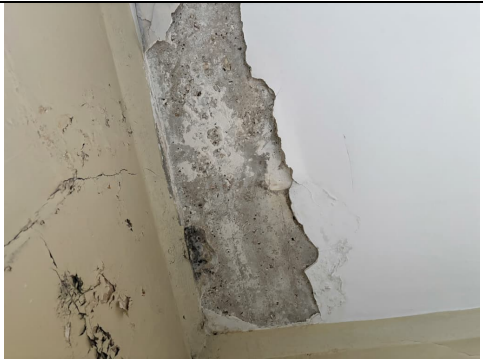
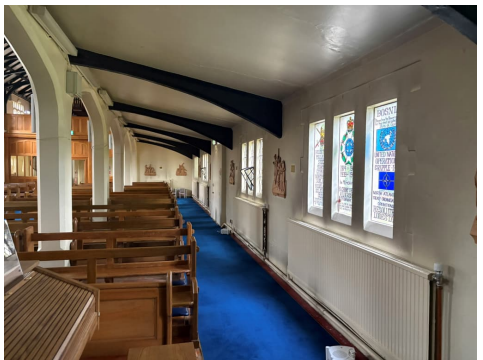
| 14.3 | The lean to roof to the Aisles are formed of cast in situ concrete slabs all with, we understand, a potential asbestos cement finish to the underside with a painted finish. Extensive areas of staining and damage caused by water ingress are evident to a number of areas to both aisles, with the worst damage located to the north-west corner of the north aisle where the plaster skim coat to the underside has failed and dropped away from the ceiling exposing the concrete roof slab. | |

| 18.3 | Due to the failure of the roof coverings to the Aisle roofs with subsequent water ingress damage, given the nature of the construction of cast in situ concrete slab, we anticipate the concrete has become saturated in places. As a result, we cannot rule out the possibility of corrosion and issues occurring to the reinforcement mesh within the slab and recommend that further investigations are undertaken to the carbonation levels of the concrete and condition of the reinforcement within. | |

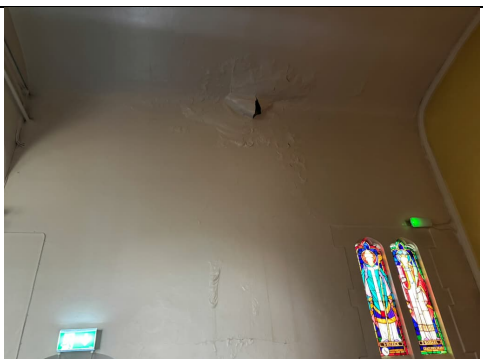
| 14.4 | High level water ingress is clearly evident to the ceilings within the Sanctuary and the Chapel, located to the eastern end of the church, with corresponding damage to the adjacent walls. | |

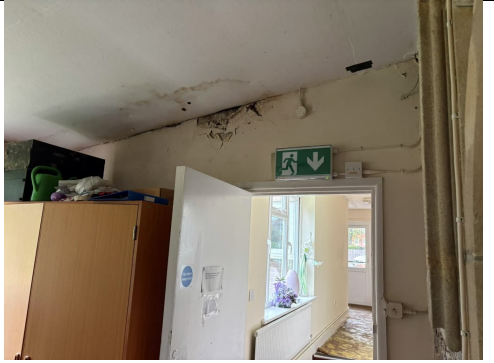
| 14.6 | Extensive staining and damage to the ceiling caused as a result of water ingress is present within the Vestry. | |

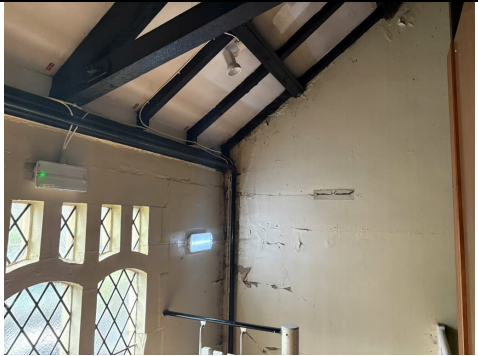
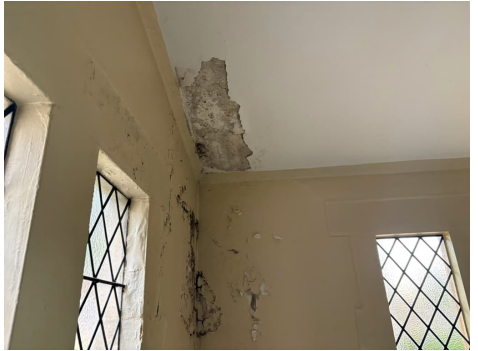
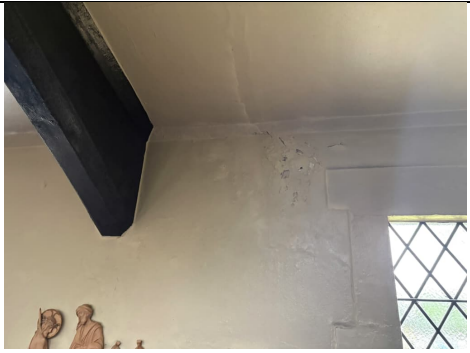
| 15.2 | Extensive areas of damage caused by water ingress are present to all the walls within the property, which corresponds with the areas of water ingress within adjacent ceilings and also corresponding with signs of cracking externally allowing the water ingress. | |

| 18.5 | Following the planned roof repairs and also the recommended investigations of the steel frame and any subsequent repairs, extensive internal decorations and repairs will be required to make good the areas of water ingress damage present internally. | |

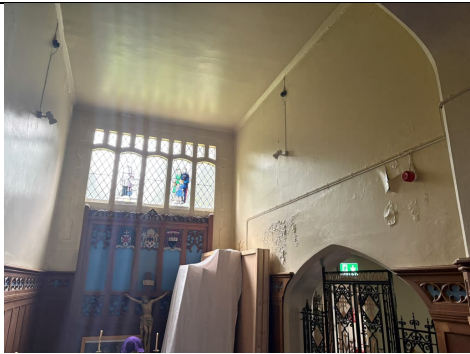
| 15.3 | High level water ingress staining and damage is present within the chapel, the pattern of which corresponds with the slope of the roof of the adjacent Vestry. | |
