SECOND FLOOR

Second Floor | Staircase 2 & Lobby

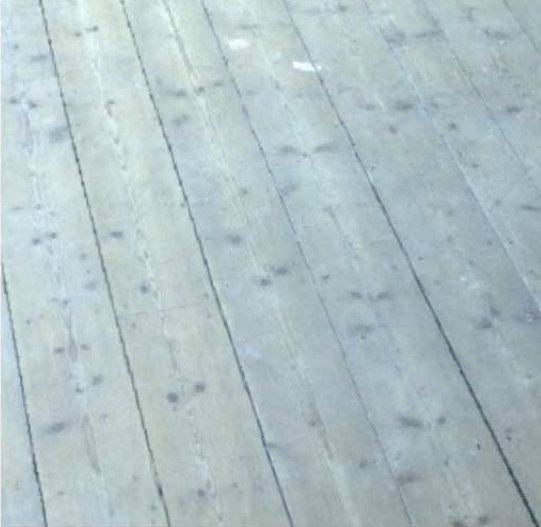
| | Photo | Description | | Proposed strategy of works<br>Retain / Restore /Celebrate | Reference |
|---|---|---|--|---|---|
| Floor | | Timber floorboards exposed now carpet has been removed. What looks like a mixture of original and non-original boards throughout | | Investigate, restore if possible, or overlay with new character timber | |

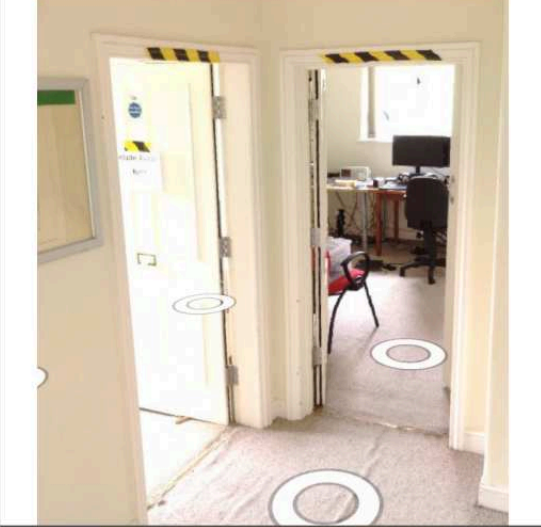
| | Photo | Description | | Proposed strategy of works<br>Retain / Restore /Celebrate | Reference |
|---|---|---|--|---|---|
| | | Timber panelled fire door with architrave | | Retain panelled doors (strip/sand and repaint) | <b>Drawing Number</b> - 088-XX-02-11120<br><b>Annotation / Room</b> - Staircase 2 |

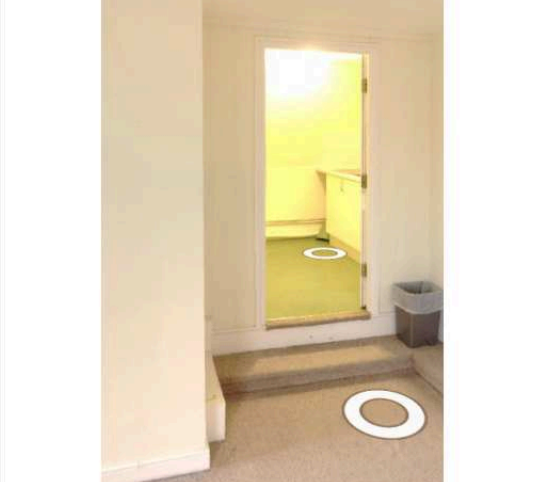
| | Photo | Description | | Proposed strategy of works<br>Retain / Restore /Celebrate | Reference |
|---|---|---|--|---|---|
| | | Timber panelled fire door with architrave | | Door removed and opening blocked up to create new en-suite WC for Guest Bedroom 06 | <b>Drawing Number</b> - 088-XX-02-11521<br><b>Annotation / Room</b> - Staircase 2 |

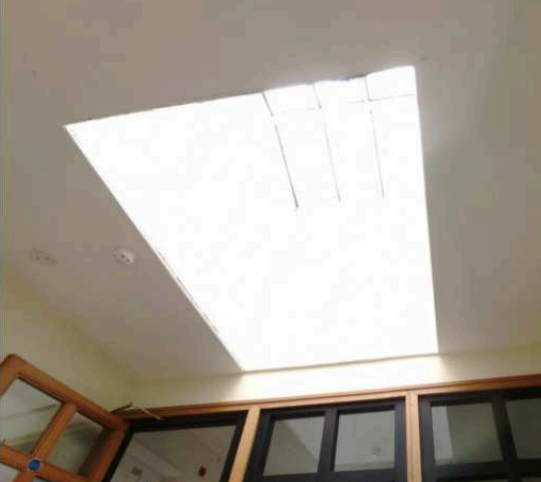
| | Photo | Description | | Proposed strategy of works<br>Retain / Restore /Celebrate | Reference |
|---|---|---|--|---|---|
| Windows | | Roof light | | Replace existing roof light with double glazed to match existing | <b>Drawing Number</b> - 088-XX-03-11130<br><b>Annotation / Room</b> - 1.4 |

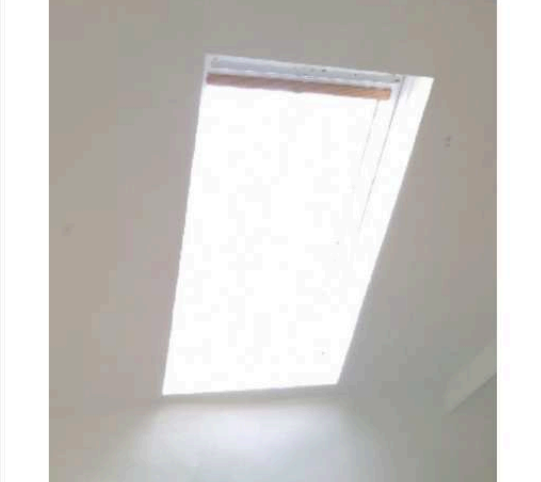
| | Photo | Description | | Proposed strategy of works<br>Retain / Restore /Celebrate | Reference |
|---|---|---|--|---|---|
| | | Velux style openable roof lights | | Velux window replace with heritage roof light | <b>Drawing Number</b> - 088-XX-03-11130<br><b>Annotation / Room</b> - 1.4 |

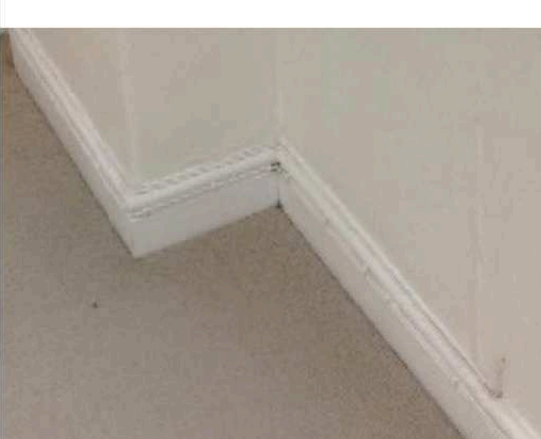
| | Photo | Description | | Proposed strategy of works<br>Retain / Restore /Celebrate | Reference |
|---|---|---|--|---|---|
| Skirting | | Skirting moulding | | Retain and refurbish as necessary | |

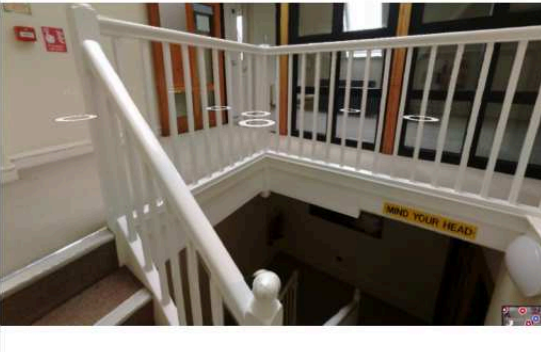
| | Photo | Description | | Proposed strategy of works<br>Retain / Restore /Celebrate | Reference |
|---|---|---|--|---|---|
| Others | | White painted timber back stair with simple detail | | <ul style="list-style-type: none"><li>Retain balustrade: sand/re-paint</li><li>Wood floor under carpet? Investigate if existing timber boards are good enough quality to refurbish. If not, lay new character grade timber floor (on top of existing heritage timber floor)</li></ul> | <b>Drawing Number</b> - 088-XX-02-11120<br><b>Annotation / Room</b> - Staircase 2 |

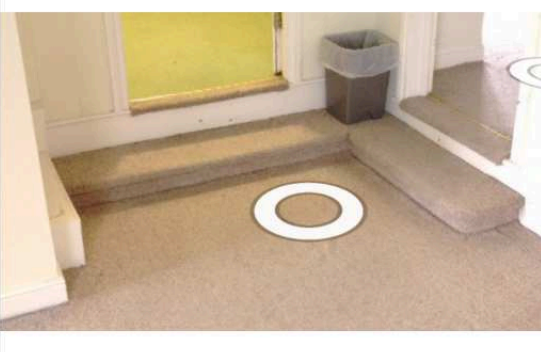
| | Photo | Description | | Proposed strategy of works<br>Retain / Restore /Celebrate | Reference |
|---|---|---|--|---|---|
| | | Steps | | New carpet to replace existing | <b>Drawing Number</b> - 088-XX-02-11120<br><b>Annotation / Room</b> - Staircase 2 |

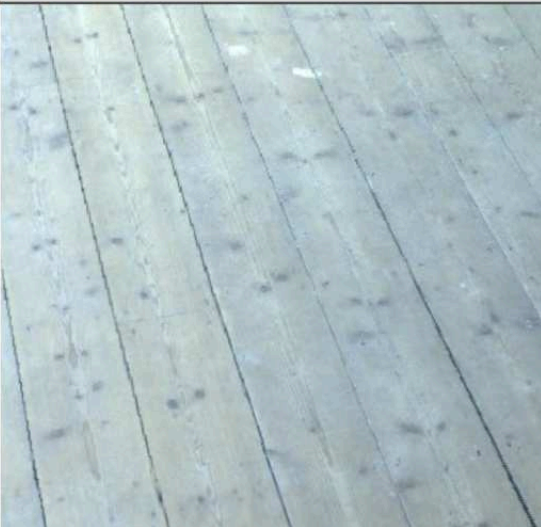
| | Photo | Description | | Proposed strategy of works<br>Retain / Restore /Celebrate | Reference |
|---|---|---|--|---|---|
| Floor | | Timber floorboards exposed now carpet has been removed. What looks like a mixture of original and non-original boards throughout | | Investigate, restore if possible, or overlay with new character timber. Tiled in new original timber floor | |

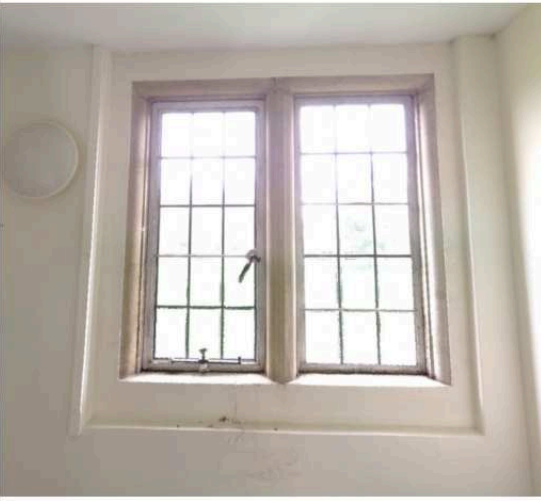
| <b>Windows</b> | | Original window with stone mullions and leaded glazing bars | | Restore stone mullion window including leaded glazing bars. | <b>Drawing Number</b> - 088-XX-02-11120<br><b>Annotation / Room</b> - Guest Bedroom 05<br><b>Window Number</b> - W2.11 |

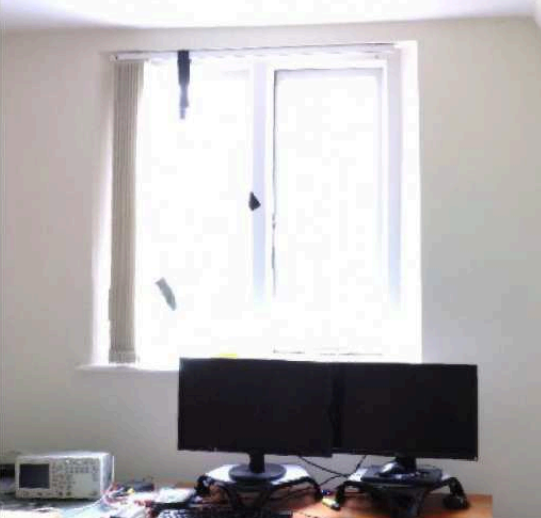
| | | Existing timber window<br>White painted timber casement window with surface mounted curtain rail and poor quality curtains | | Strip and re-paint windows and remove any curtain fittings | <b>Drawing Number</b> - 088-XX-02-11120<br><b>Annotation / Room</b> - Guest Bedroom 05<br><b>Window Number</b> - W2.10 |

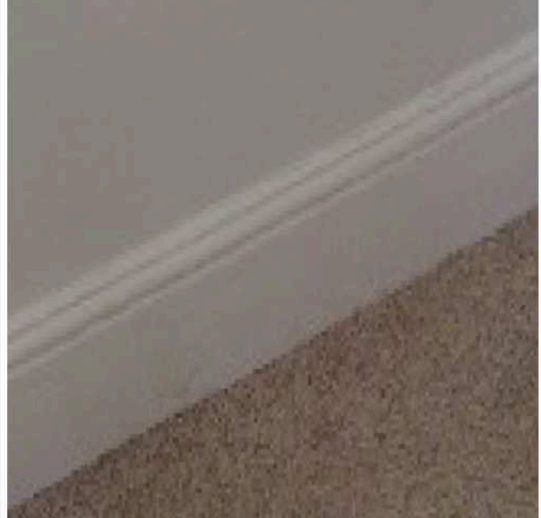
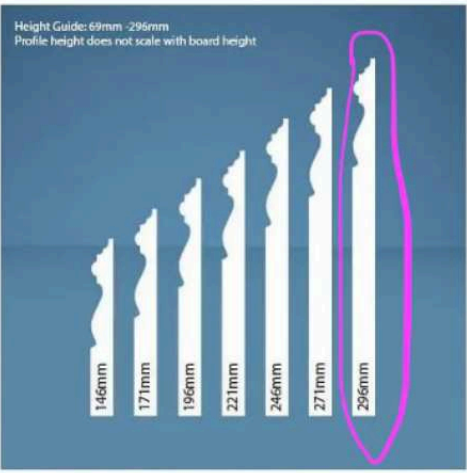
| <b>Skirting</b> | | Skirting moulding | | Replace with a simple Victorian skirting | |

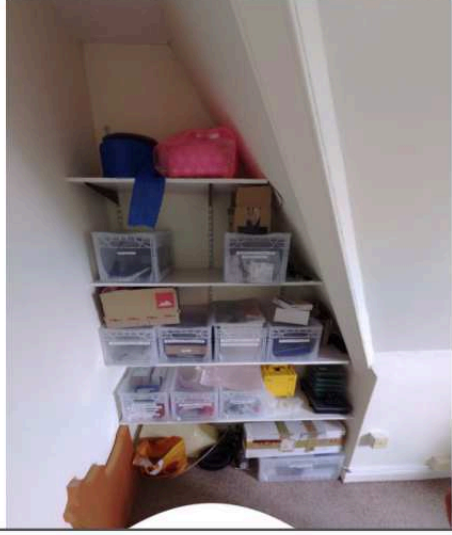
| <b>Joinery/Fixtures/Fitting</b> | | Poor quality timber open shelves | | Joinery timber open shelves – remove – poor quality | |

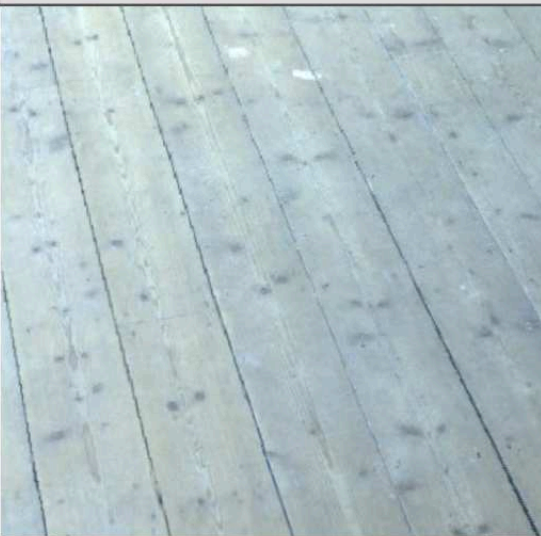
| | Photo | Description | | <b>Proposed strategy of works</b><br><b>Retain / Restore /Celebrate</b> | <b>Reference</b> |
|---|---|---|--|---|---|
| <b>Floor</b> | | Timber floorboards exposed now carpet has been removed. What looks like a mixture of original and non-original boards throughout | | Investigate, restore if possible, or overlay with new character timber | |

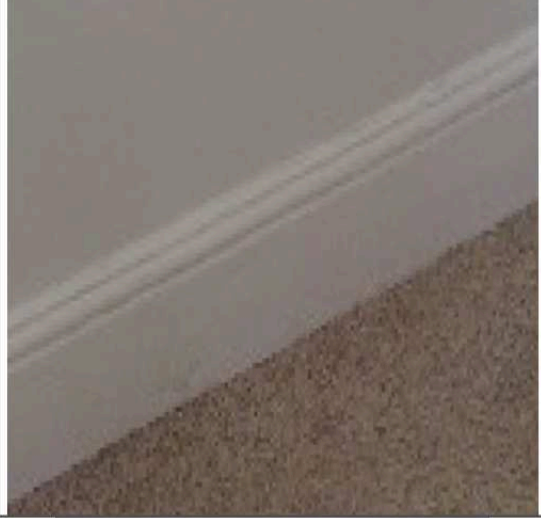
| | Photo | Description | | <b>Proposed strategy of works</b><br><b>Retain / Restore /Celebrate</b> | <b>Reference</b> |
|---|---|---|--|---|---|
| <b>Skirting</b> | | Skirting moulding | | Retain | |

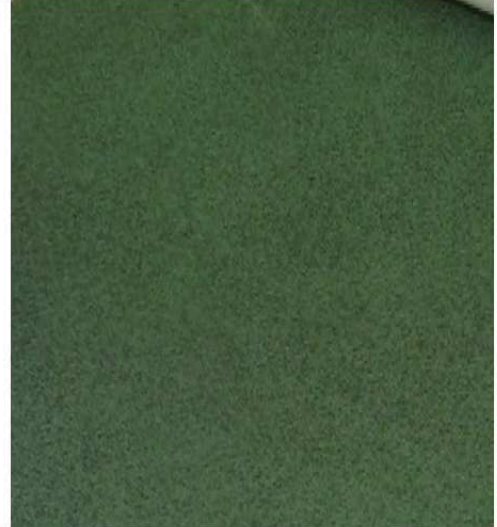
| | Photo | Description | | Proposed strategy of works<br>Retain / Restore /Celebrate | Reference |
|---|---|---|--|---|---|
| Floor | | Vinyl floor | | Remove vinyl and lay new tile over original (assumed) timber floor | <b>Drawing Number</b> - 088-XX-02-11120<br><b>Annotation / Room</b> - Guest Bedroom WC |

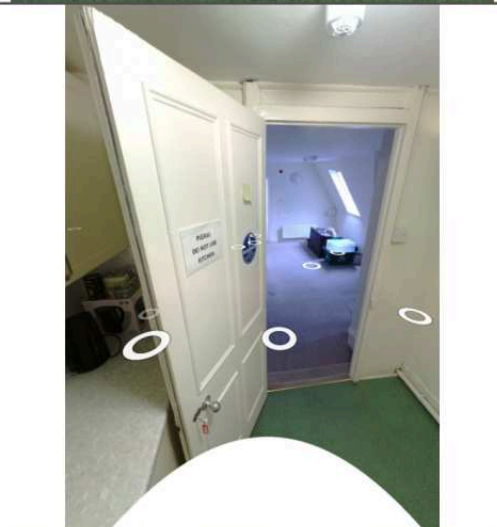
| | Photo | Description | | Proposed strategy of works<br>Retain / Restore /Celebrate | Reference |
|---|---|---|--|---|---|
| Doors / Architraves | | Fire door with simple architrave, panelled timber door | | Retain panelled door (strip and re-paint) | <b>Drawing Number</b> - 088-XX-02-11120<br><b>Annotation / Room</b> - Guest Bedroom WC |

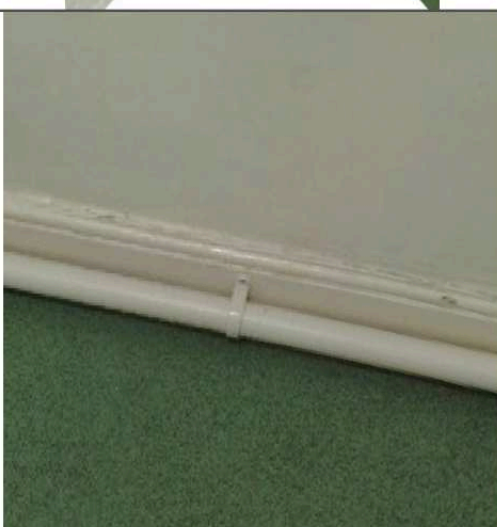
| | Photo | Description | | Proposed strategy of works<br>Retain / Restore /Celebrate | Reference |
|---|---|---|--|---|---|
| Skirting | | Skirting moulding at low level | | Retain | |

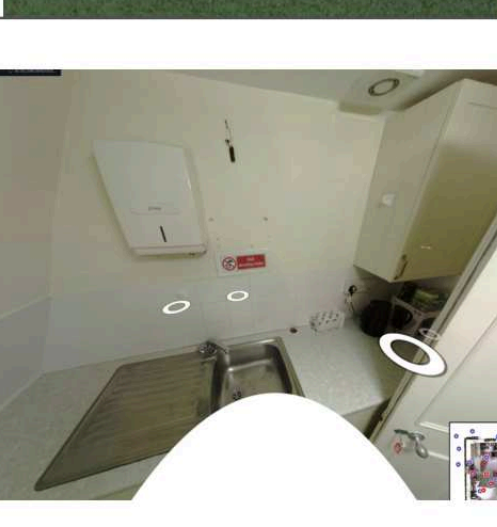
| | Photo | Description | | Proposed strategy of works<br>Retain / Restore /Celebrate | Reference |
|---|---|---|--|---|---|
| Joinery/Fixtures/Fitting | | Poor quality contemporary kitchen | | Remove | <b>Drawing Number</b> - 088-XX-02-11521<br><b>Annotation / Room</b> - Room 303 |

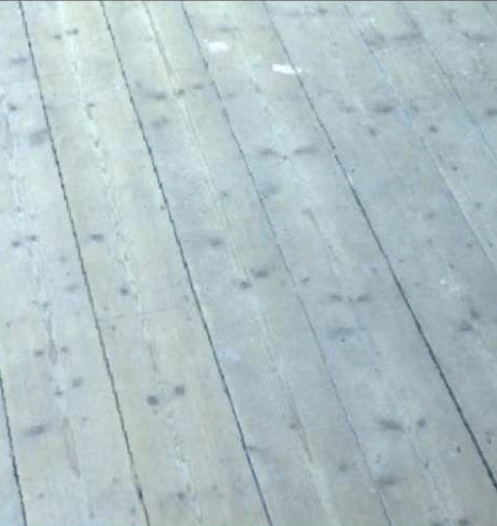
| | Photo | Description | | Proposed strategy of works<br>Retain / Restore /Celebrate | Reference |
|---|---|---|--|---|---|
| Floor | | Timber floorboards exposed now carpet has been removed. What looks like a mixture of original and non-original boards throughout | | Investigate, restore if possible, or overlay with new character timber | |

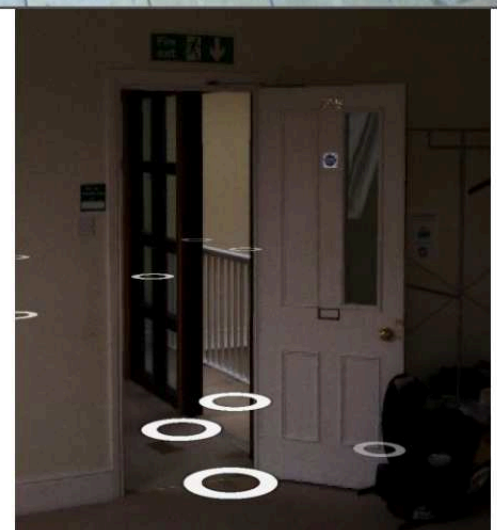
| | Photo | Description | | Proposed strategy of works<br>Retain / Restore /Celebrate | Reference |
|---|---|---|--|---|---|
| Doors / Architraves | | Fire door with architrave, panelled timber door and exposed self closer. | | Retain panelled doors (strip and re-paint) | <b>Drawing Number</b> - 088-XX-02-11120<br><b>Annotation / Room</b> - Living Room<br>4 |

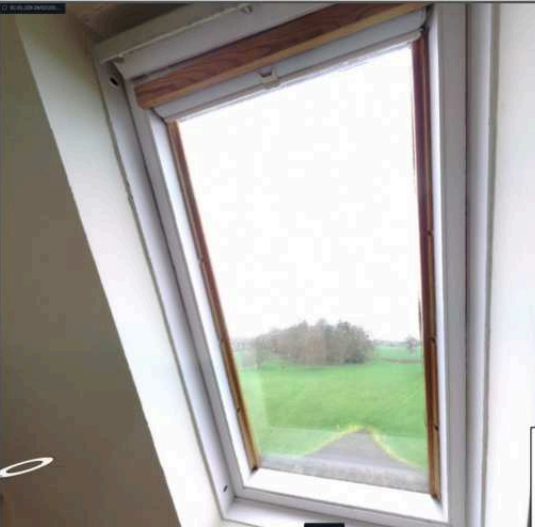
| <b>Windows</b> | | Velux style openable roof lights | | Velux window to be replaced with new heritage roof light. | <b>Drawing Number</b> - 088-XX-03-11130<br><b>Annotation / Room</b> - 1.4 |

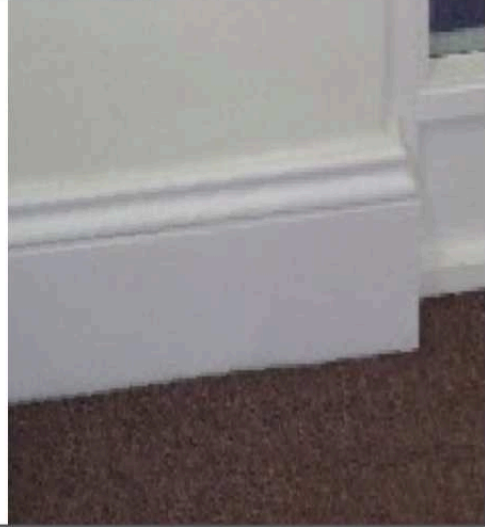
| <b>Skirting</b> | | Skirting moulding | | Retain | |

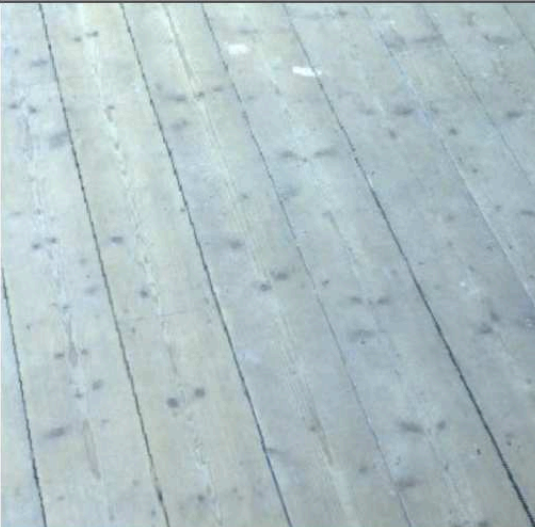
| | Photo | Description | | Proposed strategy of works<br>Retain / Restore /Celebrate | Reference |
|---|---|---|--|---|---|
| <b>Floor</b> | | Timber floorboards exposed now carpet has been removed. What looks like a mixture of original and non-original boards throughout | | Investigate, restore if possible, or overlay with new character timber. New tiled floor overlaid onto timber floor in new en-suite | |

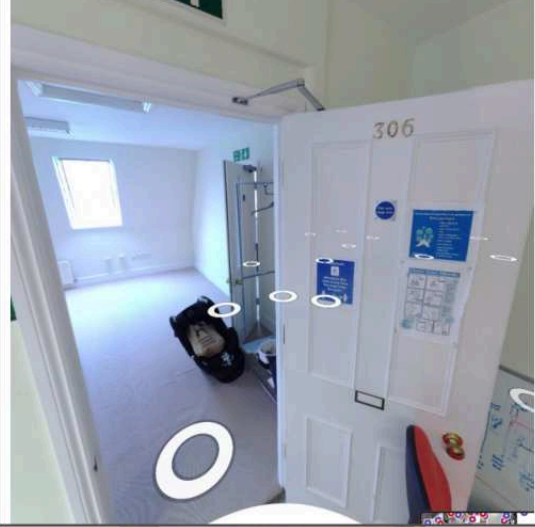
| | Photo | Description | | Proposed strategy of works<br>Retain / Restore /Celebrate | Reference |
|---|---|---|--|---|---|
| <b>Doors / Architraves</b> | | Firedoor | | Retain panelled doors (strip and re-paint) | <b>Drawing Number</b> - 088-XX-02-11120<br><b>Annotation / Room</b> - Multi Guest Bedroom 11 |

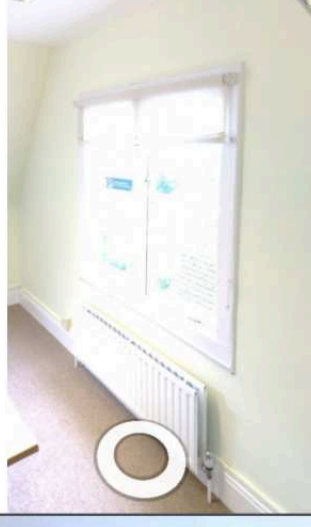
| | Photo | Description | | Proposed strategy of works<br>Retain / Restore /Celebrate | Reference |
|---|---|---|--|---|---|
| <b>Windows</b> | | Casement timber window | | Strip and re-paint windows and remove any old curtain or blind fittings | <b>Drawing Number</b> - 088-XX-02-11120<br><b>Annotation / Room</b> - Multi Guest Bedroom 11 |

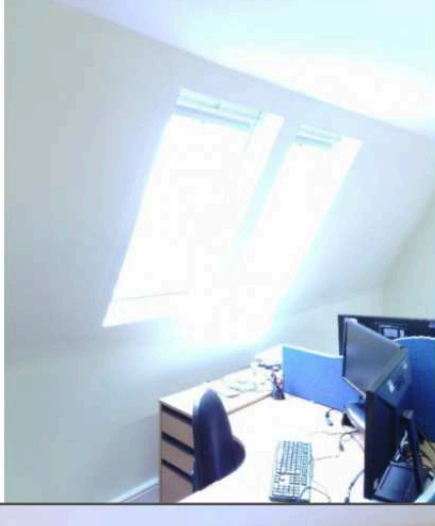
| | Photo | Description | | Proposed strategy of works<br>Retain / Restore /Celebrate | Reference |
|---|---|---|--|---|---|
| | | Velux style openable roof lights | | Velux roof lights to be removed and replaced with dormer window. See fabric removal plans and proposed elevations for details. | <b>Drawing Number</b> - 088-XX-02-11521<br><b>Roof light number</b> - W2.11, W2.10 |

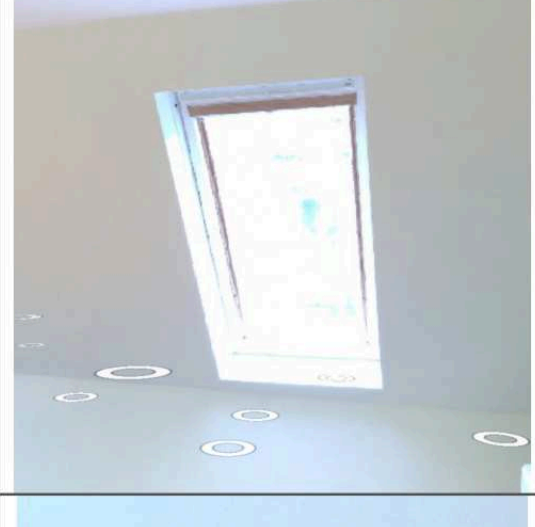
| | Photo | Description | | Proposed strategy of works<br>Retain / Restore /Celebrate | Reference |
|---|---|---|--|---|---|
| | | Velux style openable roof lights | | Velux window to be replaced with new heritage roof light. | <b>Drawing Number</b> - 088-XX-03-11130<br><b>Annotation / Room</b> - 1.4 |

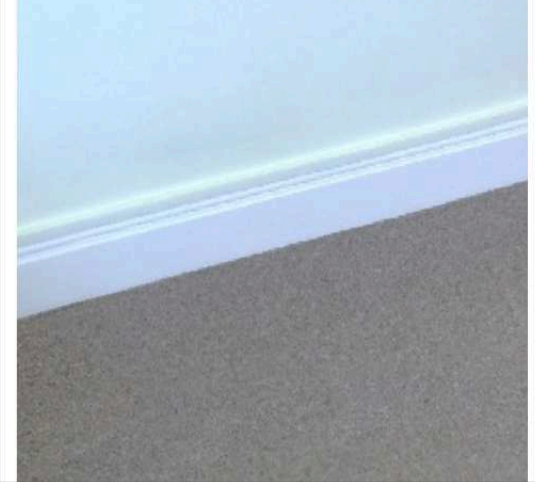
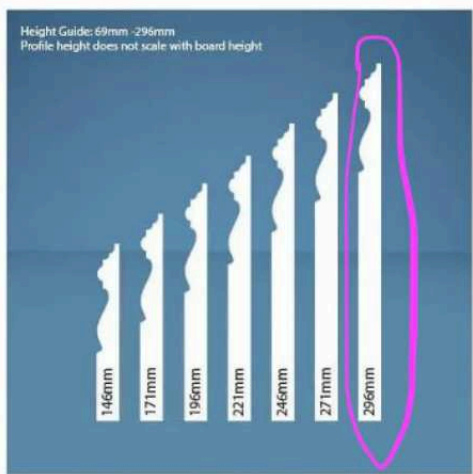
| | Photo | Description | | Proposed strategy of works<br>Retain / Restore /Celebrate | Reference |
|---|---|---|--|---|---|
| <b>Skirting</b> | | Skirting moulding at low level | | Retain | |

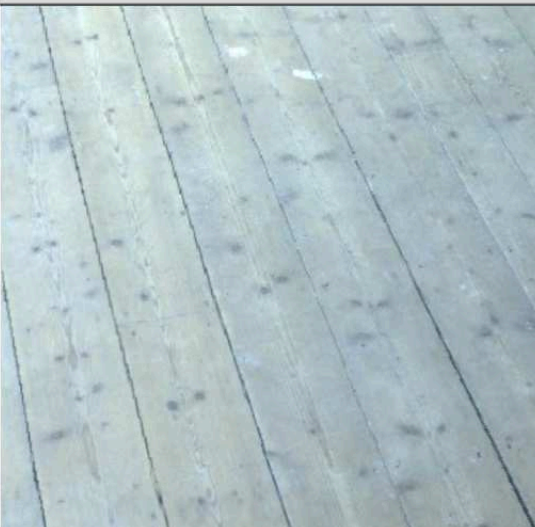
| | Photo | Description | | Proposed strategy of works<br>Retain / Restore /Celebrate | Reference |
|---|---|---|--|---|---|
| <b>Floor</b> | | Timber floorboards exposed now carpet has been removed. What looks like a mixture of original and non-original boards throughout | | Investigate, restore if possible, or overlay with new character timber. New tiled floor overlaid onto timber floor in new en-suite | |

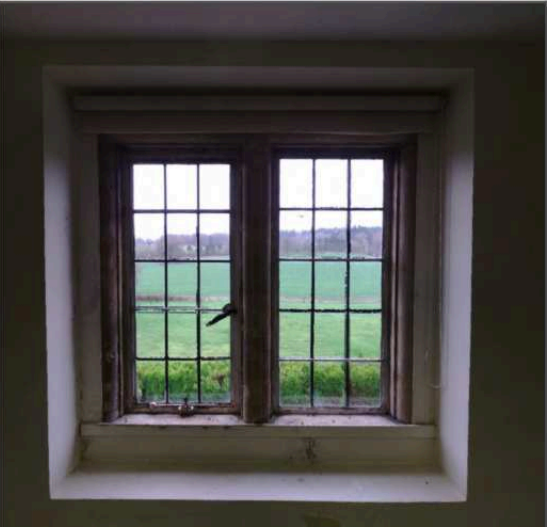
| <b>Windows</b> | | Original window with stone mullions and leaded glazing bars | | Restore stone mullion window including leaded glazing bars. Remove surface fixed curtain rail. | <b>Drawing Number</b> - 088-XX-02-11120<br><b>Annotation / Room</b> - Guest Bedroom 08<br><b>Window Number</b> - W2.05 |

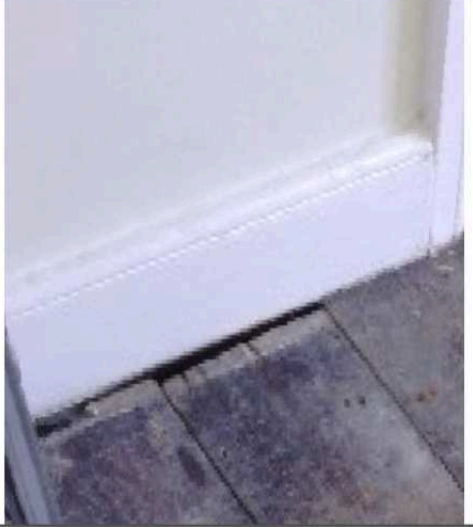
| <b>Skirting</b> | | Skirting moulding | | Retain and reinstate when new partition is added for en-suite. New skirting to match to existing. | |

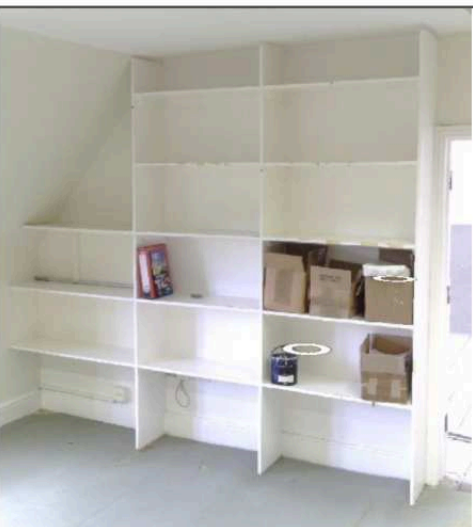
| <b>Joinery/Fixtures/Fitting</b> | | Poor quality timber open shelves | | Remove | |

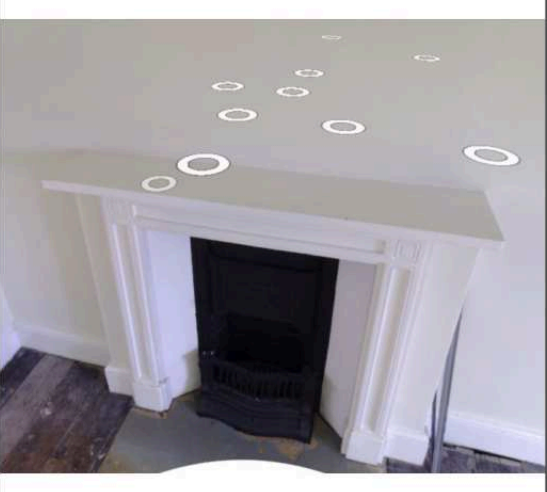
| <b>Period Feature</b> | | Fire place surround and mantle with original insert and hearth | | Retain and refurbish | <b>Drawing Number</b> - 088-XX-02-11120<br><b>Annotation / Room</b> - Guest Bedroom 08 |

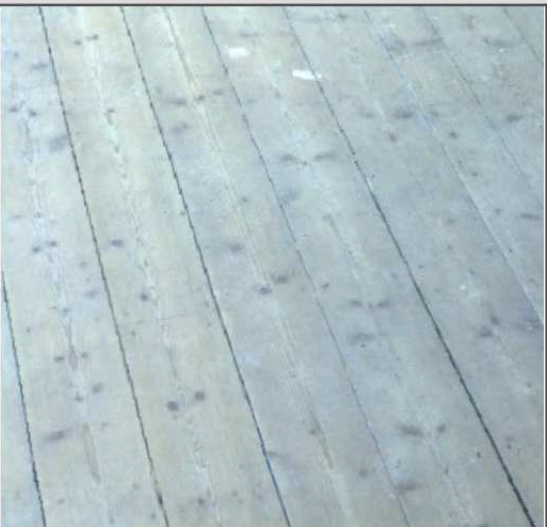
| | Photo | Description | | Proposed strategy of works<br>Retain / Restore /Celebrate | Reference |
|---|---|---|--|---|---|
| <b>Floor</b> | | Timber floorboards exposed now carpet has been removed. What looks like a mixture of original and non-original boards throughout | | New tiled floor over existing timber floor | |

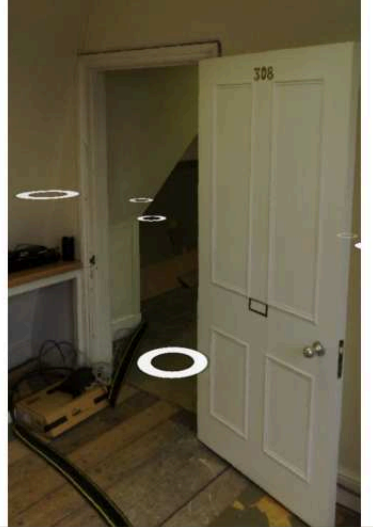
| | Photo | Description | | Proposed strategy of works<br>Retain / Restore /Celebrate | Reference |
|---|---|---|--|---|---|
| <b>Doors / Architraves</b> | | Fire door with architrave, panelled timber door and exposed self closer. | | Panelled doors removed and opening blocked up. See proposed drawings for details. | |

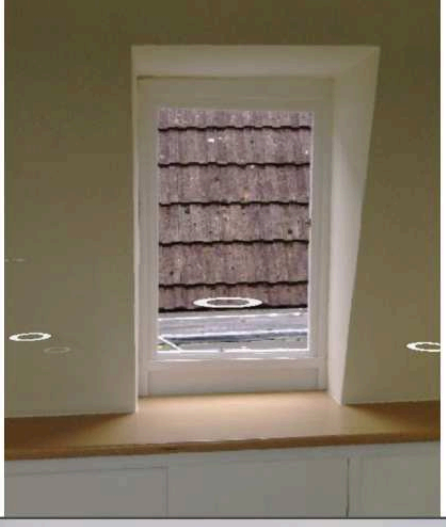
| | Photo | Description | | Proposed strategy of works<br>Retain / Restore /Celebrate | Reference |
|---|---|---|--|---|---|
| <b>Windows</b> | | White painted timber framed window | | Casement - retain and repaint | <b>Drawing Number</b> - 088-XX-02-11120<br><b>Annotation / Room</b> - Guest Bedroom 07 WC<br><b>Window Number</b> - W2.16 |

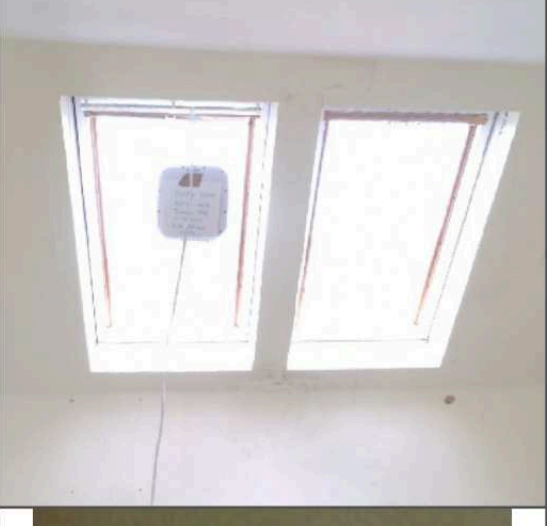
| | Photo | Description | | Proposed strategy of works<br>Retain / Restore /Celebrate | Reference |
|---|---|---|--|---|---|
| | | Velux style openable roof lights | | Velux roof lights to be removed and replaced with dormer window. See fabric removal plans and proposed elevations for details. | <b>Drawing Number</b> - 088-XX-02-11120<br><b>Annotation / Room</b> - Guest Bedroom 08 WC<br><b>Window Number</b> - W2.02 |

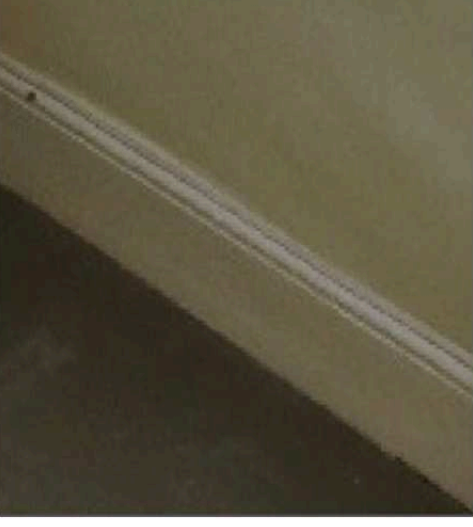
| | Photo | Description | | Proposed strategy of works<br>Retain / Restore /Celebrate | Reference |
|---|---|---|--|---|---|
| <b>Skirting</b> | | Skirting moulding | | Remove as wall in en-suites will be tiled | |

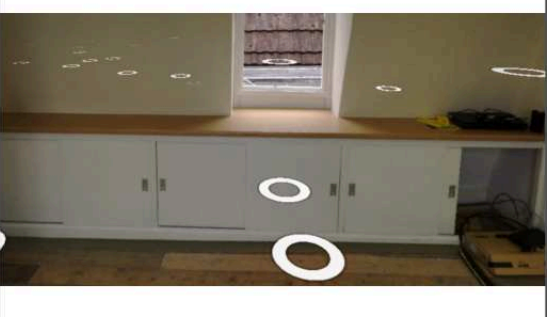
| | Photo | Description | | Proposed strategy of works<br>Retain / Restore /Celebrate | Reference |
|---|---|---|--|---|---|
| <b>Joinery/Fixtures/Fitting</b> | | Cupboards | | Remove | <b>Drawing Number</b> - 088-XX-02-11521<br><b>Annotation / Room</b> - Room 308 |

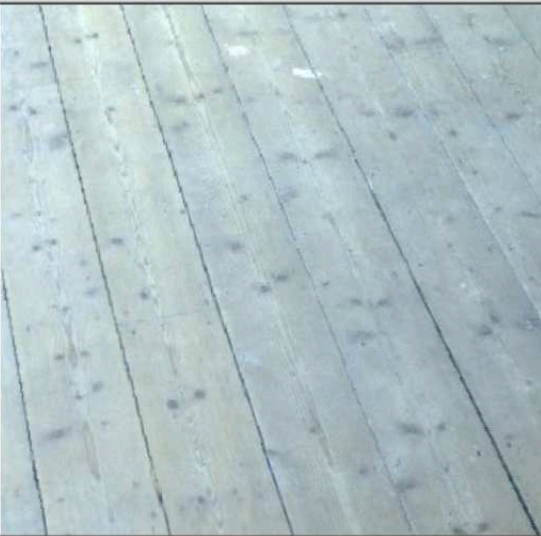
| | Photo | Description | | Proposed strategy of works<br>Retain / Restore /Celebrate | Reference |
|---|---|---|--|---|---|
| <b>Floor</b> | | Timber floorboards exposed now carpet has been removed. What looks like a mixture of original and non-original boards throughout | | New tiled floor over existing timber floor | |

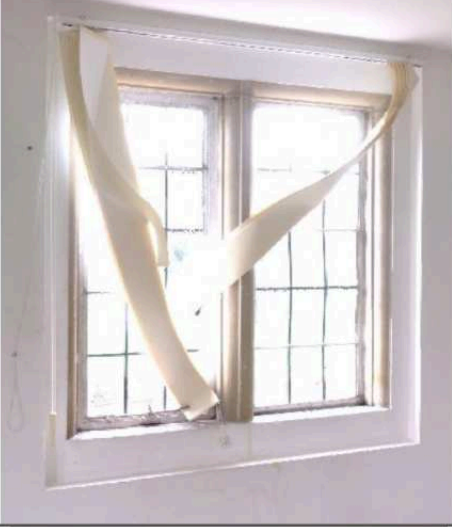
| | Photo | Description | | Proposed strategy of works<br>Retain / Restore /Celebrate | Reference |
|---|---|---|--|---|---|
| <b>Windows</b> | | Original window with stone mullions and leaded glazing bars | | Restore stone mullion window including leaded glazing bars. Remove surface fixed curtain rail. | <b>Drawing Number</b> - 088-XX-02-11120<br><b>Annotation / Room</b> - Guest Bedroom 07<br><b>Window Number</b> - W2.01 |

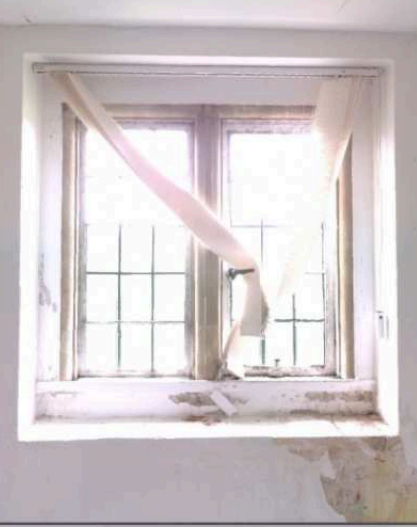
| | Photo | Description | | Proposed strategy of works<br>Retain / Restore /Celebrate | Reference |
|---|---|---|--|---|---|
| | | Original window with stone mullions and leaded glazing bars | | Restore stone mullion window including leaded glazing bars. Remove surface fixed curtain rail. | <b>Drawing Number</b> - 088-XX-02-11120<br><b>Annotation / Room</b> - Guest Bedroom 07<br><b>Window Number</b> - W2.15 |

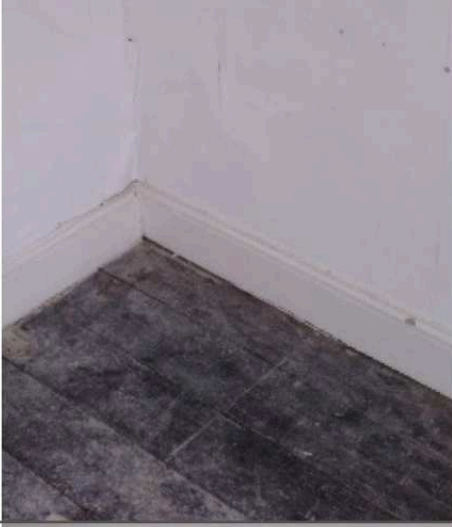
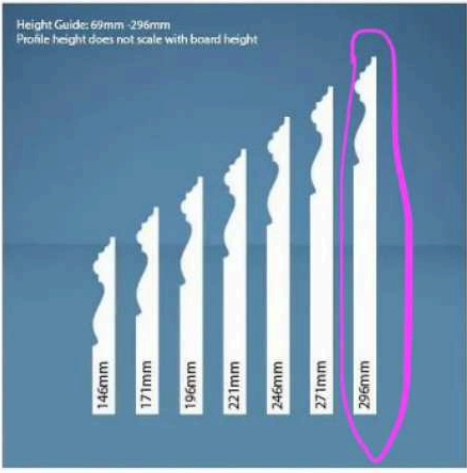
| | Photo | Description | | Proposed strategy of works<br>Retain / Restore /Celebrate | Reference |
|---|---|---|--|---|---|
| <b>Skirting</b> | | Skirting moulding at low level | | Replace with higher profile victorian skirting 196mm high | |

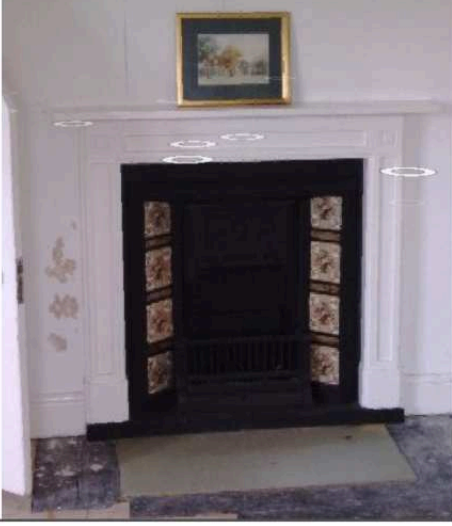
| | Photo | Description | | Proposed strategy of works<br>Retain / Restore /Celebrate | Reference |
|---|---|---|--|---|---|
| <b>Period Feature</b> | | Fireplace surround and mantel with ornate insert. Fireplace hearth location evident. | | Retain and refurbish | <b>Drawing Number</b> - 088-XX-02-11120<br><b>Annotation / Room</b> - Guest Bedroom 07 |

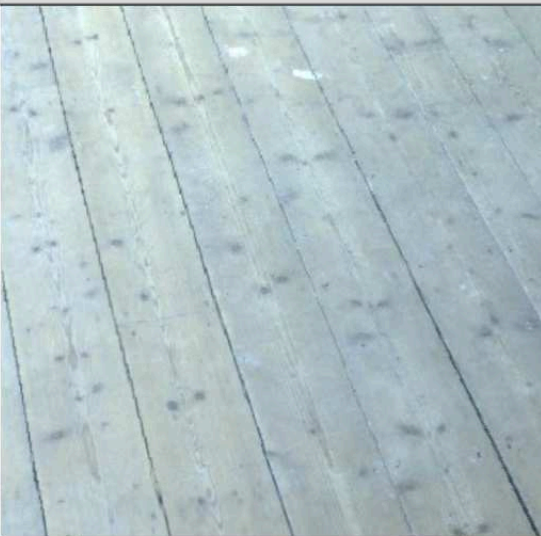
| | Photo | Description | | Proposed strategy of works<br>Retain / Restore /Celebrate | Reference |
|---|---|---|--|---|---|
| <b>Floor</b> | | Timber floorboards exposed now carpet has been removed. What looks like a mixture of original and non-original boards throughout | | Investigate, restore if possible, or overlay with new character timber | |

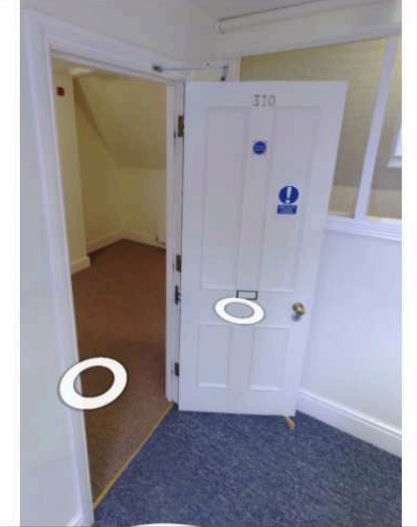
| | Photo | Description | | Proposed strategy of works<br>Retain / Restore /Celebrate | Reference |
|---|---|---|--|---|---|
| <b>Doors / Architraves</b> | | Fire door with ornate architrave, panelled timber door | | Remove | |

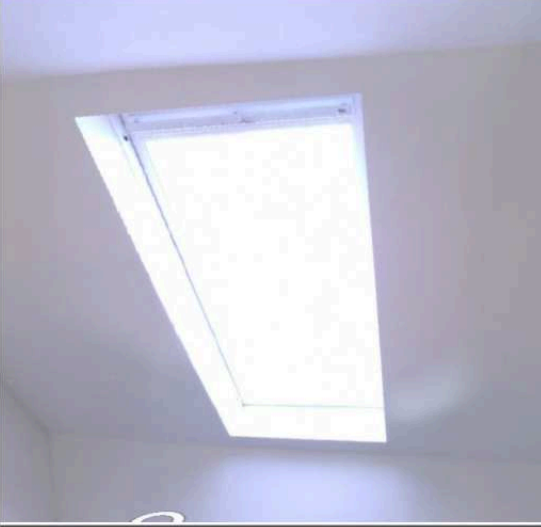
| <b>Windows</b> | | Velux style openable roof lights | | Velux window to be replace with new heritage roof light. | <b>Drawing Number</b> - 088-XX-03-11130<br><b>Annotation / Room</b> - 1.4 |

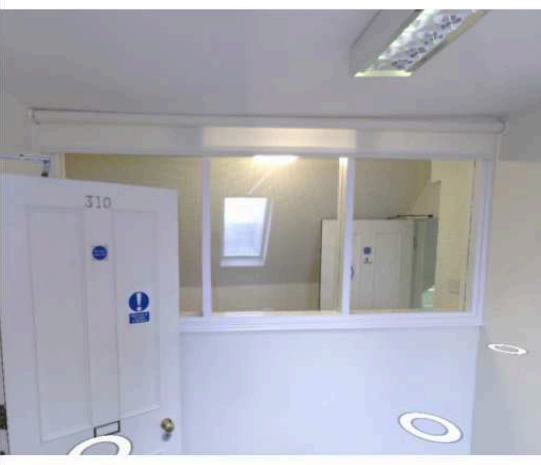
| <b>Windows</b> | | Contemporary glazed screen with blind | | Remove | |

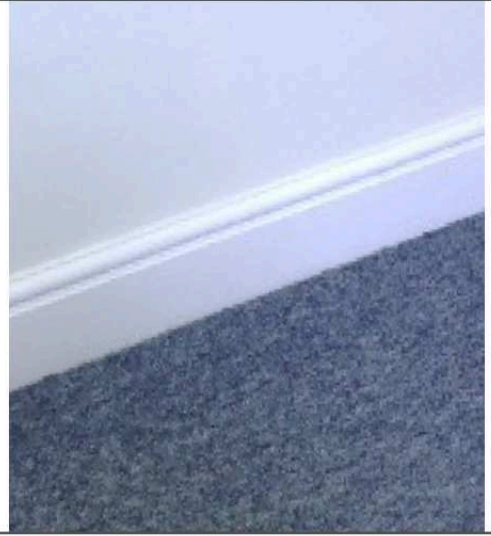
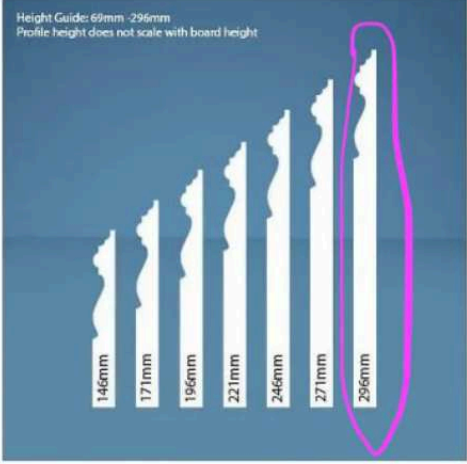
| <b>Skirting</b> | | Skirting moulding | | Replace with higher profile victorian skirting 196mm high | |

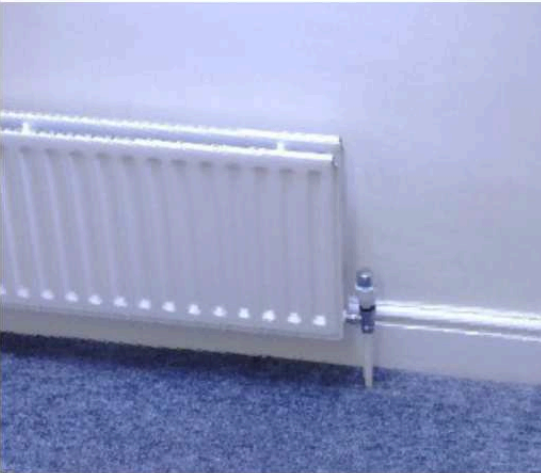
| <b>Others</b> | | Radiator | | Remove | <b>Drawing Number</b> - 088-XX-02-11521<br><b>Annotation / Room</b> - Room 310 |

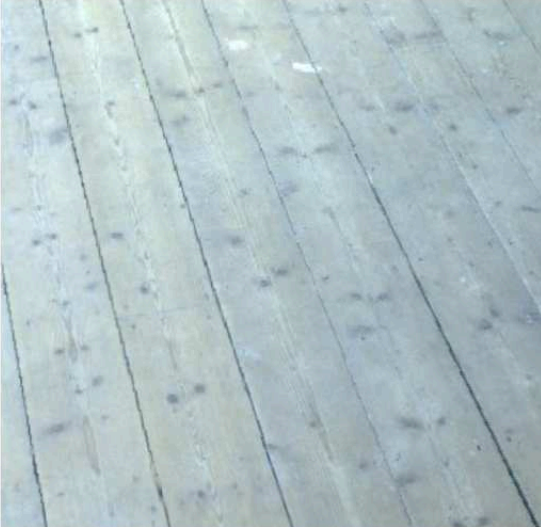
| | Photo | Description | | Proposed strategy of works<br>Retain / Restore /Celebrate | Reference |
|---|---|---|--|---|---|
| <b>Floor</b> | | Timber floorboards exposed now carpet has been removed. What looks like a mixture of original and non-original boards throughout | | Investigate, restore if possible, or overlay with new character timber | |

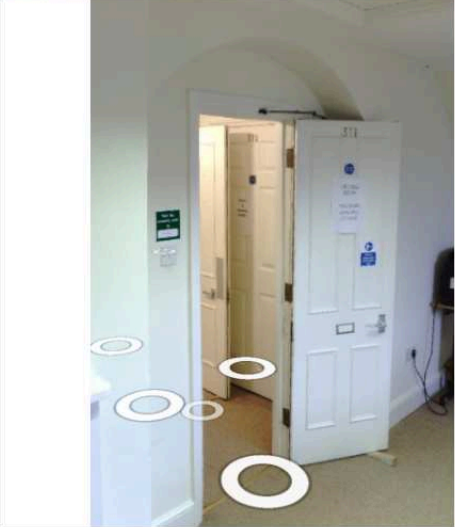
| | Photo | Description | | Proposed strategy of works<br>Retain / Restore /Celebrate | Reference |
|---|---|---|--|---|---|
| <b>Doors / Architraves</b> | | Fire door with architrave, panelled timber door and exposed self closer. Door in large arched recess suggesting original larger opening | | Existing panelled door in arched recess retain and repaint | <b>Drawing Number</b> - 088-XX-02-11120<br><b>Annotation / Room</b> - Guest Bedroom 10 |

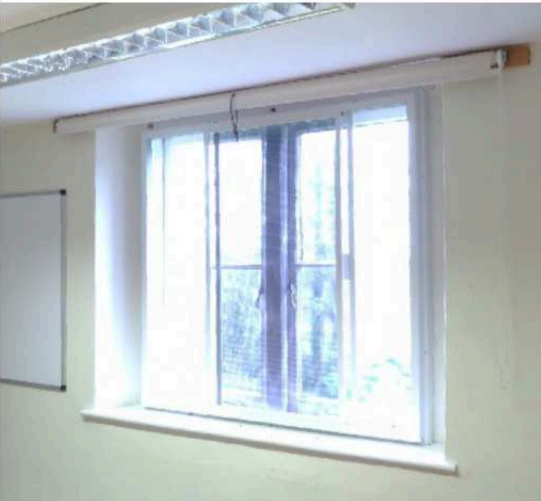
| | Photo | Description | | Proposed strategy of works<br>Retain / Restore /Celebrate | Reference |
|---|---|---|--|---|---|
| <b>Windows</b> | | Window | | Casement – retain and repaint | <b>Drawing Number</b> - 088-XX-02-11120<br><b>Annotation / Room</b> - Guest Bedroom 10<br><b>Window Number</b> - W2.06 |

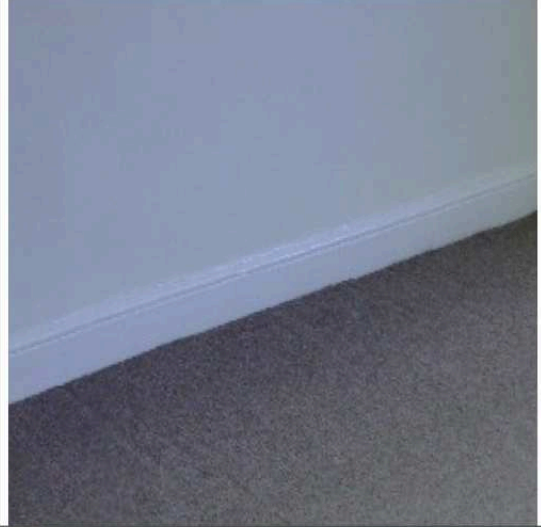
| | Photo | Description | | Proposed strategy of works<br>Retain / Restore /Celebrate | Reference |
|---|---|---|--|---|---|
| <b>Skirting</b> | | Low level skirting moulding | | Replace with higher profile victorian skirting 196mm high | |

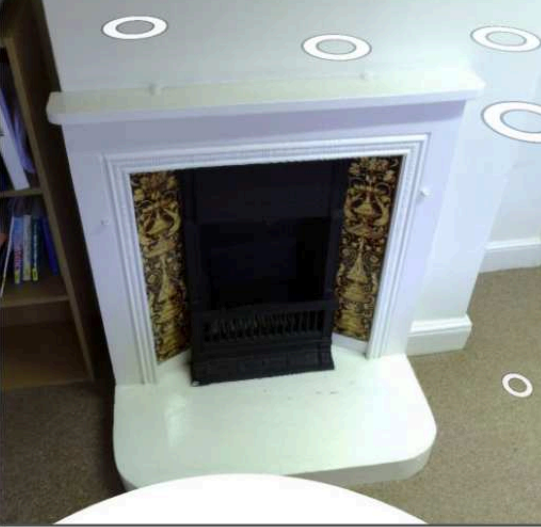
| | Photo | Description | | Proposed strategy of works<br>Retain / Restore /Celebrate | Reference |
|---|---|---|--|---|---|
| <b>Period Feature</b> | | Fireplace surround and mantel with ornate insert and raised hearth | | Retain and refurbish. Check inset hearth/brick and tiling to see if good quality/replace if not, check hearth) | <b>Drawing Number</b> - 088-XX-02-11120<br><b>Annotation / Room</b> - Guest Bedroom 10 |

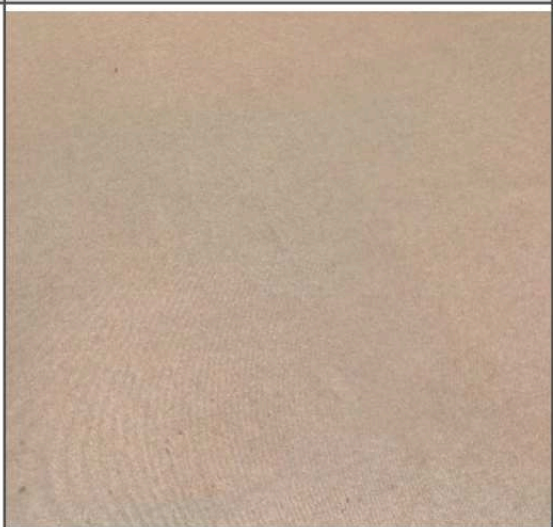
| | Photo | Description | | Proposed strategy of works<br>Retain / Restore /Celebrate | Reference |
|---|---|---|--|---|---|
| Floor | | Carpet | | Retain | <b>Drawing Number</b> - 088-XX-02-11120<br><b>Annotation / Room</b> - Storage |

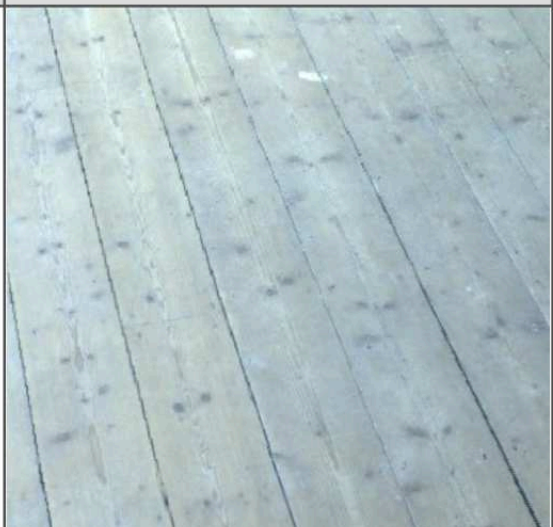
| | Photo | Description | | Proposed strategy of works<br>Retain / Restore /Celebrate | Reference |
|---|---|---|--|---|---|
| Floor | | Timber floorboards exposed now carpet has been removed. What looks like a mixture of original and non-original boards throughout | | Investigate, restore if possible, or overlay with new character timber | |

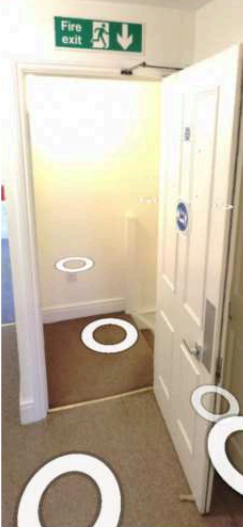
| | Photo | Description | | Proposed strategy of works<br>Retain / Restore /Celebrate | Reference |
|---|---|---|--|---|---|
| Doors / Architraves | | Fire door with architrave, panelled timber door and exposed self closer. | | Retain and repaint | <b>Drawing Number</b> - 088-XX-02-11120<br><b>Annotation / Room</b> - Staircase 3 |

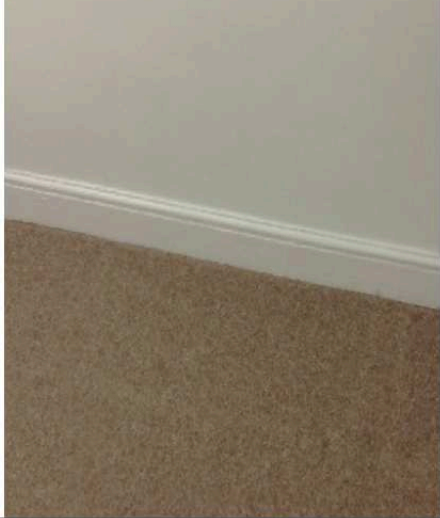
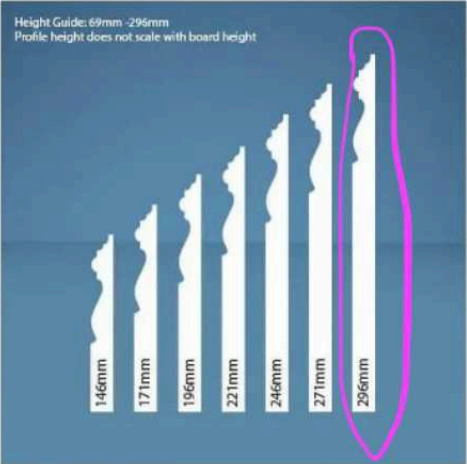
| | Photo | Description | | Proposed strategy of works<br>Retain / Restore /Celebrate | Reference |
|---|---|---|--|---|---|
| Skirting | | Skirting moulding at low level | | Use the same Victorian skirting circa 196mm high | |

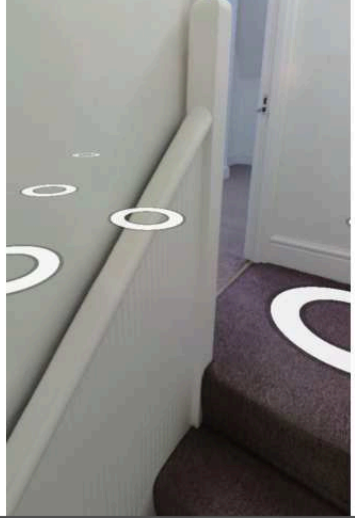
| | Photo | Description | | Proposed strategy of works<br>Retain / Restore /Celebrate | Reference |
|---|---|---|--|---|---|
| Others | | Timber staircase balustrade with solid timber infill | | Sand and repair existing timber treads if condition is ok otherwise overlay with new carpet. Sand and re-paint handrail | <b>Drawing Number</b> - 088-XX-02-11120<br><b>Annotation / Room</b> - Staircase 3 |
