FIRST LOOR

First Floor | Staircase 1 & Landing

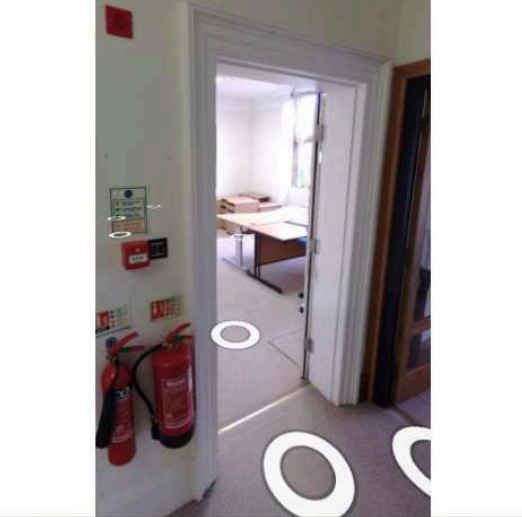
| | Photo | Description | | Proposed strategy of works<br>Retain / Restore /Celebrate | Reference |
|---|---|---|--|---|---|
| | | Ornate architrave | | Retain | Drawing Number - 088-XX-01-11110<br>Annotation / Room - Landing |

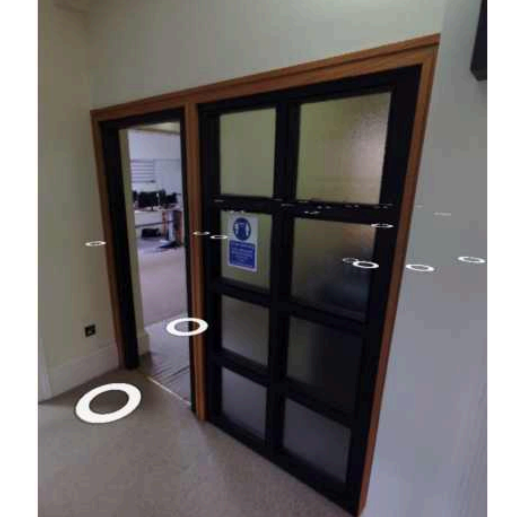
| | Photo | Description | | Proposed strategy of works<br>Retain / Restore /Celebrate | Reference |
|---|---|---|--|---|---|
| | | Poor quality timber screen with obscure glazing panel | | See fabric removal plans | Drawing Number - 088-XX-01-11511<br>Annotation / Room - Landing |

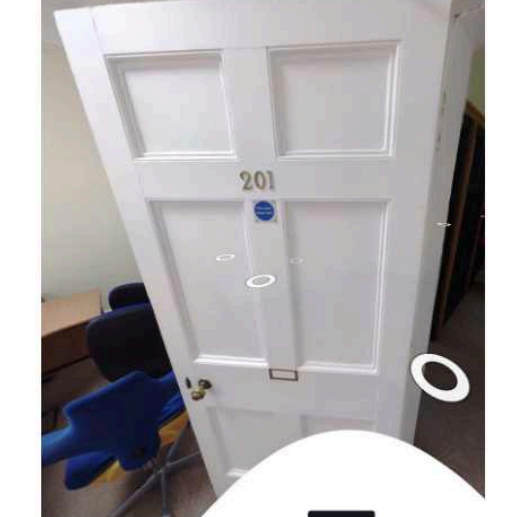
| | Photo | Description | | Proposed strategy of works<br>Retain / Restore /Celebrate | Reference |
|---|---|---|--|---|---|
| Panelled Doors | | | | Retain panelled doors (strip/sand and re-stain or repaint). This is being retained and permanently locked shut. | Drawing Number - 088-XX-01-11110<br>Annotation / Room - Landing |

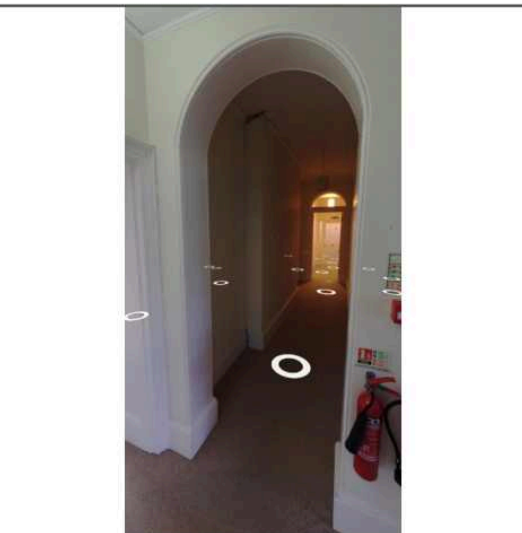
| | Photo | Description | | Proposed strategy of works<br>Retain / Restore /Celebrate | Reference |
|---|---|---|--|---|---|
| Doors / Architraves | | Arched opening with beaded detail | | Retain | Drawing Number - 088-XX-01-11110<br>Annotation / Room - Landing |

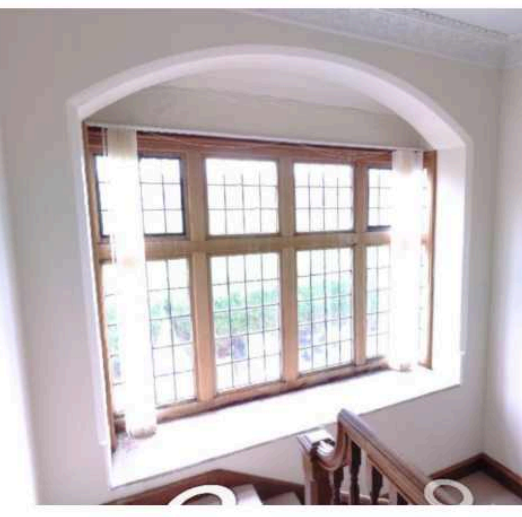
| | Photo | Description | | Proposed strategy of works<br>Retain / Restore /Celebrate | Reference |
|---|---|---|--|---|---|
| Windows | | Original window with stone mullions and leaded glazing bars | | Restore stone mullion window including leaded glazing bars. Remove surface fixed curtain rail. | Drawing Number - 088-XX-01-11110<br>Annotation / Room - Staircase 1<br>Window Number - W1.03 |

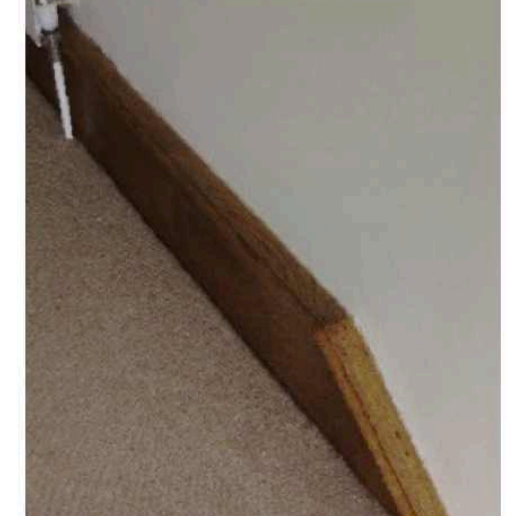
| | Photo | Description | | Proposed strategy of works<br>Retain / Restore /Celebrate | Reference |
|---|---|---|--|---|---|
| Skirting | | Varnished timber skirting | | Retain and re-stain/de-saturate to match doors and stairs | |

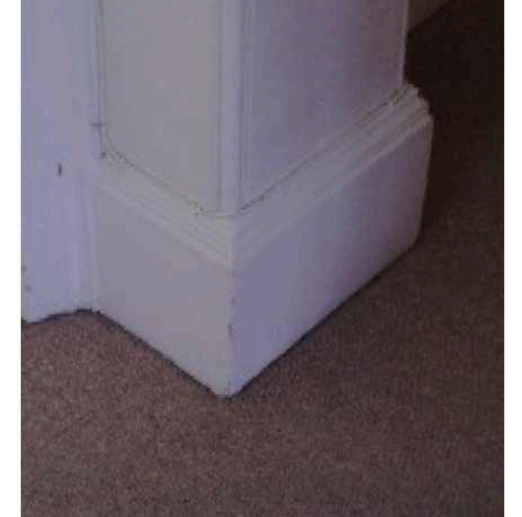
| | Photo | Description | | Proposed strategy of works<br>Retain / Restore /Celebrate | Reference |
|---|---|---|--|---|---|
| | | Skirting moulding | | Retain and re-stain/de-saturate to match doors and stairs | |

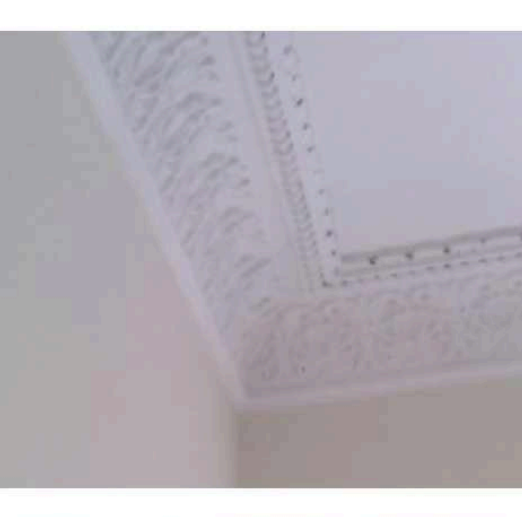
| | Photo | Description | | Proposed strategy of works<br>Retain / Restore /Celebrate | Reference |
|---|---|---|--|---|---|
| Cornice | | Ornate cornicing | | Retain existing elaborate cornice | |

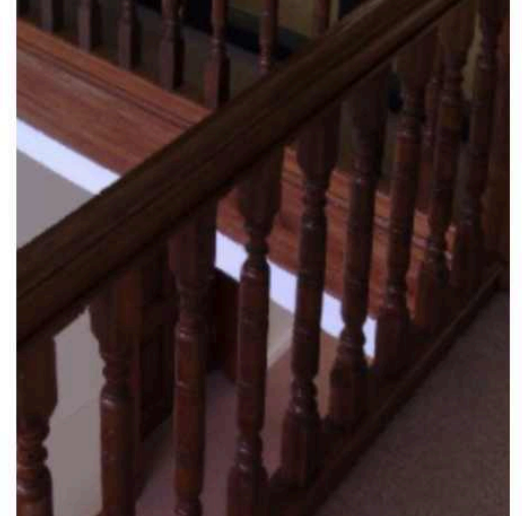
| | Photo | Description | | Proposed strategy of works<br>Retain / Restore /Celebrate | Reference |
|---|---|---|--|---|---|
| Period Feature | | Staircase Balustrade with turned timber spindles | | Retain: sand/re-stain less red/mahogany/shiny | |

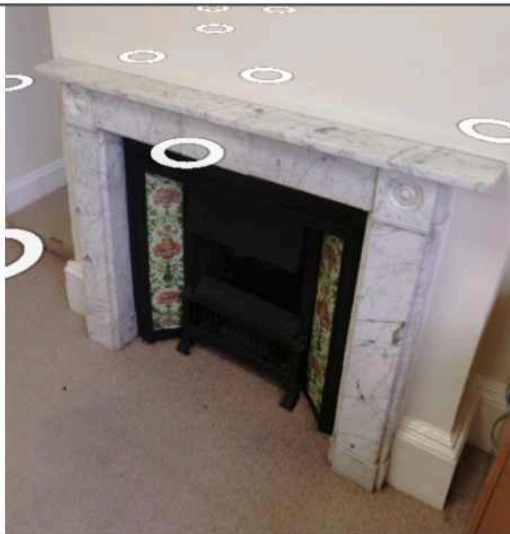
| | Photo | Description | | Proposed strategy of works<br>Retain / Restore /Celebrate | Reference |
|---|---|---|--|---|---|
| Period Feature | | Stone fireplace surround and mantle with ornate fireplace insert | | Surround and mantel - retain and refurbish. grate/hearth retained | |

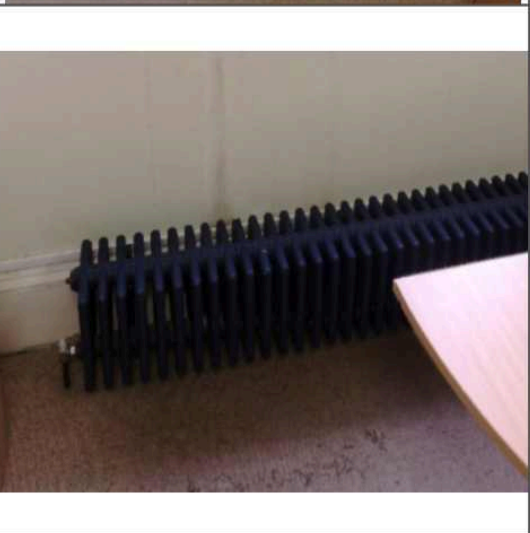
| | Photo | Description | | Proposed strategy of works<br>Retain / Restore /Celebrate | Reference |
|---|---|---|--|---|---|
| Others | | Blue column radiator | | Retain if possible and work otherwise replace to match | <b>Drawing Number</b> - 088-XX-01-11511<br><b>Annotation / Room</b> - Room 201 |

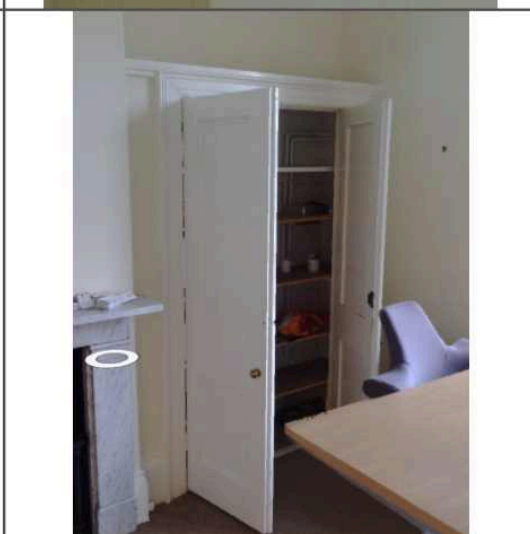
| | Photo | Description | | Proposed strategy of works<br>Retain / Restore /Celebrate | Reference |
|---|---|---|--|---|---|
| Joinery/Fixtures/Fitting | | Cupboard with panelled door and architrave | | Cupboard with panelled door and architrave. Retain and refurbish. | <b>Drawing Number</b> - 088-XX-01-11110<br><b>Annotation / Room</b> - Guest Bedroom 4 |

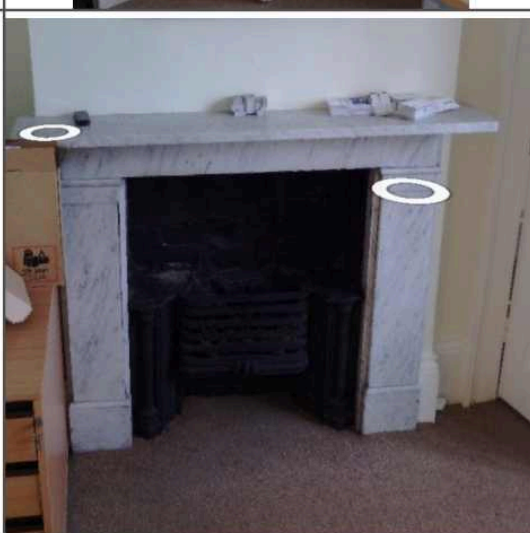
| | Photo | Description | | Proposed strategy of works<br>Retain / Restore /Celebrate | Reference |
|---|---|---|--|---|---|
| Period Feature | | Stone fireplace surround and mantle with what appears to be original insert | | Surround and mantel - retain and refurbish – check if grate/hearth can be retained | <b>Drawing Number</b> - 088-XX-01-11110<br><b>Annotation / Room</b> - Guest Bedroom 4 |

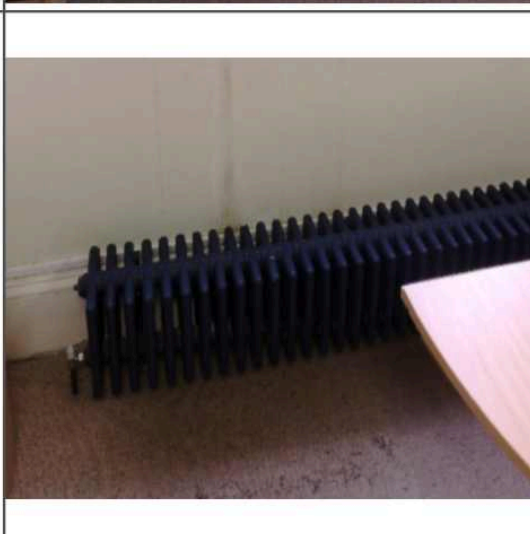
| | Photo | Description | | Proposed strategy of works<br>Retain / Restore /Celebrate | Reference |
|---|---|---|--|---|---|
| Others | | | | Retain if possible and work otherwise replace to match | <b>Drawing Number</b> - 088-XX-01-11511<br><b>Annotation / Room</b> - Room 202 |

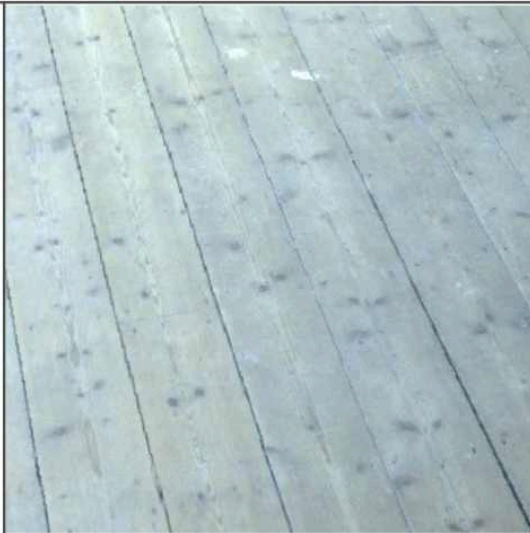
| <b>Floor</b> | | Timber floorboards exposed now carpet has been removed. What looks like a mixture of original and non-original boards throughout | | Investigate, restore if possible, or overlay with new character timber | |

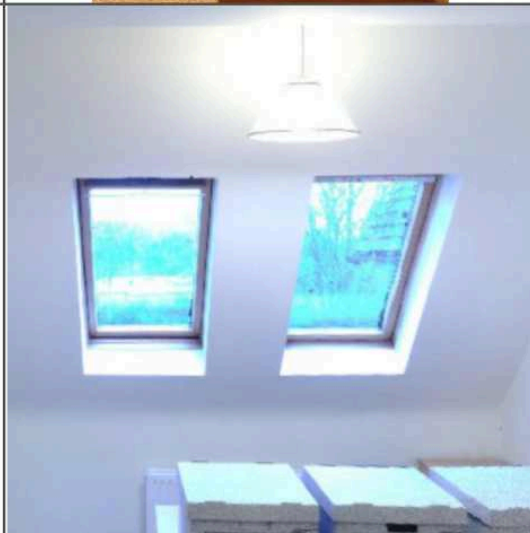
| <b>Windows</b> | | Velux style contemporary windows | | Remove existing velux's and replace with heritage skylights | <b>Drawing Number</b> - 088-XX-01-11511<br><b>Annotation / Room</b> - Room 205 |

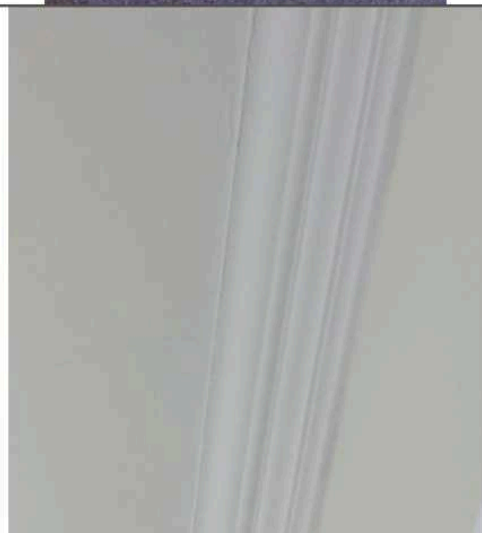
| <b>Cornice</b> | | Cornicing moulding | | Retain | |

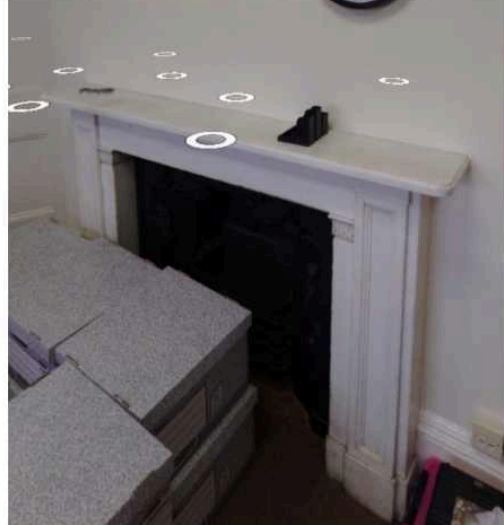
| Period Feature | | Fireplace Surround and mantle | | Retain and refurbish | <b>Drawing Number</b> - 088-XX-01-11110<br><b>Annotation / Room</b> - Semi Master Suite 1<br><b>Window Number</b> - W1.11 |

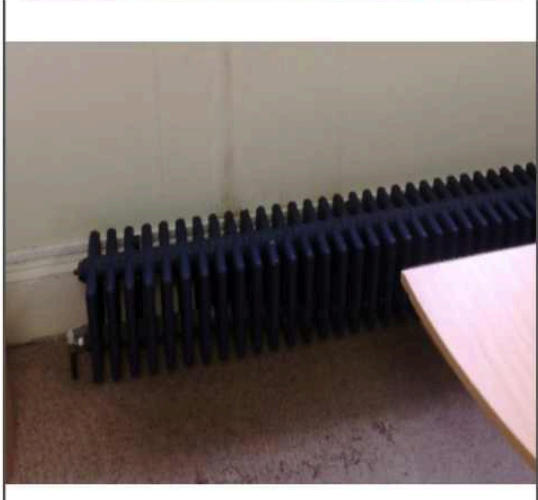
| Others | | Blue column radiator | | Retain if possible and work otherwise replace to match | <b>Drawing Number</b> - 088-XX-01-11511<br><b>Annotation / Room</b> - Room 206 |

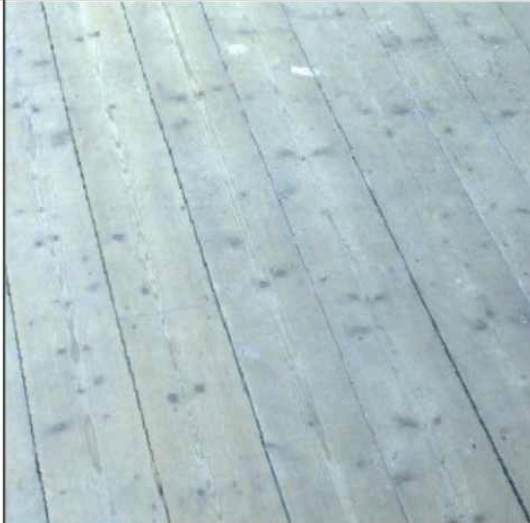
| | Photo | Description | | Proposed strategy of works<br>Retain / Restore /Celebrate | Reference |
|---|---|---|--|---|---|
| Floor | | Timber floorboards exposed now carpet has been removed. What looks like a mixture of original and non-original boards throughout | | Investigate, restore if possible, or overlay with new character timber | |

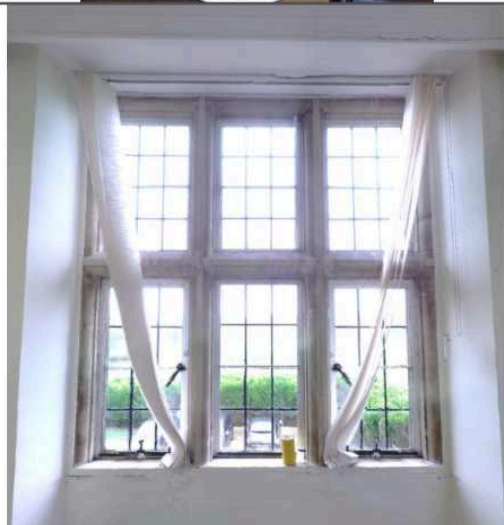
| | Photo | Description | | Proposed strategy of works<br>Retain / Restore /Celebrate | Reference |
|---|---|---|--|---|---|
| Windows | | Original window with stone mullions and leaded glazing bars | | Restore stone mullion window including leaded glazing bars. Remove surface fixed curtain rail. | <b>Drawing Number</b> - 088-XX-01-11110<br><b>Annotation / Room</b> - Bridal Suite<br><b>Window Number</b> - W1.02 |

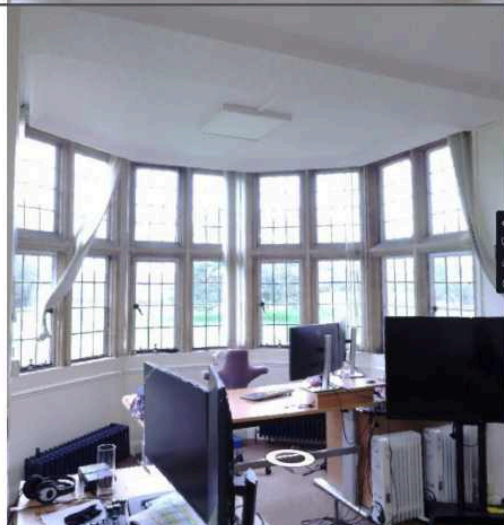
| | Photo | Description | | Proposed strategy of works<br>Retain / Restore /Celebrate | Reference |
|---|---|---|--|---|---|
| | | Bay Window added to the house in the 1920's. Stone mullions and lead glazing bars | | Restore stone mullion window including leaded glazing bars. Remove surface fixed curtain rail. | <b>Drawing Number</b> - 088-XX-01-11110<br><b>Annotation / Room</b> - Bridal Suite<br><b>Window Number</b> - W1.01 |

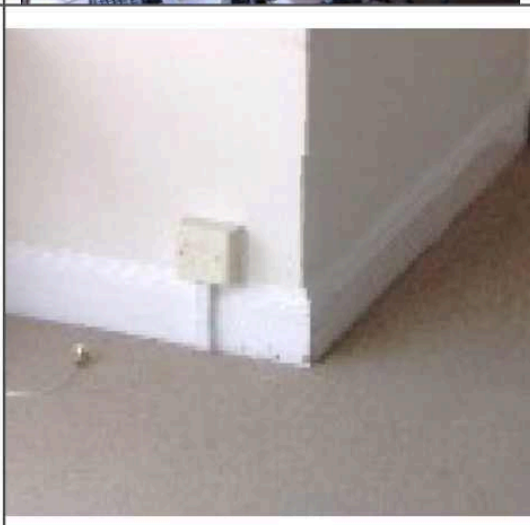
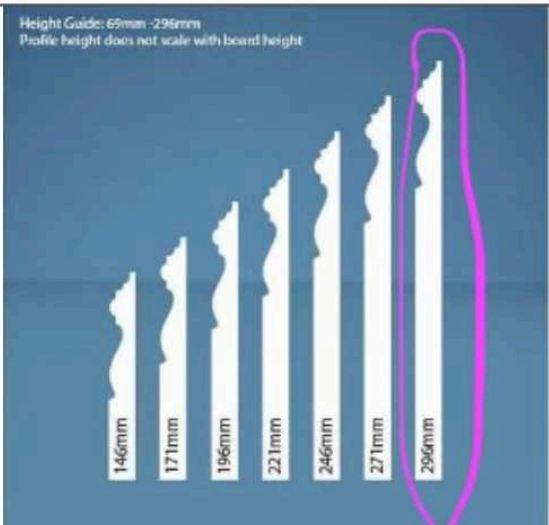
| | Photo | Description | | Proposed strategy of works<br>Retain / Restore /Celebrate | Reference |
|---|---|---|--|---|---|
| Skirting | | Basic skirting | | Replace low skirting with taller Victorian style seen below | |

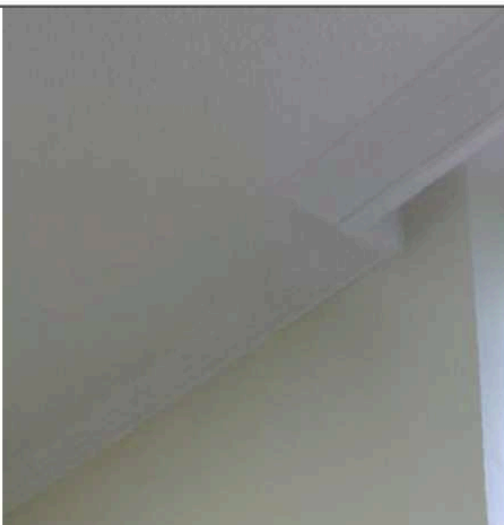
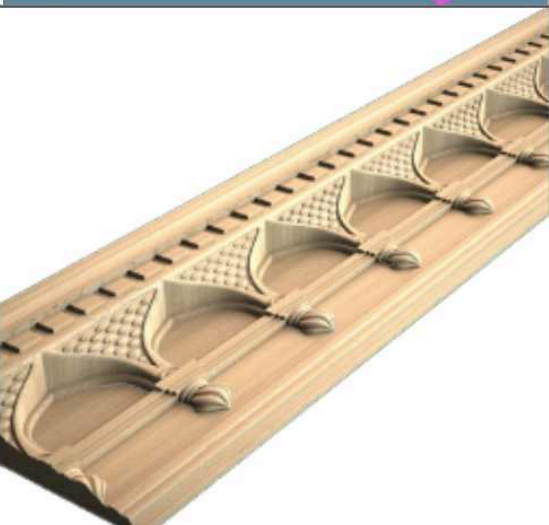
| | Photo | Description | | Proposed strategy of works<br>Retain / Restore /Celebrate | Reference |
|---|---|---|--|---|---|
| Cornice | | Cornicing moulding | | Too simple for Bridal Master - upgrade to Gothic period style | |

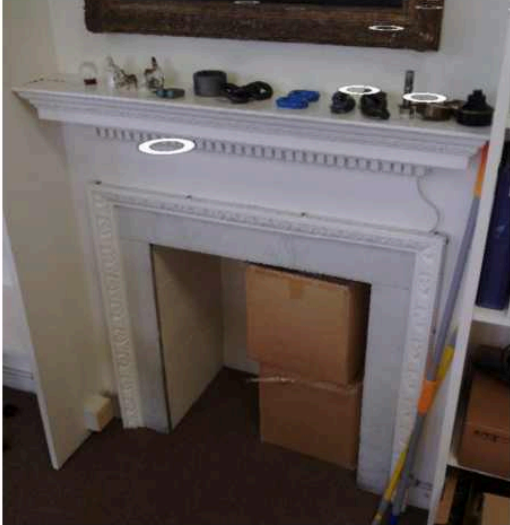
| <b>Period Feature</b> | | Fireplace surround and mantle. No visible hearth or insert | | Remove and Instal new Gothic antique fireplace | |

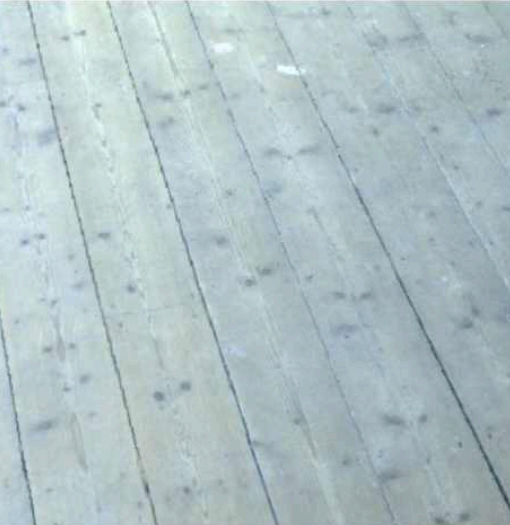
| | Photo | Description | | Proposed strategy of works<br>Retain / Restore /Celebrate | Reference |
|---|---|---|--|---|---|
| <b>Floor</b> | | Timber floorboards exposed now carpet has been removed. What looks like a mixture of original and non-original boards throughout | | Investigate, restore if possible, or overlay with new character timber | |

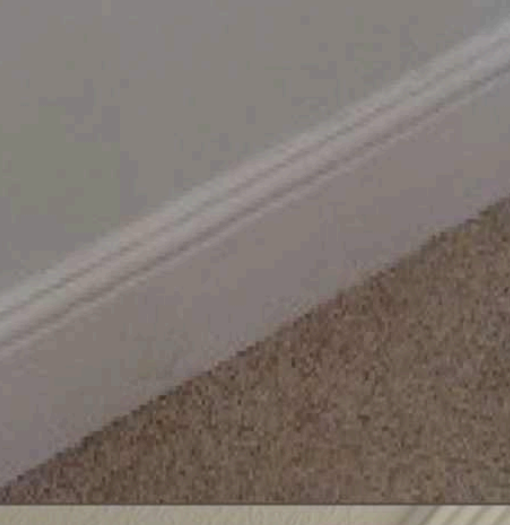
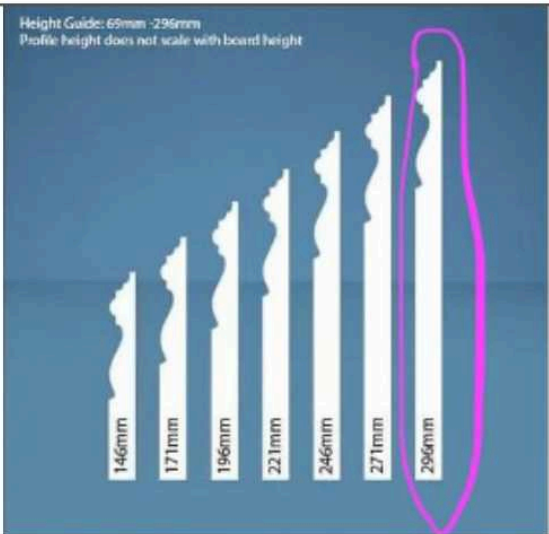
| | Photo | Description | | Proposed strategy of works<br>Retain / Restore /Celebrate | Reference |
|---|---|---|--|---|---|
| <b>Skirting</b> | | Skirting moulding | | Replace low skirting with taller Victorian style seen below | |

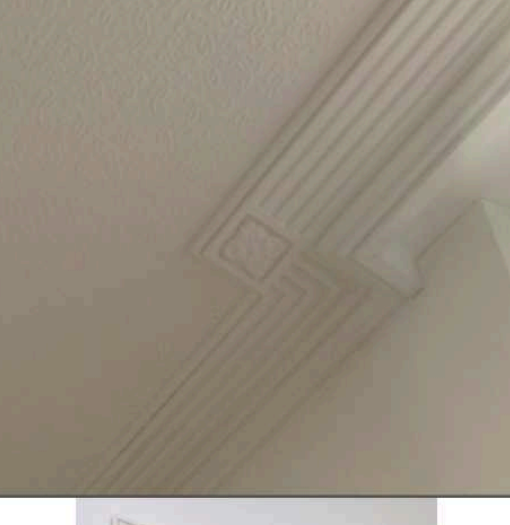
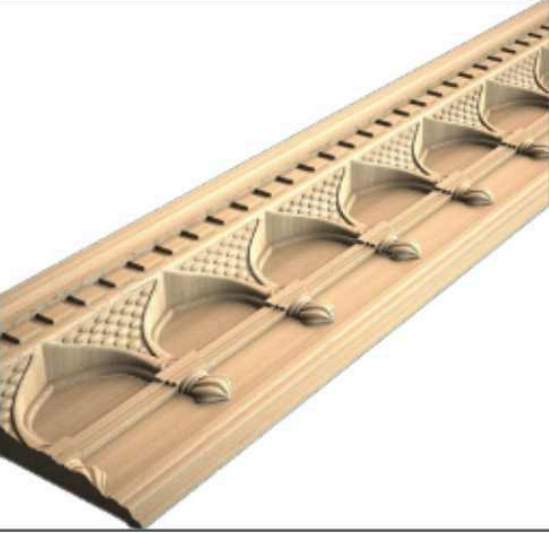
| | Photo | Description | | Proposed strategy of works<br>Retain / Restore /Celebrate | Reference |
|---|---|---|--|---|---|
| <b>Cornice</b> | | Ornate cornicing | | Replace with Gothic period style cornice | |

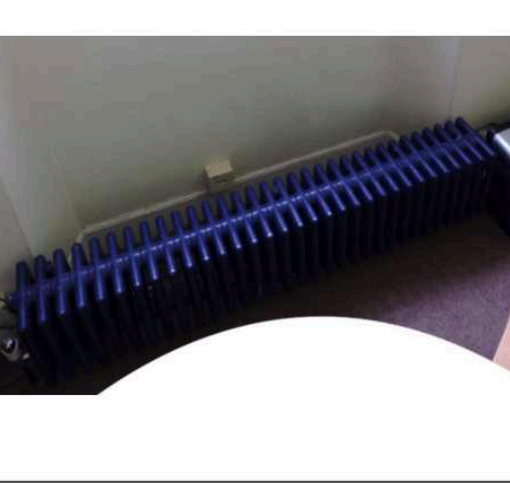
| | Photo | Description | | Proposed strategy of works<br>Retain / Restore /Celebrate | Reference |
|---|---|---|--|---|---|
| <b>Others</b> | | Blue column radiator | | Retain if possible and work otherwise replace to match | <b>Drawing Number</b> - 088-XX-01-11511<br><b>Annotation / Room</b> - Room 208 |

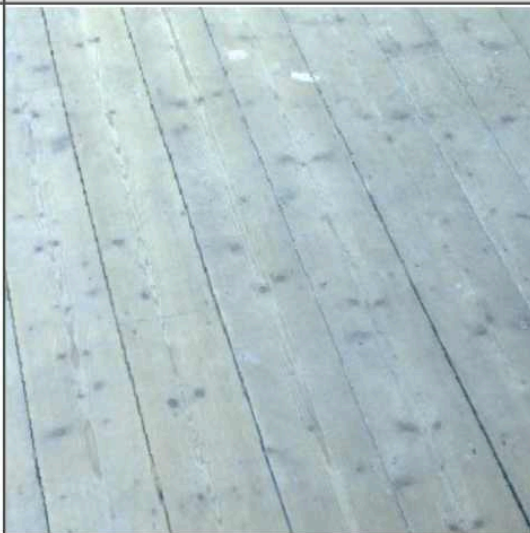
| | Photo | Description | | Proposed strategy of works<br>Retain / Restore /Celebrate | Reference |
|---|---|---|--|---|---|
| Floor | | Timber floorboards exposed now carpet has been removed. What looks like a mixture of original and non-original boards throughout | | Overlay existing timber floor with new tiled floor | |

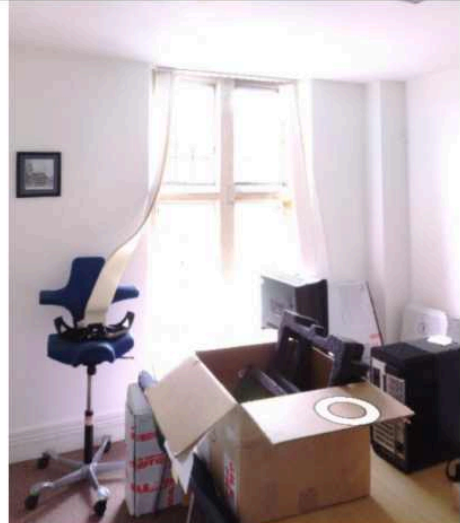
| | Photo | Description | | Proposed strategy of works<br>Retain / Restore /Celebrate | Reference |
|---|---|---|--|---|---|
| Windows | | Original window with stone mullions and leaded glazing bars. Curtain rail and poor quality curtains | | Restore stone mullion window including leaded glazing bars. Remove surface fixed curtain rail. | <b>Drawing Number</b> - 088-XX-01-11110<br><b>Annotation / Room</b> - Bridal Dressing Area WC<br><b>Window Number</b> - W1.18 |

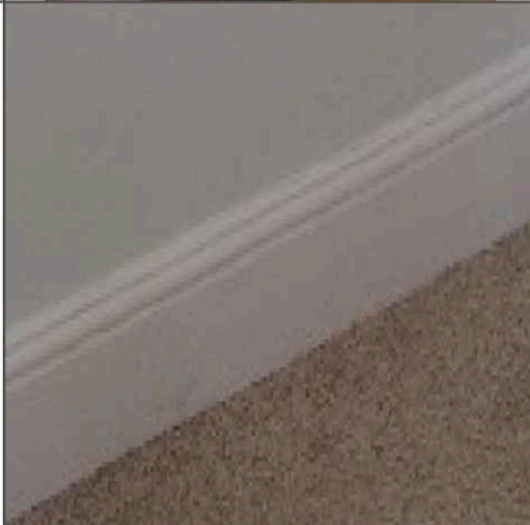
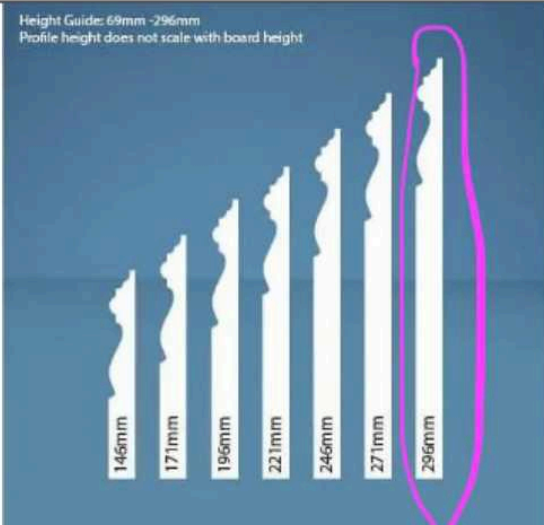
| | Photo | Description | | Proposed strategy of works<br>Retain / Restore /Celebrate | Reference |
|---|---|---|--|---|---|
| Skirting | | Skirting moulding | | Isn't the worst but let's harmonise with taller skirting in other bridal suite rooms (though we might want to tile down to the floor – so we may dispense with skirting in this room | |

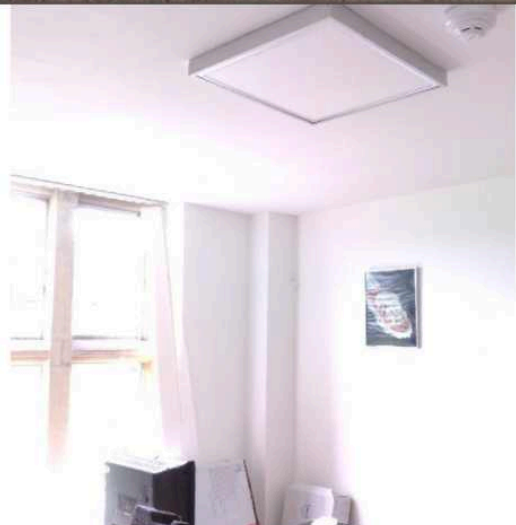
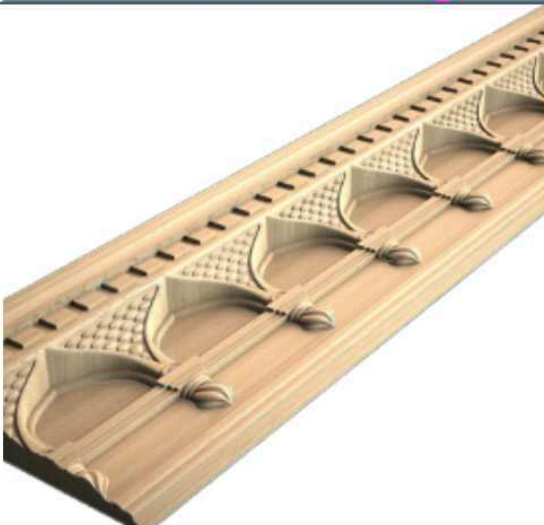
| | Photo | Description | | Proposed strategy of works<br>Retain / Restore /Celebrate | Reference |
|---|---|---|--|---|---|
| Cornice | | | | Non exists. Proposal to add new to match Gothic upgrade in rest of the Bridal / Master Suite | |

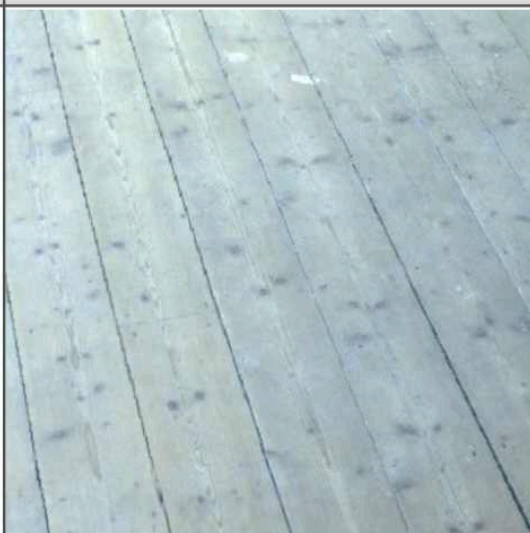
| | Photo | Description | | Proposed strategy of works<br>Retain / Restore /Celebrate | Reference |
|---|---|---|--|---|---|
| Floor | | Timber floorboards exposed now carpet has been removed. What looks like a mixture of original and non-original boards throughout | | Investigate, restore if possible, or overlay with new character timber | |

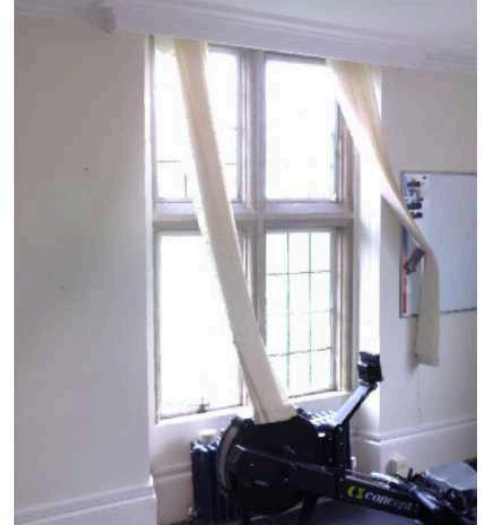
| Windows | | Original window with stone mullions and leaded glazing bars. Curtain rail and poor quality curtains | | Restore stone mullion window including leaded glazing bars. Remove surface fixed curtain rail. | <b>Drawing Number</b> - 088-XX-01-11110<br><b>Annotation / Room</b> - Guest Bedroom 01<br><b>Window Number</b> - W1.17 |

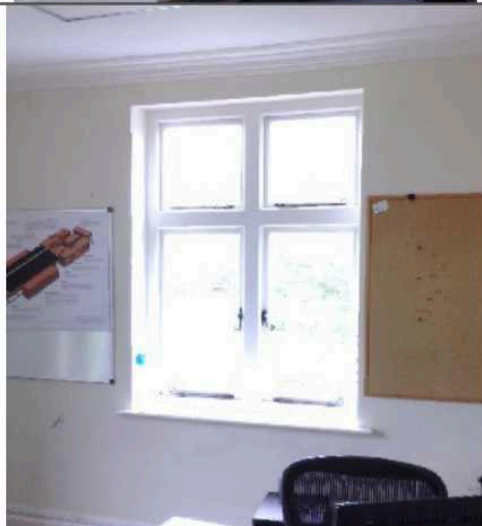
| | | White painted timber casement window | | strip and re-paint windows and remove any curtain fittings | <b>Drawing Number</b> - 088-XX-01-11110<br><b>Annotation / Room</b> - Guest Bedroom 01<br><b>Window Number</b> - W1.16 |

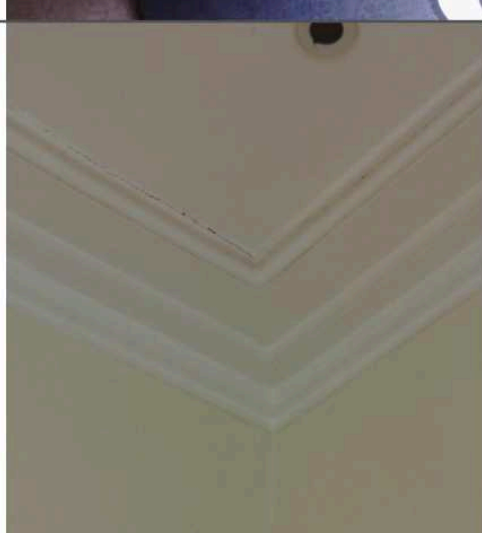
| Cornice | | Cornicing moulding | | Retain | |

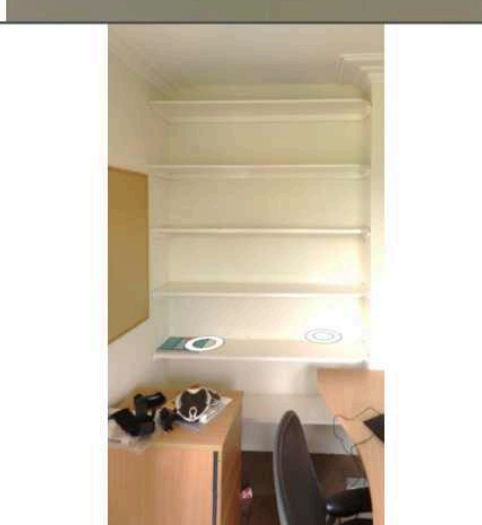
| Joinery/Fixtures/Fitting | | Basic timber open shelves, modern addition | | Open shelves – heritage? If not, remove | |

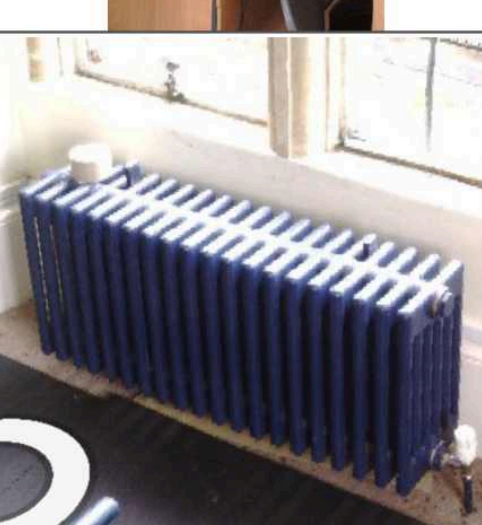
| Others | | Blue column radiator | | Retain if possible and work otherwise replace to match | <b>Drawing Number</b> - 088-XX-01-11511<br><b>Annotation / Room</b> - Room 210 |

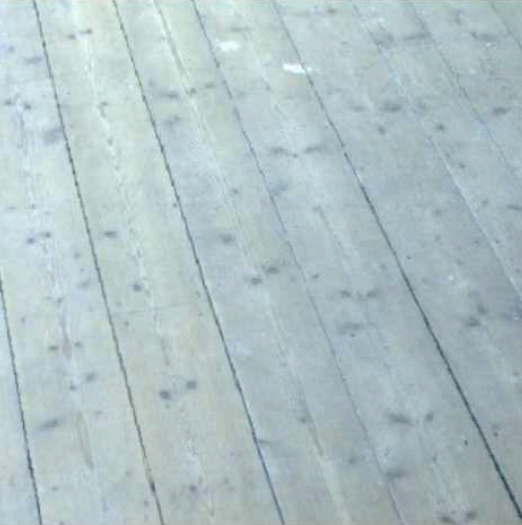
| | Photo | Description | | Proposed strategy of works<br>Retain / Restore /Celebrate | Reference |
|---|---|---|--|---|---|
| Floor | | Timber floorboards exposed now carpet has been removed. What looks like a mixture of original and non-original boards throughout | | Investigate, restore if possible, or overlay with new character timber | |

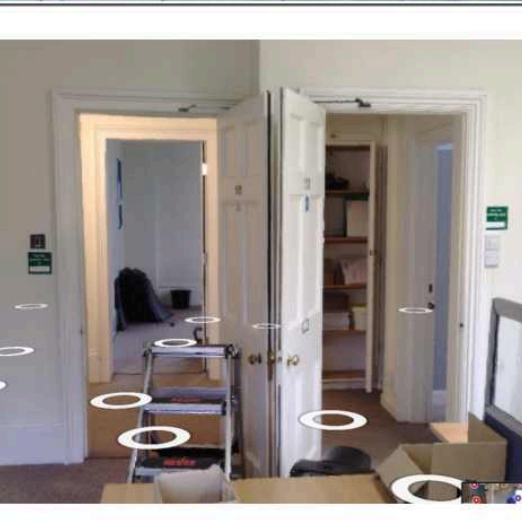
| | Photo | Description | | Proposed strategy of works<br>Retain / Restore /Celebrate | Reference |
|---|---|---|--|---|---|
| Doors / Architraves | | Fire door with architrave, panelled timber door and exposed self closer | | Retain panelled door (re-stain less mahogany glossy or repaint) | <b>Drawing Number</b> - 088-XX-01-11110<br><b>Annotation / Room</b> - Guest Bedroom 01 |

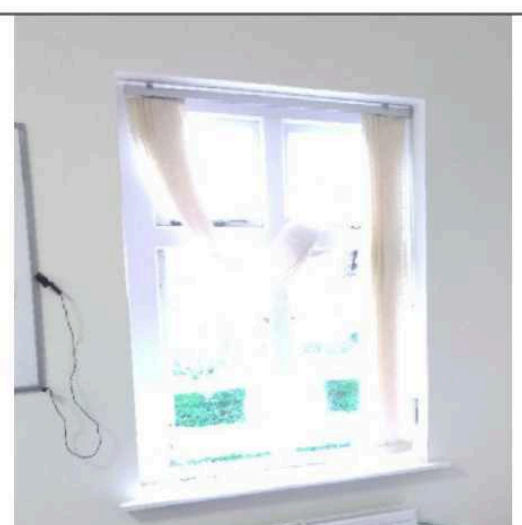
| | Photo | Description | | Proposed strategy of works<br>Retain / Restore /Celebrate | Reference |
|---|---|---|--|---|---|
| Windows | | White painted timber casement window with surface mounted curtain rail and poor quality curtains | | Strip and re-paint windows and remove any curtain fittings | <b>Drawing Number</b> - 088-XX-01-11110<br><b>Annotation / Room</b> - Guest Bedroom 02<br><b>Window Number</b> - W1.14 |

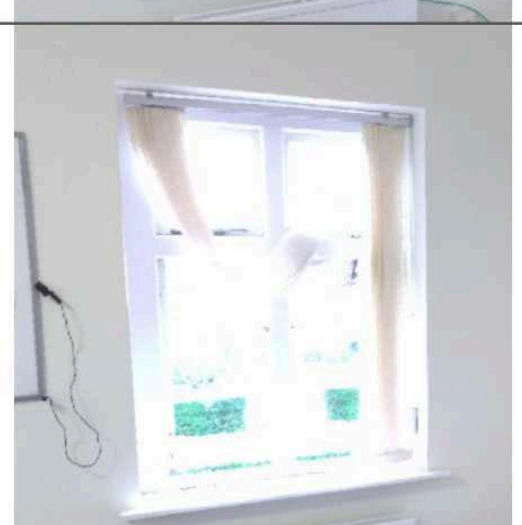
| | Photo | Description | | Proposed strategy of works<br>Retain / Restore /Celebrate | Reference |
|---|---|---|--|---|---|
| | | | | Strip and re-paint windows and remove any curtain fittings | <b>Drawing Number</b> - 088-XX-01-11110<br><b>Annotation / Room</b> - Guest Bedroom 02<br><b>Window Number</b> - W1.13 |

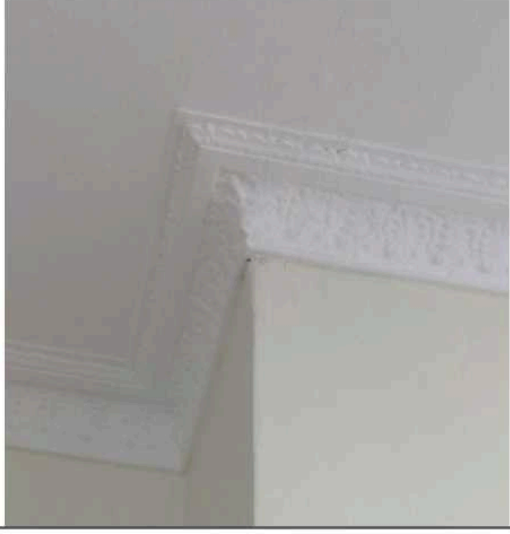
| <b>Cornice</b> | | Ornate corninging moulding | | Retain | |

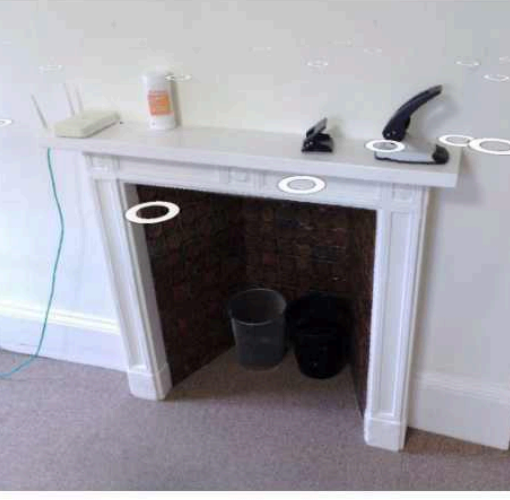
| <b>Period Feature</b> | | Fireplace surround and mantle with tiled insert | | Retain restore fireplace | <b>Drawing Number</b> - 088-XX-01-11110<br><b>Annotation / Room</b> - Guest Bedroom 02<br><b>Window Number</b> - W1.13 |

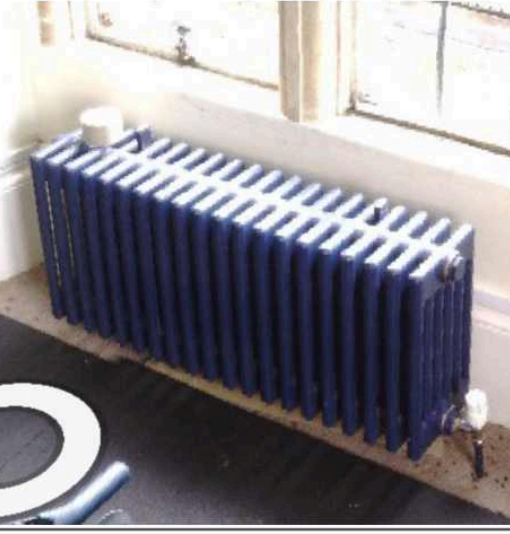
| <b>Others</b> | | Radiator | | Retain if possible and work otherwise replace to match | |

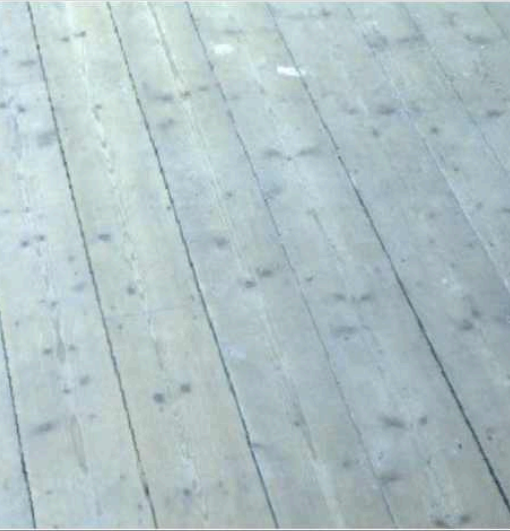
| | Photo | Description | | Proposed strategy of works<br>Retain / Restore /Celebrate | Reference |
|---|---|---|--|---|---|
| <b>Floor</b> | | Timber floorboards exposed now carpet has been removed. What looks like a mixture of original and non-original boards throughout | | Investigate, restore if possible, or overlay with new character timber | |

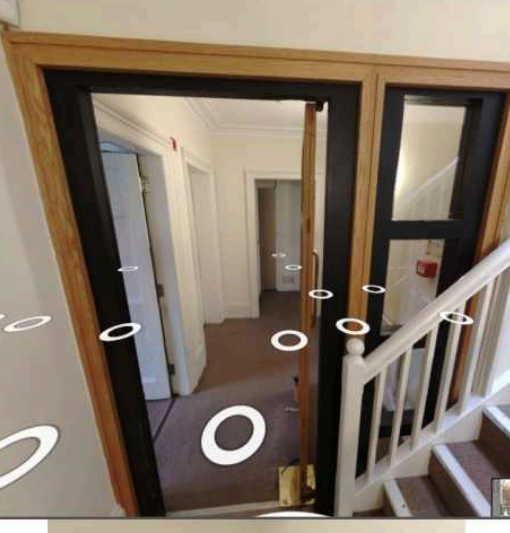
| | Photo | Description | | Proposed strategy of works<br>Retain / Restore /Celebrate | Reference |
|---|---|---|--|---|---|
| <b>Doors / Architraves</b> | | Fire door and glazed screen in contemporary frame | | Replace glass with fire rated | <b>Drawing Number</b> - 088-XX-01-11110<br><b>Annotation / Room</b> - Staircase 2 |

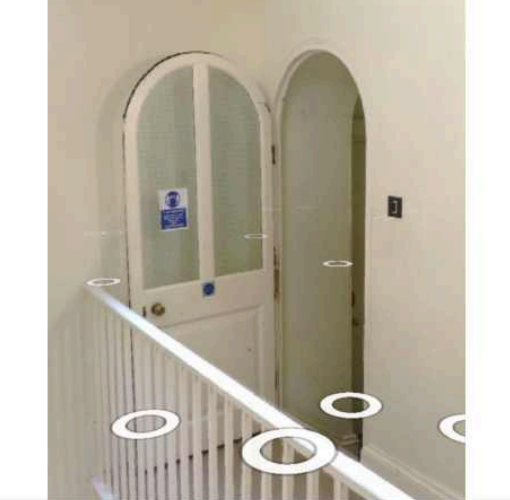
| | Photo | Description | | Proposed strategy of works<br>Retain / Restore /Celebrate | Reference |
|---|---|---|--|---|---|
| | | Arched glazed timber door with georgian wire glass and moulded base. Arched architrave and opening | | Retain and refurbish. Replace wire glass with new fire rated glazed panel | <b>Drawing Number</b> - 088-XX-01-11110<br><b>Annotation / Room</b> - Staircase 2 |

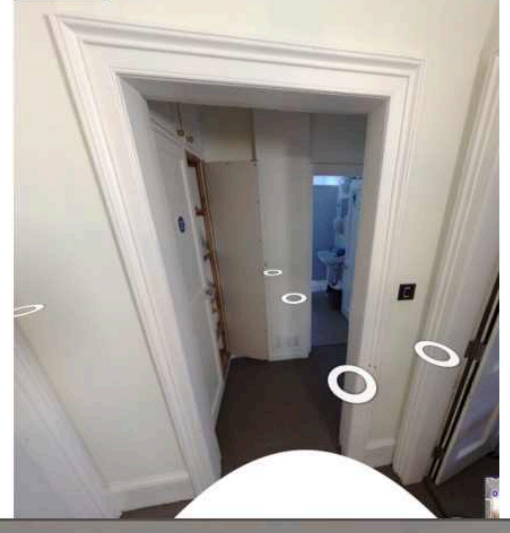
| | Photo | Description | | Proposed strategy of works<br>Retain / Restore /Celebrate | Reference |
|---|---|---|--|---|---|
| | | Ornate architrave which look as if door has been removed | | Square – ornate architrave, door has been removed. Proposal to replace with panelled door to match others | <b>Drawing Number</b> - 088-XX-01-11110<br><b>Annotation / Room</b> - Staircase 2 |

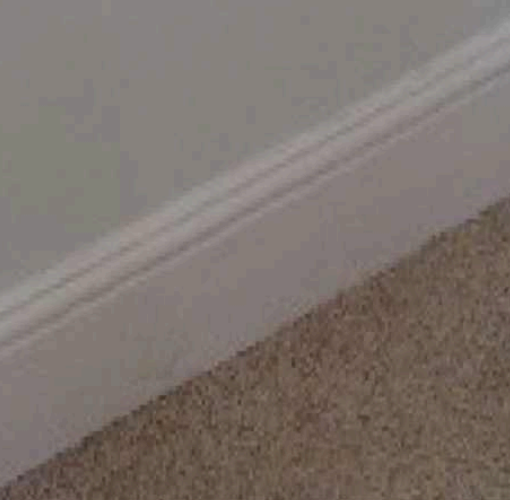
| | Photo | Description | | Proposed strategy of works<br>Retain / Restore /Celebrate | Reference |
|---|---|---|--|---|---|
| <b>Skirting</b> | | Skirting moulding | | Retain | |

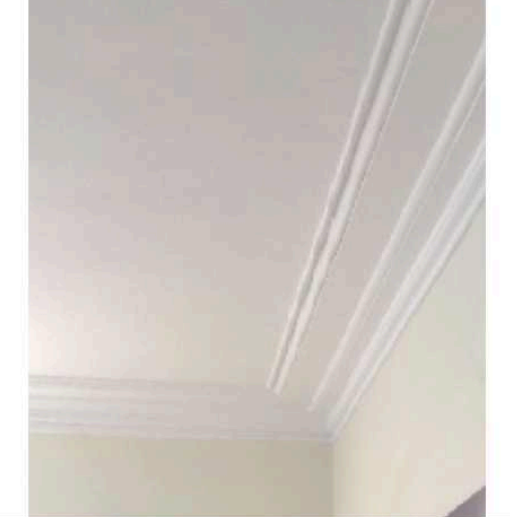
| | Photo | Description | | Proposed strategy of works<br>Retain / Restore /Celebrate | Reference |
|---|---|---|--|---|---|
| <b>Cornice</b> | | Cornicing moulding | | Retain | |

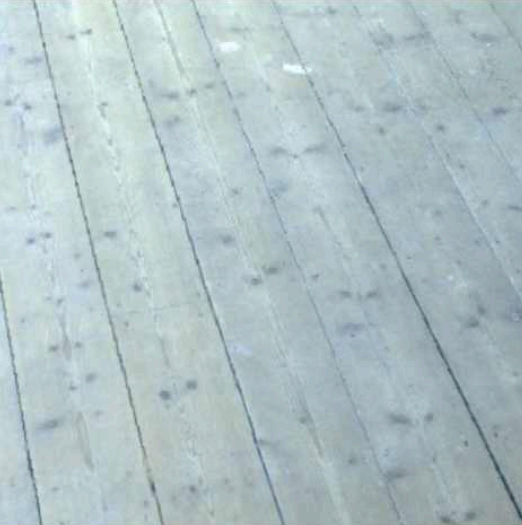
| | Photo | Description | | Proposed strategy of works<br>Retain / Restore /Celebrate | Reference |
|---|---|---|--|---|---|
| Floor | | Timber floorboards exposed now carpet has been removed. What looks like a mixture of original and non-original boards throughout | | Investigate, restore if possible, or overlay with new character timber | |

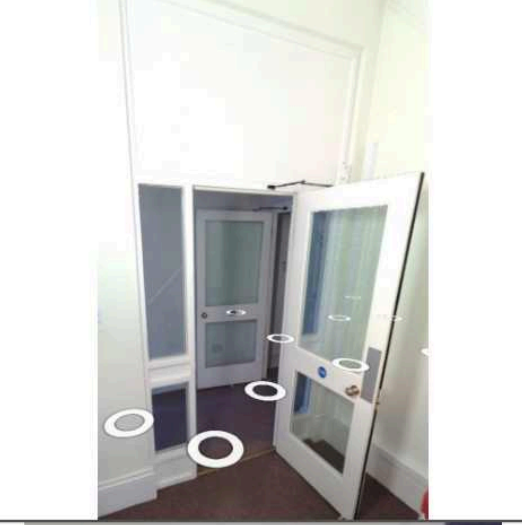
| | Photo | Description | | Proposed strategy of works<br>Retain / Restore /Celebrate | Reference |
|---|---|---|--|---|---|
| Doors / Architraves | | Contemporary fire door with glazed panels and no architrave of note | | Lobby door horrible modern glazed fire door. Replace with period panelled door (consider if need glazing vision panel) but just to top section not full height as with current) | <b>Drawing Number</b> - 088-XX-01-11110<br><b>Annotation / Room</b> - Staircase 3 |

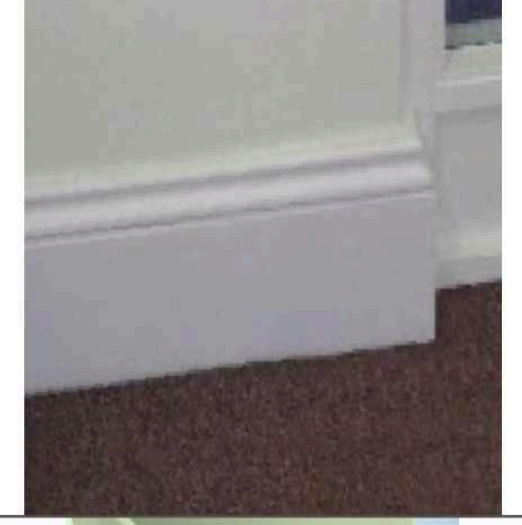
| | Photo | Description | | Proposed strategy of works<br>Retain / Restore /Celebrate | Reference |
|---|---|---|--|---|---|
| Skirting | | Skirting moulding | | Retain | |

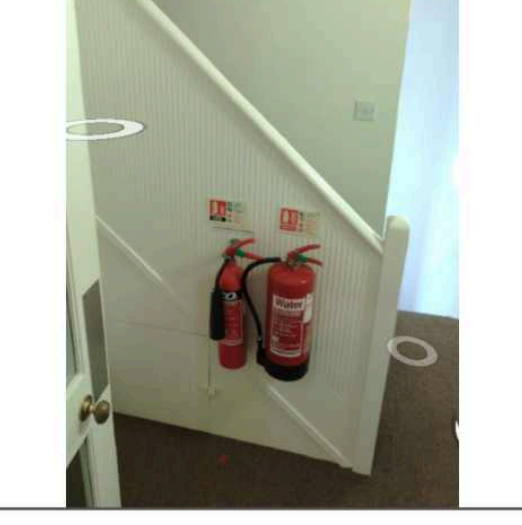
| | Photo | Description | | Proposed strategy of works<br>Retain / Restore /Celebrate | Reference |
|---|---|---|--|---|---|
| Stairs | | Stair Balustrade with solid grooved timber infill | | Solid balustrade to be replaced with painted timber spindles to match staircase 2. Newel post and handrail to be retained if possible. | <b>Drawing Number</b> - 088-XX-01-11110<br><b>Annotation / Room</b> - Staircase 3 |

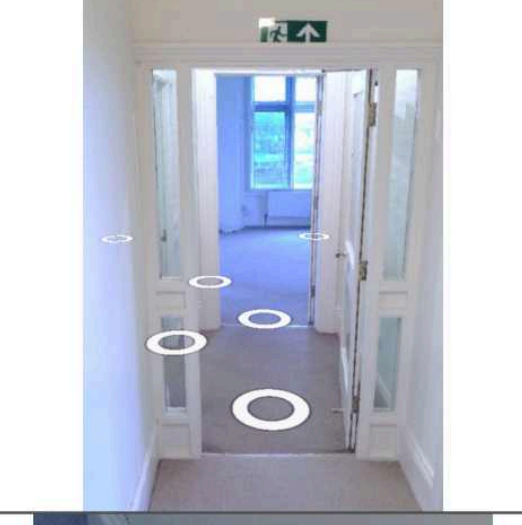
| | Photo | Description | | Proposed strategy of works<br>Retain / Restore /Celebrate | Reference |
|---|---|---|--|---|---|
| | | Fire door with architrave, panelled timber door and glazed side light and exposed self closer | | Infill side lights and retain door so more in keeping with rest of the house | <b>Drawing Number</b> - 088-XX-01-11110<br><b>Annotation / Room</b> - Hallway 1 |

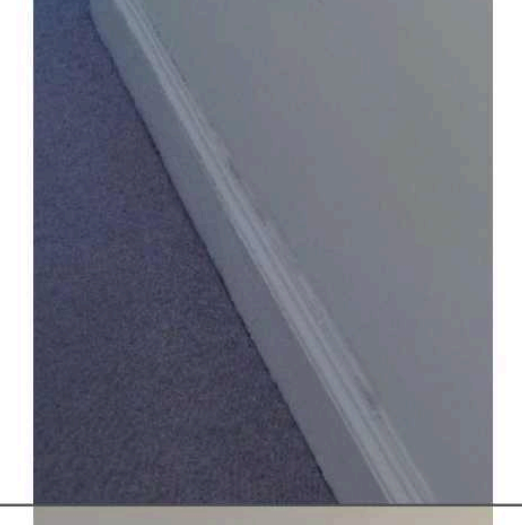
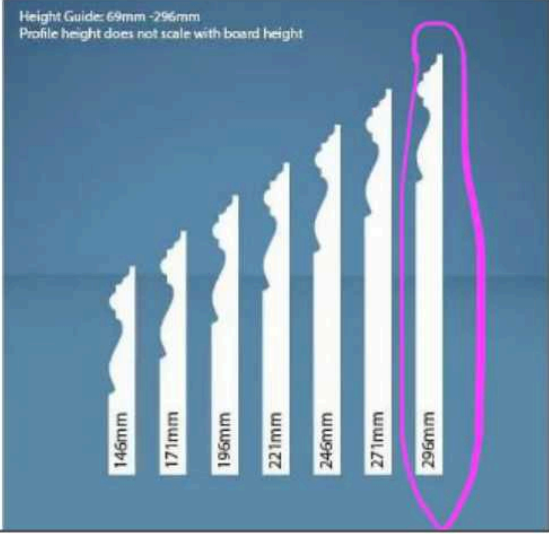
| | Photo | Description | | Proposed strategy of works<br>Retain / Restore /Celebrate | Reference |
|---|---|---|--|---|---|
| Skirting | | Basic Skirting moulding | | Skirting very basic and low. Proposal to add new higher profile Victorian skirting | |

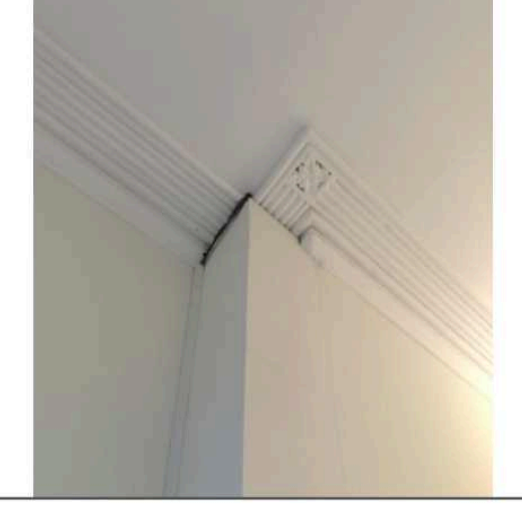
| | Photo | Description | | Proposed strategy of works<br>Retain / Restore /Celebrate | Reference |
|---|---|---|--|---|---|
| Cornice | | Ornate cornice partially broken by boxing out | | Retain and refurbish. Where areas are broken and boxed out, reinstate to match existing | |

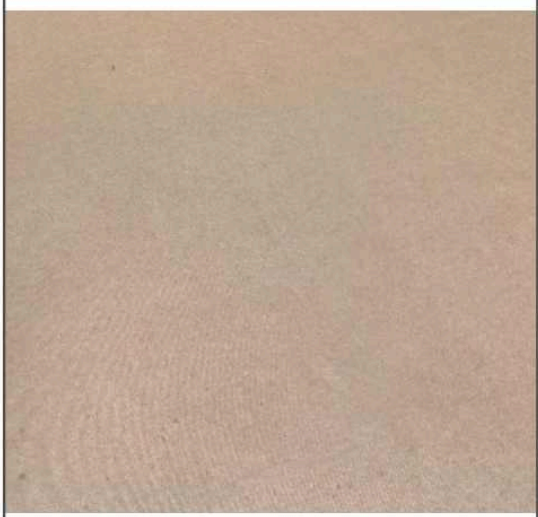
| | Photo | Description | | Proposed strategy of works<br>Retain / Restore /Celebrate | Reference |
|---|---|---|--|---|---|
| Floor | | Carpet | | Investigate, restore timber floor below if possible, or overlay with new character | |
