FIRST LOOR

First Floor | Staircase 1 & Landing

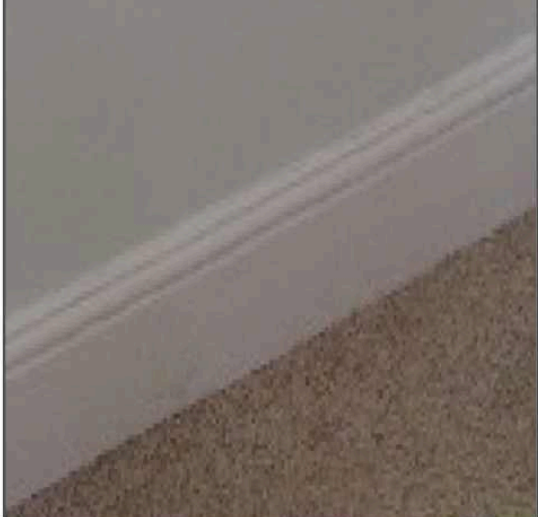
| | Photo | Description | | Proposed strategy of works<br>Retain / Restore /Celebrate | Reference |
|---|---|---|--|---|---|
| Skirting | | Skirting moulding | | Retain and repair where required | |

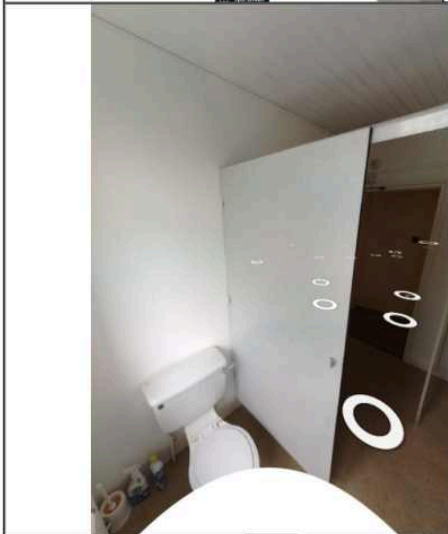
| | Photo | Description | | Proposed strategy of works<br>Retain / Restore /Celebrate | Reference |
|---|---|---|--|---|---|
| | | Sanitary fixtures and fittings | | | <b>Drawing Number</b> - 088-XX-01-11511<br><b>Annotation / Room</b> - WC 2 |

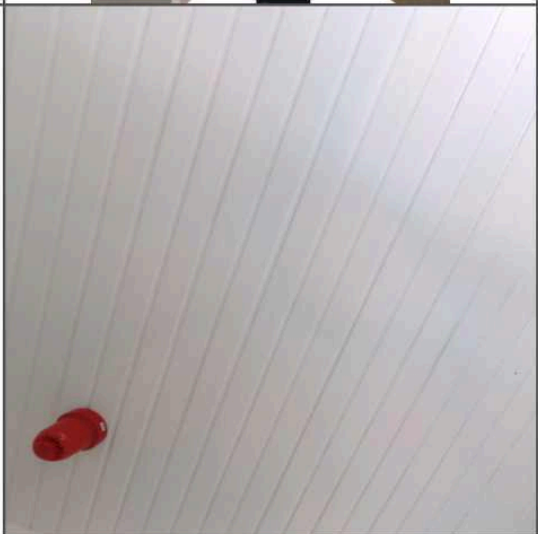
| | Photo | Description | | Proposed strategy of works<br>Retain / Restore /Celebrate | Reference |
|---|---|---|--|---|---|
| Others | | Timber tongue and groove style ceiling | | Remove and replace with plasterboard ceiling to match rest of property | |
