# Random Forge

Structural inspection and report

4 March 2026  
6723-MOM-XX-XX-RP-S-11000-P01

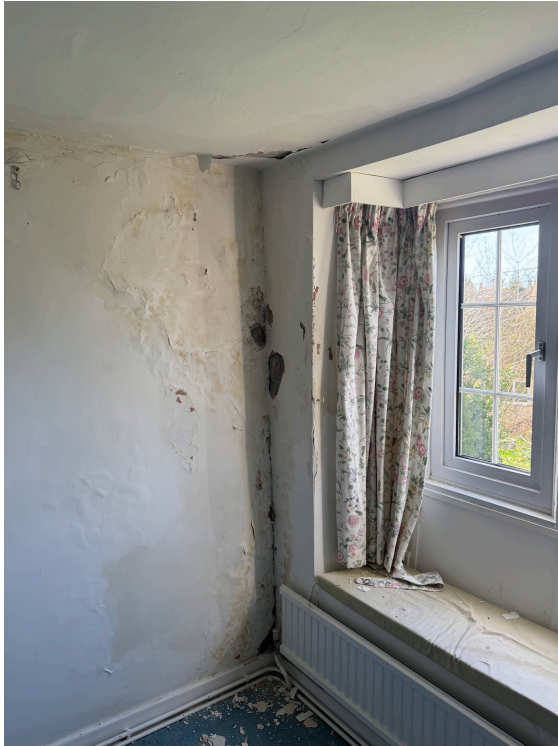
Excessive damp on internal walls

Damp and moisture is trapped within the stone structure to the extent it has saturated the stone right through with excessive damp on the internal surfaces.

The excessive moisture within the fabric, trapped by the cement based render is causing damage to the internal surfaces and to the structure.

Good conservation practice of existing stone buildings that have been inappropriately rendered is to remove the render. This will then allow the wall to manage moisture properly by having a large surface area to dry out, preventing it getting trapped and damaging the fabric and internal finishes.

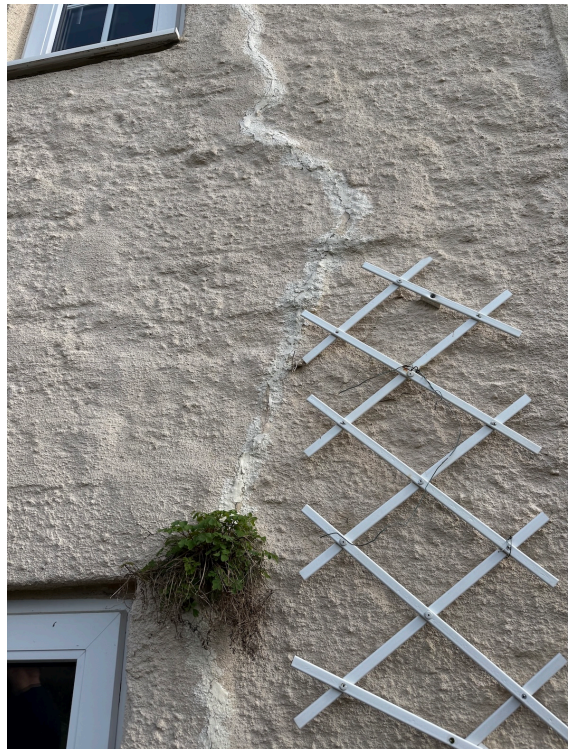
There are cracks in the render which appear to coincide with the location of excessive damp on the internal surfaces.

It is noted that moisture trapped in the wall is sufficient for plant growth within the wall.

Cracks in the external render with plant growth

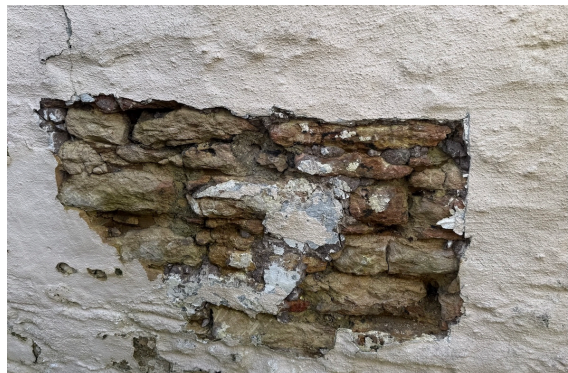
Where the render has been locally removed for inspection of the stone, it was noted that the mortar was easily removed without tools and was easily hollowed out.

Close inspection of the wall shows that many of the stones have fractured and there are no facing stones within the wall.

There composition through the wall is assumed to be random stone throughout rather than internally faced with bricks or facing stone.

Section of wall with render removed to expose random stone

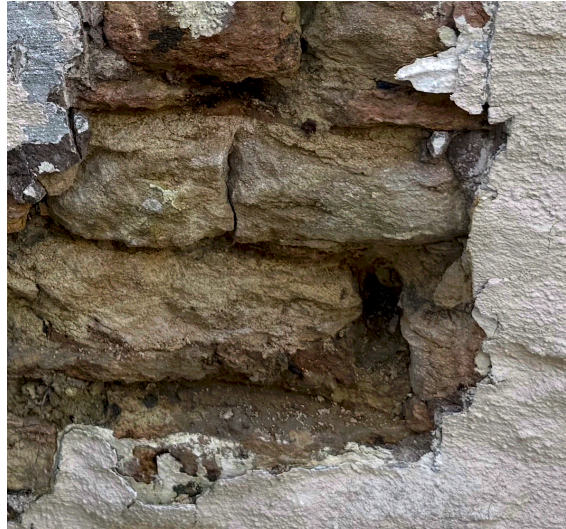
Example of fractured stone most likely caused by expansion of water trapped in the fabric

Due to the damage caused by the excessive long term moisture in the wall that has caused fracturing of stone from expansion of water during freezing periods, any alterations and repair works will likely require substantial re-building of the walls.

As the work will also require the re-positioning of windows and door openings, we would recommend that the best long term solution and additionally the safest method would be to rebuild the walls using any of the existing stone that has a good facing and has not been damaged.
