# Preliminary Ecological Appraisal and Roost Assessment

Home Farm, Shaw Hill, Shaw, Wiltshire, SN12 8EW

22<sup>nd</sup> August 2024

‘The erection of 2no. dwellings with associated soft landscaping’.

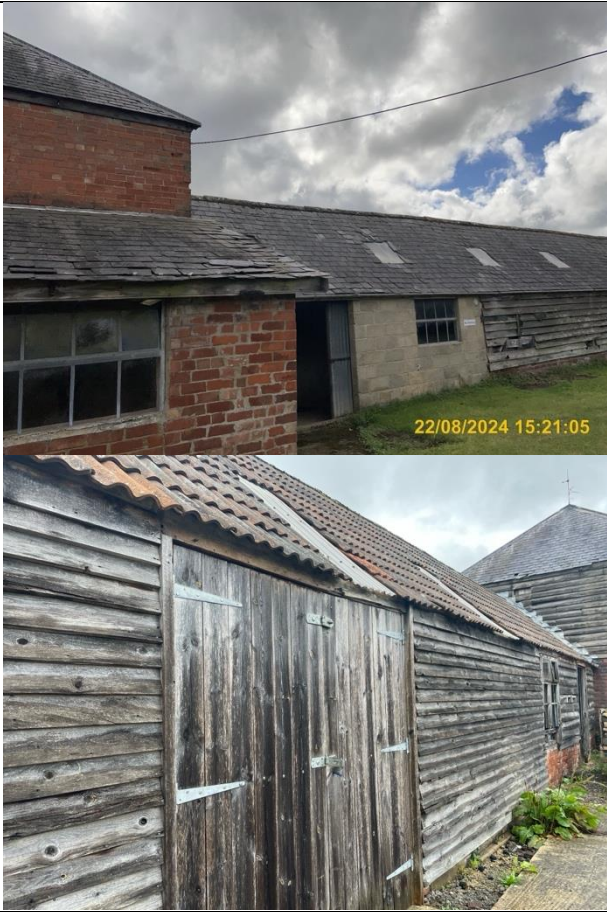
| Walls B1a | Timber cladding, breeze blocks | <p><b>Condition/description</b></p> <p>Timber cladding on the southern, northern and western elevations as well as breeze blocks on the northern elevation. The cladding is in poor condition - aged and lifted on all elevations.</p> <p><b>Suitability/access/evidence of bats</b></p> <p>Raised external cladding provides crevices under which bats could roost or gain access into the interior.</p> | |

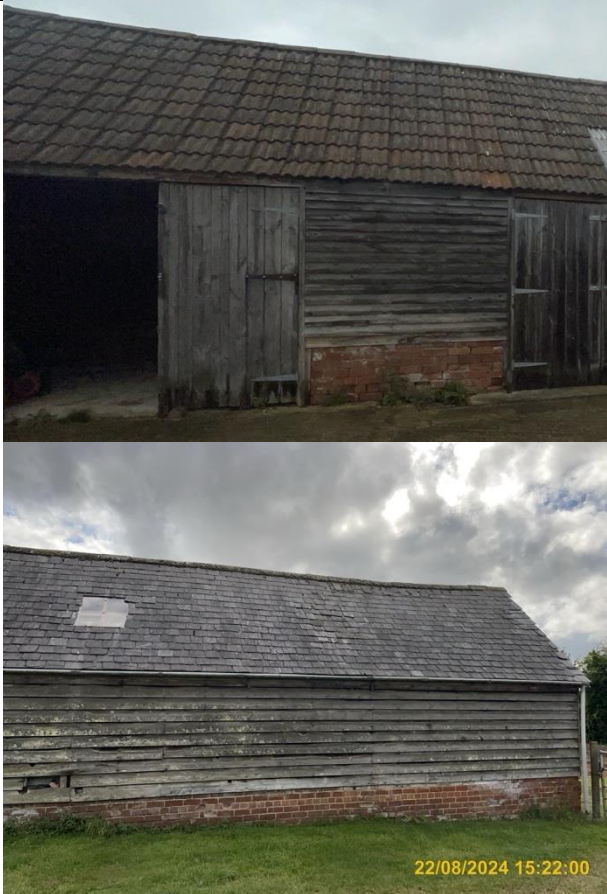
| Roof B1a | Clay interlocking tiles, slate tiles. | <p><b>Condition/description</b></p> <p>The roof is pitched and gable ended on the western elevation. It is clad in clay interlocking tiles on the southern elevation and slate tiles on the northern elevation. The gable end has timber cladding in poor condition and numerous interlocking tiles and slate tiles are dislodged or missing on all elevations.</p> <p><b>Suitability/access</b></p> <p>Crevice dwelling bats could roost in-between lining and tiles on the northern elevation and in crevices created under dislodged tiles. Both crevice and void-dwelling bats could access into the interior through crevices created by missing and raised tiles.</p> | |

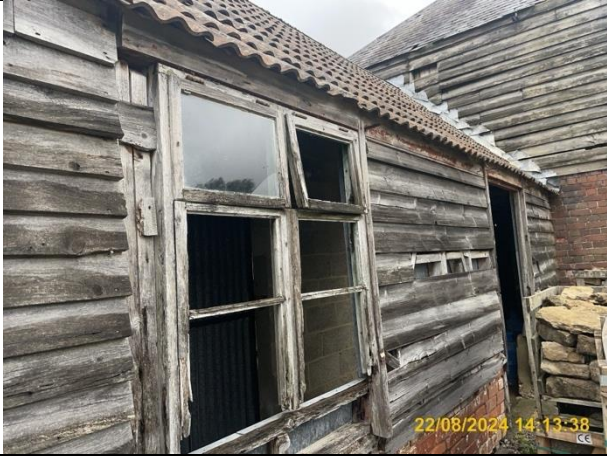
| Eaves B1a | Closed | <p><b>Condition/description</b><br/>Gaps between tiles and eaves.</p> <p><b>Suitability/access</b><br/>These gaps can provide crevices in which bats could roost or gain access into internal void.</p> | | |

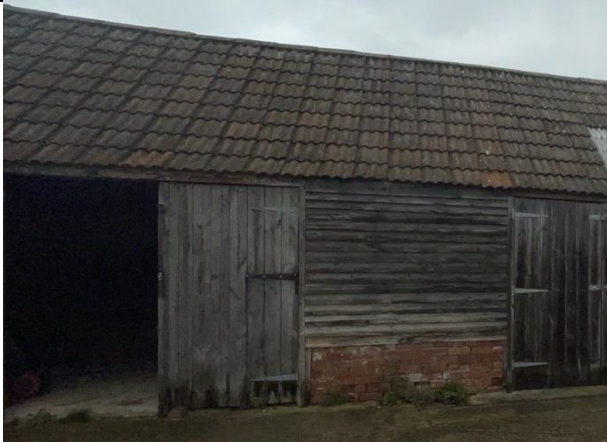
| Window/doors frames and lintels B1a | Timber | <p><b>Condition/description</b><br/>Timber doors with small gaps along the frame, broken window with metal sheet behind on the southern elevation and opening without barrier on the northern and southern elevation, and well-sealed window on the northern elevation.</p> <p><b>Suitability/access</b><br/>Small gaps between door frame and doors provide access into internal void. Metal sheet behind the broken window on the southern elevation limits access into internal void, but the unrestricted openings on the southern and northern elevation provide access into the interior.</p> | | |

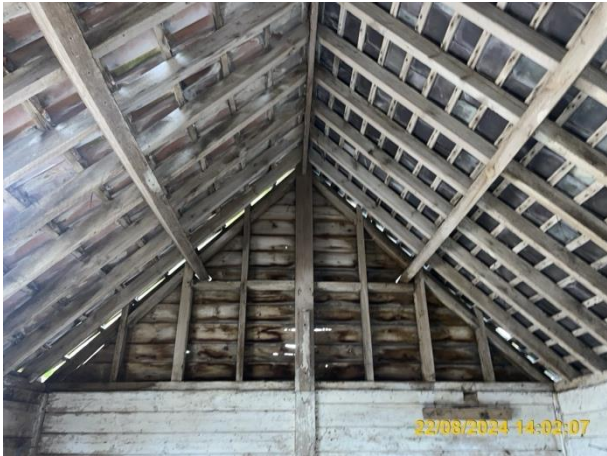
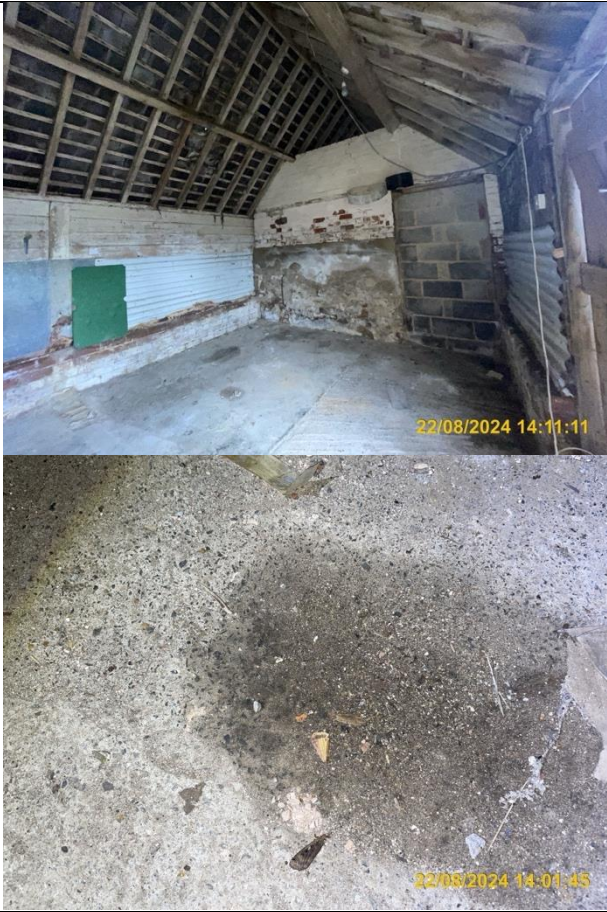
| Internal voids<br>B1a | Timber rafters and ridge beam. Open floor to ridge. Mortise and tenon joints. Internal stone wall with large opening below the ridge beam. | <p><b>Condition/description</b></p> <p>Internal space measures approx. 10 m long, 4 m wide, floor to ridge height approx. 5 m. The internal timbers appear to be original and in good condition. Humidity of the interior was 80.7%, with mycelium present on walls. Internal stone wall separates area with unrestricted opening and creates darker interior with only small amount of natural light spill from gaps in door frame and eaves. There is slate lining under the slate tiles on the northern elevation, and no lining on the southern elevation.</p> <p><b>Suitability/access/evidence of bats</b></p> <p>Low number of bat droppings (~10) and discarded moths and butterfly wings (~5) were found on the floor of the building. Samples of bat droppings were collected for DNA analysis. Some droppings were of bigger size, which is indicative of large bat species. Discarded insect parts indicate bat-feeding activity inside the building. Moreover, high humidity inside the building and low number of droppings would be indicative of a non-maternity roost. The unrestricted</p> | <p>22/08/2024 14:02:07</p> |

| | | <p>openings into the building, gaps in dislodged tiles and gaps in door frame and eaves provide access into the void. The void is suitable for roof-void dwelling bats, which require gaps from as small as the width of our thumb to access the roost and need timber joists or beams on which to roost.</p> | |

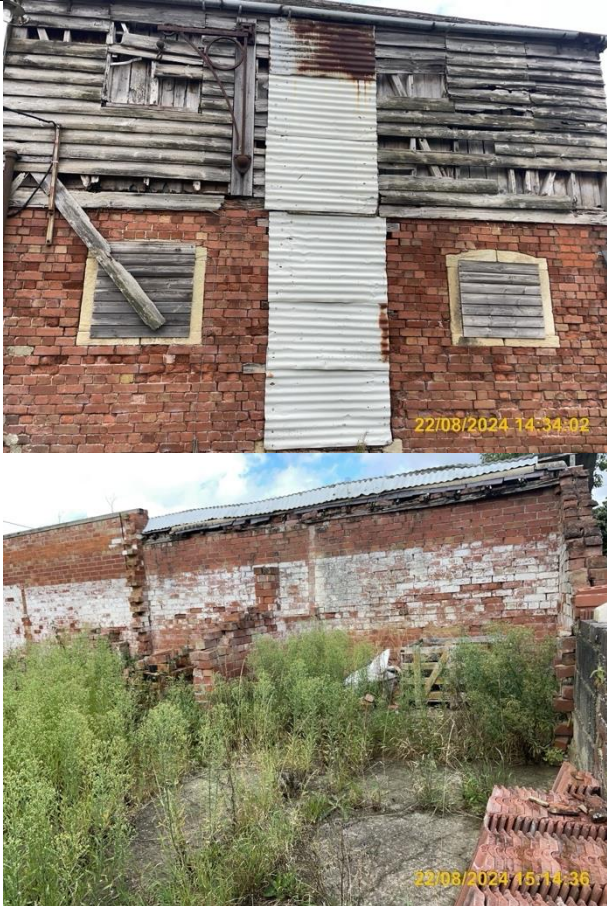
| Walls B1b | Brickwork,<br>timber<br>cladding,<br>metal sheets | <p><b>Condition/description</b></p> <p>Brickwork with gaps on northern and southern elevation and aged, raised timber cladding on southern and eastern elevation. Wall on the southern elevation has six metal sheets running vertically, and it is assumed the sheets were used to cover an open area which was utilised by animals to access the interior of the second storey and subsequently the loft void. This is supported by the presence of two dead birds in the loft void, which most likely got trapped in the loft void after the opening got boarded up. A brick wall on the south-eastern elevation has numerous gaps in brickwork and lifted timber cladding.</p> <p><b>Suitability/access</b></p> <p>These gaps in brickwork and raised cladding create crevices in which bats can roost or use as an access point into the internal void.</p> | |

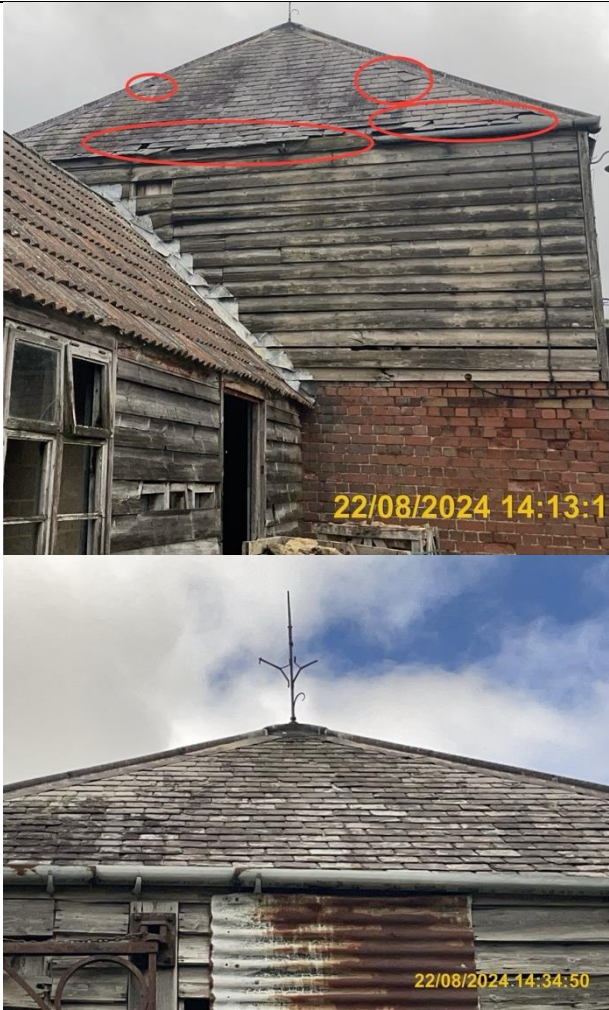
| Roof B1b | Clad in slate tiles and metal roofing sheets | <p><b>Condition/description</b></p> <p>The main roof of B1b is hipped and clad in slate tiles, and two adjacent lean-on roofs on the northern elevation have metal roofing sheet and slate tiles clad. Both the main roof and lean-on roof clad in slate tiles have broken, dislodged or missing tiles, revealing gaps, and there is exposed lead flashing on all elevations of the main roof.</p> <p><b>Suitability/access</b></p> <p>The numerous gaps in roofs clad in slate tiles create crevices in which bats could roost or gain access into the interior void and loft void.</p> | |

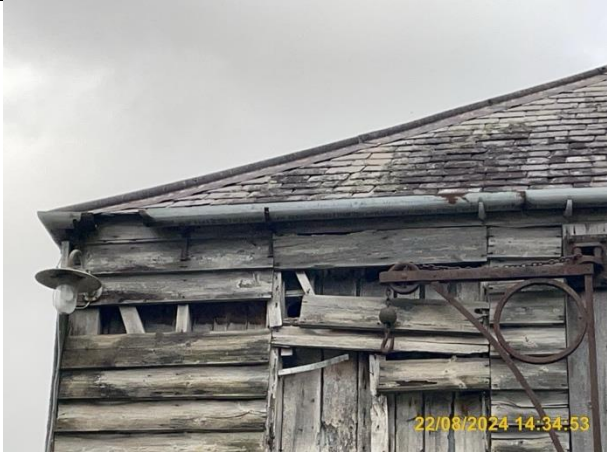
| Eaves B1b | Closed | <b>Condition/description</b><br>Eaves are in poor condition with gaps between tiles and eaves on all elevations.<br><br><b>Suitability/access</b><br>These gaps can provide crevices through which bats could gain access into internal void and loft void. | | <br>22/08/2024 14:34:53 | |

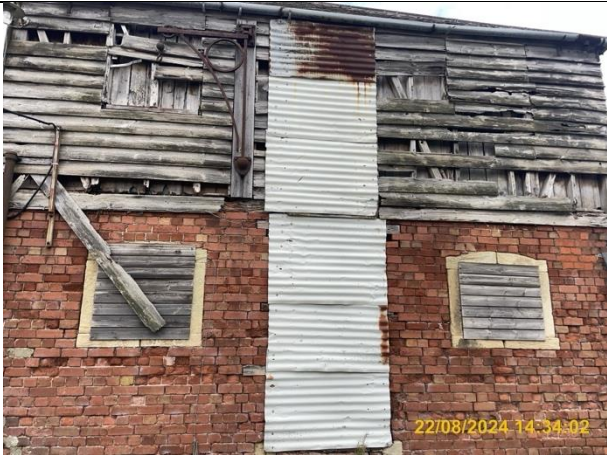
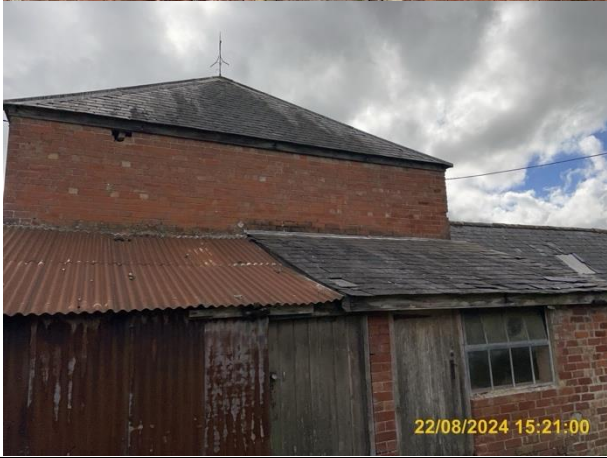
| Windows/door frames and lintels B1b | Stone and timber window frame, timber door frame | <p><b>Condition/description</b></p> <p>Windows on the southern elevation are boarded up, with gaps in stone and timber frames, creating natural light spill visible from the interior. Doors on the northern elevation seem to be tight fitting.</p> <p><b>Suitability/access</b></p> <p>Gaps in window frames allow access into the interior void and subsequently the loft void.</p> | |

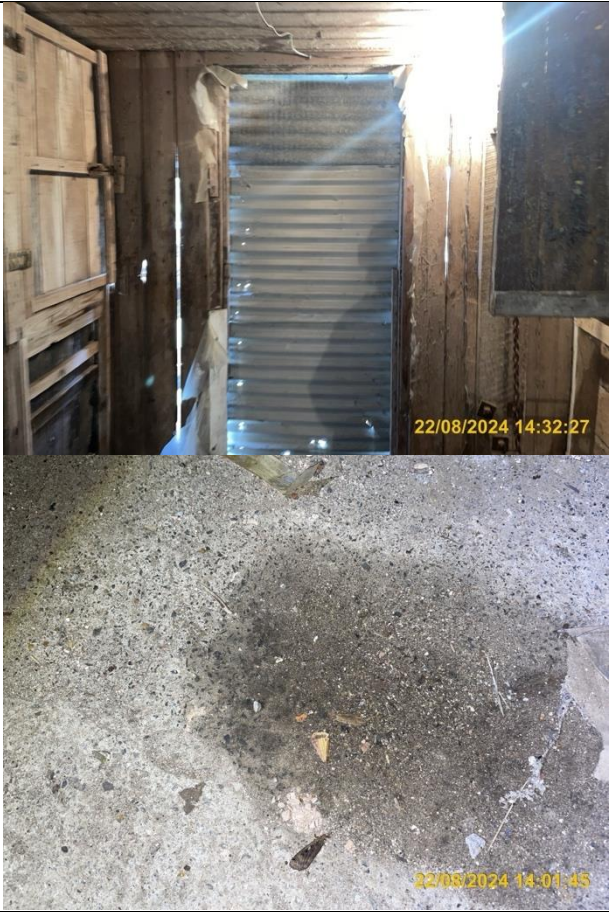
| Internal voids<br>B1b | Timber<br>rafters and<br>ridge beam.<br>Open floor to<br>ridge.<br>Mortise and<br>tenon joints. | <p><b>Condition/description</b></p> <p>First storey can be accessed through opening into the corridor between B1a and B1b. The interior was dark with low levels of natural light spill through gaps in window frames and brickwork. Second storey is accessed by a ladder and contains two dark enclosed spaces, running along eastern elevation and western elevation of the building. Both spaces don't have a barrier in their opening, allowing full access. The second storey has some natural light spill through the gaps between timber cladding and metal sheets which were used to board up windows and door.</p> <p><b>Suitability/access/evidence of bats</b></p> <p>First storey had a low number (&lt;5) of discarded moths and butterfly wings. A large number of bat droppings (~50) with mixture of colours and discarded moths and butterfly wings (~20) were seen within both two dark enclosed spaces on the second storey. Samples were collected for DNA analysis. There is a mixture of colours which shows different ages of droppings, with darkest droppings indicating more recent activity. Size and shape of droppings indicate a large bat, such as serotine or horseshoe.</p> | |

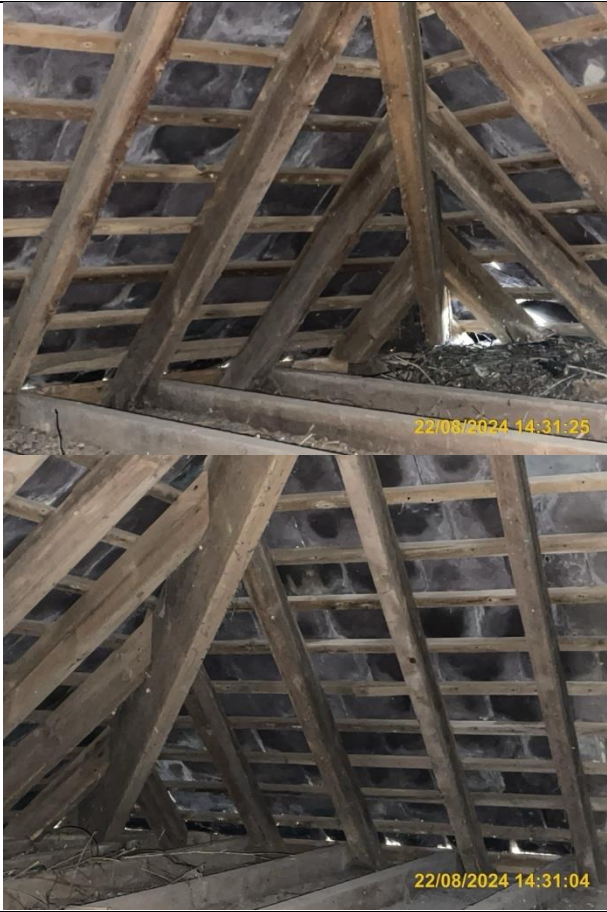
The loft void of Building B1b had unstable loft joists, and therefore couldn't be fully accessed and surveyed.

| Loft void B1b | Timber rafters and ridge beam. Open floor to ridge. | <p><b>Condition/description</b></p> <p>Loft void is on the third storey of the building, it has timber rafters and ridge beam in good condition, and it is 2 m high and 4 m wide in diameter. The loft roof is not lined, with exposed slate tiles. 2 dead birds, presumably pigeons, 4 pigeon nests and rodent droppings were seen. The loft void couldn't be fully accessed and surveyed due to safety reasons as the loft joists were unstable.</p> <p><b>Suitability/access/evidence of bats</b></p> <p>Bats can access the loft void through crevices in slate tiles, eaves and opening leading to the second storey. ~10 bat droppings and discarded moth and butterfly wings were found, however due to safety reasons it was not possible to inspect the whole area of loft void and therefore more evidence of bats might have been missed. Samples were collected for DNA analysis. The loft is suitable for roof-void dwelling bats, which require gaps from as small as the width of our thumb to access the roost and need timber joists or beams on which to roost.</p> | |

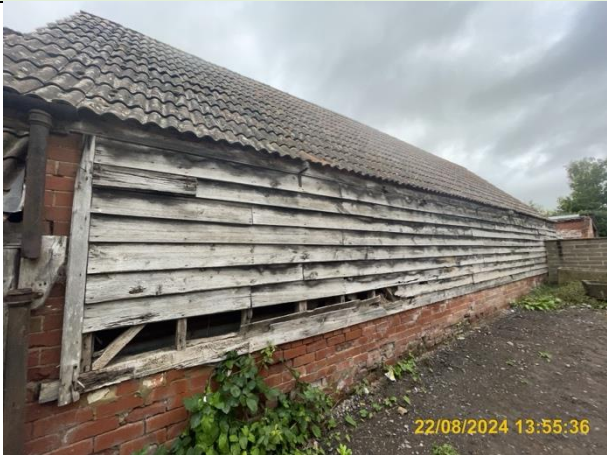
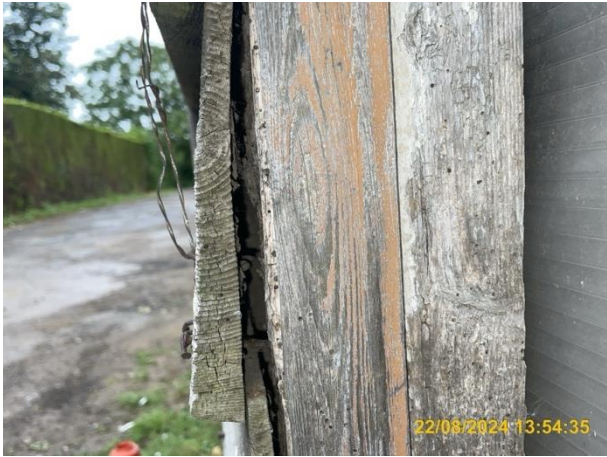
| external evidence would be quickly weathered away. The building has <b>high roosting habitat value</b> . | | | |
|---|---|---|---|
| Walls B2a | Timber clad, breeze blocks, brick columns. | <p><b>Condition/description</b></p> <p>Aged, lifted and broken timber cladding on the northern, and eastern elevation, creating crevices. Breeze blocks with missing blocks on the western elevation, brick columns with gaps on the northern elevation.</p> <p><b>Suitability/access</b></p> <p>Crevices formed under lifted cladding and in brick columns provide roosting habitat for bats and access into the internal void. The interior can also be accessed through a large gap in area of missing breeze blocks.</p> | |

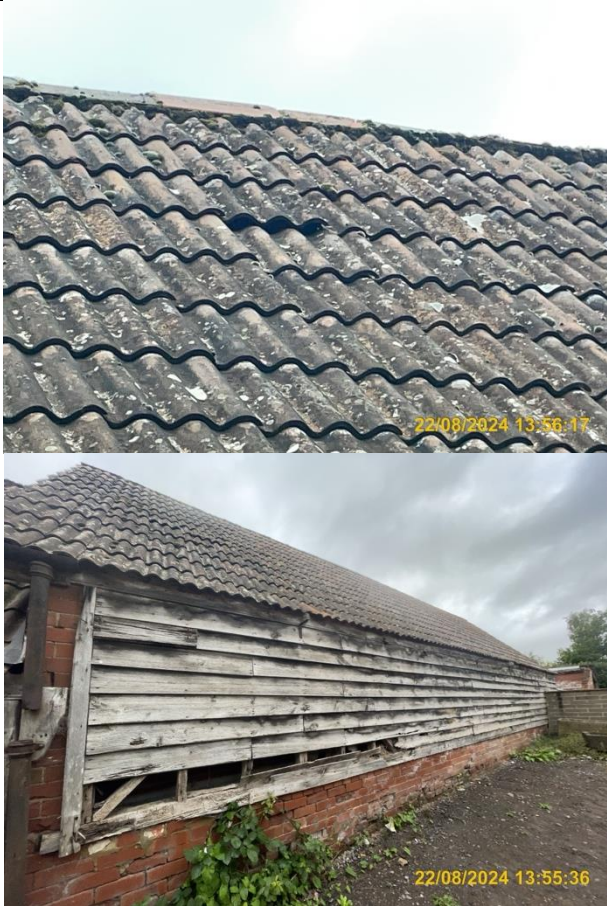
| Roof B2a | Clay interlocking tiles | <p><b>Condition/description</b></p> <p>The roof is pitched, clad in clay interlocking tiles and gable ended on the northern elevation. The tiles are raised and dislodged on all elevations. The gable end has timber cladding in poor condition, with raised and broken timer boards.</p> <p><b>Suitability/access</b></p> <p>Crevices formed under raised and dislodged clay tiles provide roosting habitat for bats and access into the internal void.</p> | |

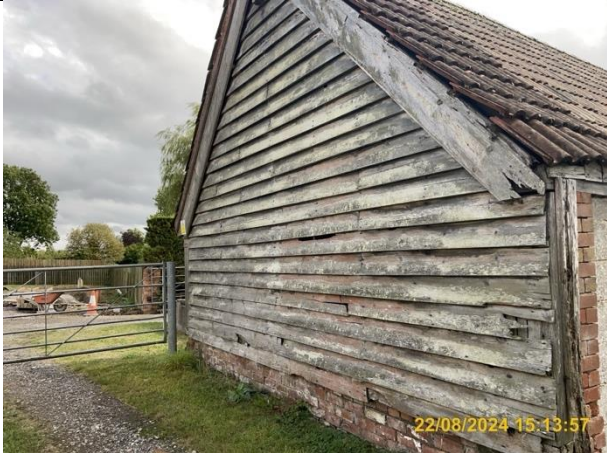
| Barge boards/fascia boards B2a | Timber | <p><b>Condition/description</b><br/>Barge board on the gable end is aged and broken with gaps between the board, cladding and tiles.</p> <p><b>Suitability/access</b><br/>These gaps provide roosting habitat for bats and access into the internal void.</p> | |

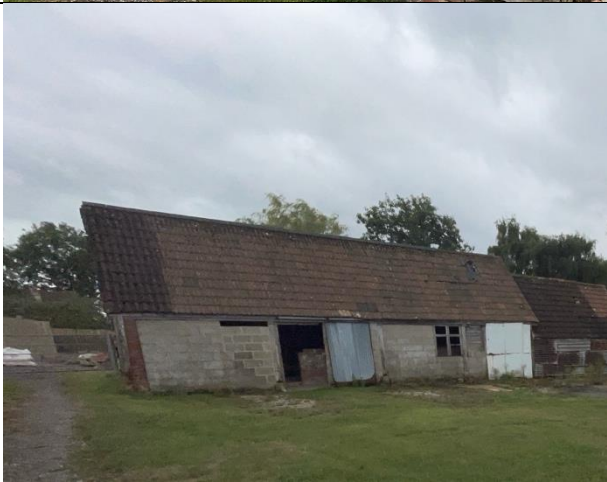
| Window/doors frames and lintels B2a | Timber | <p><b>Condition/description</b><br/>Timber frames on the northern elevation are in poor condition – aged and rotten, creating crevices.</p> <p><b>Suitability/access</b><br/>Crevices formed within timber frames provide roosting habitat for crevice-dwelling bats.</p> | |

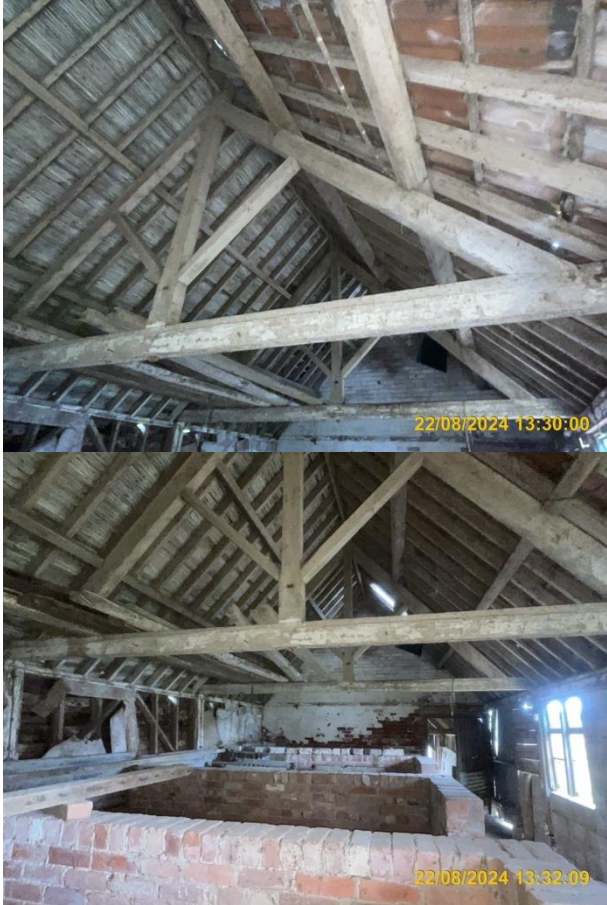
| Internal voids<br>B2a | Timber rafters and ridge beam. Open floor to ridge. Mortise and tenon joints. | <p><b>Condition/description</b></p> <p>Internal space measures approx. 11.5 m long, 4.5 m wide, floor to ridge height approx. 5 m. The internal timbers appear to be original with traditional mortise and tenon joints. There is timber lining under clay tiles and some areas with plastic and metal sheets on eastern elevation and no lining on western elevation. Gaps in timber cladding, metal and plastic sheets and roof tiles are present, especially on the northern and western elevation. The void has a large amount of natural light entering the space through gaps in timber cladding, clay tiles, missing breeze blocks, window and opening into B2b. There were four old bird nests on the intersection of timber beams.</p> <p><b>Suitability/access/evidence of bats</b></p> <p>Between 20 - 59 bat droppings and ~20 moth and butterfly wings were found on the floor. Samples were collected for DNA analysis. Size and shape of droppings indicate a large bat species. There is a mixture of colours which shows different ages of droppings, with darkest droppings indicating more recent activity. This, along with the volume found eliminates a one-off exploratory visit. High level of natural light internally is indicative of this space not being used as a day or maternity roost, and therefore the void is most likely used as a feeding roost.</p> | |

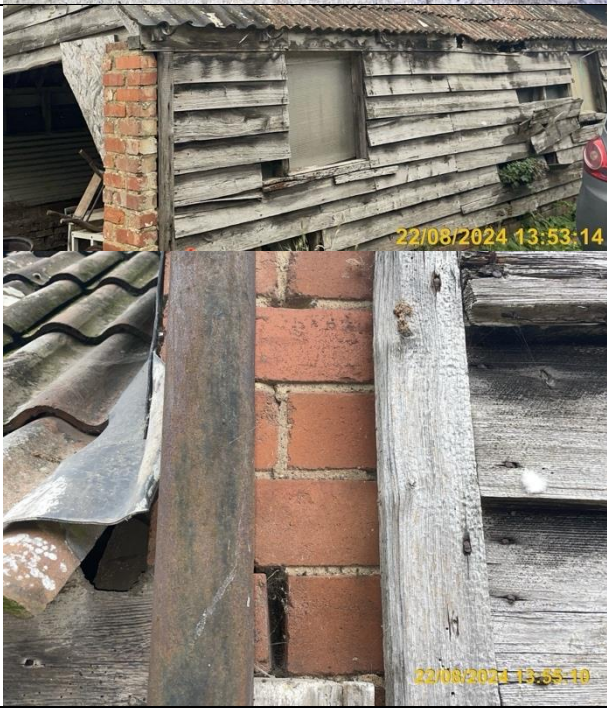
| Walls B2b | Timber clad, brick columns, metal sheets. | <p><b>Condition/description</b><br/>Aged, lifted and broken timbercladding on the southern, and eastern elevation, creating crevices. Metal sheets on the western elevation, brick columns with gaps on the southern elevation. There is no wall on the southern elevation, creating open area into the exterior.</p> <p><b>Suitability/access</b><br/>Crevices formed under lifted cladding and in brick columns provide roosting habitat for bats and access into the internal void. The interior can also be accessed through the open area on the southern elevation.</p> | |

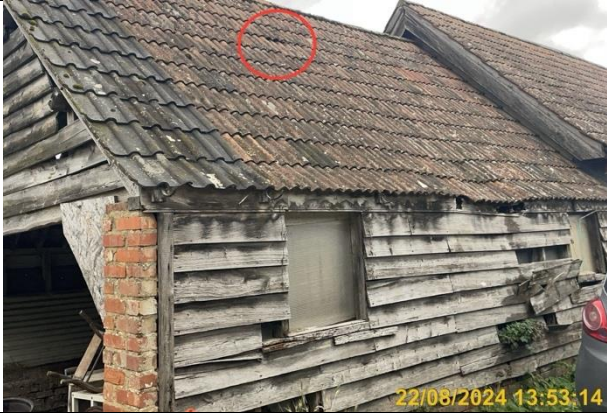
| Roof B2b | Clay interlocking tiles | <p><b>Condition/description</b><br/>The roof is pitched and clad in clay interlocking tiles. The tiles are raised on all elevations.</p> <p><b>Suitability/access</b><br/>Crevices formed under raised clay tiles provide roosting habitat for bats and access into the internal void.</p> | |

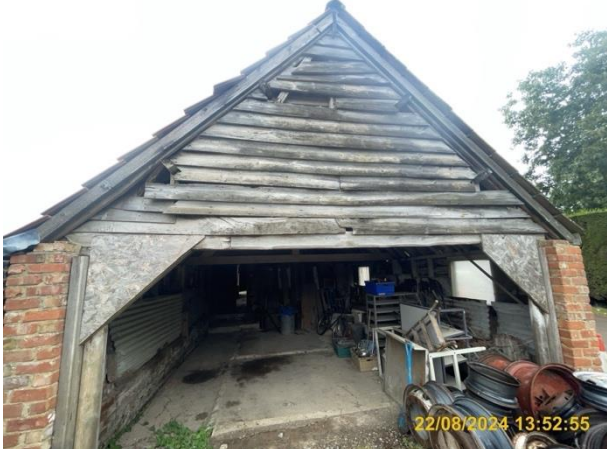
| Windows/door frames and lintels B2b | | <p><b>Condition/description</b><br/>Timber frames on the western elevation are in poor condition – aged and rotten, creating crevices.</p> <p><b>Suitability/access/evidence of bats</b><br/>Crevices formed within timber frames provide roosting habitat for crevice-dwelling bats.</p> | |

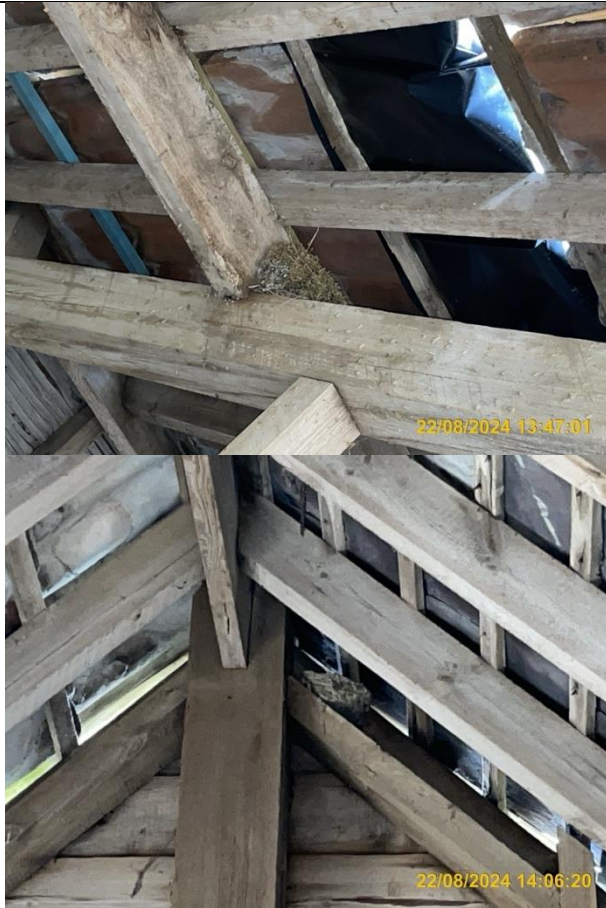
| <i>Summary of Survey Findings</i> | <p><b>Buildings</b><br/>Five old bird nests were identified in the buildings' interior (Figure 10), four in B2 and one in B1, all on the intersections of timber beams. Four nests were open-cup type nests of mud composition, which is suggestive of them being swallow nests. One nest was of bigger size than the other three and was made of sticks and twigs, which is suggestive of pigeon nest.</p> <p><b>Trees and vegetation</b><br/>No bird nests were identified within the vegetation of the native hedgerows with trees and ornamental hedgerow, however these habitats offer nesting opportunities and nest-building resources for birds.</p> <p><b>Barn owls</b><br/>The site provides suitable nesting sites for barn owls in the form of farm buildings, however, no evidence of nesting barn owls was recorded on-site.</p> <p><b>Overwintering birds</b><br/>Due to the small size of the site and the extent and type of the habitats recorded, the site not considered suitable to support a significant assemblage of protected and/or notable birds.</p> |

Figure 10: Old bird nests in the interior of B1 and B2

| <i>Recommendations</i> | <p><b>Buildings/trees</b><br/>Any building removal should be undertaken outside the period 1st March to 31st August. If this timeframe cannot be avoided, a close inspection of the buildings should be undertaken immediately, by a qualified ecologist, prior to the commencement of work. All active nests will need to be retained until the young have fledged.</p> <p>Precautions should be taken with machinery and noise levels when working close to any retained nests within buildings or native hedgerows with trees and ornamental hedgerow so as not to disturb any nearby nesting birds during construction works. At least a 3-5m buffer should be created between any machinery and active nests until the young have fledged.</p> <p><b>Barn owls</b><br/>None required.</p> <p><b>Overwintering birds</b><br/>None required.</p> <p><b>Suggested biodiversity enhancements</b><br/>The installation of a minimum of three bird boxes on created buildings will provide additional nesting habitat for birds (e.g., Schwegler No 17 Swift Nest Box and/or Schwegler 1SP Sparrow Terrace, or a similar alternative brand). Sparrow boxes should be positioned at the eaves of a building.</p> |
