**BATTERY STORAGE FACILITY,**  
**STONEHILL, MINETY, WILTSHIRE**

**PRE-CONSTRUCTION ROAD CONDITION SURVEY**

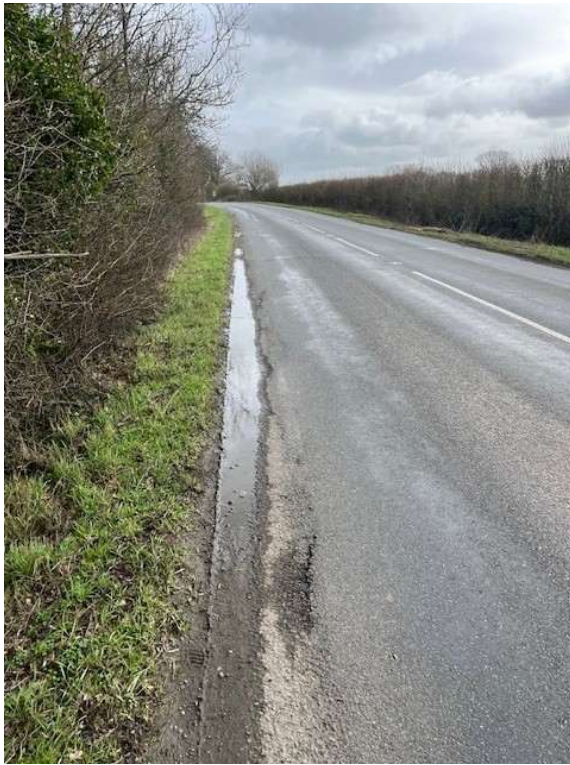
**Photograph 1**

| Photograph | Chainage (m) | Description of Defect |
|---|---|---|
| 1 | -87 | Overrun of verge edge, minor damage to edge of carriageway surfacing. |

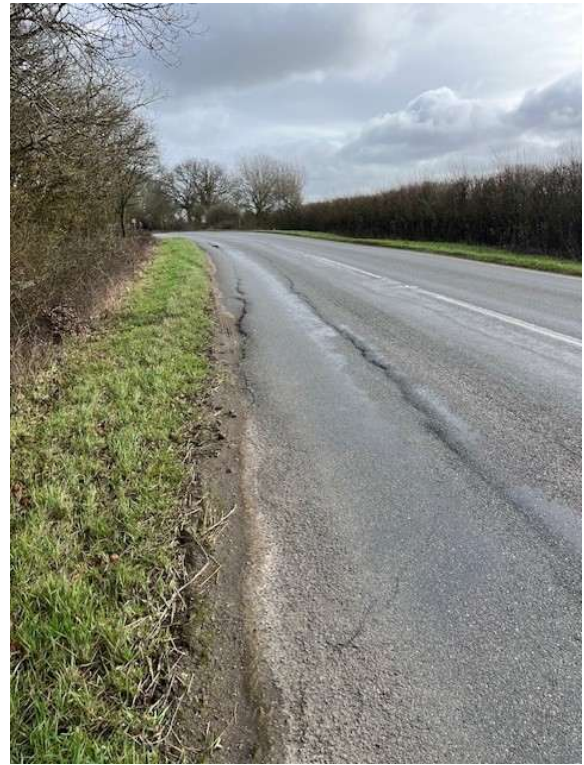
**Photograph 2**

| Photograph | Chainage (m) | Description of Defect |
|---|---|---|
| 2 | -65 | Longitudinal cracks and sunken carriageway along wheel track possibly associated with historic trench reinstatement. |

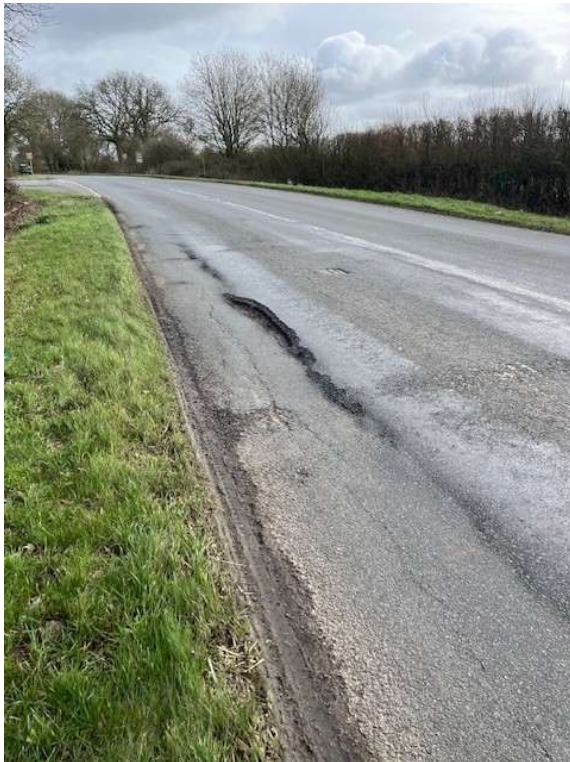
**Photograph 3**

| Photograph | Chainage (m) | Description of Defect |
|---|---|---|
| 3 | -47 | Continuation of the above resulting in split in the surfacing. |

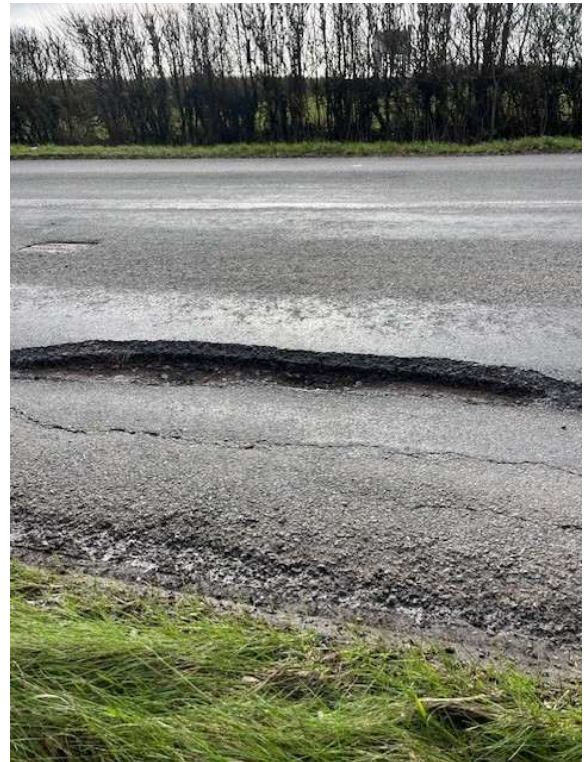
**Photograph 4**

| Photograph | Chainage (m) | Description of Defect |
|---|---|---|
| 4 | -45 | Looking south at edge of the split – vertical edge of approximately 50mm with exposed subbase below. |

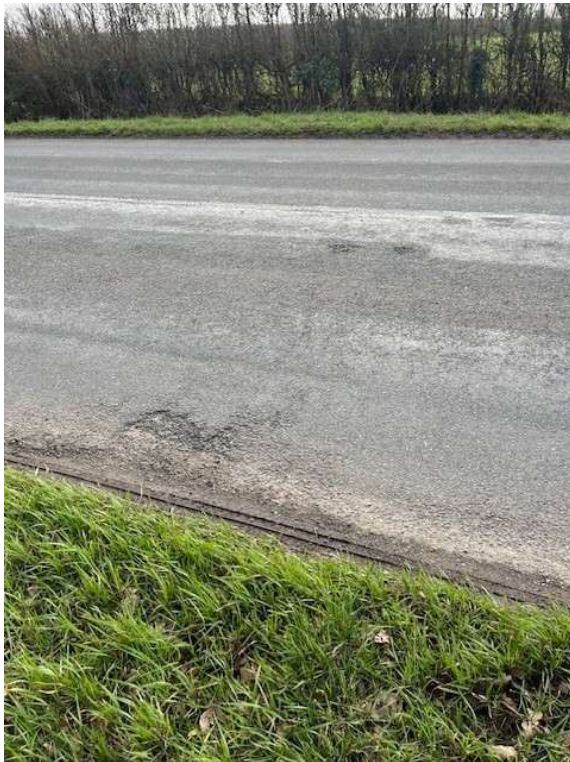
**Photograph 5**

| Photograph | Chainage (m) | Description of Defect |
|---|---|---|
| 5 | -30 | Looking south – areas of stone loss across eastbound traffic lane with perpendicular cracks between. |

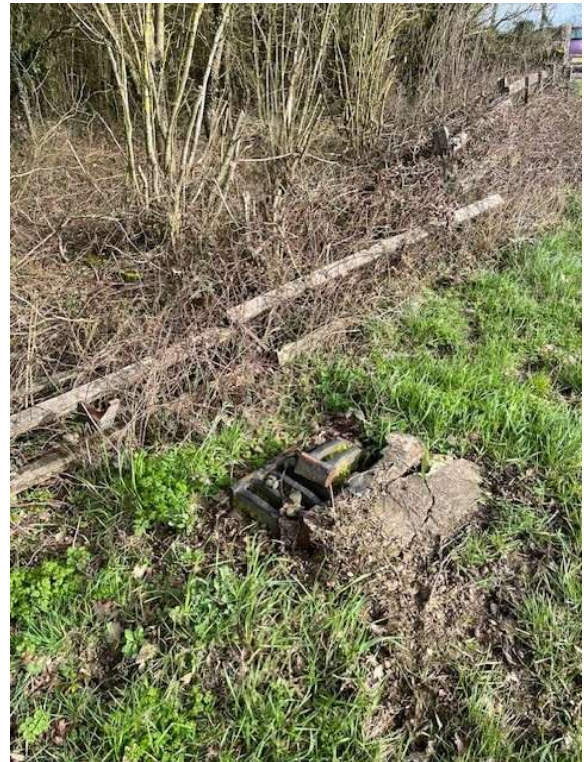
**Photograph 6**

| Photograph | Chainage (m) | Description of Defect |
|---|---|---|
| 6 | -27 | Broken gulley and grating within the verge. |

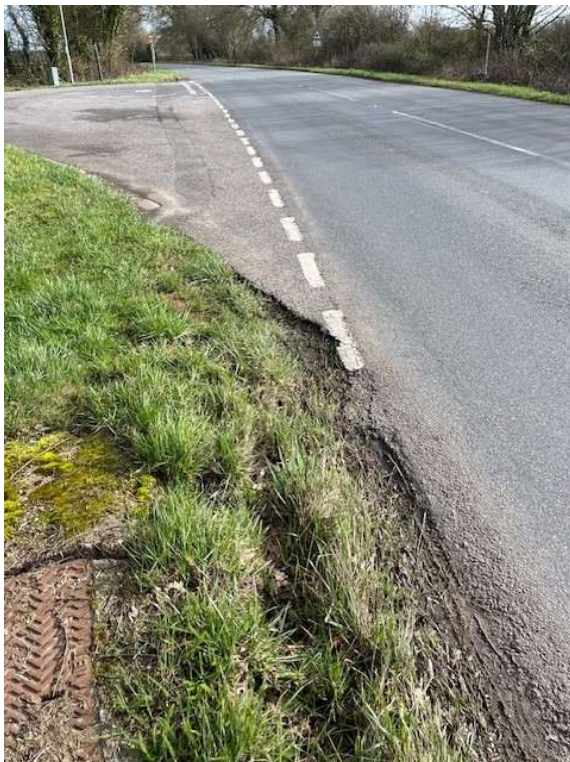
**Photograph 7**

| Photograph | Chainage (m) | Description of Defect |
|---|---|---|
| 7 | -20 | Overrun of verge on left turn into the access. |

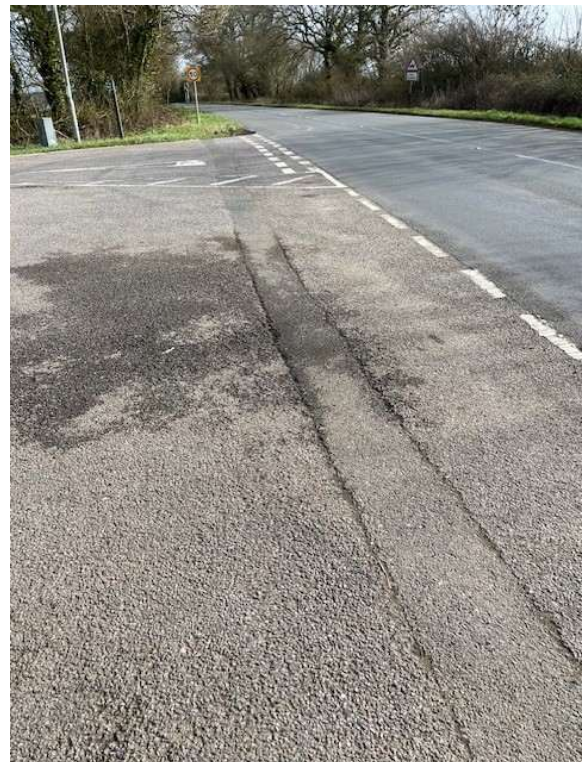
**Photograph 8**

| Photograph | Chainage (m) | Description of Defect |
|---|---|---|
| 8 | -7 | Picking out of joints either side of trench reinstatement. |

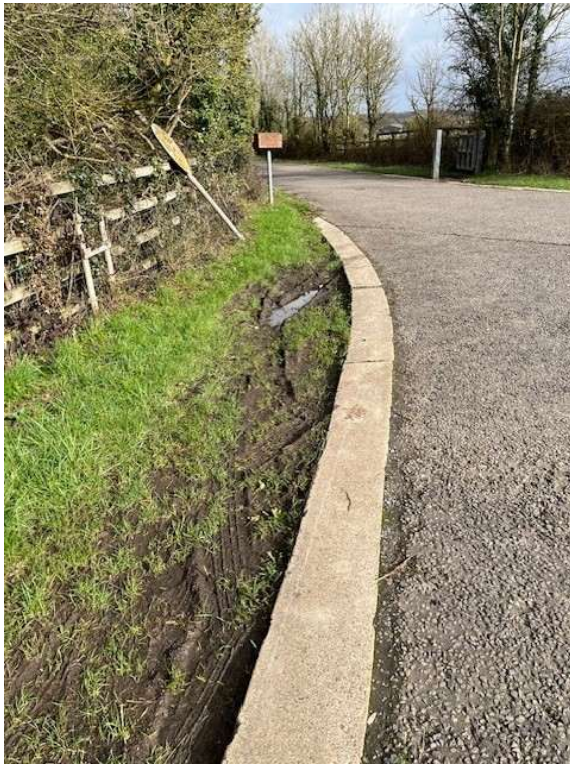
**Photograph 9**

| Photograph | Chainage (m) | Description of Defect |
|---|---|---|
| 9 | -7 | Looking north – overrun of verge on left turn into the access. |

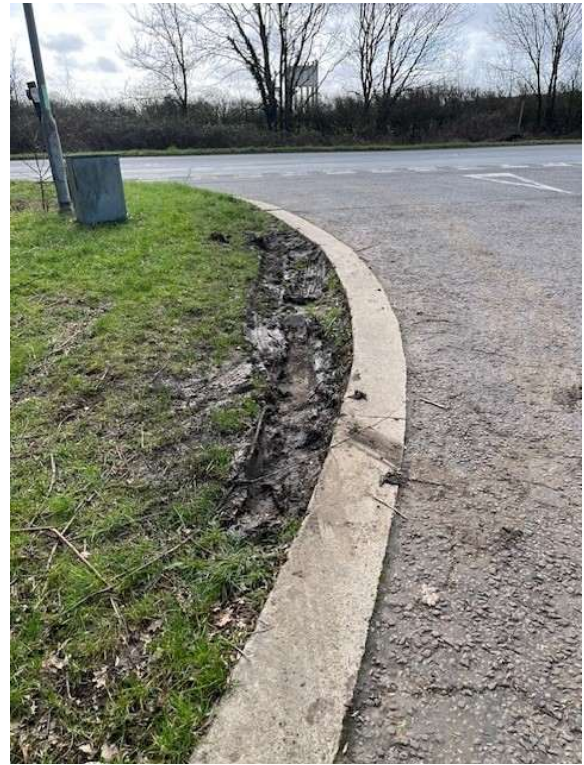
**Photograph 10**

| Photograph | Chainage (m) | Description of Defect |
|---|---|---|
| 10 | 10 | Looking south – overrun of verge on left turn out of the access. |

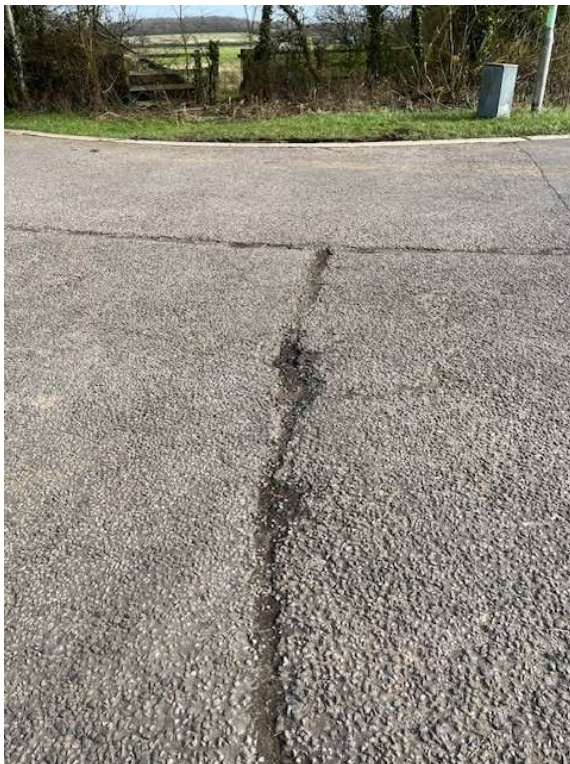
**Photograph 11**

| Photograph | Chainage (m) | Description of Defect |
|---|---|---|
| 11 | -2 | Picking out of surfacing construction joints within the access. |

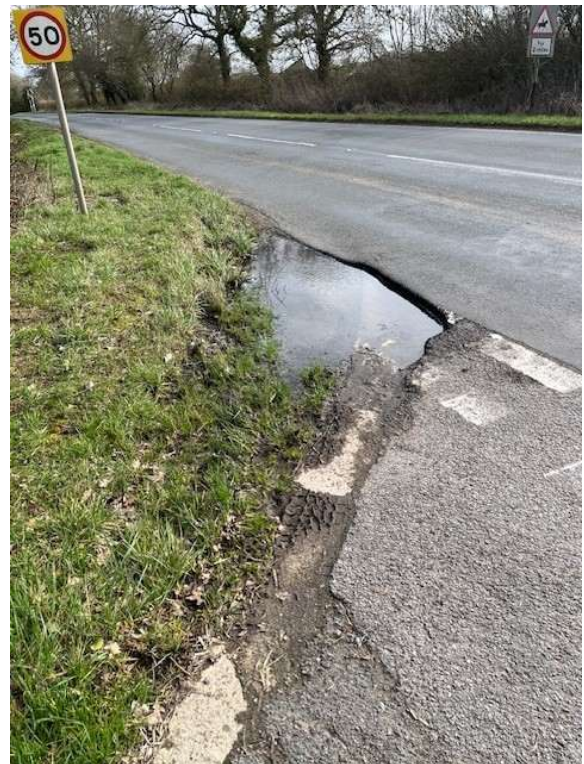
**Photograph 12**

| Photograph | Chainage (m) | Description of Defect |
|---|---|---|
| 12 | 18 | Overrun of verge on left turn out of the access with up to 100mm depth. |

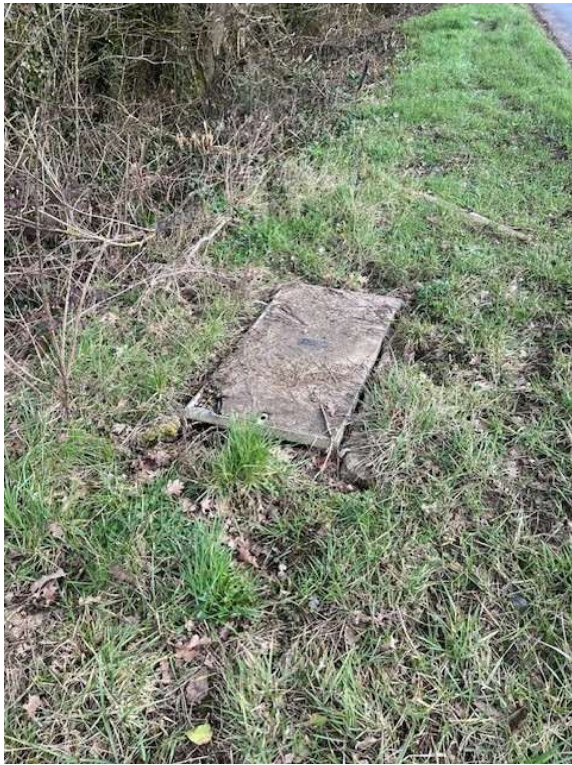
**Photograph 13**

| Photograph | Chainage (m) | Description of Defect |
|---|---|---|
| 13 | 23 | BT chamber cover dislodged and not sitting correctly on frame. |

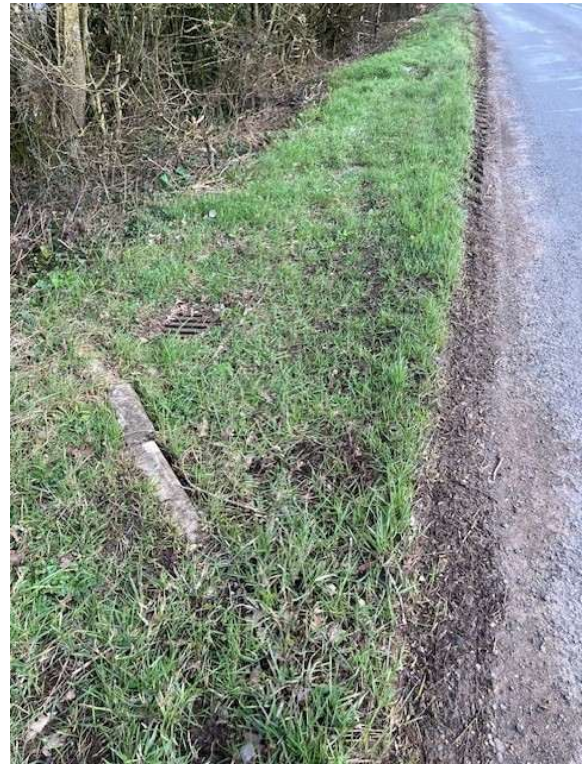
**Photograph 14**

| Photograph | Chainage (m) | Description of Defect |
|---|---|---|
| 14 | 29 | Road side gulley grassed over and unlikely to catch runoff from carriageway. |

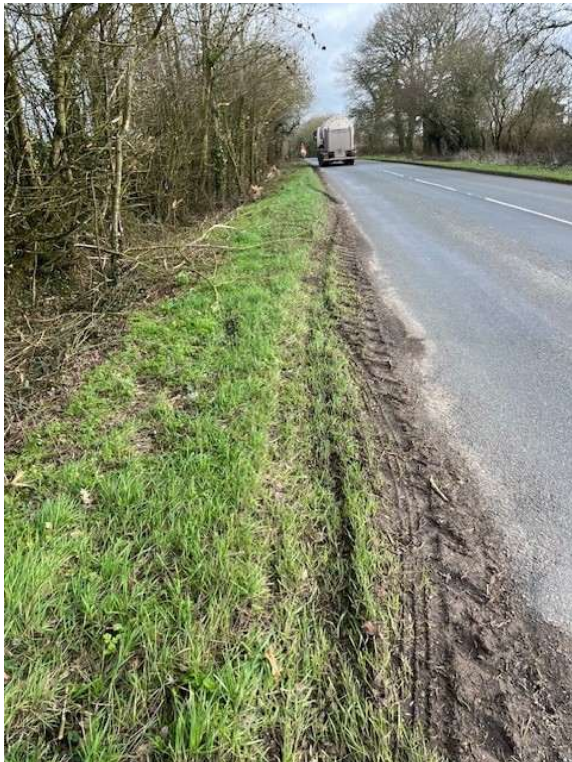
**Photograph 15**

- 3.3 The northern road side hedge to the east of the access road has recently been cut back using a flail. The debris from this exercise has not been cleared from the verge with some cut branches extending close to the edge of carriageway. The tractor used to cut the hedge has left tyre tracks along sections of the verge primarily immediately at the edge of the carriageway.

| Photograph | Chainage (m) | Description of Defect |
|---|---|---|
| 15 | 43 | Damage to verge caused by cutting back of the hedge. |

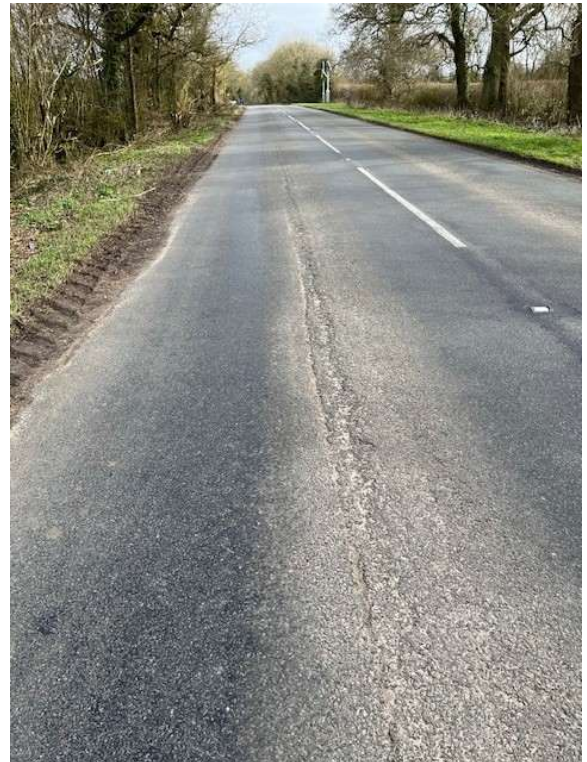
**Photograph 16**

| Photograph | Chainage (m) | Description of Defect |
|---|---|---|
| 16 | 55 | Stone loss along centre of eastbound traffic lane. |

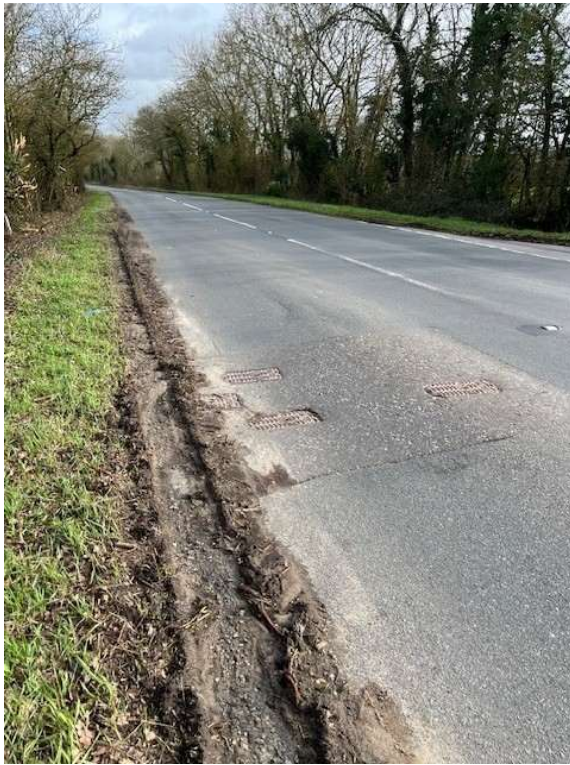
**Photograph 17**

| Photograph | Chainage (m) | Description of Defect |
|---|---|---|
| 17 | 196 | Reinstatement around covers sunken slightly plus damage to verge. |

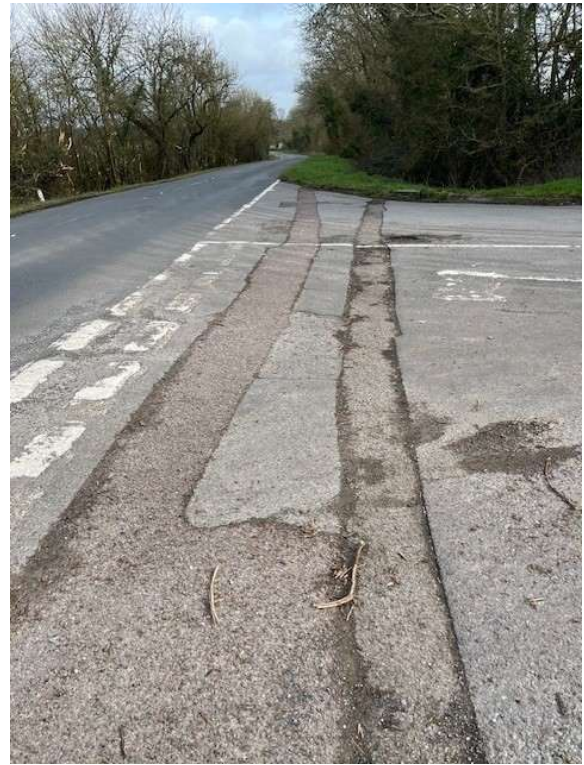
**Photograph 18**

| Photograph | Chainage (m) | Description of Defect |
|---|---|---|
| 18 | 188 | Picking out of edges of trench reinstatements. |

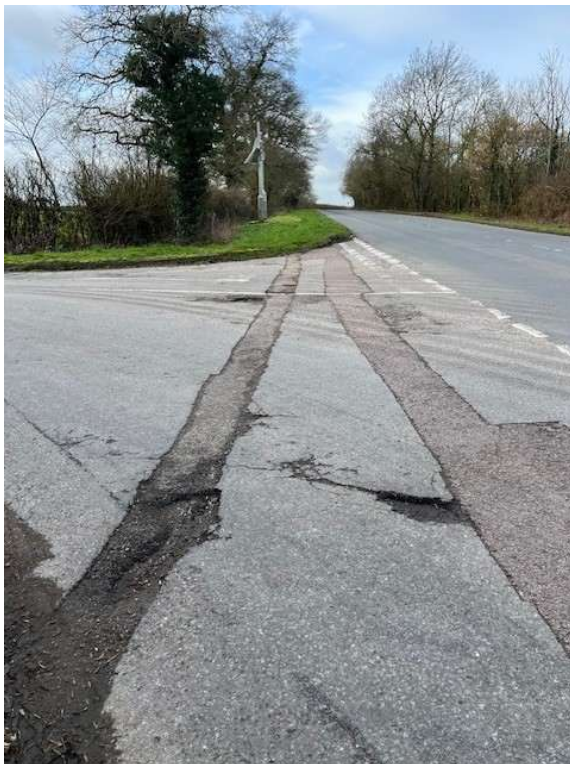
**Photograph 19**

| Photograph | Chainage (m) | Description of Defect |
|---|---|---|
| 19 | 203 | Looking west – picking out of edges of trench reinstatements including formation of at least three moderate sized potholes. |

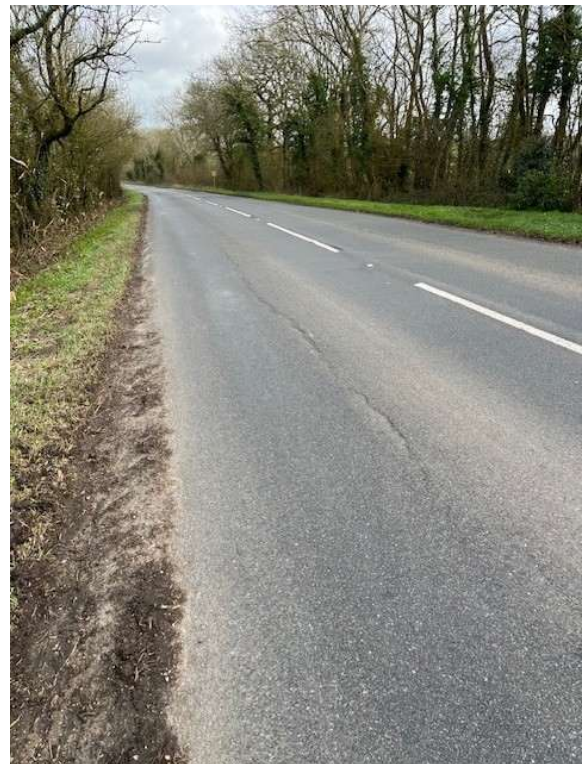
**Photograph 20**

| Photograph | Chainage (m) | Description of Defect |
|---|---|---|
| 20 | 211 | Longitudinal crack along centre of eastbound traffic lane. |

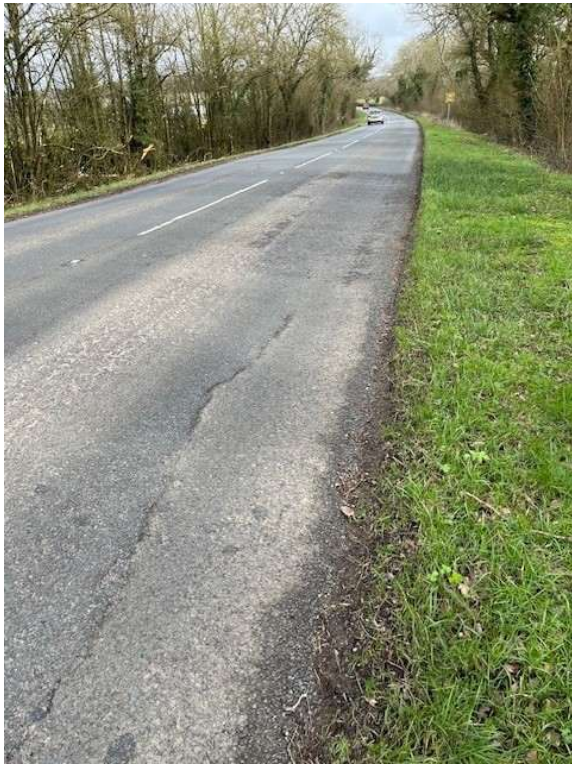
**Photograph 21**

| Photograph | Chainage (m) | Description of Defect |
|---|---|---|
| 21 | 222 | Longitudinal crack along westbound traffic lane leading to wide area of stone loss from surfacing. |

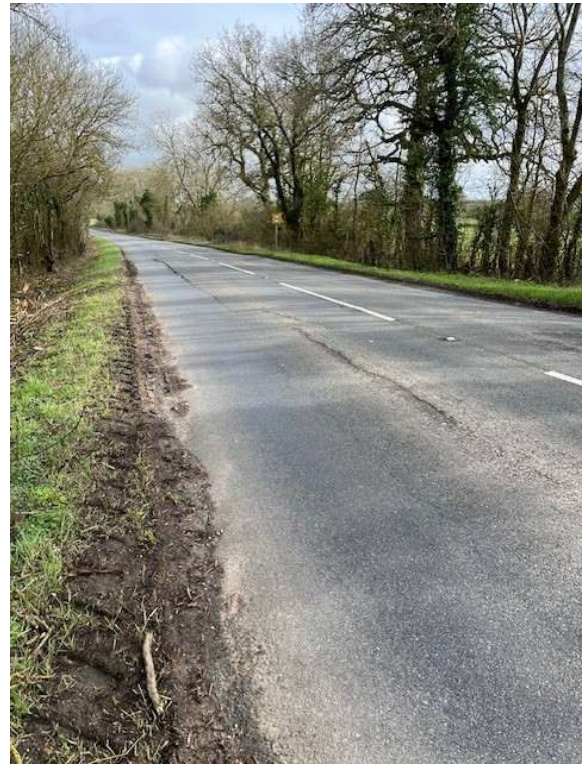
**Photograph 22**

| Photograph | Chainage (m) | Description of Defect |
|---|---|---|
| 22 | 227 | Longitudinal crack along centre of eastbound traffic lane with associated dip of carriageway level on the verge side. |

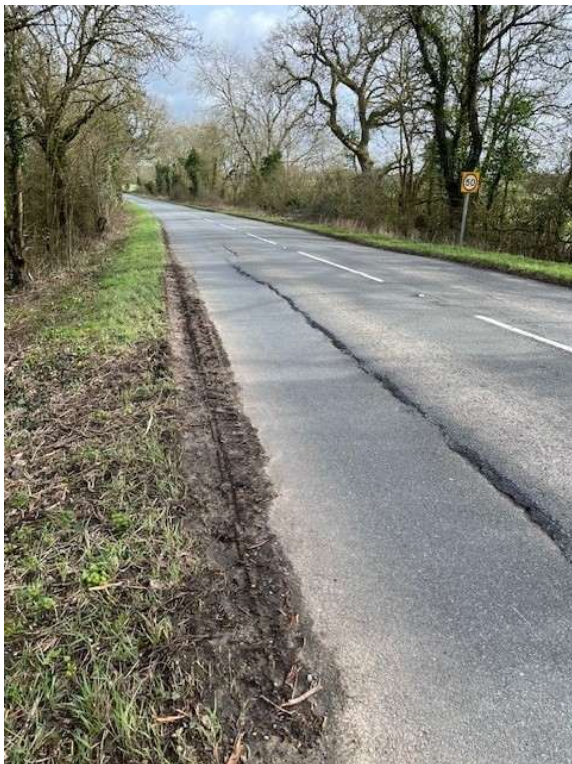
**Photograph 23**

| Photograph | Chainage (m) | Description of Defect |
|---|---|---|
| 23 | 232 | Continuation of the above with level difference of the dip more marked at approximately 25mm. |

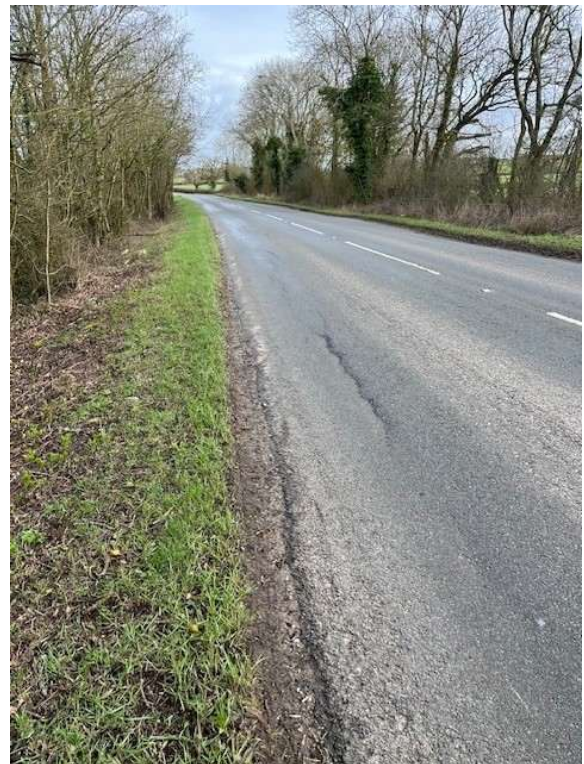
**Photograph 24**

| Photograph | Chainage (m) | Description of Defect |
|---|---|---|
| 24 | 290 | Longitudinal cracking along wheel line of eastbound traffic lane. |

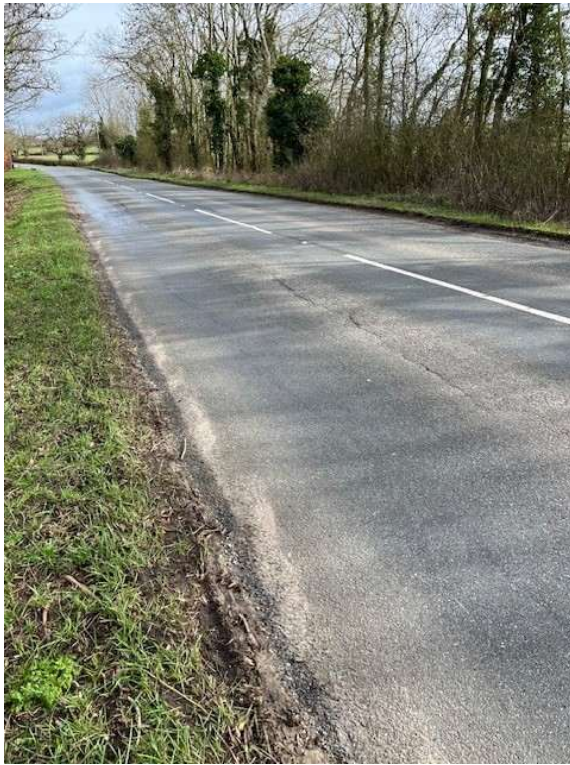
**Photograph 25**

| Photograph | Chainage (m) | Description of Defect |
|---|---|---|
| 25 | 340 | Longitudinal crack along centre of eastbound traffic lane. |

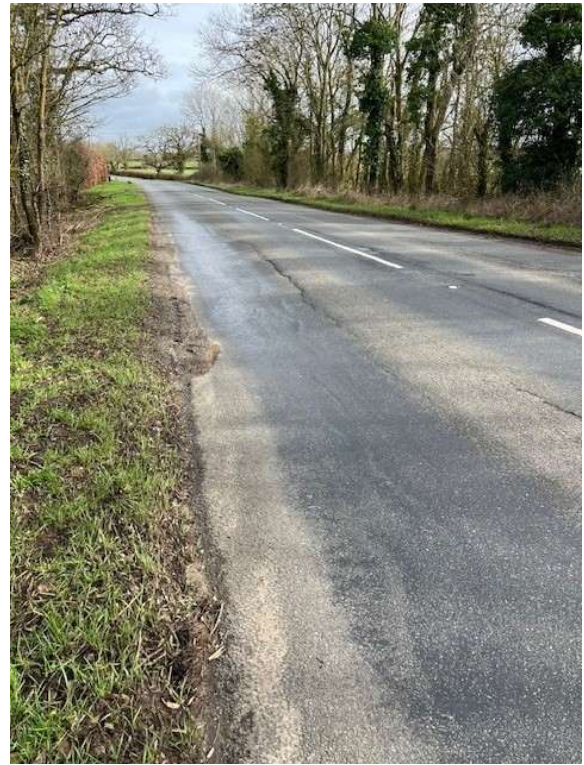
**Photograph 26**

| Photograph | Chainage (m) | Description of Defect |
|---|---|---|
| 26 | 380 | Continuation of the above with level difference more marked at approximately 25mm. |

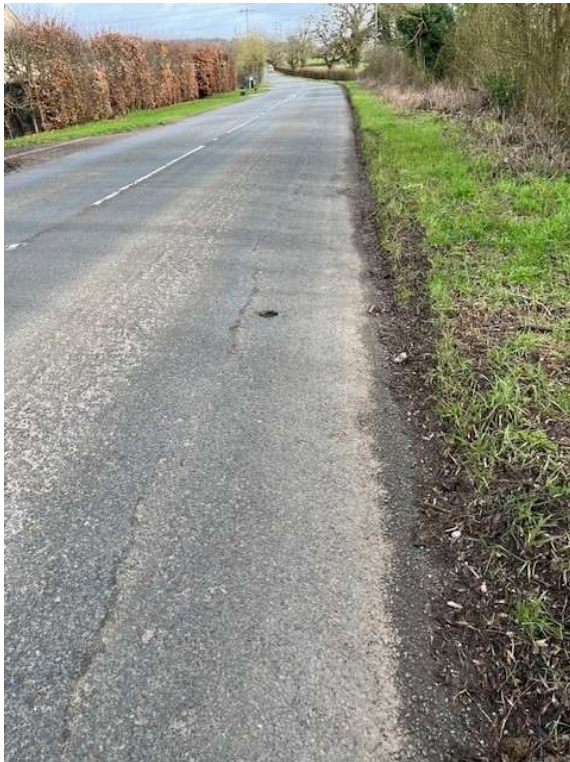
**Photograph 27**

| Photograph | Chainage (m) | Description of Defect |
|---|---|---|
| 27 | 432 | Longitudinal crack along wheel line of westbound traffic lane and small pothole. |

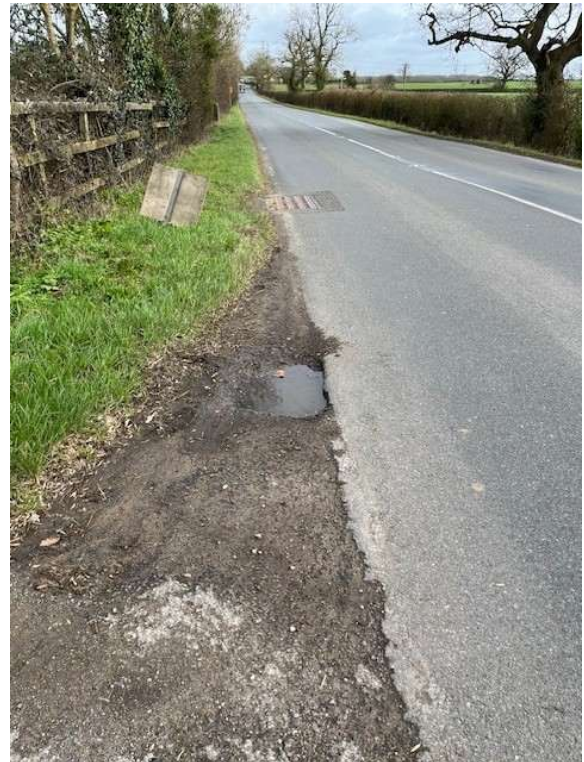
**Photograph 28**

| Photograph | Chainage (m) | Description of Defect |
|---|---|---|
| 28 | 510 | Overrun of verge on left turn out of private access. |

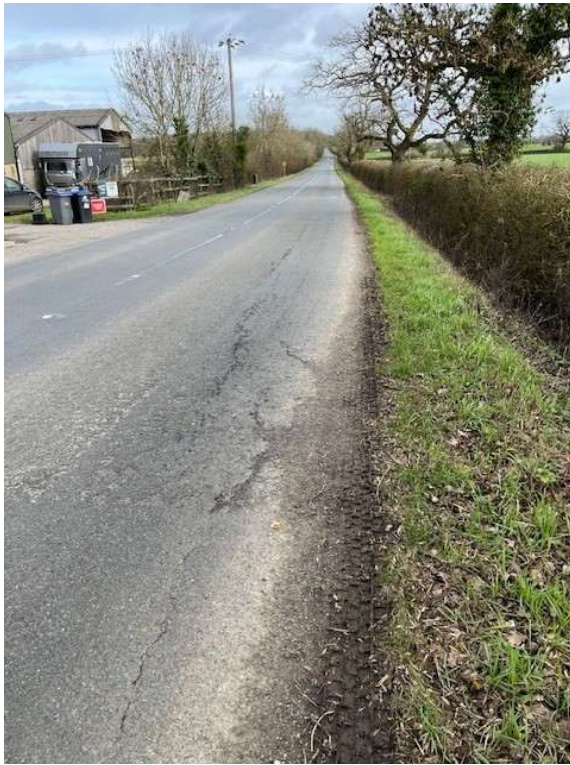
**Photograph 29**

| Photograph | Chainage (m) | Description of Defect |
|---|---|---|
| 29 | 493 | Longitudinal cracks along wheel line of westbound traffic lane, slightly sunken carriageway with stone loss from surfacing. |

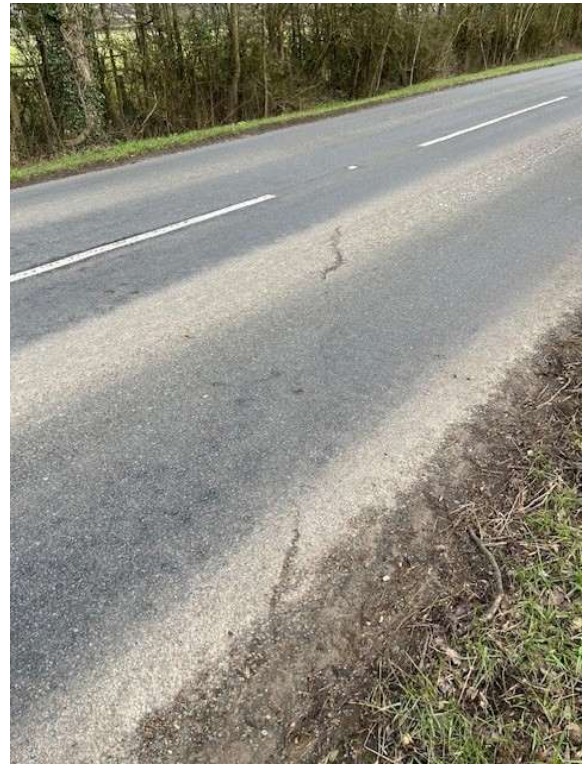
**Photograph 30**

| Photograph | Chainage (m) | Description of Defect |
|---|---|---|
| 30 | 304 | Diagonal cracking across westbound traffic lane. |

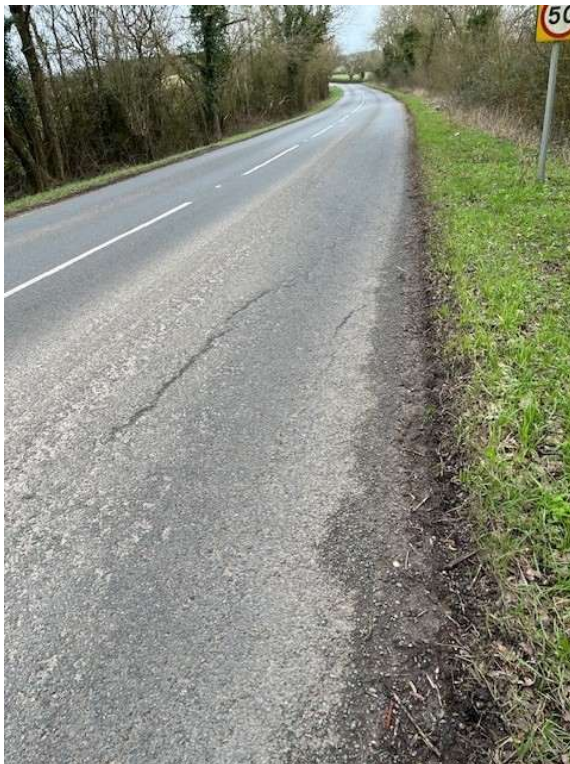
**Photograph 31**

| Photograph | Chainage (m) | Description of Defect |
|---|---|---|
| 31 | 261 | Longitudinal cracking along westbound traffic lane with larger area of stone loss from surfacing. |
