Detail Specifications for repair works to:  
Window W.02/G.02

1306.D.34

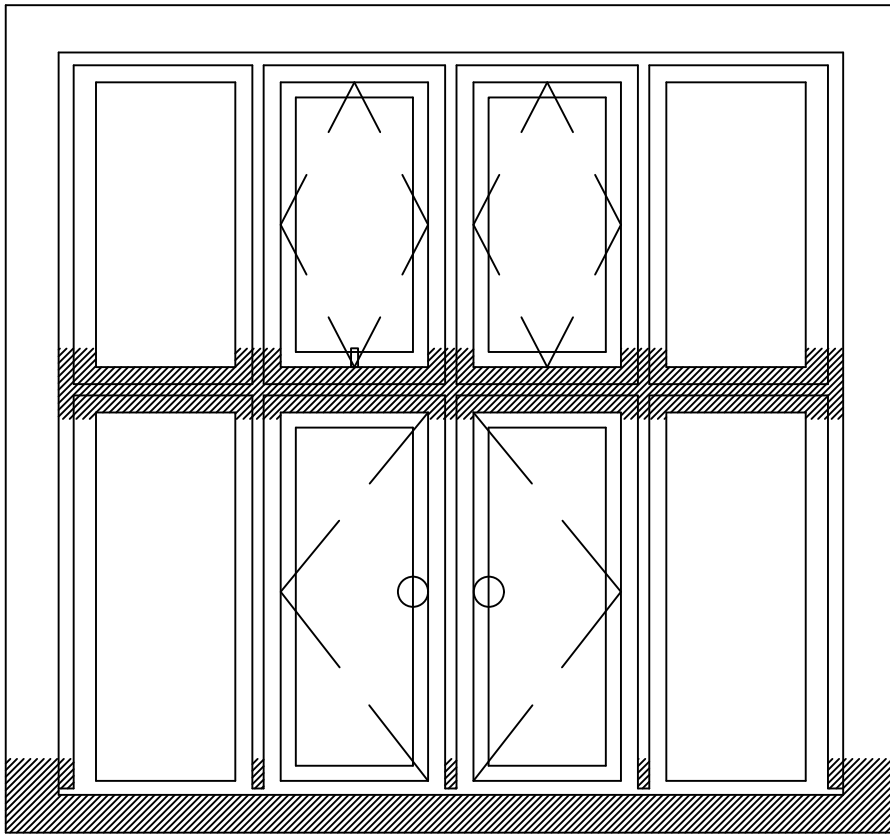
Chilmark stone mullioned window with matching, moulded transom.

Moulding is ovolo with fillets. There are some open joints between components. External sills and transome have weathered resulting in a loss of profiles. The internal sill is covered with hard cement fillets. The internal transome has some soft patches.

Glazing is hand-blown cylinder glass. Glass quarries are fixed using a mixture of linseed oil putty and/or a soft lime mortar.

There are 4 metal, side-hung casements with wrought iron, spring casement stays and 2 upper metal, centre-pivot casements. Their catches and stays are missing.

At each side plain, flat lining boards are slightly splayed.

Rake out the open joints and fill with a mixture of lime putty and stone dust. Brush the surface to expose the aggregate.

Soft and waste areas to be either cut out and matching pieces let in using the mortar, above. Alternatively, the wasted areas to be cut back to solid stone and a plastic repair undertaken using s/steel wire drilled and epoxy glued-in and a mix of slaked lime and stone dust tooled on and tooled to match existing profiles.

Remove hard cement patches and repair with lim-based plastic repairs.

Remove the casements, sprung stays and frames. De-rust the metal components. Paint with an epoxy-based primer and give 2 coats of Zinser oil-based paint in off-white. Replace the casements set in a soft lime mortar. Add new, matching metal casement fasteners and stays.

Fixing putty and mortar pointing to be replaced where cracked or loose, to match existing.
