Detail Specifications for repair works to:

Window W 2/F-02

1306-D-45

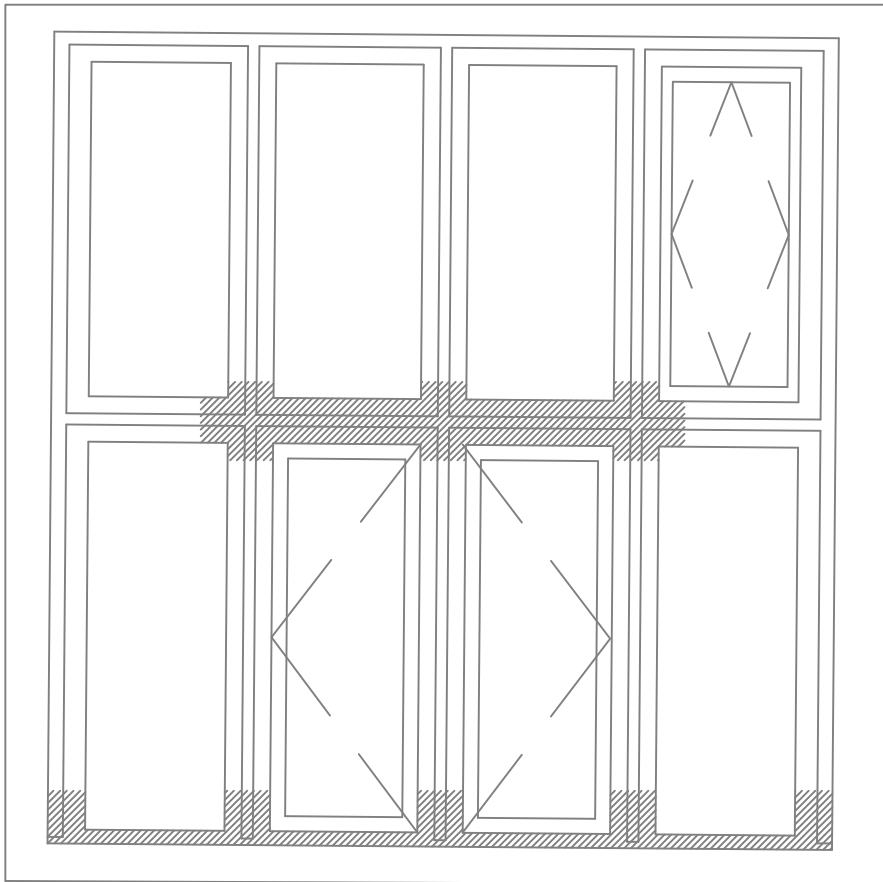
Chilmark stone mullioned window with matching, moulded transom.

Mouldings are ovolo with fillets. There are some open joints between components. The sills and transoms have weathered resulting in a loss of profiles.

Glazing is hand-blown cylinder glass. Some panes are cracked and they are marked with the letter 'C'. Glass quarries are fixed using a mixture of linseed oil putty and/or a soft lime mortar.

There are 2 metal, side-hung casements with wrought iron, spring casement stays and, above the transome, a center pivot metal casement..

A casement has a missing stay. The sprung stays are all rusted

Shutters are to be eased, including some paint removal. They are to be made to open and close, as intended.

Fixing putty and mortar pointing to be replaced where cracked or loose, to match existing.

Remove the pane with the hole. Clean out the rebates. Replace using matching cylinder glass set in soft lime mortar.

Remove the casements, sprung stays and frames. Replace missing catches and stays, to match existing.

De-rust the metal components. Paint with an epoxy-based primer and give 2 coats of Zinser oil-based paint in off-white. Replace the casements in a soft lime mortar.

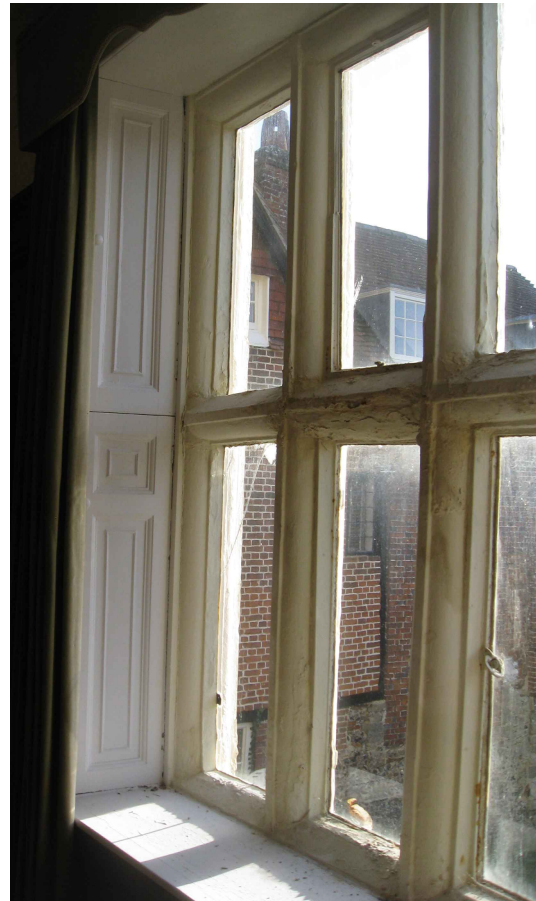
Image showing typical degradation of stone.

Rake out the open joints and fill with a mixture of lime putty and stone dust. Brush the surface to expose the aggregate. Soft and waste areas to be either cut out and matching pieces let in using the mortar, above. Alternatively, the wasted areas to be cut back to solid stone and a plastic repair undertaken using s/steel wire drilled and epoxy glued-in and a mix of slaked lime and stone dust tooled on and tooled to match existing profiles.
