Detail Specifications for repair works to:  
Window W.12/F.02

1306.D.44

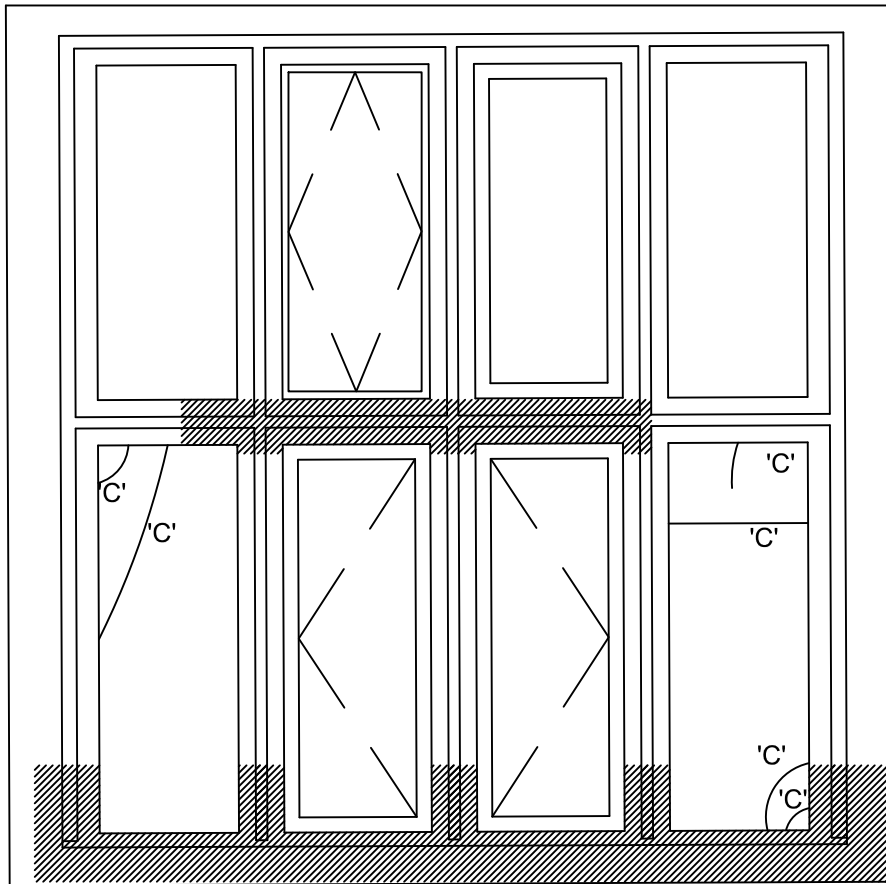
Chilmark stone mullioned window with matching, moulded transom.

Mouldings are ovolo with fillets. There are some open joints between components. The sills and transome have weathered resulting in a loss of profiles.

Glazing is hand-blown cylinder glass. Some panes are cracked and they are marked with the letter 'C'. Glass quarries are fixed using a mixture of linseed oil putty and/or a soft lime mortar.

There are 2 metal, side-hung casements with wrought iron, spring casement stays and, above the transome, a center pivot metal casement..

A casement has a missing stay. The sprung stays are all rusted

Remove the pane with the hole. Clean out the rebates. Replace using matching cylinder glass set in soft lime mortar.

Remove the casements, sprung stays and frames. Replace missing catches and stays, to match existing.

De-rust the metal components. Paint with an epoxy-based primer and give 2 coats of Zinser oil-based paint in off-white. Replace the casements in a soft lime mortar.

Fixing putty and mortar pointing to be replaced where cracked or loose, to match existing.

Rake out the open joints and fill with a mixture of lime putty and stone dust. Brush the surface to expose the aggregate. Soft and waste areas to be either cut out and matching pieces let in using the mortar, above. Alternatively, the wasted areas to be cut back to solid stone and a plastic repair undertaken using s/steel wire drilled and epoxy glued-in and a mix of slaked lime and stone dust tooled on and tooled to match existing profiles.
