Detail Specifications for repair works to:  
Window W.21/S.07

1306.D.54

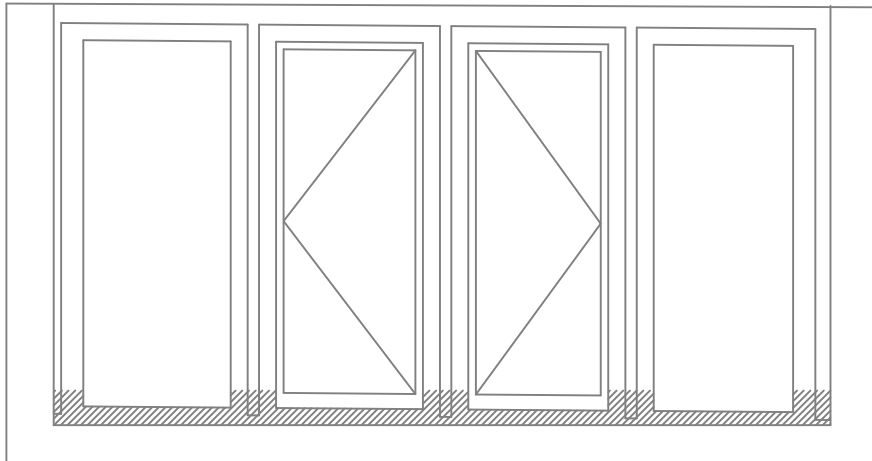
Drawing from exterior

Chilmark stone mullioned window with matching, moulded transom.

Mouldings are ovolo with fillets. The sills and transoms have weathered resulting in a loss of profiles.

Remove the casements, sprung stays and frames. Replace missing catches and stays, to match existing.

De-rust the metal components. Paint with an epoxy-based primer and give 2 coats of Zinser oil-based paint in off-white. Replace the casements in a soft lime mortar.

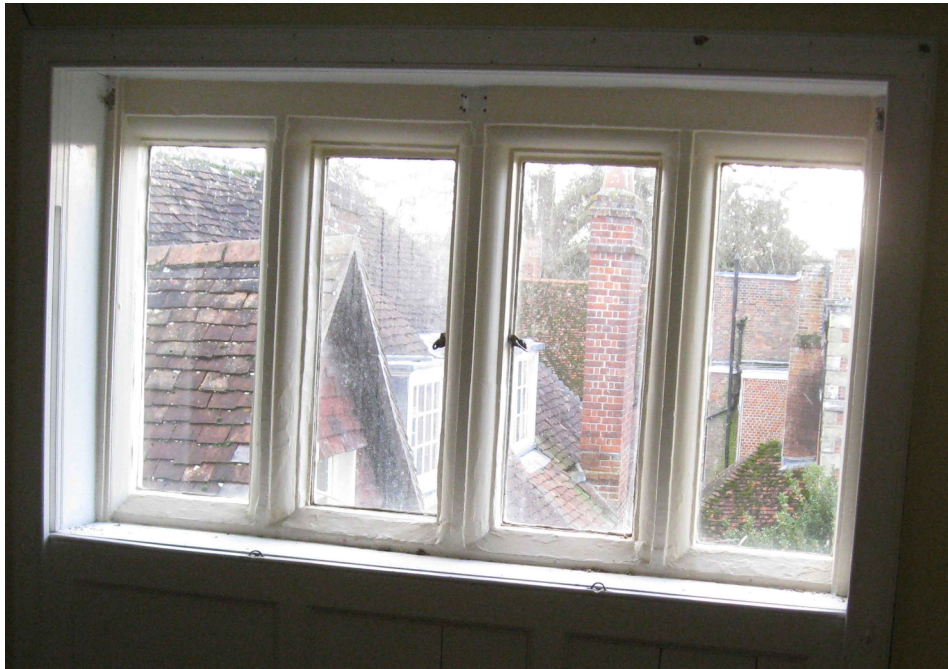
Photo from interior

Glazing is hand-blown cylinder glass. Glass quarries are fixed using a mixture of linseed oil putty and/or a soft lime mortar.

There are 2 metal, side-hung casements with wrought iron, spring casement stays.

There is a panelled shutter below the sill, hidden in the panelling, which could be drawn up to cover the inside of the window.
