Detail Specifications for repair works to:  
Window W.01/G.01

1306.D.33

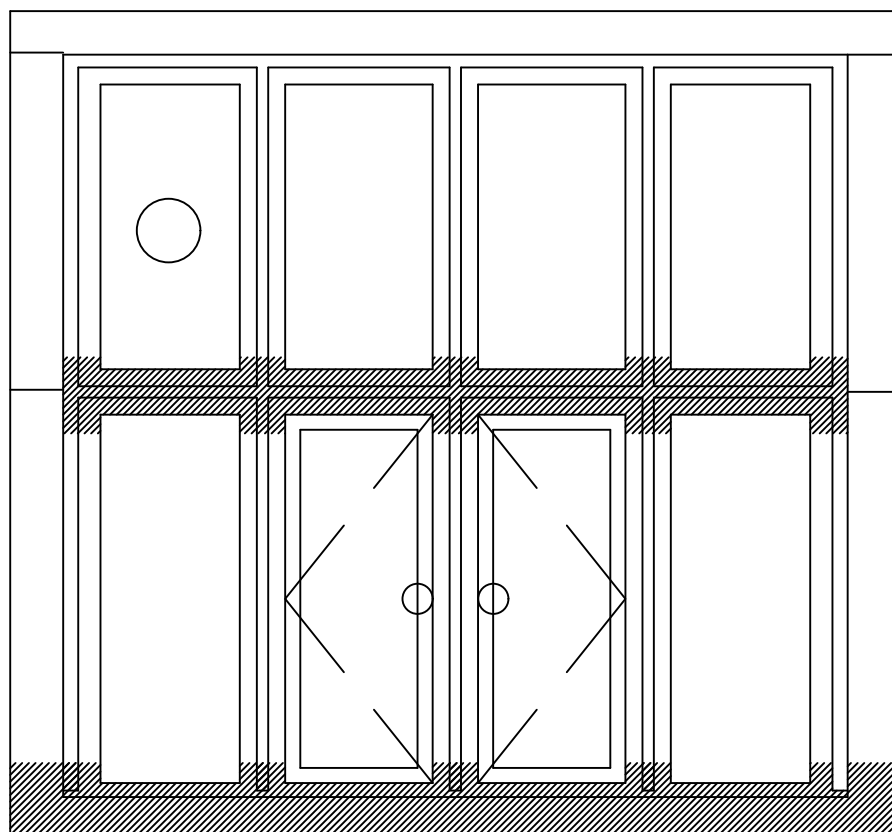
Chilmark stone mullioned window with matching, moulded transom.

Moulding is ovolo with fillets. There are some open joints between components. The sills and transome have weathered resulting in a loss of profiles.

Glazing is hand-blown cylinder glass. There is one, upper pane cut with a circular vent. Glass quarries are fixed using a mixture of linseed oil putty and/or a soft lime mortar.

There are 2 metal, side-hung casements with wrought iron, spring casement stays.

Joinery: There are upper and lower sets of paneled and plain board shutters in shutter boxes.

Rake out the open joints and fill with a mixture of lime putty and stone dust. Brush the surface to expose the aggregate. Soft and waste areas to be either cut out and matching pieces let in using the mortar, above. Alternatively, the wasted areas to be cut back to solid stone and a plastic repair undertaken using s/steel wire drilled and epoxy glued-in and a mix of slaked lime and stone dust tooled on and tooled to match existing profiles.

Remove the pane with the hole. Clean out the rebates. Replace using matching cylinder glass set in soft lime mortar.

Remove the casements, sprung stays and frames. De-rust the metal components. Paint with an epoxy-based primer and give 2 coats of Zinser oil-based paint in off-white. Replace the casements in a soft lime mortar.

Shutters are to be eased, including some paint removal. They are to be made to open and close, as intended.

Fixing putty and mortar pointing to be replaced where cracked or loose, to match existing.
