Detail Specifications for repair works to:  
Window W.11/G.05

1306.D.43

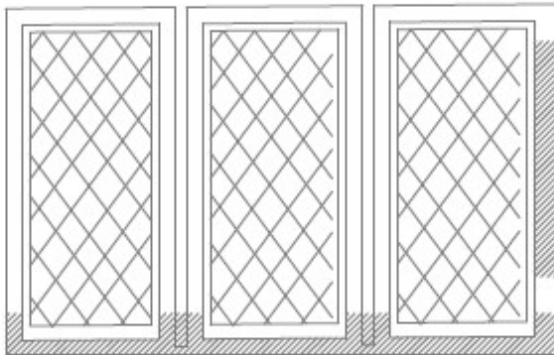
Drawing from outside

Stone mullioned window with hollow moulded chamfers.

Casements are fixed lights with lattice leaded glazing.

There is a steel security bar let in to the head and sill.

The sill on the outside is soft.

The side of the wall abutment is also soft with some wastage.

Remove the cement-based render to the sills.

Replace with sections of matching stone for areas where there is a large amount of wastage.

Use a lime-based plastic repair for smaller areas of soft stone.

On completion add 3 coats of lime shelter coat.

Fixed casements to have the putty and pointing checked and repaired or replaced where leakage occurring.

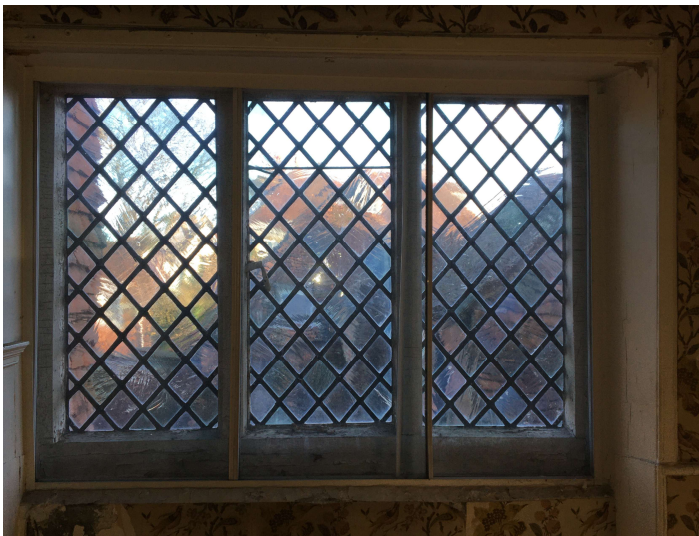
Photo of interior

Plain wood, splayed lining boards.
