# **Stage 2 Road Safety Audit Report (Detailed Design)**

**West Ashton,  
Leap Gate – West Ashton Road  
New Residential Development  
S278 Highway Access Works**

**Produced for:  
Persimmon Wessex**

**Date: 30<sup>th</sup> May 2024**

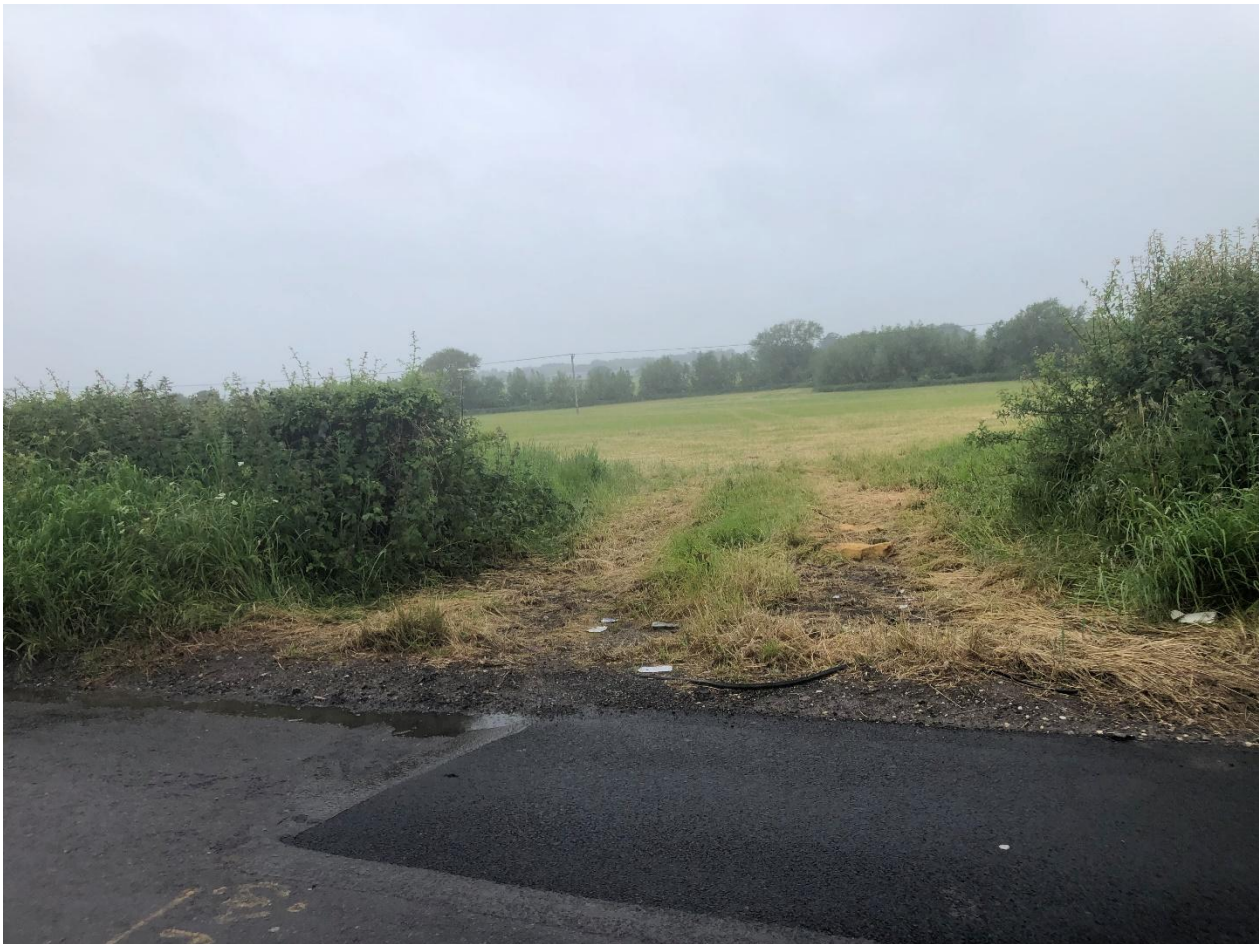
| 8.2 *Problem* (Item B1.13) | |
|---|---|
| <b>Location:</b> | West Ashton Road /Junction 3 |

| 8.2 *Problem* (Item B1.13) | |
|---|---|
| <b>Summary:</b> | Existing field access not being retained opposite junction 3 |
| <p>There is an existing field access that is opposite the new junction that is not being retained. Check if the field access is still required and amend the design accordingly if required.</p> | |
| Risk of vehicles being unable to access existing field access | |

| 8.2 *Problem* (Item B1.13) | |
|---|---|
| Check if the field access is still required and amend the design accordingly | |

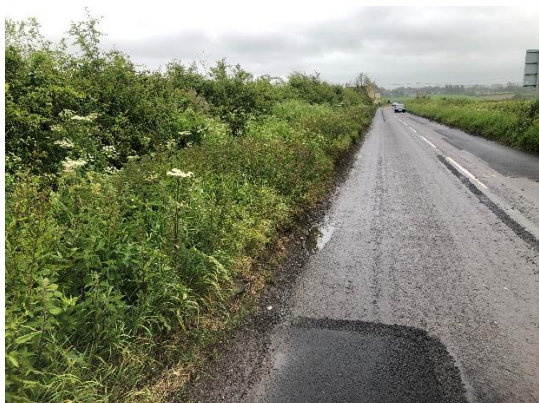
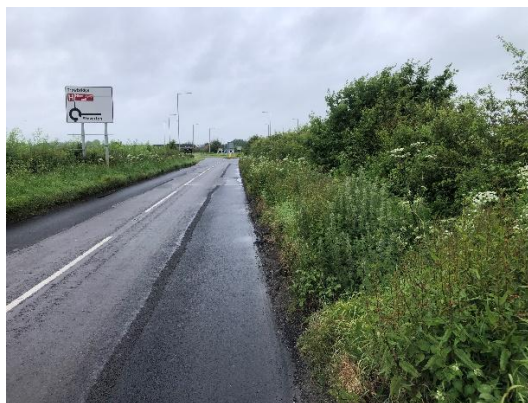
| <b>Summary:</b> | Verge hedge obstructs visibility for vehicles exiting junction 3 |
| <p>A new side road junction is detailed. There is verge vegetation that obstructs the visibility of oncoming vehicles for vehicles exiting the side road. Remove vegetation where it is within the required visibility splay for vehicles exiting the side road</p> | |
| Risk of vehicle collisions due to obstructed visibility when exiting side road | |

| Remove vegetation where it is within the required visibility splay for vehicles exiting the side road | |

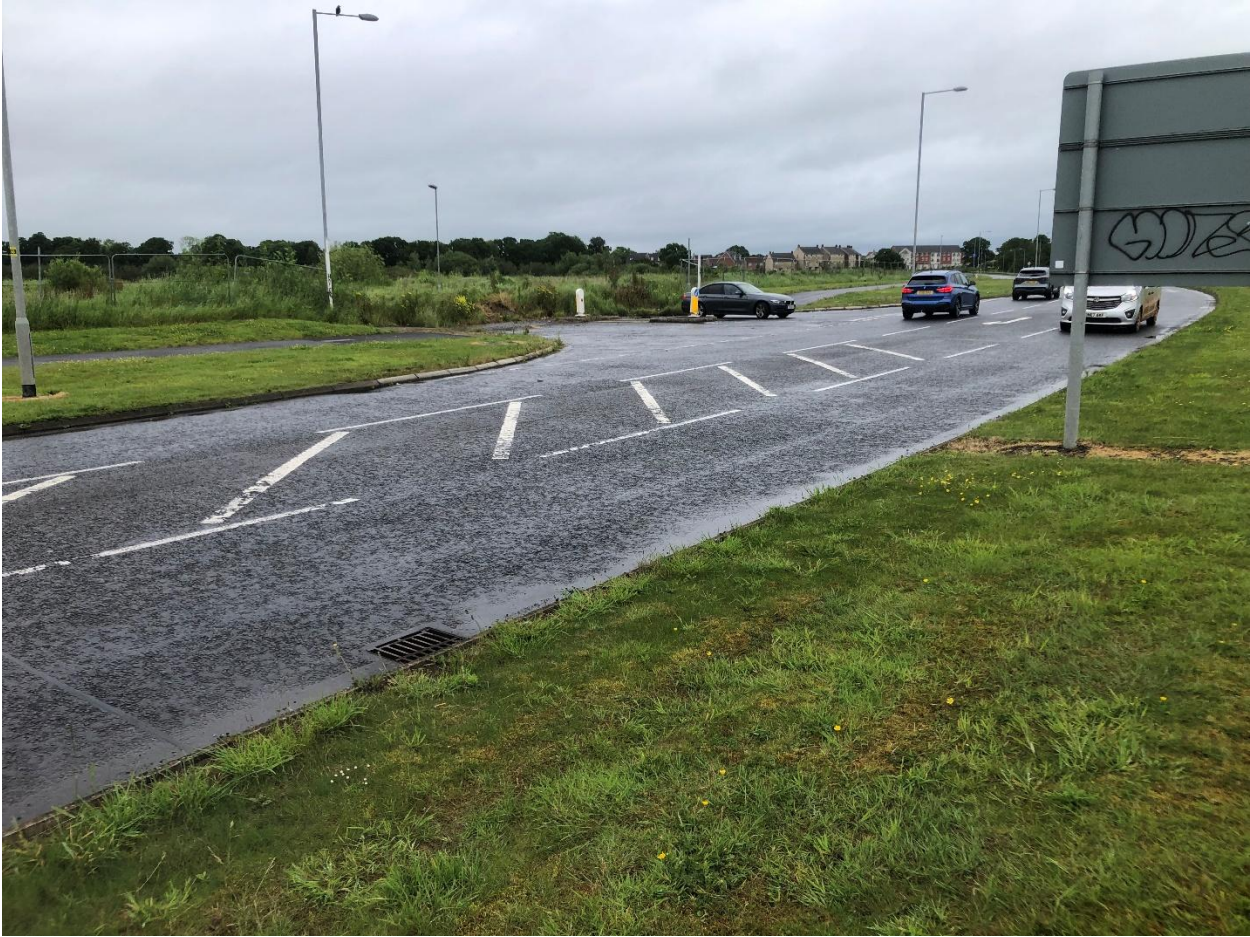
| 8.5 *Problem* (Item B3.2) | |
|---|---|
| <b>Summary:</b> | ADS sign obstructs visibility for vehicles exiting side road at junction 2 |
| <p>There is an existing ADS sign that is being relocated to the eastern side of junction 2 that obstructs the visibility of oncoming vehicles for vehicles exiting side road. This sign needs to be relocated away from the required visibility splay where it will not cause an obstruction</p> | |
| Risk of collisions at junction due to obstructed visibility | |

| 8.5 *Problem* (Item B3.2) | |
|---|---|
| <p>This sign needs to be relocated away from the required visibility splay where it will not cause an obstruction</p> | |

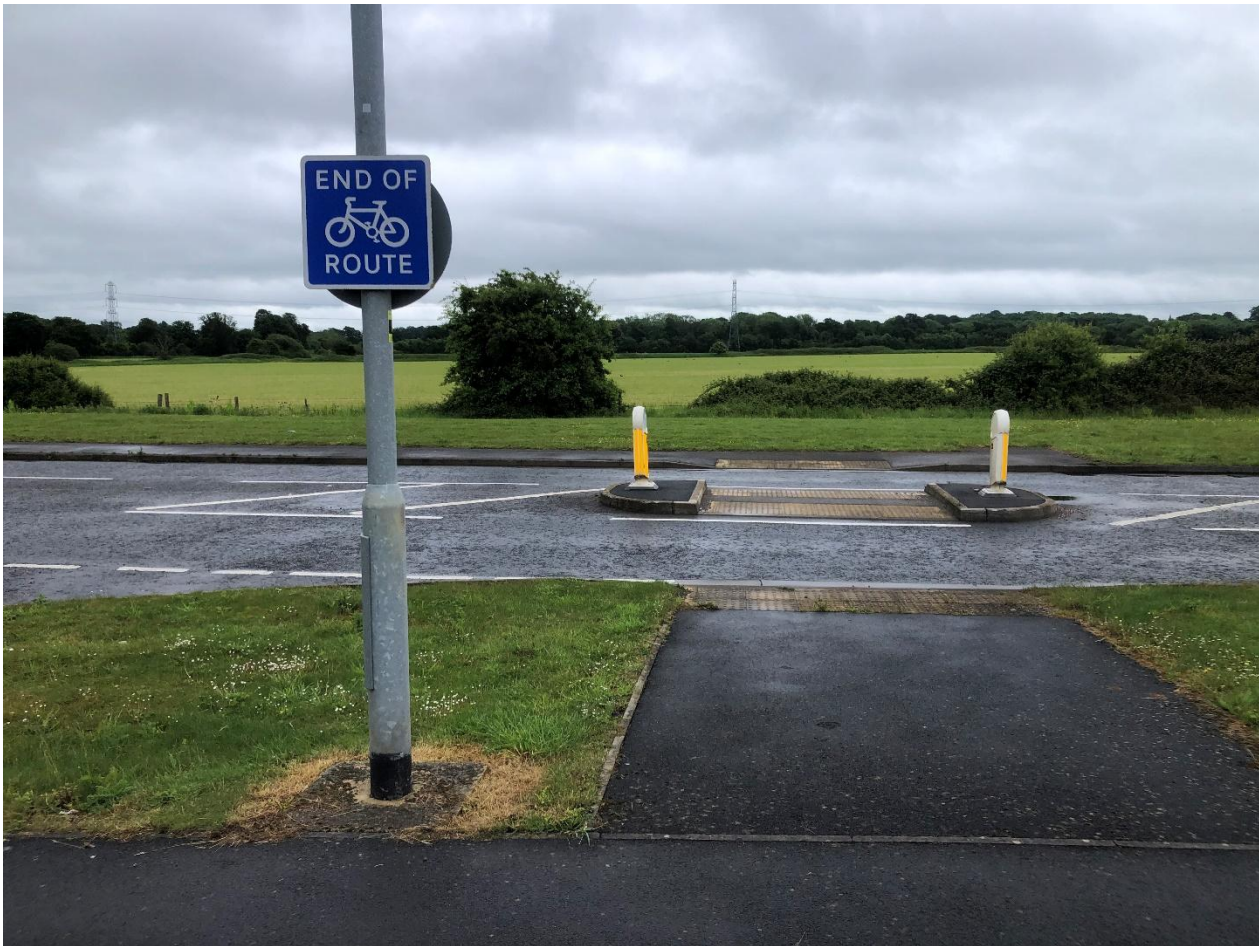
| 8.15 *Problem* (Item B4.2) | |
|---|---|
| <b>Location:</b> | Leap Gate / Pedestrian /cycle crossing point |

| 8.15 *Problem* (Item B4.2) | |
|---|---|
| <b>Summary:</b> | Existing End of Cycle Route sign needs to be removed as cycle path extended across road |
| <p>The shared use pedestrian/cycle path is now being extended across Leap Gate. The existing end of cycle route sign needs to be removed as this is no longer required. Remove existing sign.</p> | |
| Risk of incorrect information causing confusion for cyclists. | |

| 8.15 *Problem* (Item B4.2) | |
|---|---|
| Remove existing sign. | |
