PRELIMINARY ROOST APPRAISAL REPORT

FONT HOUSE, TEFFONT MAGNA, WILTSHIRE

MARCH 2026

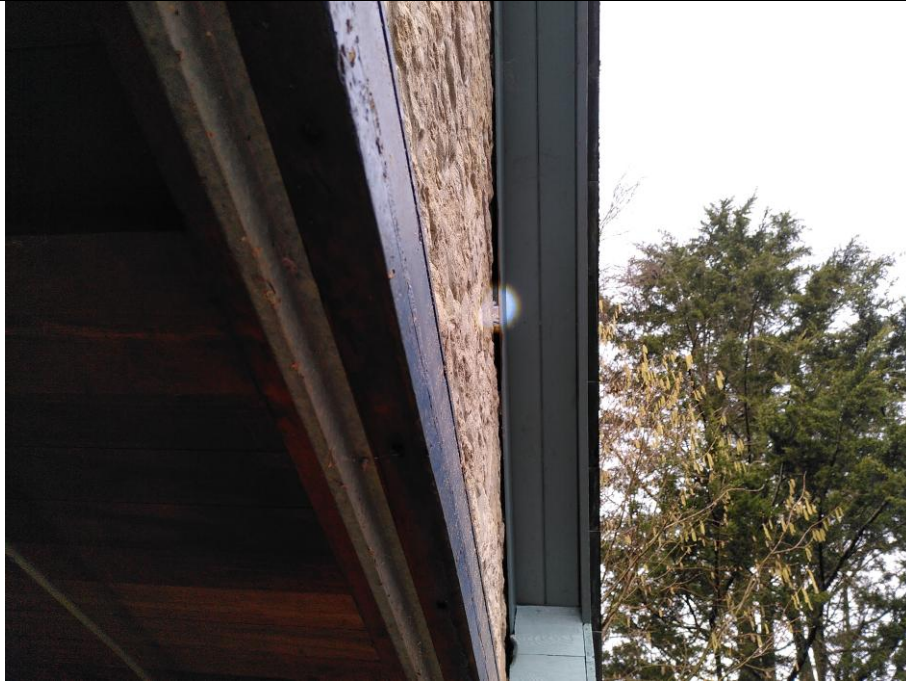
The link and garage were faced in stone with wooden soffit boxes and slate tiles on the roof. The stonework was all in good condition with no features suitable for bats to roost within. Where the soffit met the stonework on each gable end of the garage there were sufficient gaps to allow bats to enter the garage roof void as well as roost behind the boards themselves. One gap between the brickwork and soffit was also present at the centre of the northeastern elevation. In addition, there was a large hole at the base of each of the soffit boxes on the southeast elevation of the garage. The southern corner hole resulted from some missing venting and evidence of a moss bird nest was present. The eastern corner hole appeared to have been gnawed or caused by a knot hole in the board, paint over the edges indicated it was not a recent development. On the northwestern gable end of the garage there had once been a substantial gap between the brickwork and soffit but was filled with strong wire mesh. The soffits of the link were in good condition and there were no gaps where they abutted the stonework.

**Fig 2.** Where the soffit met the stonework on each gable end of the garage there were sufficient gaps to allow bats to enter the garage roof void as well as roost behind the boards themselves.

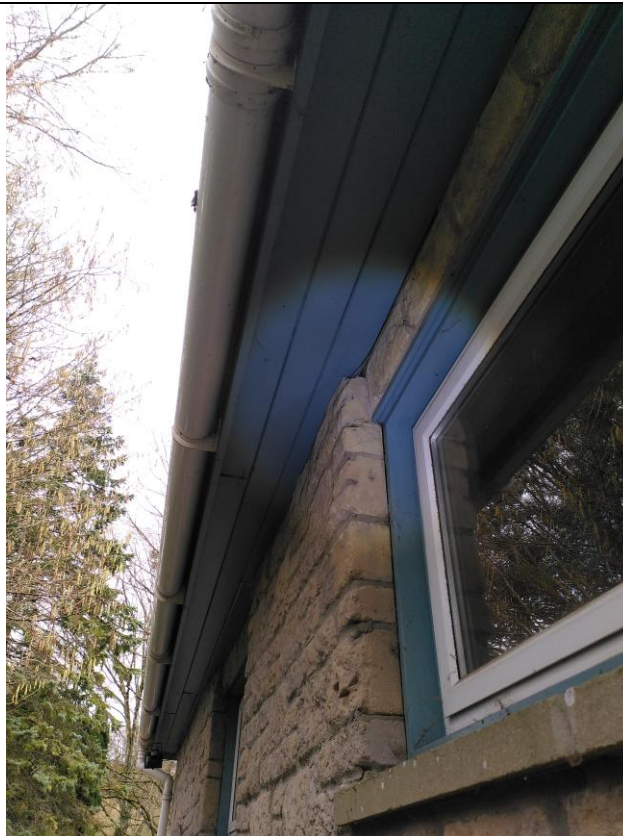
**Fig 3.** One gap between the brickwork and soffit was also present at the centre of the northeastern elevation

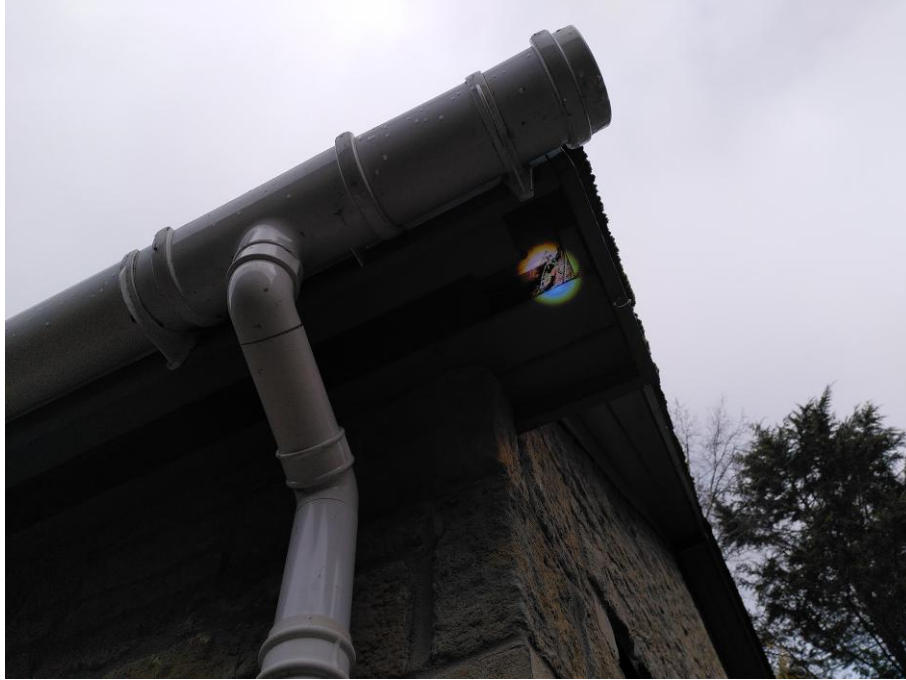
**Fig 4.** The southern corner hole resulted from some missing venting and evidence of a moss bird nest was present.

A moss nest was present within the soffit on the southern corner of the garage gable. No activity was recorded during the survey, and the nest may have been from the previous season.

Nesting birds have used the garage soffit in recent years and it is highly likely that they will use the same site in the coming season if the hole in the soffit is still accessible.

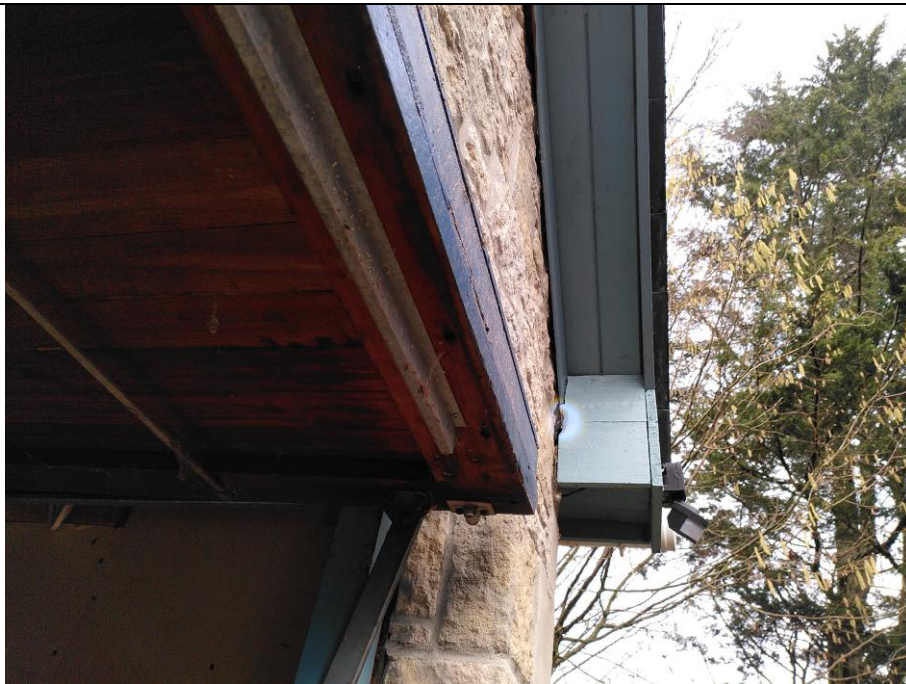
**Fig 5.** The eastern corner hole appeared to have been gnawed or caused by a knot hole in the board.

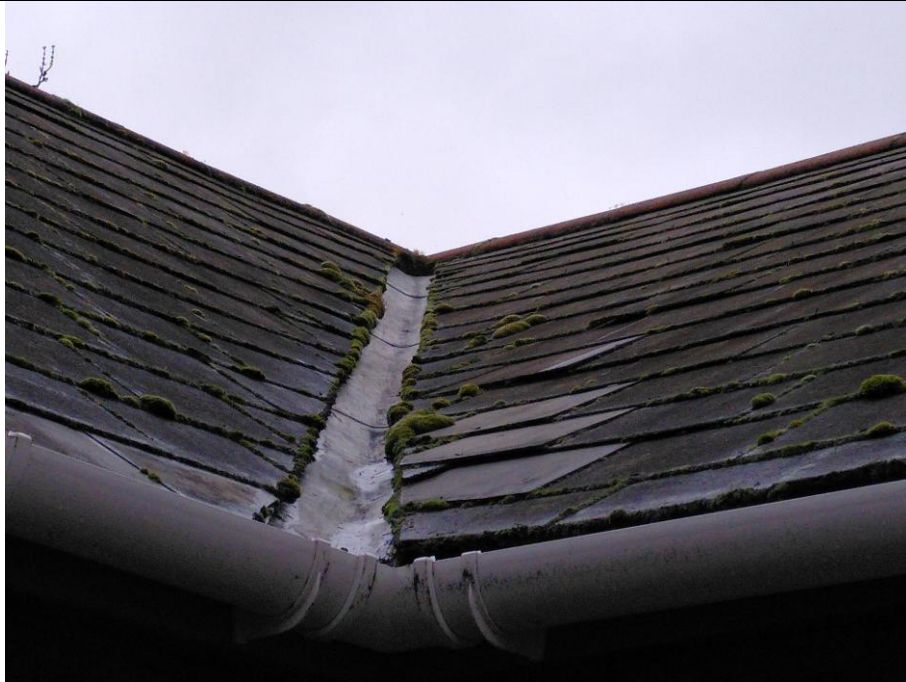
**Fig 6.** Example of lifted slate tiles.

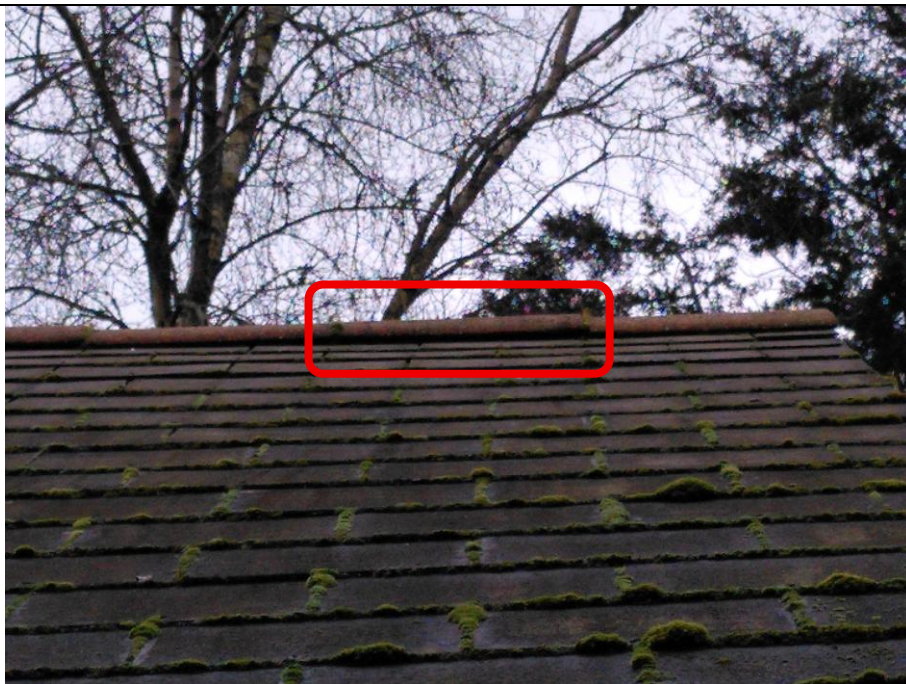
**Fig 7.** Example of raised ridge tile.

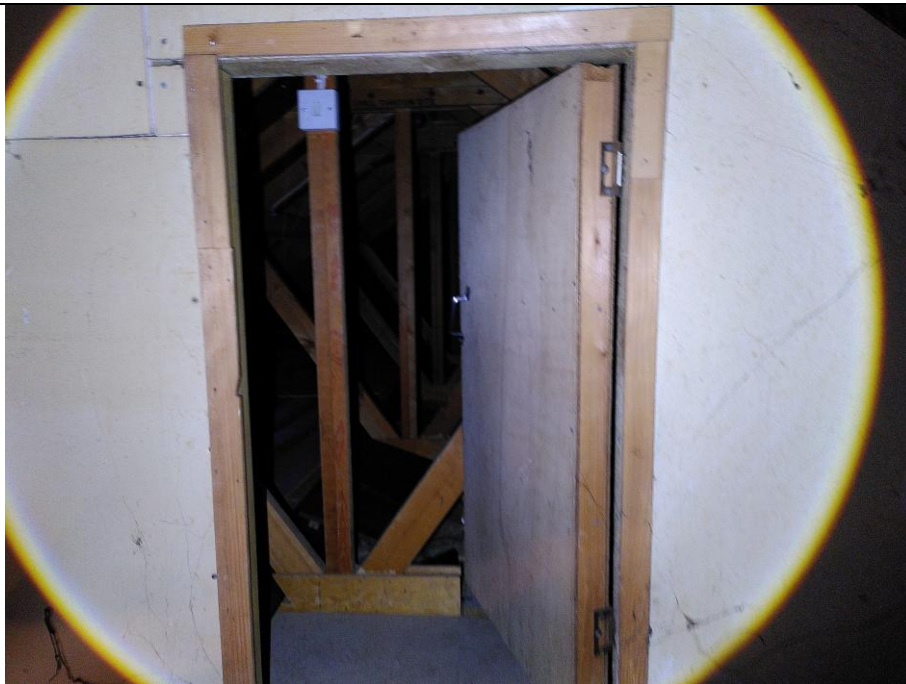
**Fig 8.** Access door between garage and link roof voids.

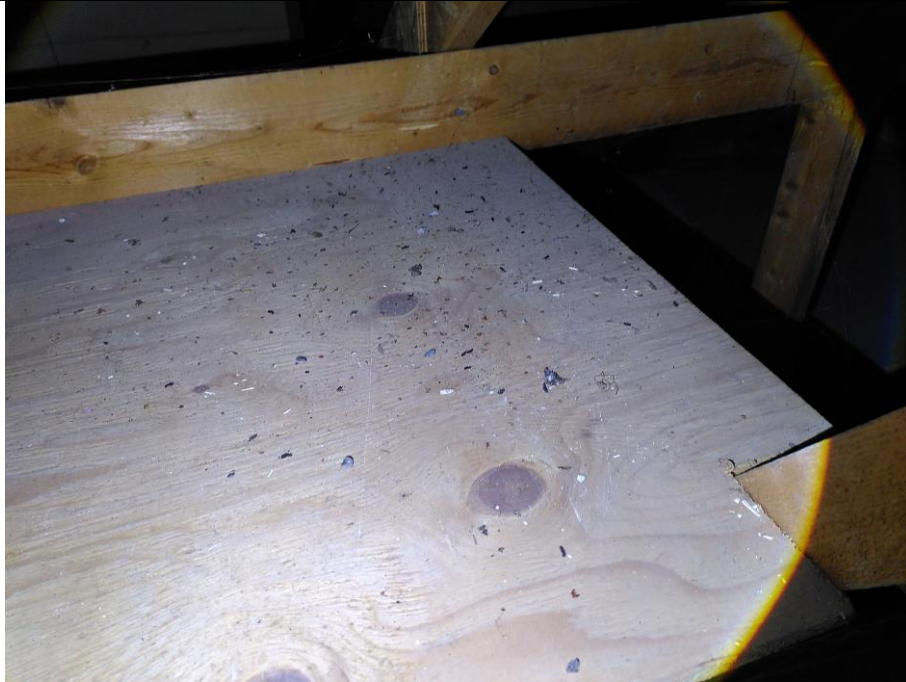
**Fig 9.** Example bat droppings interspersed with rodent droppings.

Internally, evidence of bats was identified by droppings present in numerous locations.

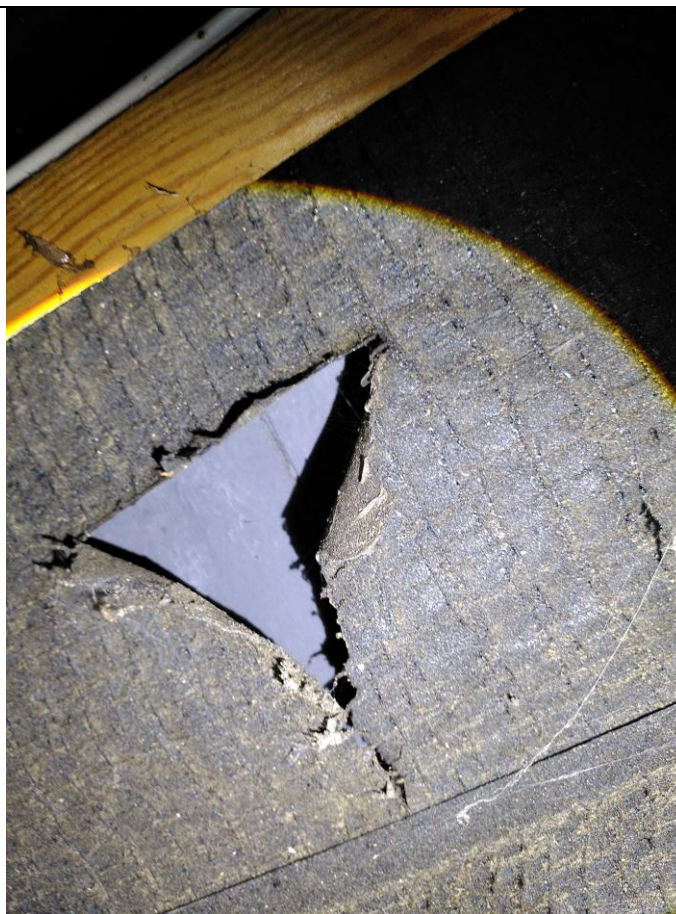
**Fig 10.** Torn bitumen felt in roof void above link.

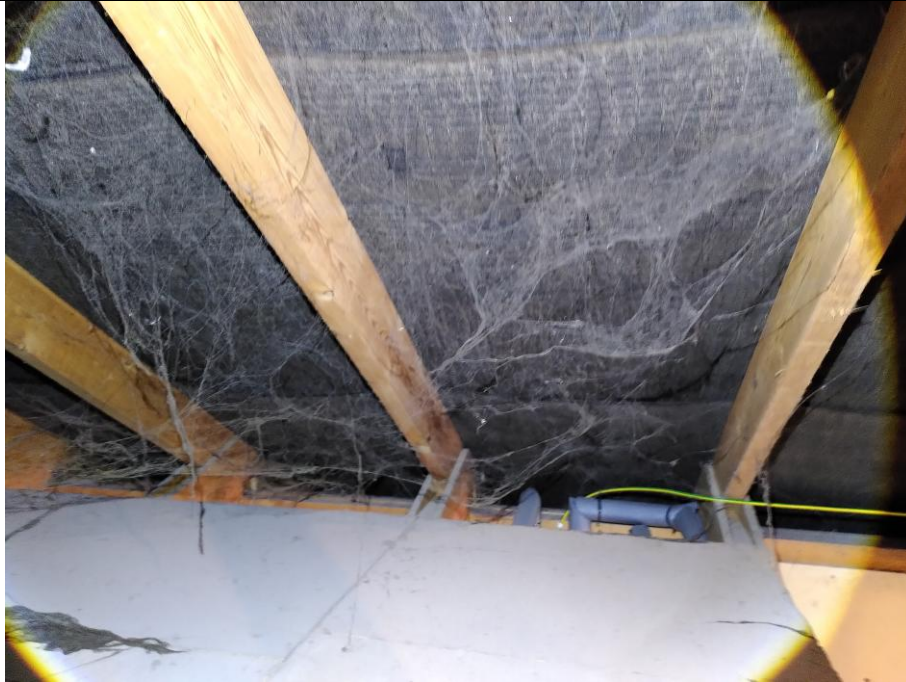
**Fig 11.** Heavy cobwebbing.
