**Off Mains Drainage Survey Report Prepared For:**

Dollys Cottage, 39 Church Lane, Cholderton  
Salisbury  
SP4 0DW

**Date of Survey:** 05/12/2024

## Drainage Survey

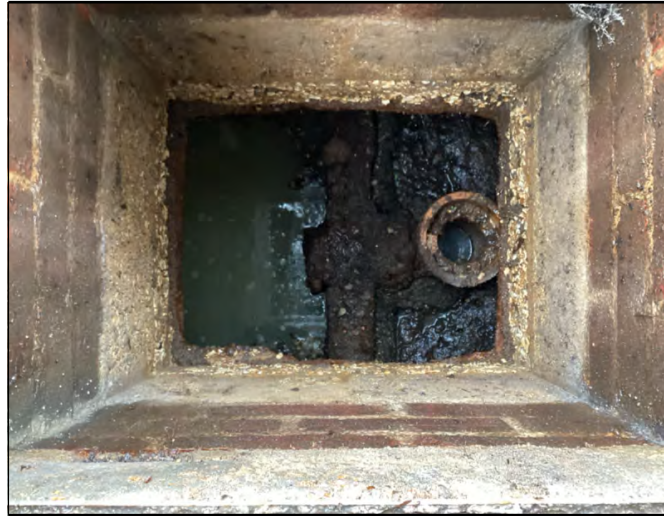
Photograph of the tank before the system was emptied:

| <b>Construction / design of the tank at the property:</b> | A rectangle brick constructed tank with rendered internal surfaces |
| <b>Overall condition of the tank:</b> | Good |

| Was there any damage observed to the tank during the inspection? | No |

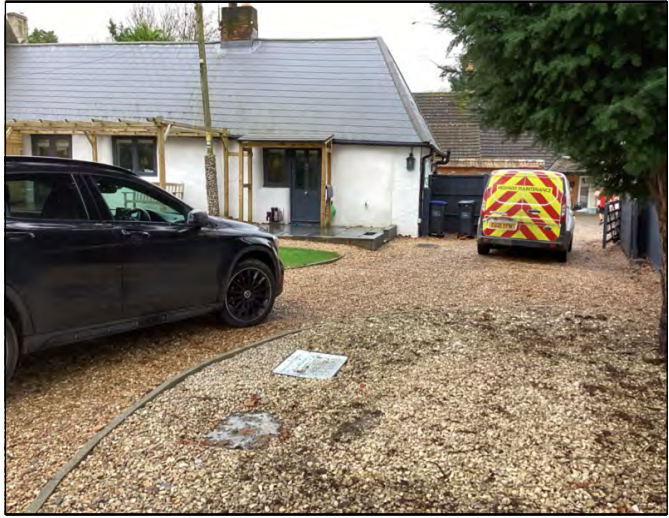
| Is the existing discharge functioning correctly? | Yes |
| Photograph of the general area of the tank: | |

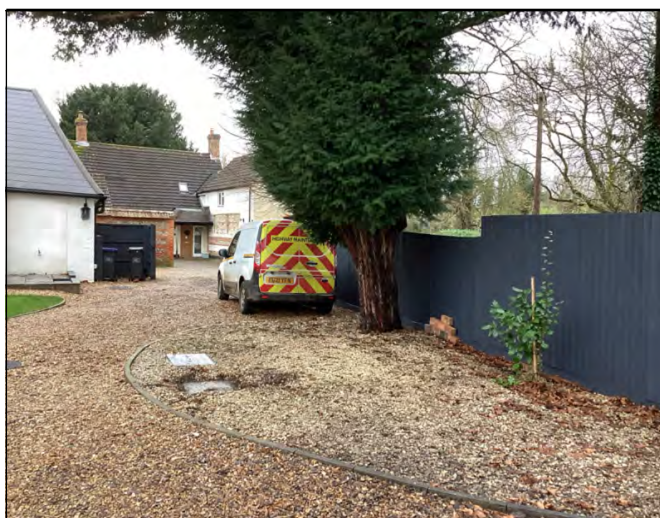
septic tank and the new STP location

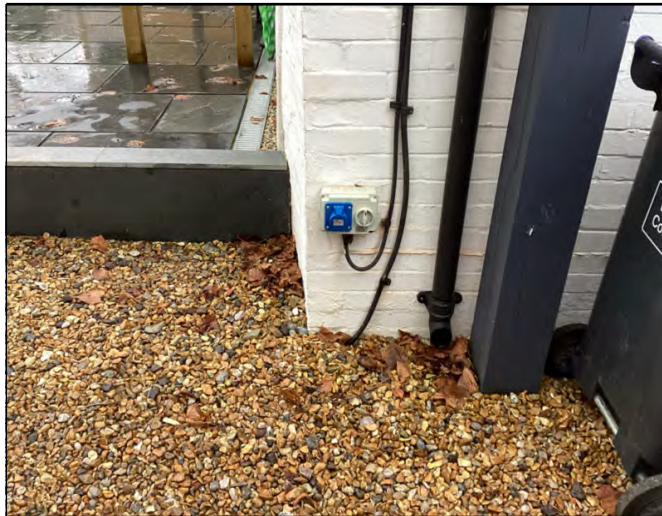
electric point on the rear  
corner of the cottage

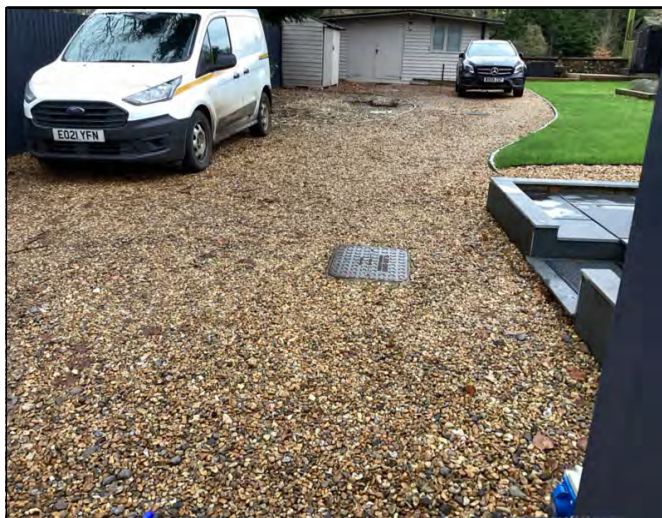
electric cable route

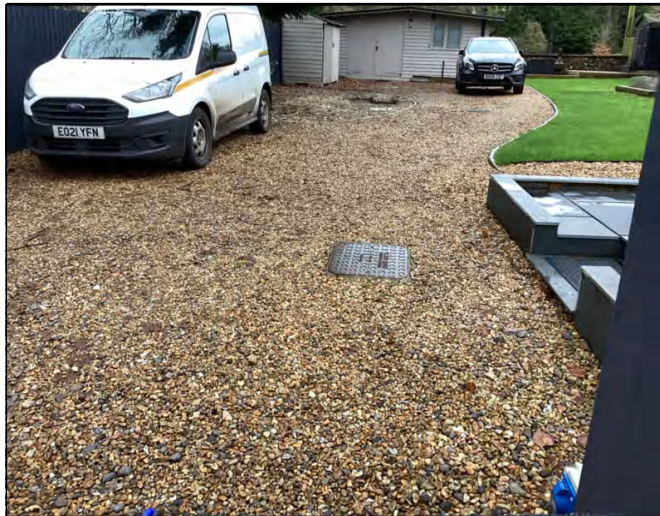
manhole 1 location to  
the septic tank

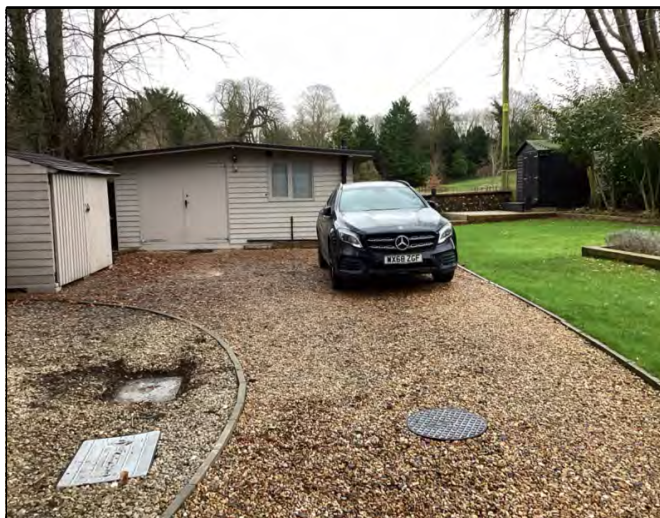
manhole 3 the annex  
and SVP2

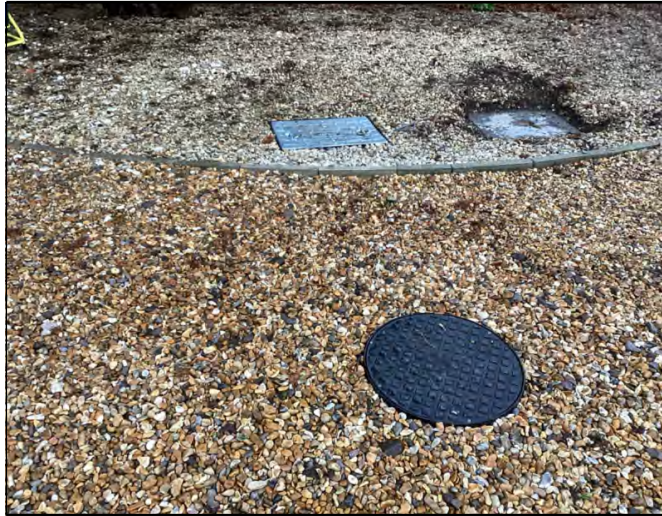
manhole 3 location to  
manhole 2 and the  
septic tank

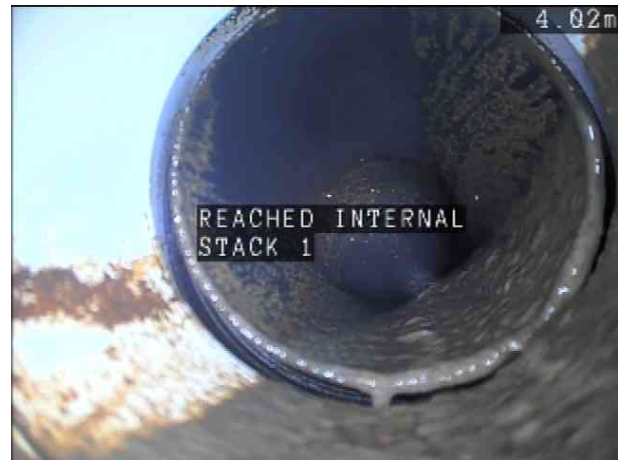
Stack1X\_c9881961-2471-4c57-9dbe-593b78140eae\_20241206\_130344\_605.jpg, 00:01:04, 4.02 m  
Finish survey, Reached base of interna stack1

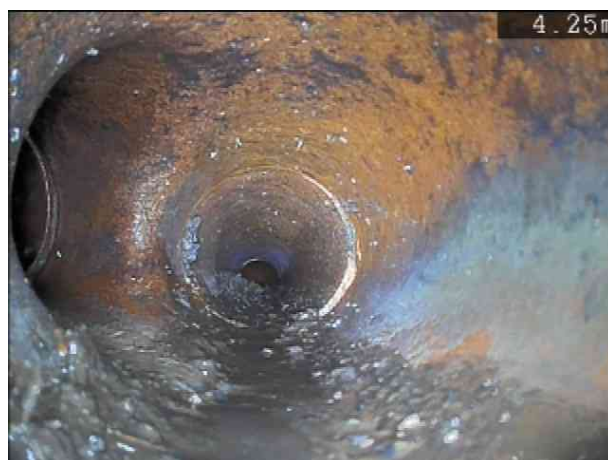
SVP1X\_e54b8949-8de3-4482-b53e-6b3516f22f6f\_20241206\_130454\_055.jpg, 00:00:28, 4.25 m  
Junction at 9 o'clock, 100mm diameter, WG1

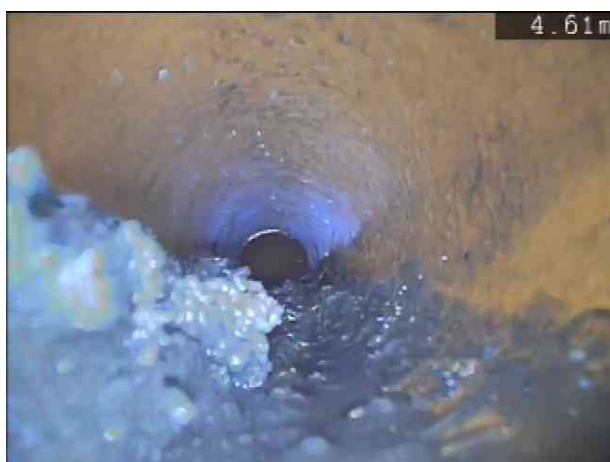
| Scale: | 1:57 | Position [m] | Code | Observation | MPEG | Photo | Grade |
|---|---|---|---|---|---|---|---|
| <div> <div>4.61</div> <div>DE</div> <div>Debris, other, 20% cross-sectional area loss: Loose</div> <div>00:00:34</div> <div>SVP1X_8d<br/>2ec630-e7<br/>87-4dea-bf</div> <div>4</div> </div> | | | | | | | |

| Construction Features | | | | | Miscellaneous Features | | | | |
|---|---|---|---|---|---|---|---|---|---|
| 0 | 0.0 | 0.0 | 0.0 | 1.0 | 1 | 5.0 | 0.8 | 5.0 | 4.0 |

SVP1X\_8d2ec630-e787-4dea-bfcf-d6c0afdf1d77\_20241206\_130526\_393.jpg, 00:00:34, 4.61 m  
Debris, other, 20% cross-sectional area loss, Loose

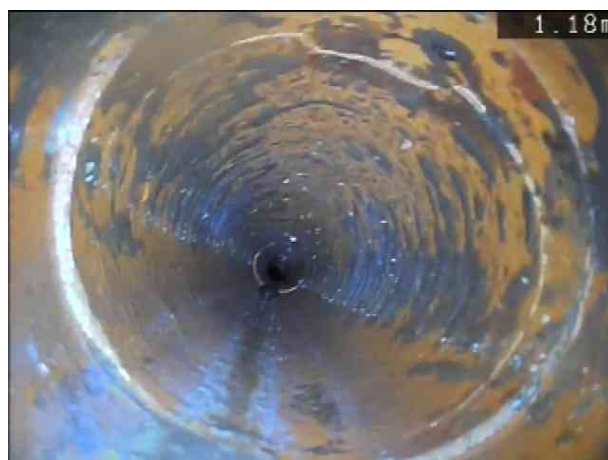
| Scale: | 1:76 | Position [m] | Code | Observation | MPEG | Photo | Grade |
|---|---|---|---|---|---|---|---|
| <div> <div> <div>1.18</div> <div>CCJ</div> <div>Crack, circumferential at joint from 12 o'clock to 12 o'clock</div> <div>00:00:22</div> <div>MH1X_ff2fb486-0bd9-4632-926</div> </div> <div>2</div> </div> | | | | | | | |

MH1X\_ff2fb486-0bd9-4632-926e-02687f8afa35\_20241206\_130813\_761.jpg, 00:00:22, 1.18 m  
Crack, circumferential at joint from 12 o'clock to 12 o'clock

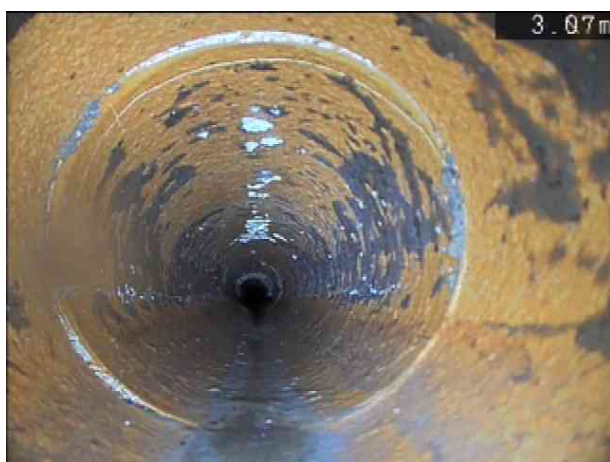
| Scale: | 1:76 | Position [m] | Code | Observation | MPEG | Photo | Grade |
|---|---|---|---|---|---|---|---|
| <div> <div> <div>3.07</div> <div>CCJ</div> <div>Crack, circumferential at joint from 12 o'clock to 12 o'clock</div> <div>00:00:32</div> <div>MH1X_878f84d6-29fa-4e80-b5</div> </div> <div>2</div> </div> | | | | | | | |

| Construction Features | | | | | Miscellaneous Features | | | | |
|---|---|---|---|---|---|---|---|---|---|
| 2 | 10.0 | 2.3 | 20.0 | 2.0 | 0 | 0.0 | 0.0 | 0.0 | 1.0 |

MH1X\_878f84d6-29fa-4e80-b513-5fda8c6601b8\_20241206\_130912\_433.jpg, 00:00:32, 3.07 m  
Crack, circumferential at joint from 12 o'clock to 12 o'clock

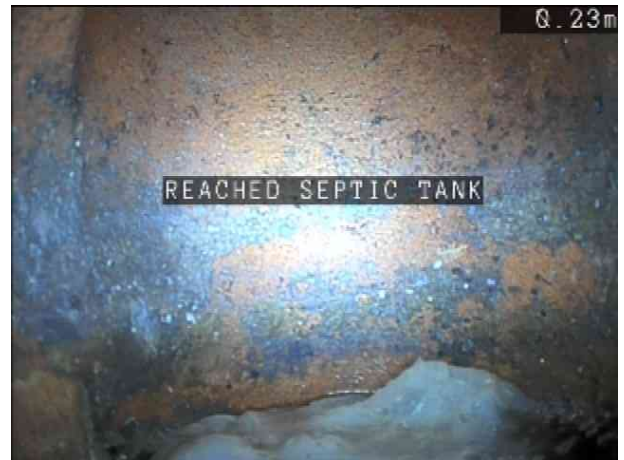
MH2X\_1efb10a0-5498-4782-946a-04e523c5b8a2\_20241206\_131232\_254.jpg, 00:00:18, 0.23 m  
Finish survey, Reached septic tank inlet
