**Date: 5<sup>th</sup> June 2025**

**Beaumont Business Park, Woodlands Road, Mere**

### **Preliminary Findings Of Intrusive Investigation**

#### **Groundwater Monitoring Summary**

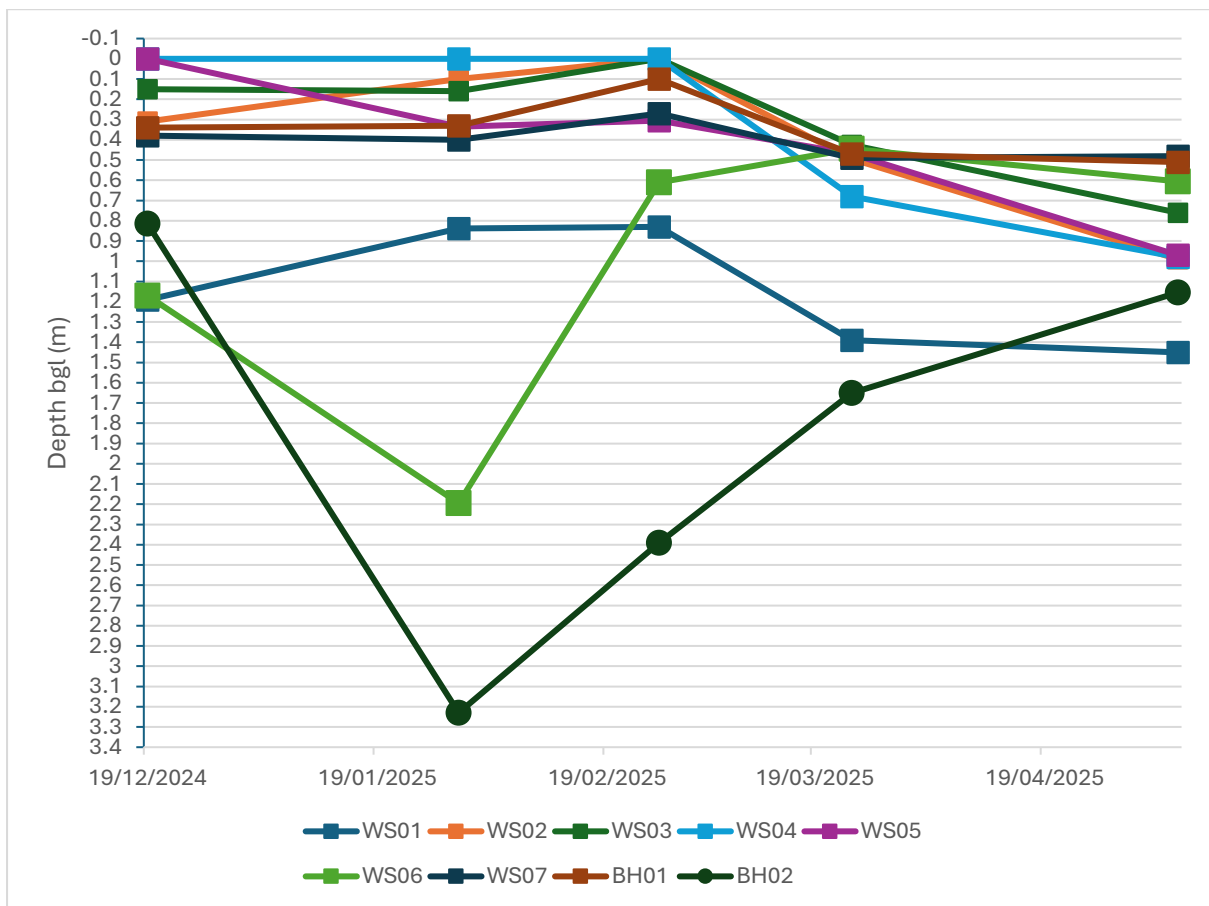
**Chart 1. Groundwater levels.**

This indicates that in the majority of locations that depth to water decreased up to the February monitoring round or represented flood monitoring and then increased. However, In the case of BH01, BH02 and WS06, the opposite relationship is demonstrated with this particularly apparent in BH02. Except for the latter boreholes, this appears to be in response to rainfall preceding monitoring events. This is demonstrated by comparing rainfall data with depth to water in the wells.

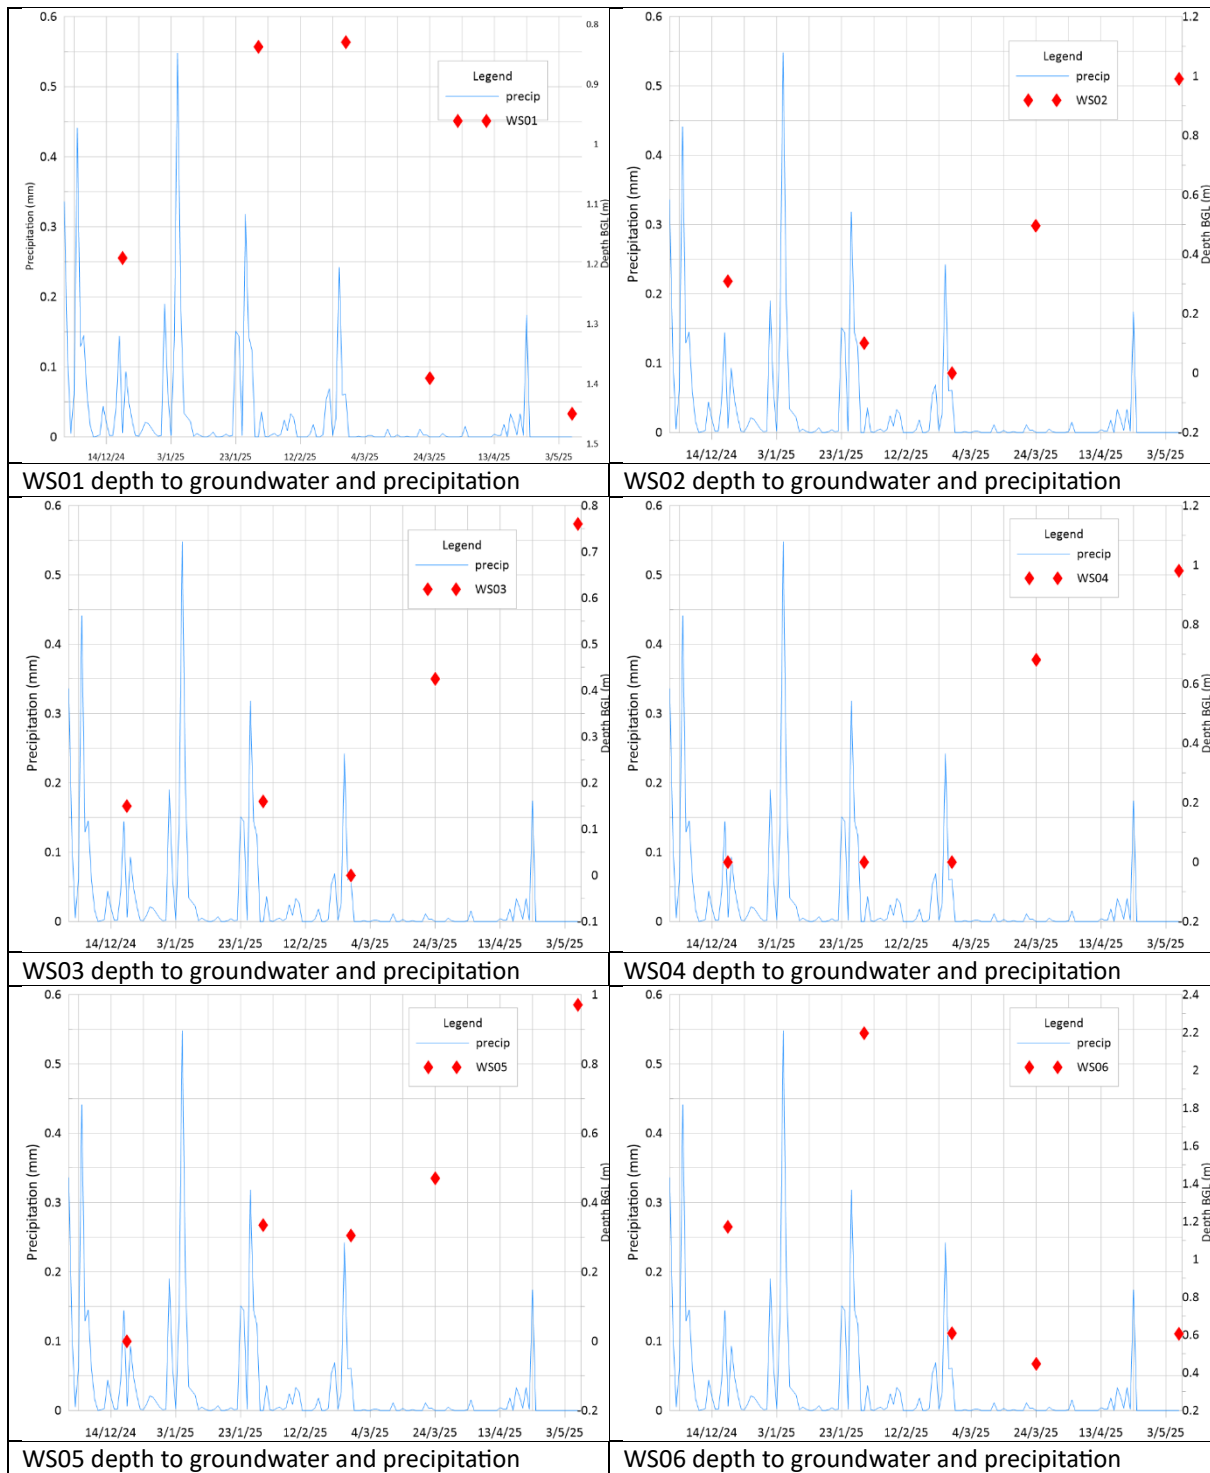
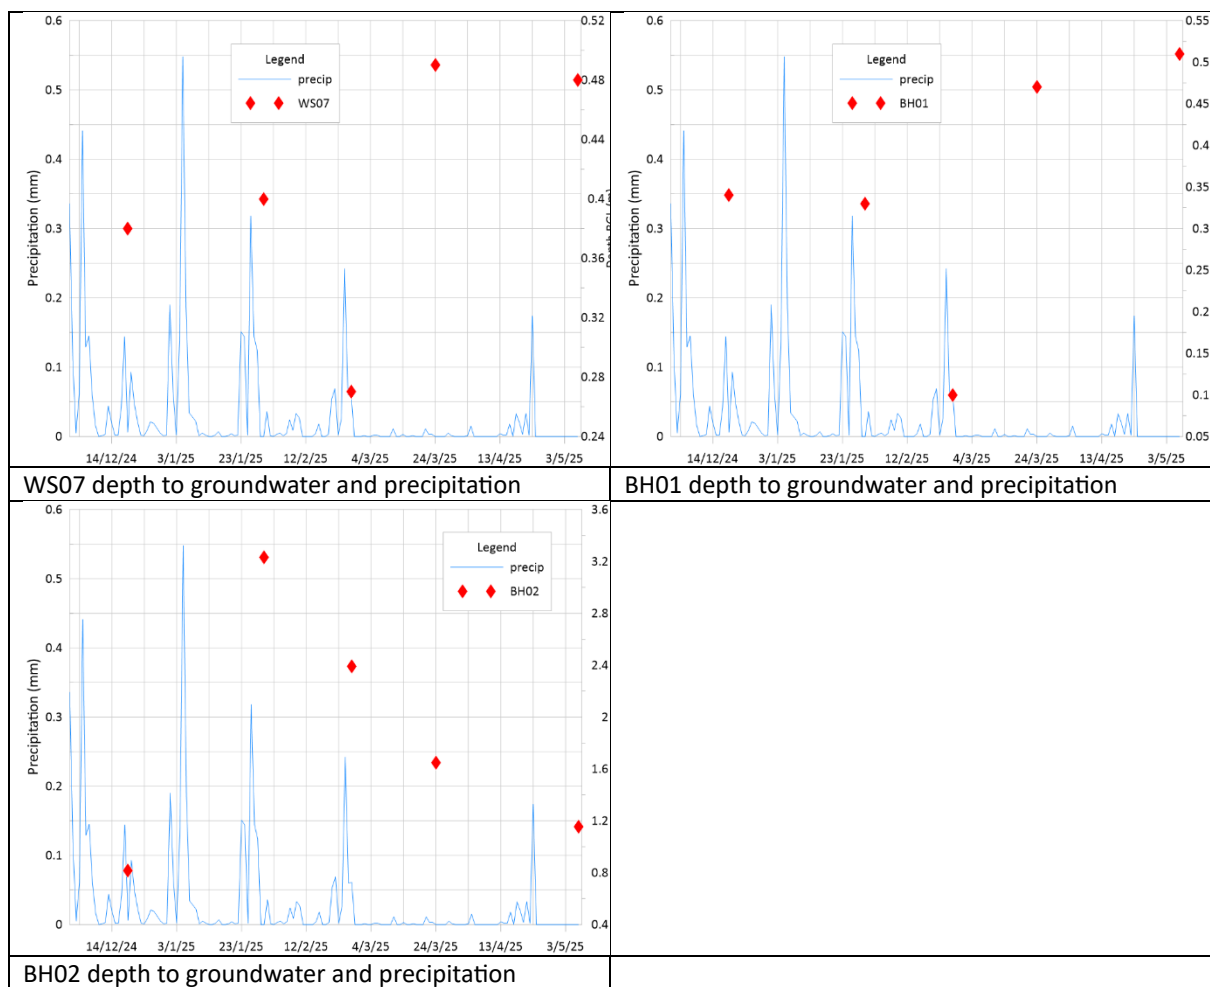
Charts 2-9. Groundwater depth compared to precipitation.

This demonstrates that in the majority of boreholes, depth to water is very responsive to precipitation over the period preceding monitoring with the exception of BH01, BH02 and WS06.

The borehole data generally indicates that the groundwater encountered was responsive to rainfall. Given that water was not encountered in the boreholes when drilling except for that encountered in the made ground we would contend that this is evidence that the water in the monitoring wells originated in the overlying made ground as opposed to in the deeper clay strata. BH02 and WS06 however appear to contradict this. We would hypothesise that this is due to a lag in response time to precipitation. In the case of BH2, this is located in an area

of substantial hardstanding with buildings adjacent. WS06 is located adjacent to an area of hardstanding with hardstanding to the north with the culverted land drain occurring to the south. In both cases, the location the boreholes and the immediately surrounding environment appears to have reduced the response time to rainfall events. Consequently, water in the strata overlying the clay was not able to enter the monitoring wells which occurred in other locations despite section of plain pipe and bentonite seal. It was notable in WS6 that during sampling despite using low flow techniques with the pump set to the lowest recovery setting achievable the well pumped dry indicating that whilst the source of water in the well was from the overlying strata, ingress was very slow.
