## FORMER WESTBURY AND DISTRICT HOSPITAL

## SECTION 73 PL/2023/07503

## BACKHOUSE RESPONSE NOTE

## APPENDIX 1 – DRAINAGE IMPLEMENTATION SITE INSPECTION REPORT

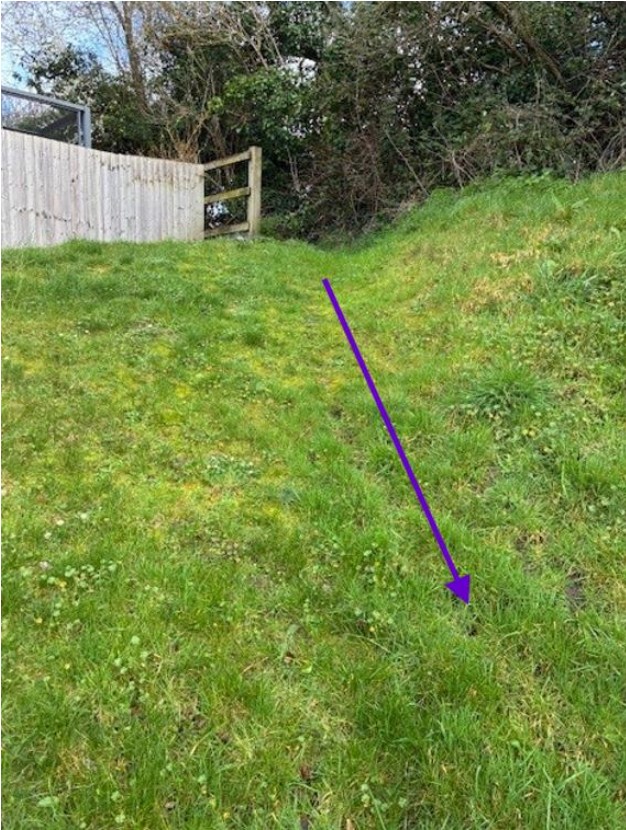
*Photo 1 – There is clear evidence of water run off into the basin – it has caused a small track line through the grass*

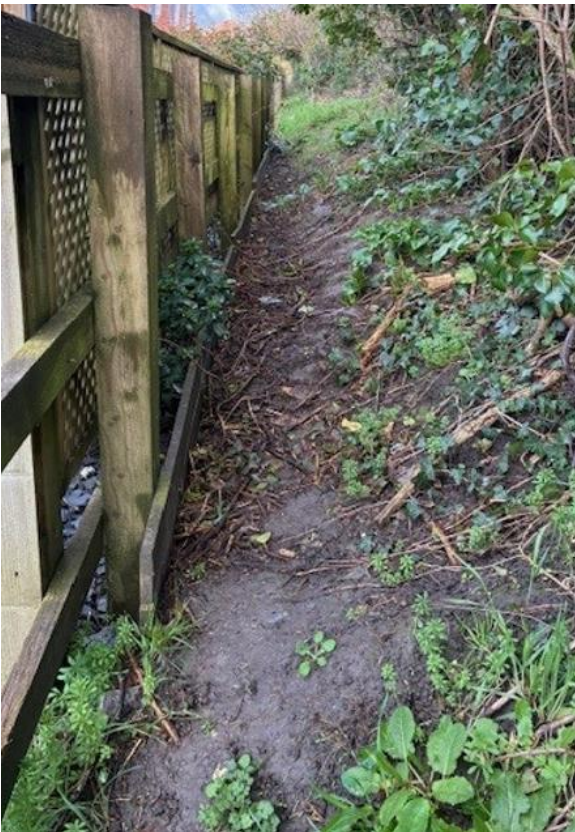
*Photo 2 – There is clear evidence that the 'ditch' was created and that the minimal run off from the neighbouring field is being caught and directed to the basin*

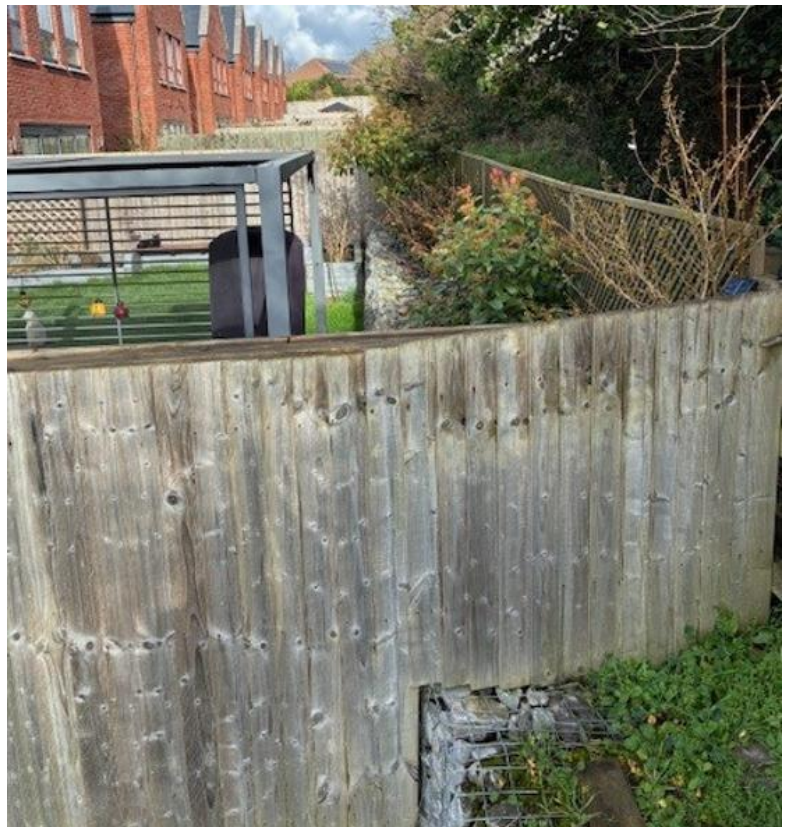
*Photo 3 – Evidence that the gabion walls stand c1m high and that there is no run off getting into the gardens – we also have not had a single customer care report in the last 24 months since my involvement of these gardens being wet in any way.*

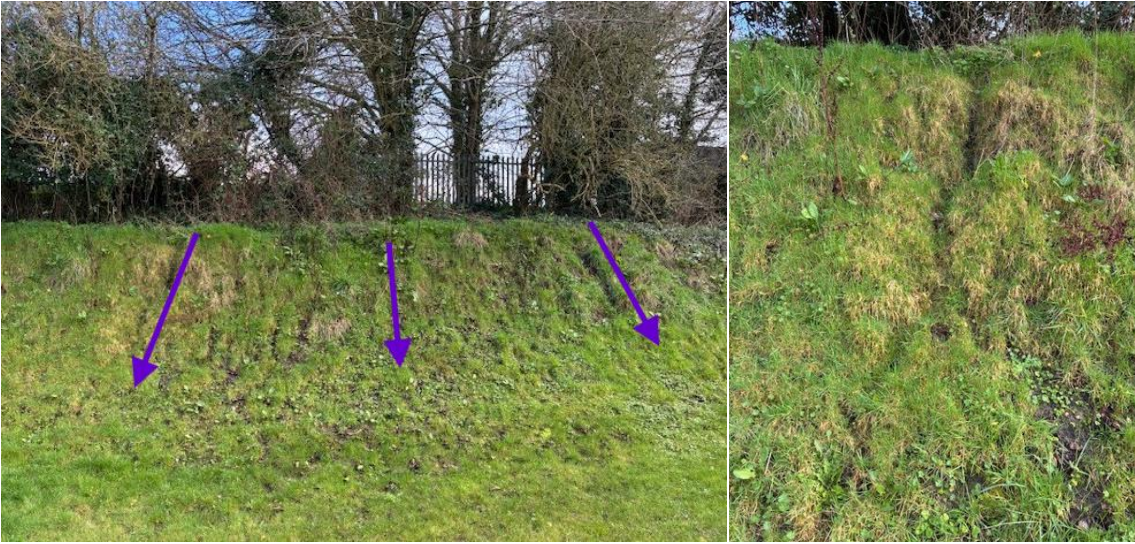
***SE towards neighbouring land***

*Photo 1 – Clear evidence along the side of the basin wall of where surface water run off is coming in to the ditch*

*Photo 2 – close up of the track lines the water has created*
