## **Holford Arms**

Knockdown, Gloucestershire GL8 8QY

## **Structural Report on Conversion of Barn to a Hospitality Facility**

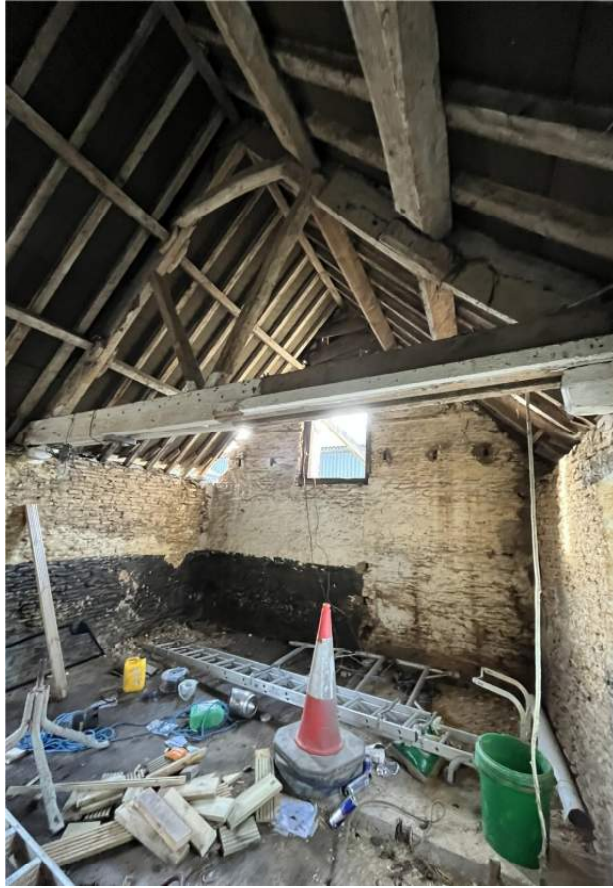
There is some minor cracking in the stone walls and the southwest gable is poorly bonded to sidewalls.

3: Internal view within store 1 looking southwest (dividing gable wall with store 2)

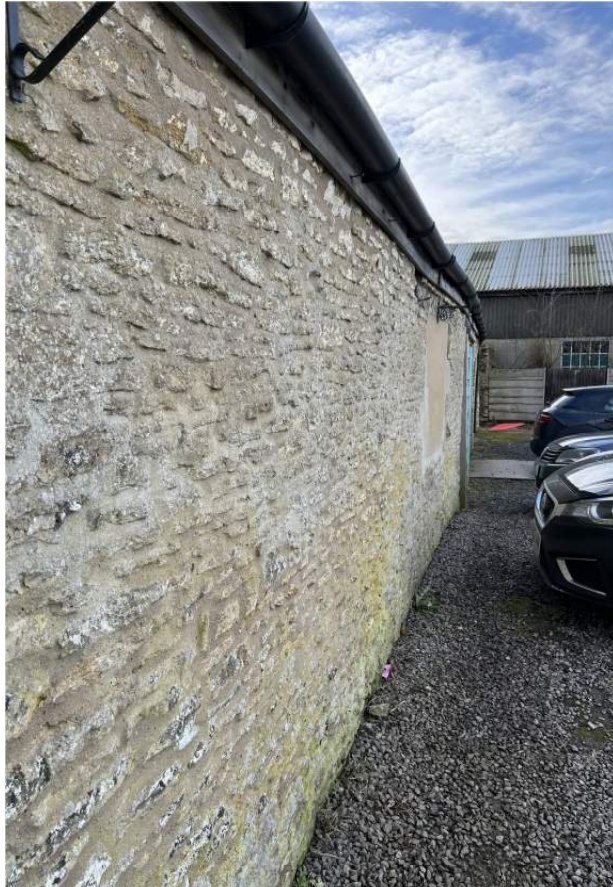
The roof of the main barn is clad in plain concrete tiles. There are dips in the ridge line suggesting spreading has occurred and there is corresponding lateral movement at the top of the walls but not at a level that is structurally significant.

7: Ripples in top of wall reflect areas where the roof has spread

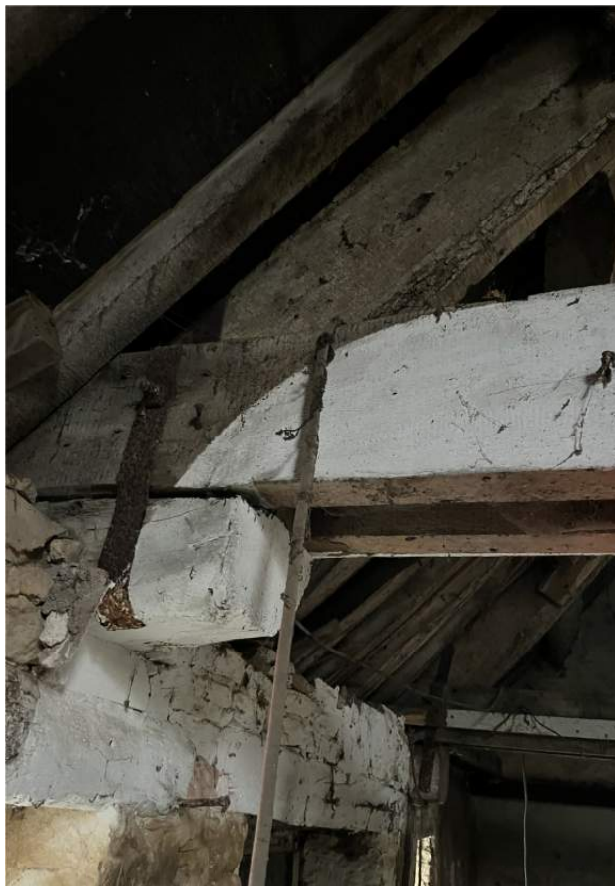
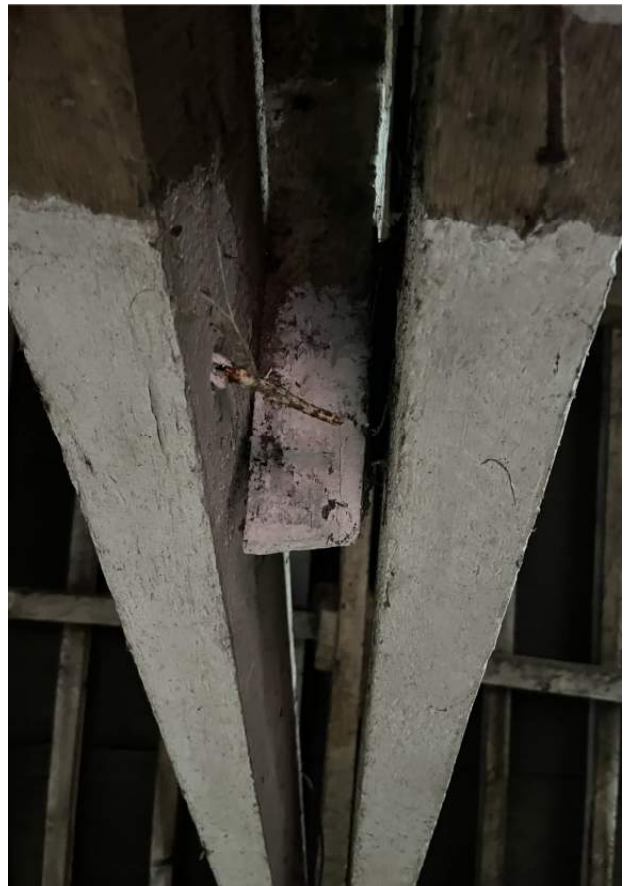
The original structure has undergone various repairs over the years and many of the older elements have been altered or replaced with more modern timbers. In the storage area, the truss ties have been cut at the wall and replaced with a pair of timbers to raise the collar and give improved access. The truss bracing is not properly connected to the tie beam. Element sizes were measured (or estimated where noted) as follows:-

8: Alterations to the timber trusses - original tie beam cut and replaced with a pair of timbers. Diagonal struts are not properly attached to tie beam

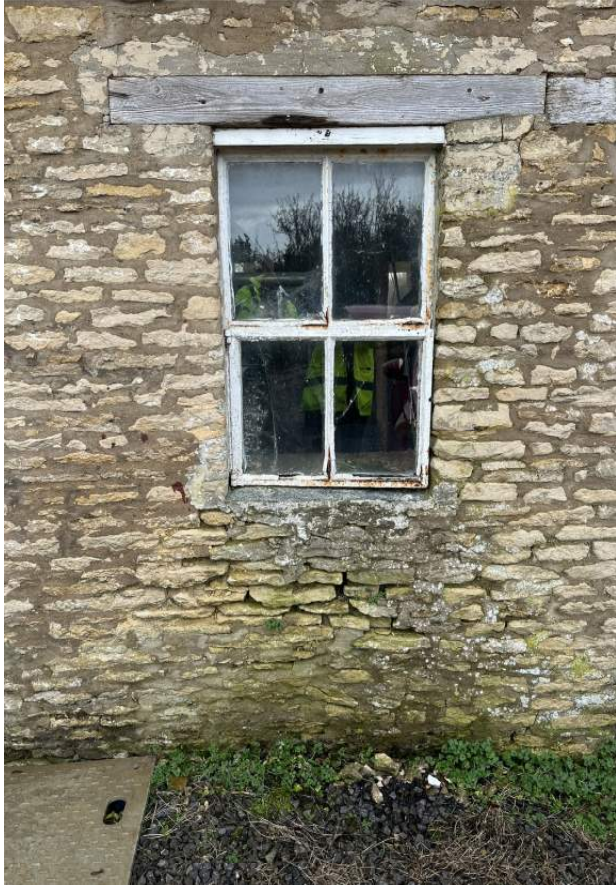
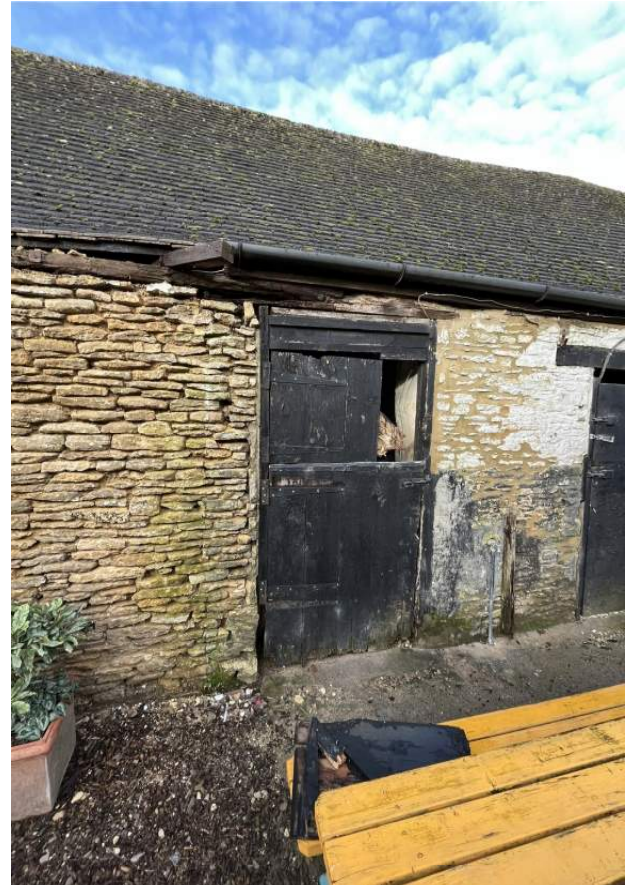
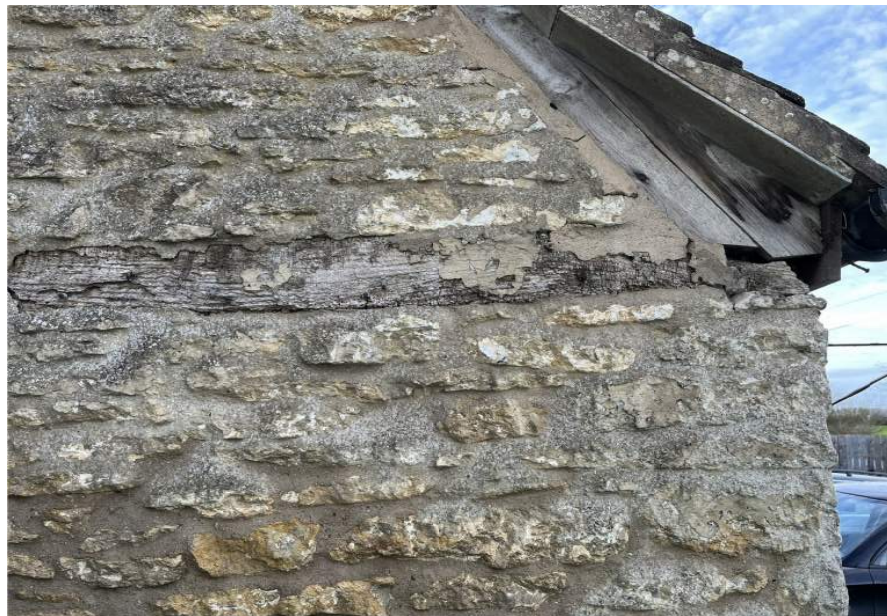
Various timber lintels and embedded timbers within the wall are soft and have decayed. There are some areas where roof timbers are exposed particularly at the southwest end.

8: Timbers exposed to the elements are soft and have degraded. Stonework would benefit from repointing with lime mortar and locally rebuilding/replacing damaged stones in some locations

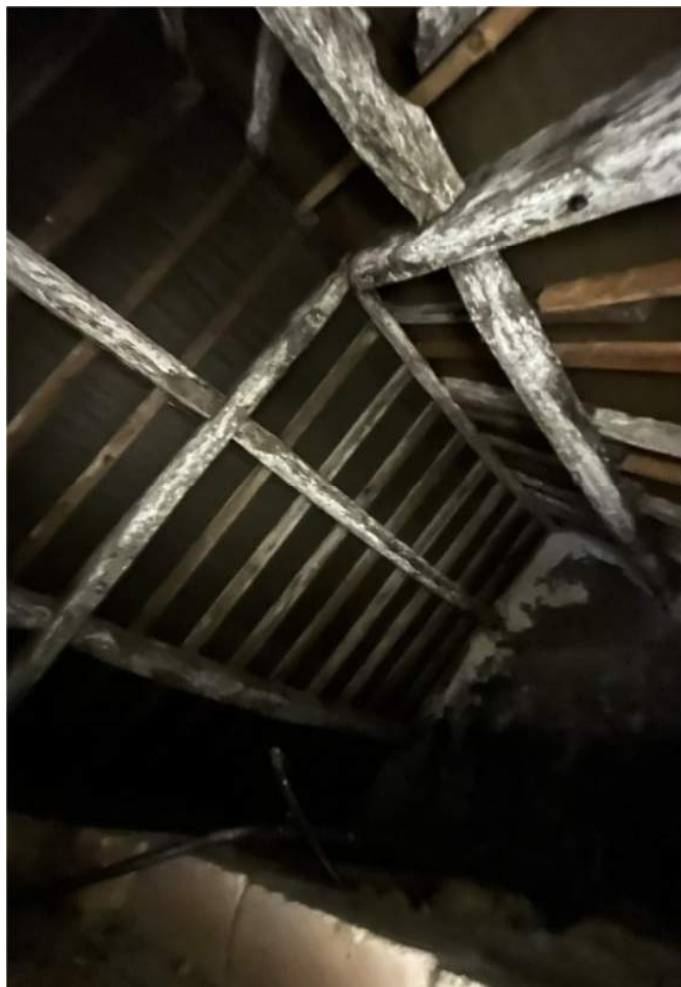
The loft to the tap room was not accessible but could be viewed through a loft hatch. The timber elements had white patches on them which is most likely to be paint as the appearance matched the gables. This roof has also been altered with more modern timber elements visible, but in this case the older truss tie is in place.

10: View into loft over tap room - white on timbers to be checked but most likely to be paint

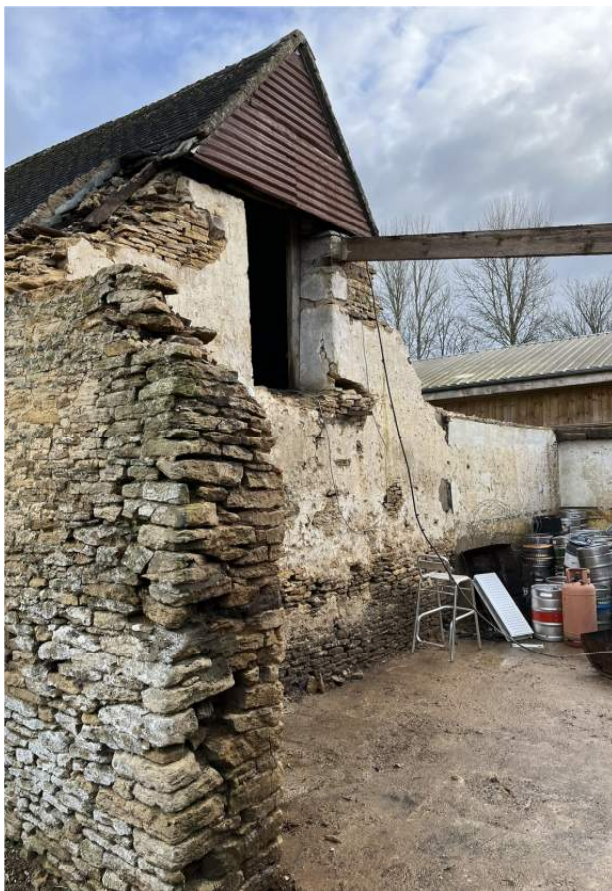
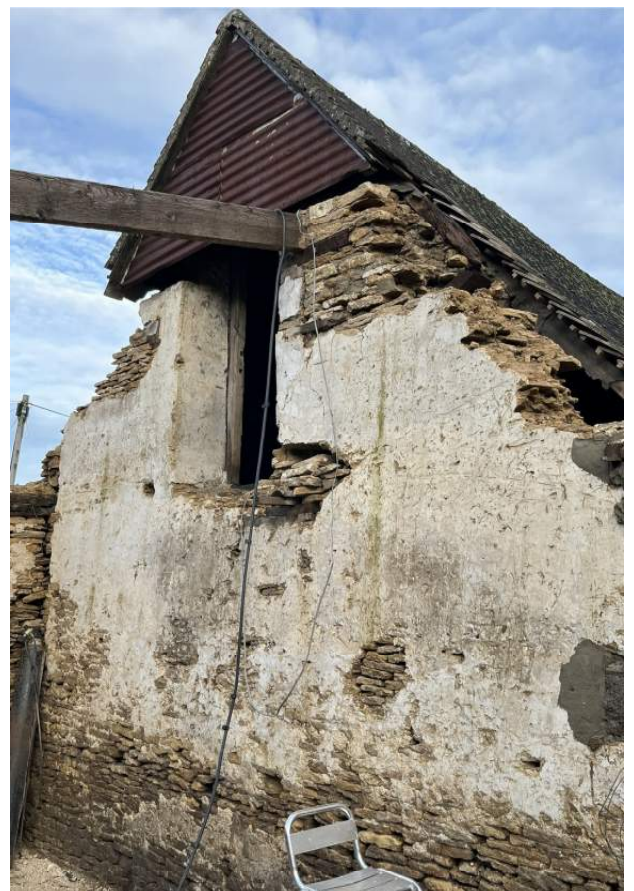
There is significant movement in the southwest gable that divides store 1 from store 2. The upper part of the gable is in poor condition and has distorted probably due to roof movement. Building material piled up against this

at the first inspection may also have caused some movements.

12: Views of main barn gable at interface store 2

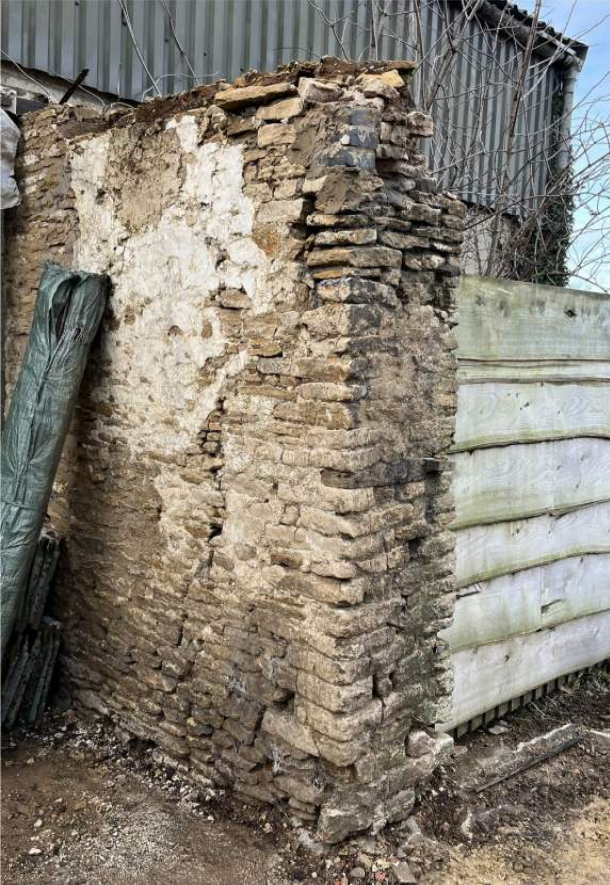
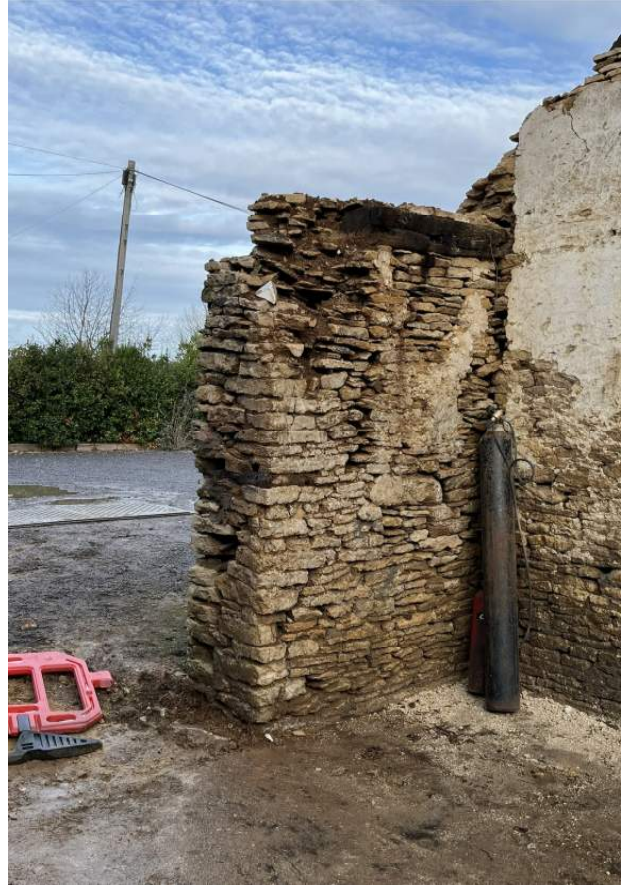
The rubblestone walls that flank the north entrance are in very poor condition. The rubblestone walls that flank the south entrance shows signs of delamination at the reveals. There are areas of these walls that are unpointed. Timbers that run along the head of the wall show signs of decay. The tops of the walls are open to the elements.

13: Views of north opening to store 2

- The rubble stone walls are mostly sound, needing only localised repairs, removal of concrete mortar and repointing with lime mortar
- The rubble stone walls flanking the entrance to the store 2 are in poor condition and will need some localised rebuilding. The wall heads should be protected from water ingress.
- Delaminating rubble stone walls on the south entrance will need repair with suitable anchors.
- Helifix bars should be used to reinforce cracks in the stone walls and improve bonding at junctions
- The southwest gable to the barn will need to be partially rebuilt – most likely taken down to eaves and rebuilt from there
- Timber lintels that are rotten will need replacing
- Embedded rotten timbers should be removed and replaced with stonework
- The roof structures would be strengthened with the addition timber ridge beams spanning between frames to prevent further roof spread

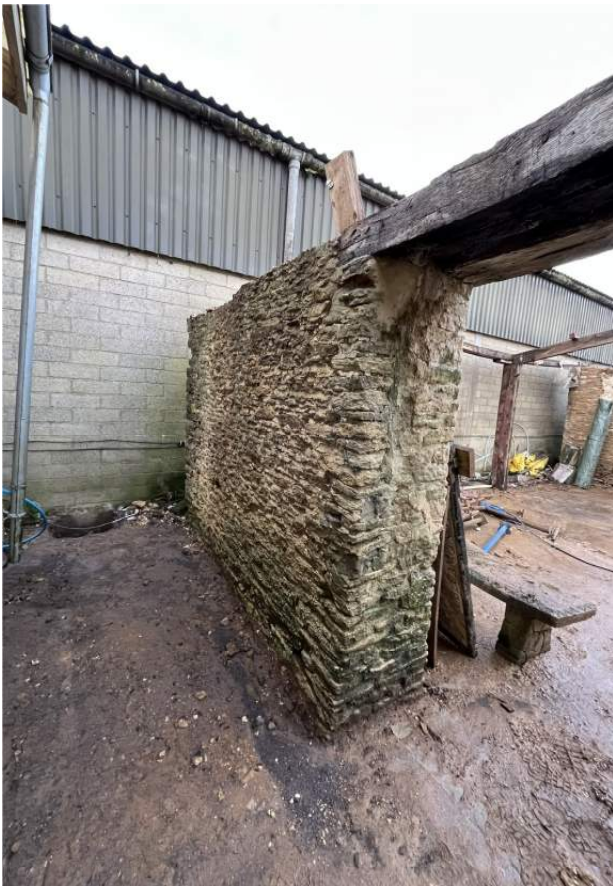
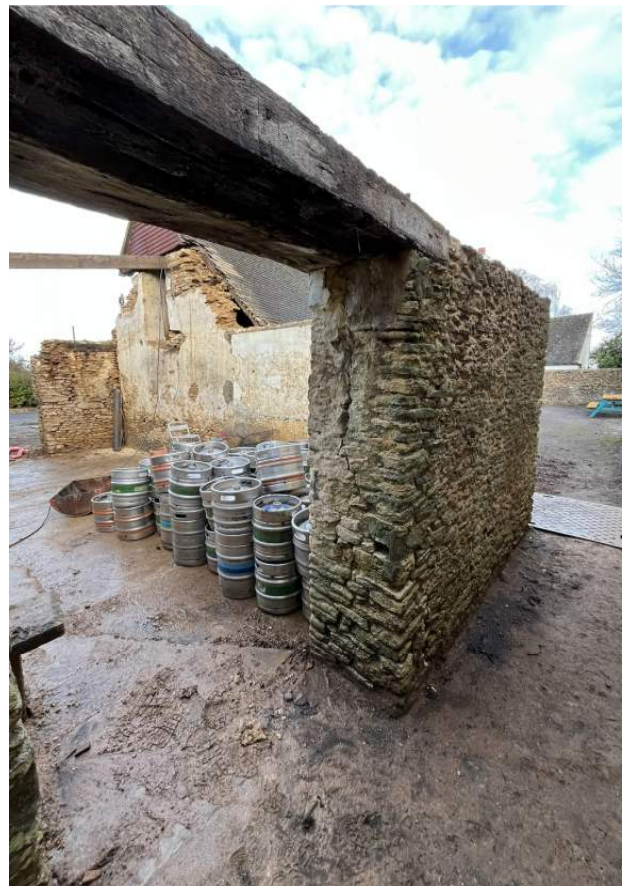
14: Views of south opening to store 2
