## Off Mains Drainage Survey Report Prepared For:

Dairy Cottage, North Newnton, Pewsey, Wiltshire SN9 6LA

**Date of Survey:** 30/05/2025

## Drainage Survey Standard Report:

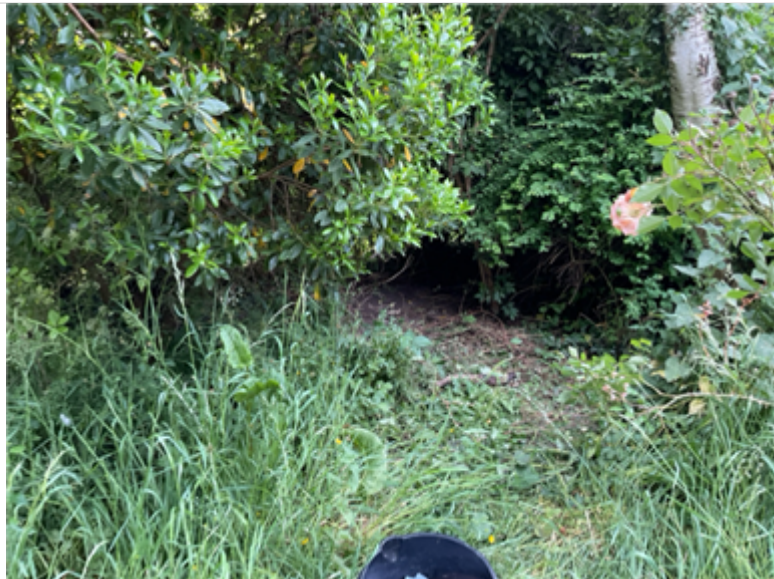
Photograph of the general area of the tank:

| <b>Overall condition of the tank:</b> | Satisfactory |
| <b>Was there any damage observed to the tank during the inspection?</b> | Yes |
| <b>Was the outlet pipework accessible from the tank in order to conduct a CCTV survey?</b> | No<br>Pipework fully surcharged due to soakaway failure. |
| <b>Is the existing discharge functioning correctly?</b> | No<br>Failed soakaway. |

Clear bushes and small tree from around the area of the septic tank and manhole 3.

Install a new 7 person sewage treatment plant (STP) with integral pumped outlet. Inlet invert depth 900mm. Surface grass. To be located on the area of rough grass adjacent to the existing septic tank. There is a stream not far from the property that floods in wet months, ground water is likely to be encountered in the excavation for the STP, provision should be made for de-watering and temporary shoring.

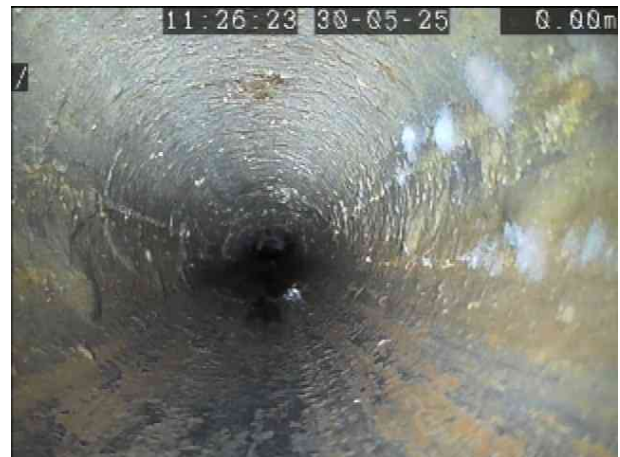
InternalX\_d7a14202-124a-4108-900b-8a39d523f016\_20250604\_131258\_732.jpg, 00:00:07, 0.00 m  
Water level, 5% of the vertical dimension

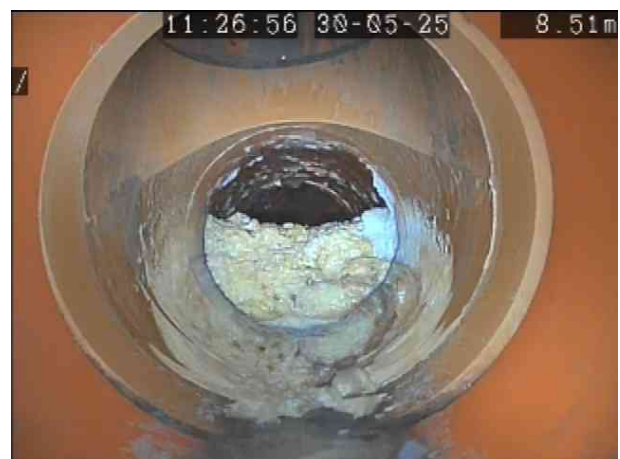
InternalX\_546a6515-bc16-4f24-bafc-8bc8a2373bb8\_20250604\_131424\_633.jpg, 00:00:39, 8.50 m  
Junction at 12 o'clock, 100mm dia

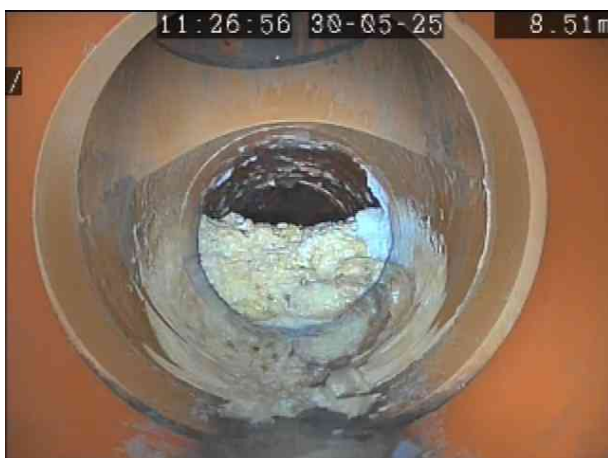
| Scale: | 1:75 | Position [m] | Code | Observation | MPEG | Photo | Grade |
|---|---|---|---|---|---|---|---|
| | | 8.60 | DER | Settled deposits, coarse, 50% cross-sectional area loss | 00:00:39 | InternalX_c2824007-2947-4b7a | 4 |

InternalX\_c2824007-2947-4b7a-b1c0-2463925ce845\_20250604\_131439\_676.jpg, 00:00:39, 8.60 m  
Settled deposits, coarse, 50% cross-sectional area loss

Advisory - high pressure water jet runs 2 & 3 to remove the build up of fat & grease debris in the pipework.

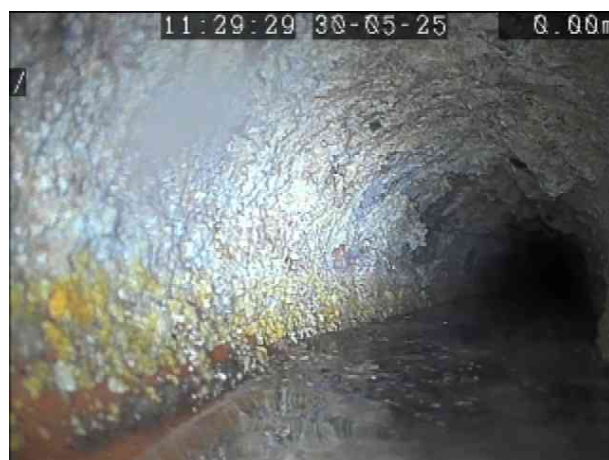
| Scale: | 1:50 | Position [m] | Code | Observation | MPEG | Photo | Grade |
|---|---|---|---|---|---|---|---|
| | | 0.10 | DEG | Attached deposits, grease from 12 o'clock to 12 o'clock, 30% cross-sectional area loss | 00:00:06 | Waste GYX_596c 5082-9b38 | 5 |

GYX\_596c5082-9b38-4fe4-a1da-91995e22a6f3\_20250604\_13  
1744\_530.jpg, 00:00:06, 0.10 m

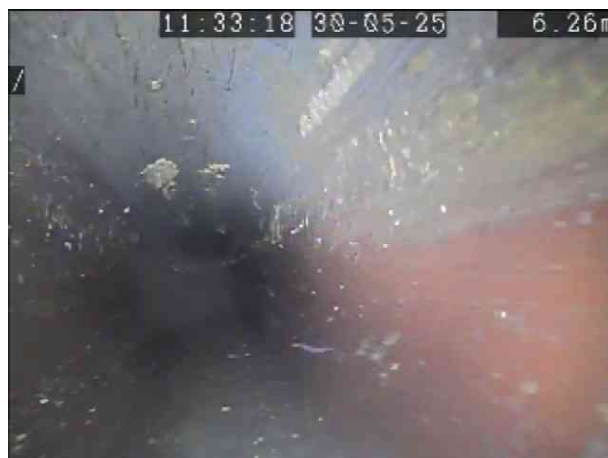
IC1X\_be7cd570-4ca7-453f-ac48-1612c56e9c7d\_20250604\_13  
2720\_585.jpg, 00:00:20, 6.26 m  
Line deviates left

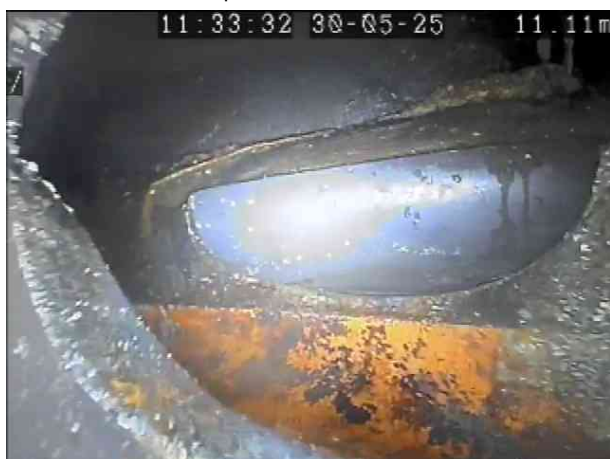
IC1X\_0c566261-75fe-4059-99a9-1574410c98aa\_20250604\_1  
32739\_800.jpg, 00:00:34, 11.23 m  
General remark, MH3

From existing MH3, install new 110mm gravity pipework to connect to the STP inlet (7m). Surface grass.
