# VISUAL STRUCTURAL INSPECTION REPORT

BARNs 4 AND 6  
PICKER PALMER FARM, CAPP LANE, HEYWOOD  
Prepared for:  
Mr J Buck  
Acorn Architectural  
Office 107  
8 The Bridge  
Chippenham  
SN15 1FY

6 March 2026

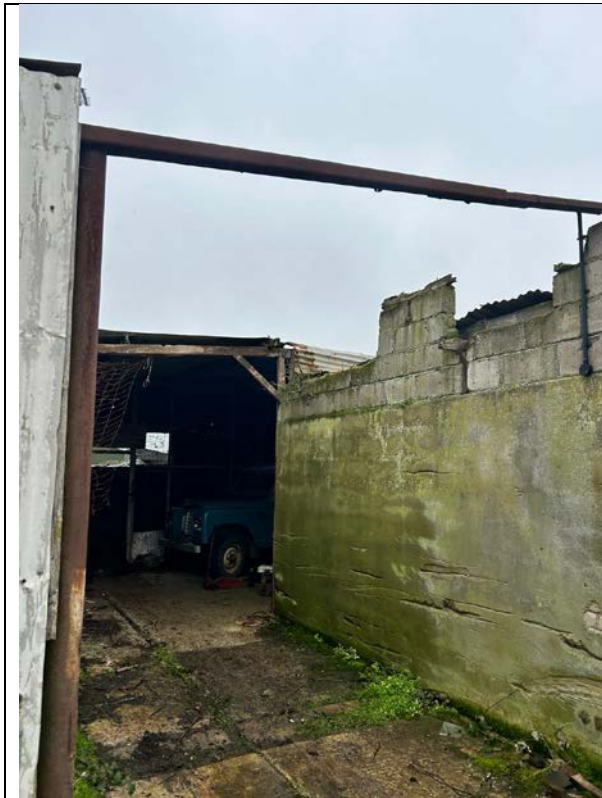
Barn 4 Front (Northern) Elevation

4.1.5 No significant signs of structural distress were observed during the inspection.

4.1.6 The roof covering will require upgrading, and the walls may require improvement works. However, the structure itself appears structurally adequate.

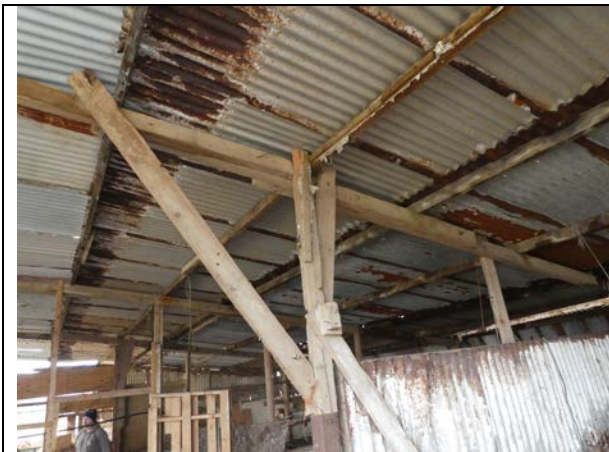
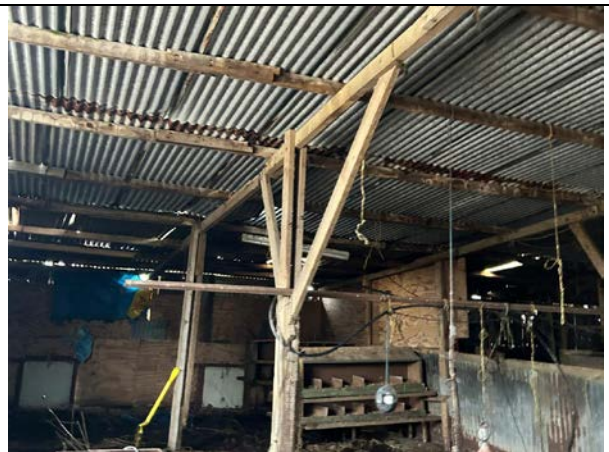
Knee Braced Timber Frames

4.2.6 These frames incorporate knee braces (cruxes) which provide the primary structural stability to the building.

4.3.3 The timber frames appear to be structurally sound and suitable for incorporation into any proposed conversion.

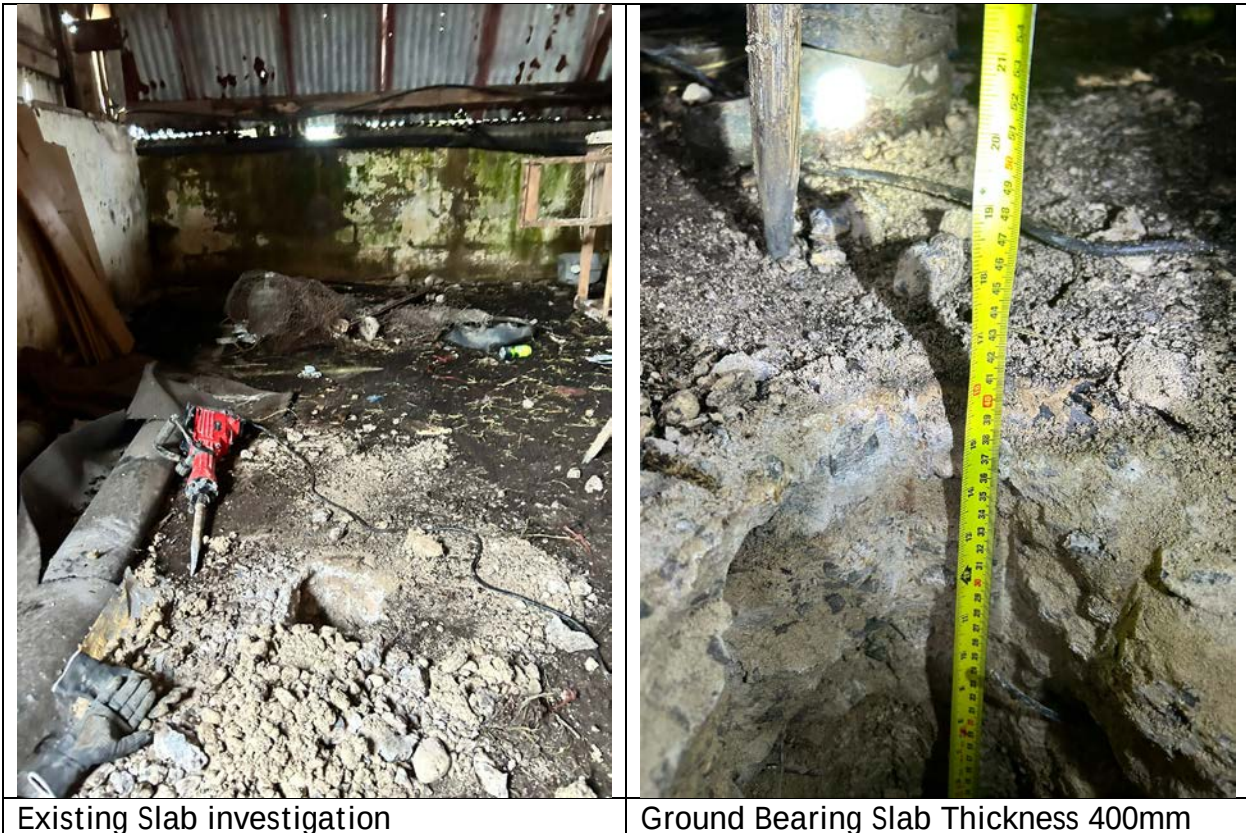
4.4.2 The concrete slab was recorded as being approximately 400mm thick.

4.4.3 The building has historically been used for agricultural purposes, and the existing slab thickness is considered adequate for proposed domestic loading.
