# THE OLD VICARAGE, ASHTON KEYNES

## DETAILED TREE ASSESSMENT

30 April 2019

Project reference: L.2893

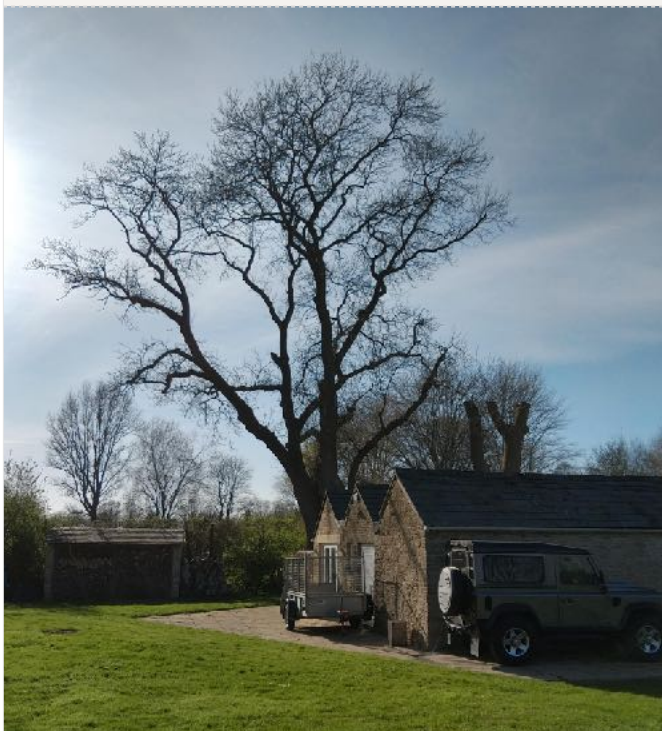
PHOTO 1: LOOKING WEST TO T16

- The tree is a tall, broad crown ash located 4 metres from the west elevation of a garage/office building.
- The tree is twin stemmed from circa 1m.
- At the base of the trunk there is a small area on the south side where the bark has died and exposed the underlying sapwood.
- On the west side of the stem an old barbed wire fence has been occluded in to the wood
- Sounding the base of the stem with a mallet does not indicate significant changes in resonance, primarily due to the stem diameter.
- The crown has been lifted in the past with many of the lower secondary and tertiary lateral branches being removed.
- There are some minor cavities at pruning wound locations.
- The density of twigs in the upper crown is good and annual tip extension growth is fair.

- 6.3. In light of the above conclusions, I recommend the following:
- ***That T16 be retained and managed*** with programme of crown reduction being undertaken over the next 5-10 years. This should commence with an initial crown reduction within the next 18 months to remove circa 2.5m from the canopy height and lateral spread. This should be accompanied by localised pruning to provide an overall natural crown shape. This work could be repeated on a 2-3 year cycle until the overall height of the tree is around 9-10m. The exact quantity and frequency of pruning after the initial works will need be specified at the time to reflect the physiological response of the tree to the previous years pruning works.

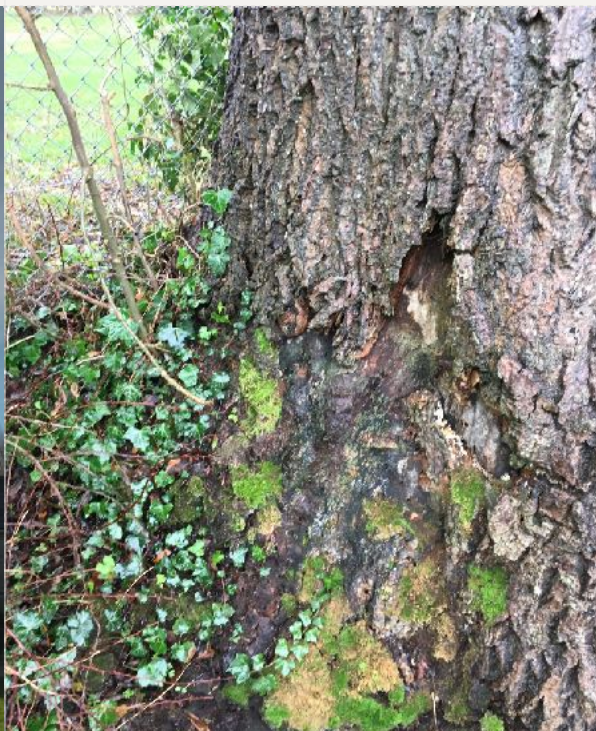
PHOTO 2: BASE OF T16 ON SOUTH SIDE

- 6.1. My assessment of this ash tree has found that the base of the tree has a relatively small amount of internal decay. The orientation of the decay shows some correlation with the location of the bark wound on the south side of the stem sensor 8. Although some decay is present, there is a large amount of sound wood around the outer edges of the wound and near ground level which, in my opinion, has sufficient bearing capacity to support the tree. Therefore, I consider the risk of whole tree failure, to be low.

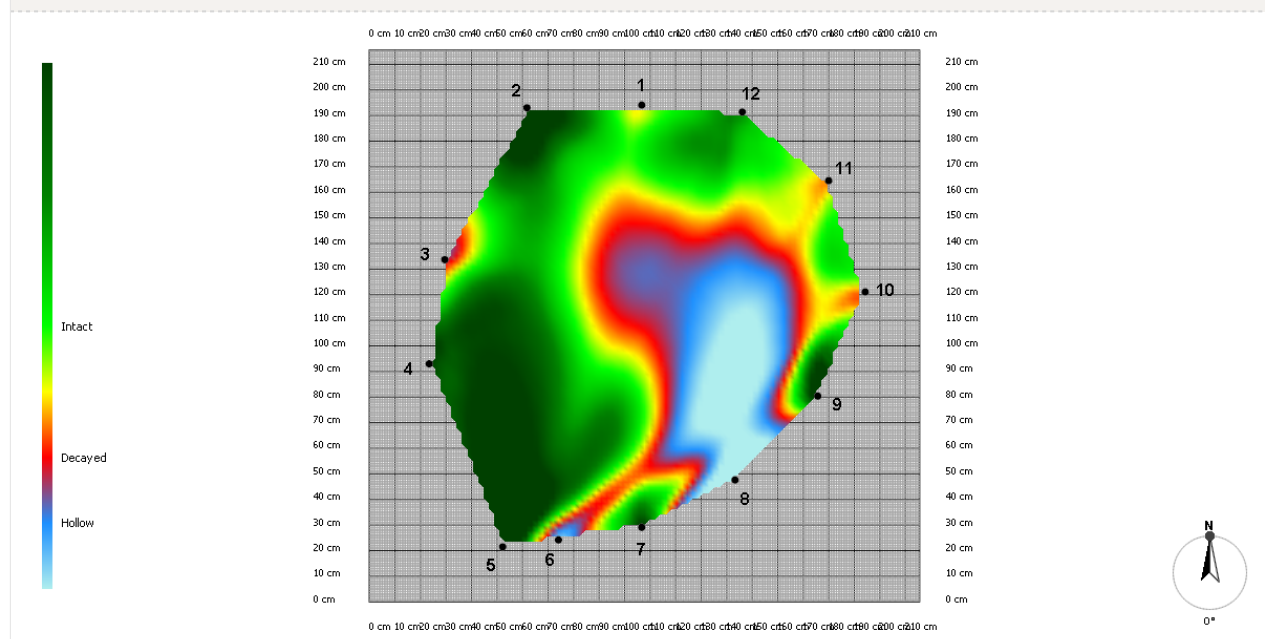
SONIC TOMOGRAM - HEIGHT: 42 CM ABOVE GROUND LEVEL

- 
- 5.1. The tomograph assessment of T16 was made as close to ground level as possible, at approximately 40cm above the ground level. The tomogram image shows an offset zone in a blue colour which indicates an area of hollowness or degraded wood. The red-yellow colours indicated less degraded areas, possibly where there is incipient decay present. Dark to light green areas indicate intact wood.

- 5.2. The ArborSonic software calculates the amount of 'decay' as approximately 25% of the cross sectional area on this plane.
  - 5.3. Given the nature of basal decay in trees this percentage of decay is likely to decrease further up the stem and increase towards ground level.

- 5.4. Despite the likely increase in percentage decay towards ground level the visual inspection of the buttress roots, and localised excavation of leaf matter and soil, revealed the visible elements of the buttress roots to be of sound appearance.

- 5.5. Given the nature of the decay it is likely the onset will be progressive in the future. It is not possible at this time to quantify with what speed the decay will progress but the visual indicators are that decay has been present on the base of the tree for some time.

- 6.2. However, given the presence of the decay and the age of the tree it would be prudent to consider proactively managing the tree down in size to manage the future risk of failure. I believe this would be the correct approach as the tree is valuable in terms of its age and size. The felling of the tree to eliminate *all* risk would be disproportionate. It should be noted that the recommendations below are not required to address any short-term risk posed by the tree and so in terms of priority they may be seen as discretionary.

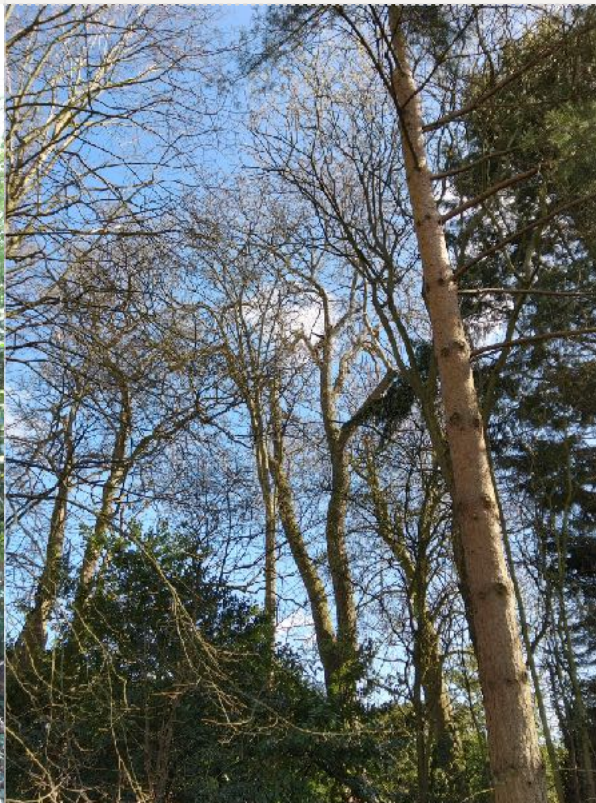
**PHOTO 4: TREE AND CONTEXT (CENTRE FRAME)**

- The tree is a tall, slender ash located in the south-east corner of the garden. The tree overhangs the High Street, the River Thames and insulated overhead power lines.
- It has a single straight trunk to approximately 6m, where it divides in to two secondary stems.
- At approximately 2m up the primary stem is a large and historic limb loss scar with decayed heartwood visible and poor reaction growth.
- In the upper crown there are numerous dead limbs on the garden side with woodpeckers holes present.
- At circa 18m on the east side of the crown there is a previous limb loss scar where a limb failed on to the high street.
- The crown has been lifted in the past.
- The density of twigs and buds in the upper crown is good and annual tip extension growth is good.

- ***That T70 be removed*** within a guide timeframe of 1 calendar year from the date of this report. The tree could be felled to ground level or, if desired, it could be reduced to circa 5m in height and maintained as a pollard below a maximum height of 8m. It should be noted that topping a tree by this amount may result in the death of the tree, in which case the 'stump' could be left in a safe condition to degrade and to also provide a wildlife habitat.

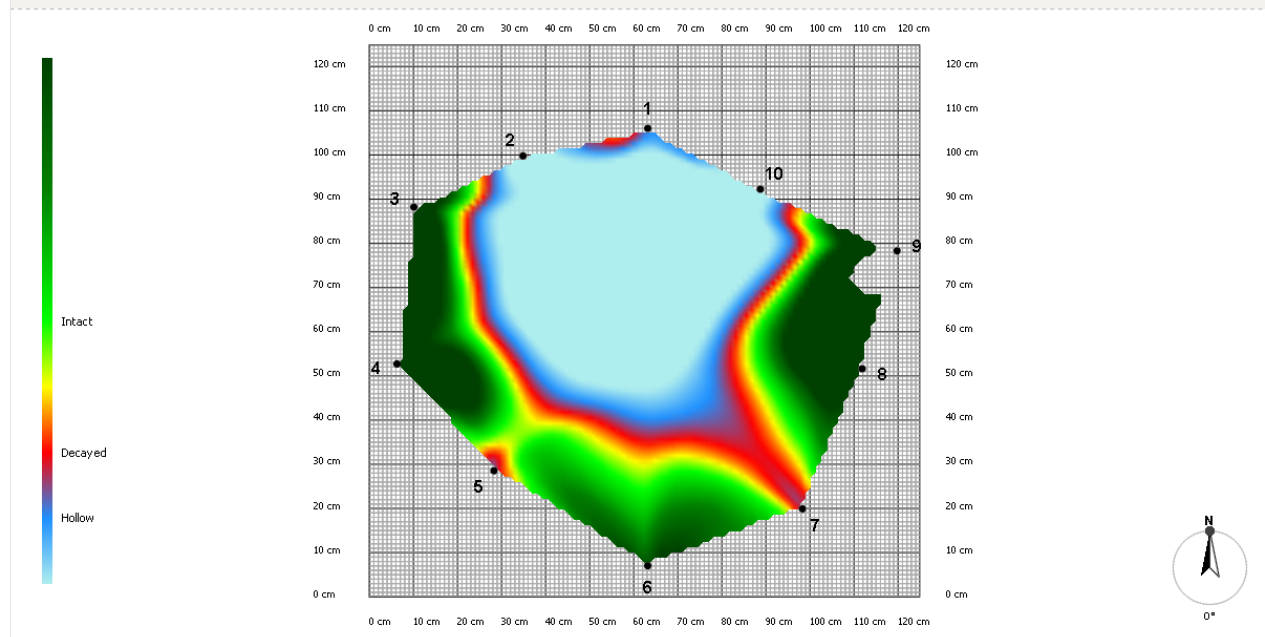
**SONIC TOMOGRAM - HEIGHT: 180 CM ABOVE GROUND LEVEL**

- 
- 5.7. The tomograph assessment of T70 was made at 1.8m, just below the open cavity at the point of previous limb loss. The tomogram image shows a central zone in a blue colour which indicates an area of hollowness or degraded wood. The red-yellow colours indicated less degraded areas, possibly where there is incipient decay present. Dark to light green areas indicate intact wood.

- 5.8. The ArborSonic software calculates the amount of 'decay' as 55% of the cross sectional area on this plane.
- 5.9. The decay at this point of the tree is well established. The nature of previous limb loss scar and the extent of decay noted on the tomogram would suggest the decay remains at this extent for some distance above the scan level.

- 5.10. The height of the tree and the mass of material in the upper crown of the tree suggests the dynamic loading applied to this point of the stem will be significant.

- 5.11. From the exposed nature of the decay and from a visual inspection with the probe it is apparent that the decay is progressive in nature.
- 5.12. Despite the limb loss occurring some years ago and the decay also having been present for some time the reaction of the tree through the putting down of new reaction wood is not as good as one would expect to see. In fact the reaction ribs either side of the decay cavity and noticeably small.

- 6.4. I conclude that the extent of decay present within the lower stem of this tree has compromised its structural integrity to the point where the failure of the stem is likely within the short-term future. This potential for failure is particularly relevant when considering the location of the tree and the likely targets that could be affected by its failure.
