# TREE SURVEY & RISK ASSESSMENT

Flers Court, Warminster

For & on behalf of: ELM Group

December 2025

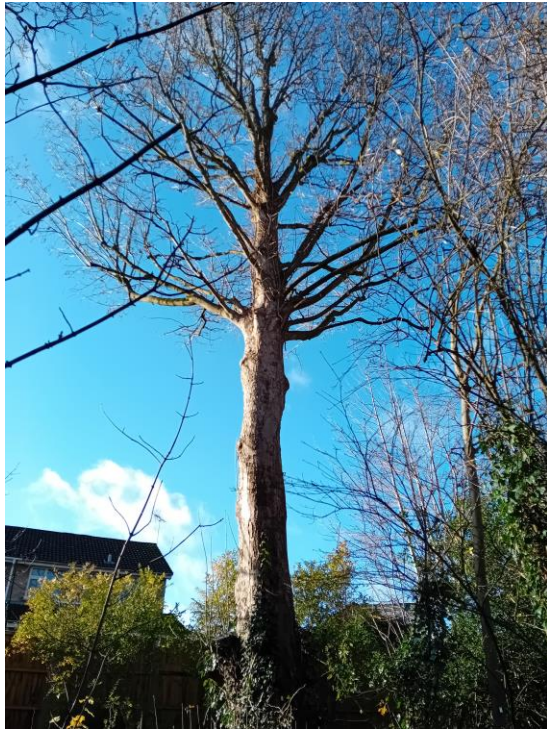
- 5.3 The photos below relate to the works specified at Appendix 1, for tree no.144 (Fig.1). This tree has been recommended for removal, due to the presence of a known wood decay fungus *Kretzschmaria deusta* (Fig.2); this will eventually lead to a brittle form failure in the stem base or structural roots, thus having serious safety implications, given the proximity of adjacent properties.

Fig.1 Overview of tree No.144

| Tree ID. | Species<br>(Common Name) | Age Class | Height (m) | Stem dia.<br>(cm) | Physiological<br>Condition | Structural<br>Condition | Observations / Comments | Recommendations | Work<br>Priority |
|---|---|---|---|---|---|---|---|---|---|
| 144 | Sycamore | mature | 28 | 70 | good | poor | <i>K.deusta</i> fungal fruit bodies at base to East with associated internal wood decay (possibly into roots), located within falling distance of adjacent properties to West – HIGH RISK of basal failure | REMOVE TO GROUND LEVEL (spot marked with orange paint) | HIGH |

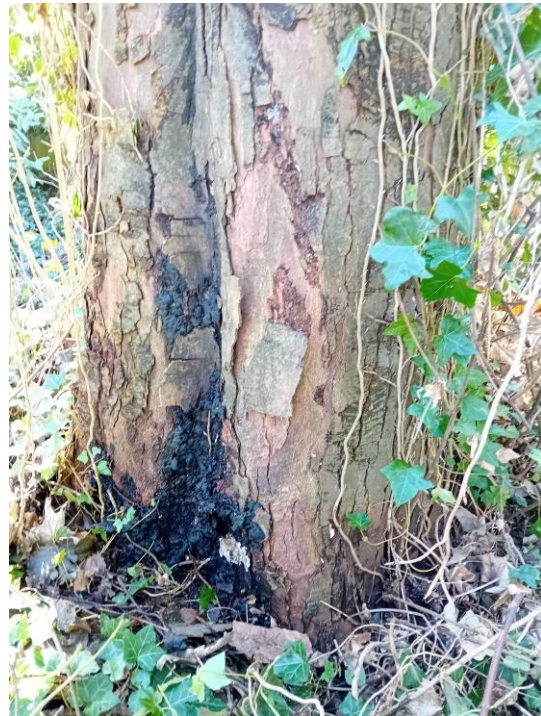
Fig.2 Close-up view of stem base
