project  
WESTFIELD FARM  
Latton, Wiltshire GL7 5QQ

| drawing | Existing Elevations | scale | 1:50 @A1 | drawn by | - | date | March 26 |
| drawing no | 251017-102 | | | | | rev | - |

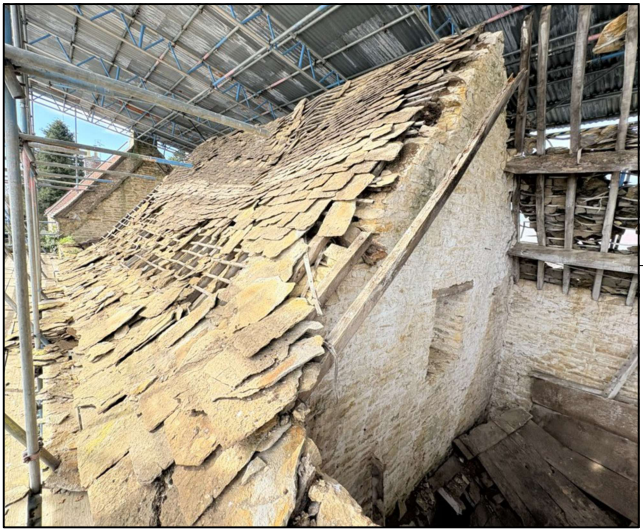
Section of existing roof with roof timbers and stone slates still in place. However, it appears that the roof timbers are starting to show signs of collapse.

Structural recommendation to remove stone slates to reduce weight load on existing timbers and prevent further damage in preparation for further structural review of existing structure.

Stone slates to be removed carefully and salvaged for reuse later on. Stone slates are to be store on site in a location to be agreed.

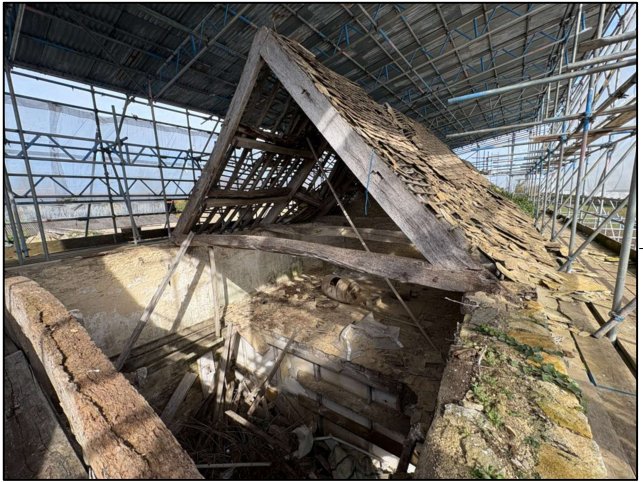
Significant amount of debris within the building, which appears to be roof structure material that has fallen in on the first floor. The build up of debris that is leaning on the external walls are starting to push the walls out with the first floor then eventually collapsing.

Structural recommendation to remove debris to reduce the load impact on the existing external walls and first floor. Further structural survey of the building to then take place.

All existing broken timbers to be removed, along with stone slates and other debris. Stone slates, significant pieces of timber and timber paneling to be salvaged and stored in safe place.

Any first floor structure that is still in original place (and not rotten or damaged) to remain as is.

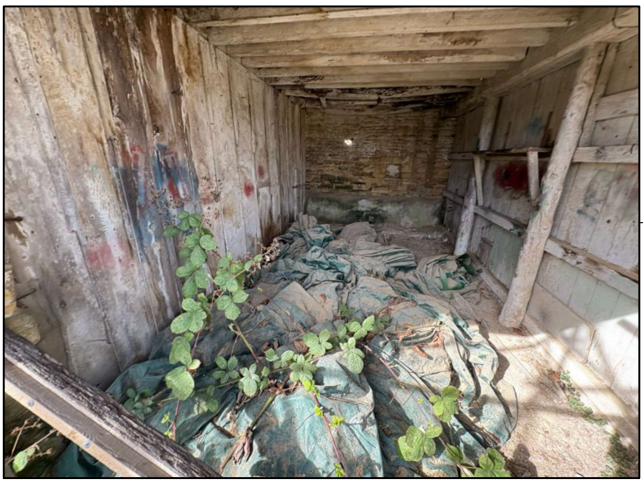
Significant amount of debris within the building on ground floor, which appears to be general stored materials.

Structural recommendation to remove debris to further structural survey of the building to take place.

Significant pieces of timber and timber paneling and any other historic fabric to be salvaged and stored in safe place.

Any floor and partition structure that is still in original place (and not rotten or damaged) to remain as is.

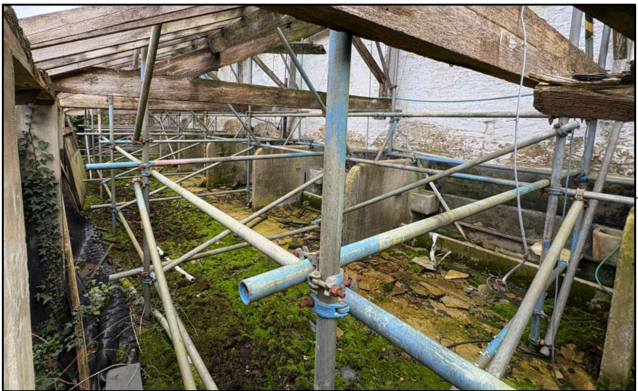
Debris within the lean-to building, which appears to be general stored materials.

Structural recommendation to remove debris and any foliage to allow further structural survey of the building to take place.

If any significant pieces of timber and timber paneling and any other historic fabric to be salvaged and stored in safe place.

Any floor and partition structure that is still in original place (and not rotten or damaged) to remain as is.

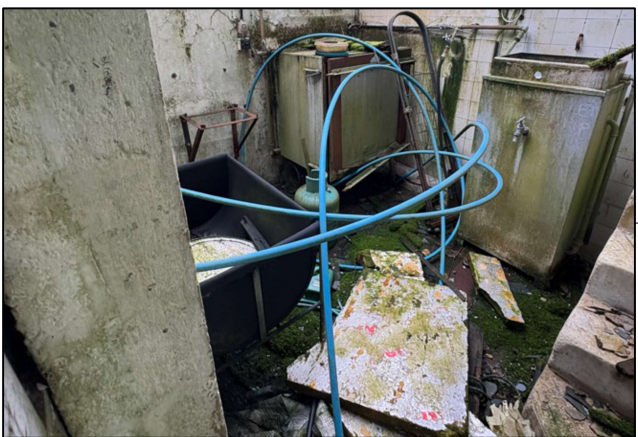
Debris within the lean-to building, which appears to be general stored materials.

Structural recommendation to remove debris and any foliage to allow further structural survey of the building to take place.

If any significant pieces of timber and timber paneling and any other historic fabric to be salvaged and stored in safe place.

Any floor and partition structure that is still in original place (and not rotten or damaged) to remain as is.

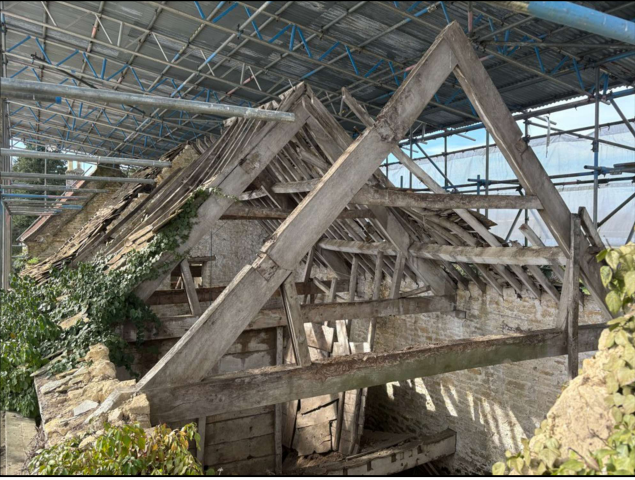
Section of existing roof with roof timbers and rafters in place.

Structural recommendation to remove loose stone slates and foliage from stonework and timbers in preparation for full structure review of building.

Any loose timbers are to also be removed, with significant pieces to be stored in safe place.

Stone slates to be removed carefully and salvaged for reuse later on. Stone slates are to be store on site in a location to be agreed.

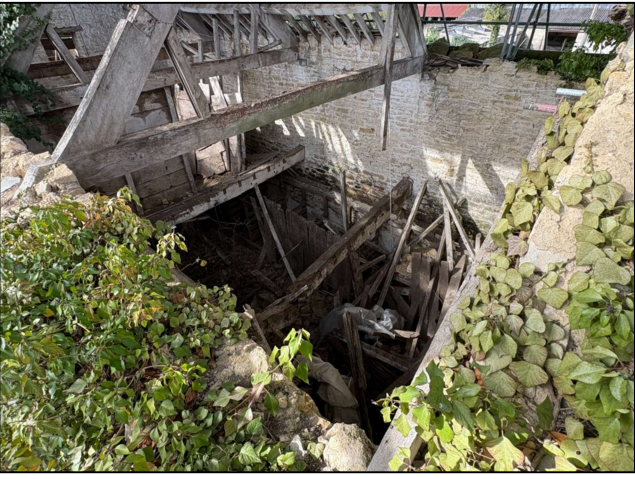
Significant amount of debris within the building, which appears to be roof structure material that has fallen in on the first floor that has further collapsed onto the ground floor. The build up of debris that is leaning on the external walls are starting to push the walls out.

Structural recommendation to remove debris and any foliage to reduce the load impact on the existing external walls. Further structural survey of the building to then take place.

All existing broken timbers to be removed, along with stone slates and other debris. Stone slates, significant pieces of timber and timber paneling to be salvaged and stored in safe place.

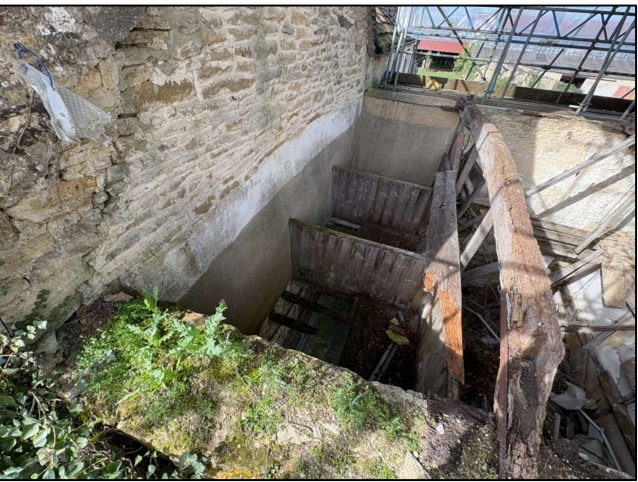
Debris within the building above passageway.

Structural recommendation to remove debris and foliage to reduce the load impact on the existing external walls. Further structural survey of the building to then take place.

All existing broken timbers and general debris to be removed. Significant pieces of timber and timber paneling to be salvaged and stored in safe place.
