project  
WESTFIELD FARM  
Latton, Wiltshire GL7 5QQ

drawing  
**Existing First Floor Plan**

251017-101 drawing no - rev

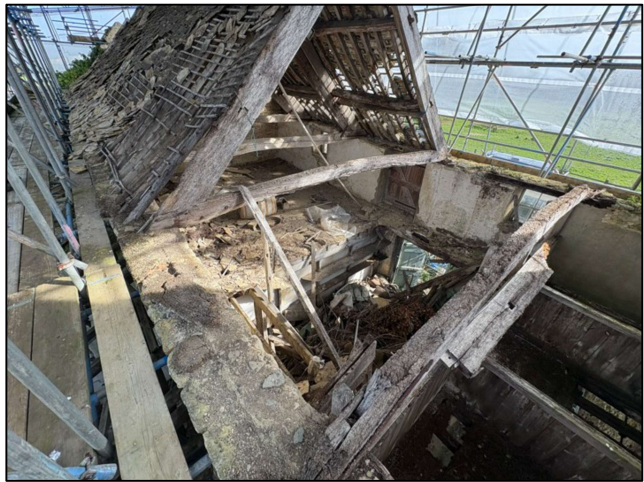
Significant amount of debris within the building, which appears to be roof structure material that has fallen in on the first floor that has further collapsed onto the ground floor. The build up of debris that is leaning on the external walls are starting to push the walls out.

Structural recommendation to remove debris to reduce the load impact on the existing external walls. Further structural survey of the building to then take place.

All existing broken timbers to be removed, along with stone slates and other debris. Stone slates, significant pieces of timber and timber panning to be salvaged and stored in safe place.

Any first floor structure that is still in original place (and not rotten or damaged) to remain as is.

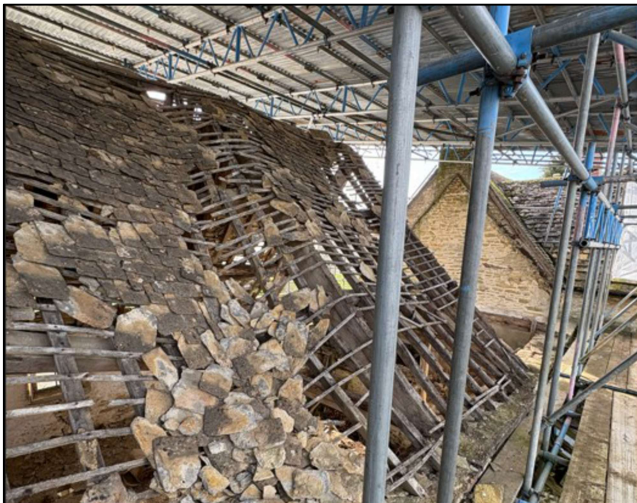
Section of existing roof with roof timbers and stone slates still in place. However, it appears that the roof timbers are starting to show signs of collapse.

Structural recommendation to remove stone slates to reduce weight load on existing timbers and prevent further damage in preparation for further structural review of existing structure.

Stone slates to be removed carefully and salvaged for reuse later on. Stone slates are to be store on site in a location to be agreed.

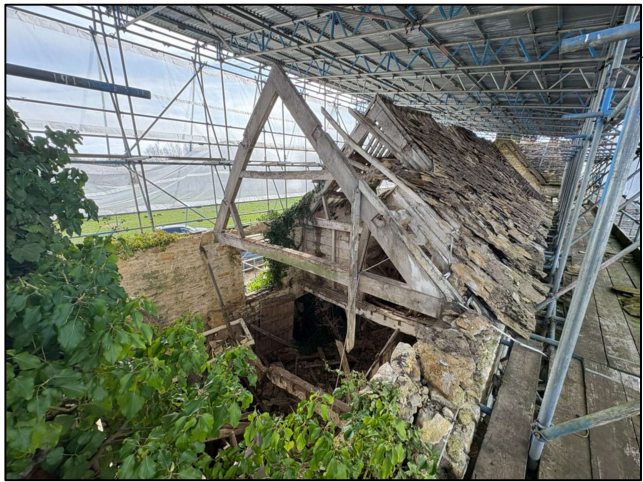
Significant amount of debris within the building, which appears to be roof structure material that has fallen in on the first floor that has further collapsed onto the ground floor. The build up of debris that is leaning on the external walls are starting to push the walls out.

Structural recommendation to remove debris and foliage to reduce the load impact on the existing external walls. Further structural survey of the building to then take place.

All existing broken timbers to be removed, along with stone slates and other debris. Stone slates, significant pieces of timber and timber panning to be salvaged and stored in safe place.

Any first floor structure that is still in original place (and not rotten or damaged) to remain as is.

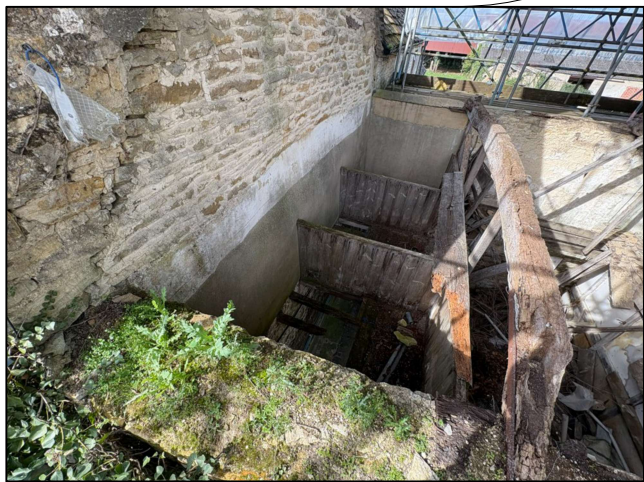
Debris within the building above passageway.

Structural recommendation to remove debris to reduce the load impact on the existing external walls. Further structural survey of the building to then take place.

All existing broken timbers and general debris to be removed. Significant pieces of timber and timber panning to be salvaged and stored in safe place.

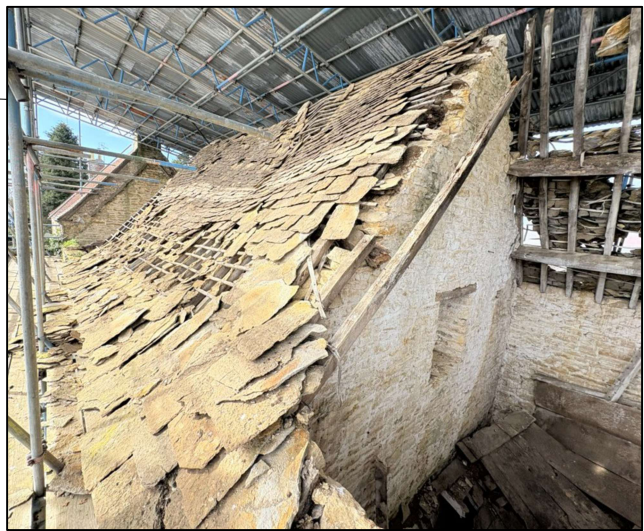
Section of existing roof with roof timbers and stone slates still in place. However, it appears that the roof timbers are starting to show signs of collapse.

Structural recommendation to remove stone slates to reduce weight load on existing timbers and prevent further damage in preparation for further structural review of existing structure.

Stone slates to be removed carefully and salvaged for reuse later on. Stone slates are to be store on site in a location to be agreed.

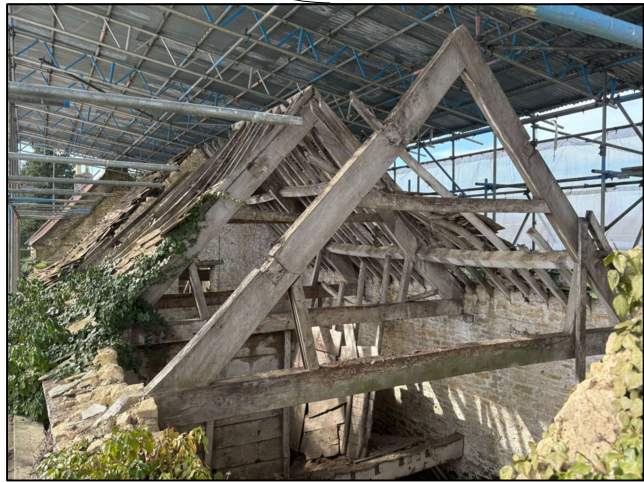
Section of existing roof with roof trusses and rafters in place.

Structural recommendation to remove loose stone slates and foliage from stonework and timbers in preparation for full structure review of building.

Any loose timbers are to also be removed, with significant pieces to be stored in safe place.

Stone slates to be removed carefully and salvaged for reuse later on. Stone slates are to be store on site in a location to be agreed.

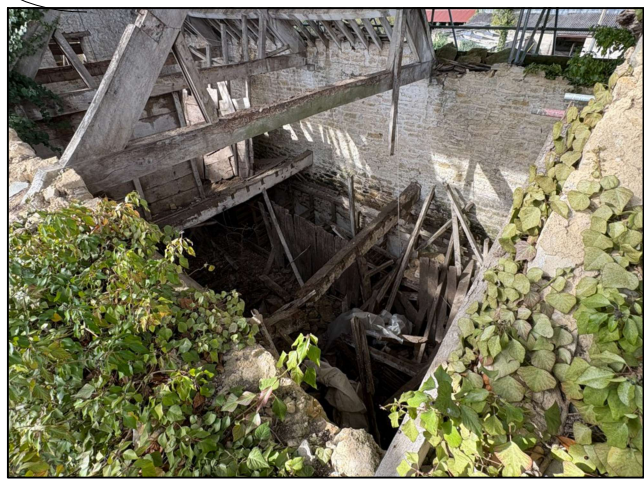
Significant amount of debris within the building, which appears to be roof structure material that has fallen in on the first floor that has further collapsed onto the ground floor. The build up of debris that is leaning on the external walls are starting to push the walls out.

Structural recommendation to remove debris and foliage to reduce the load impact on the existing external walls. Further structural survey of the building to then take place.

All existing broken timbers to be removed, along with stone slates and other debris. Stone slates, significant pieces of timber and timber panning to be salvaged and stored in safe place.
