project  
WESTFIELD FARM  
Latton, Wiltshire GL7 5QQ

drawing  
**Existing Ground  
Floor Plan**

251017-100

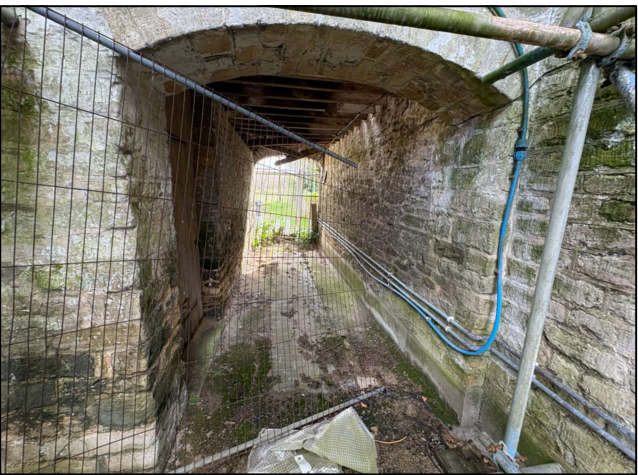
General view of passageway under listed building

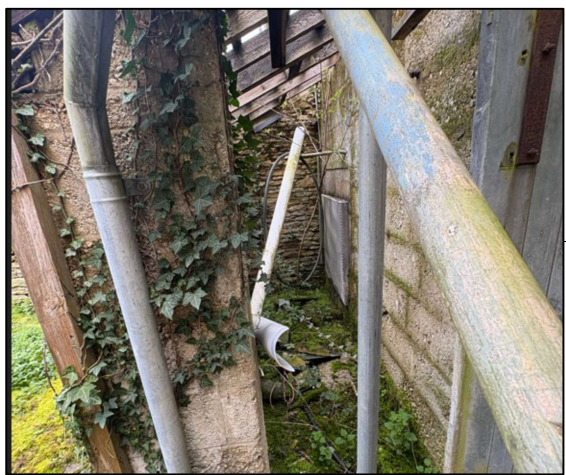
Debris within the lean-to building, which appears to be general stored materials.

Structural recommendation to remove debris and foliage to allow further structural survey of the building

If any significant pieces of timber and timber paneling and any other historic fabric to be salvaged and stored in safe place.

Any floor and partition structure that is still in original place (and not rotten or damaged) to remain as is.

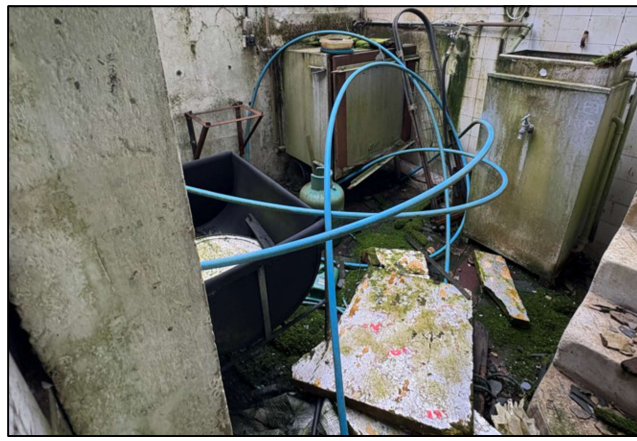
Significant amount of debris within the lean-to building, which appears to be general stored materials.

Structural recommendation to remove debris to further structural survey of the building to

If any significant pieces of timber and timber paneling and any other historic fabric to be salvaged and stored in safe place.

Any floor and partition structure that is still in original place (and not rotten or damaged) to remain as is.

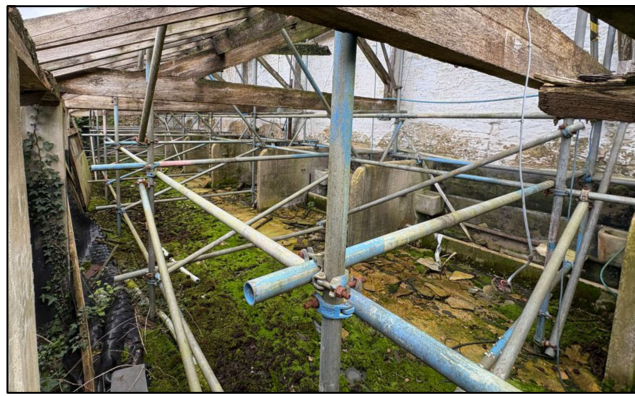
Debris within the lean-to building, which appears to be general stored materials.

Structural recommendation to remove debris to further structural survey of the building to

If any significant pieces of timber and timber paneling and any other historic fabric to be salvaged and stored in safe place.

Any floor and partition structure that is still in original place (and not rotten or damaged) to remain as is.

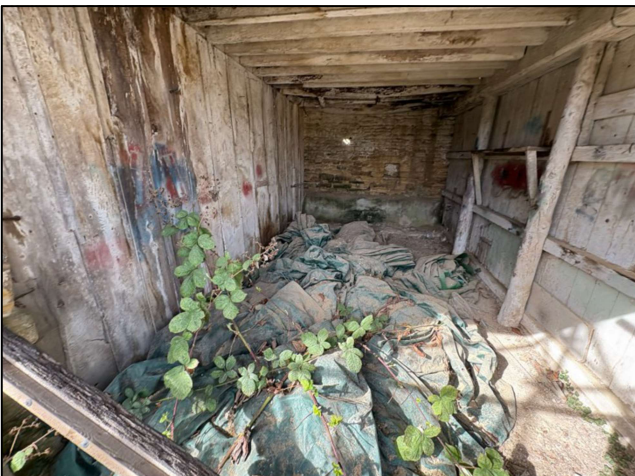
Significant amount of debris within the building on ground floor, which appears to be general stored materials.

Structural recommendation to remove debris to further structural survey of the building to take place.

Significant pieces of timber and timber paneling and any other historic fabric to be salvaged and stored in safe place.

Any floor and partition structure that is still in original place (and not rotten or damaged) to remain as is.

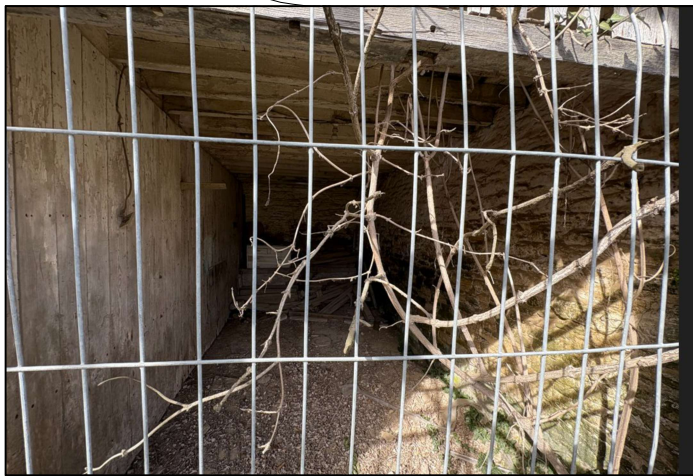
Significant amount of debris within the building on ground floor, which appears to be general stored materials.

Structural recommendation to remove debris and foliage to further structural survey of the building to take place.

Significant pieces of timber and timber paneling and any other historic fabric to be salvaged and stored in safe place.

Any floor and partition structure that is still in original place (and not rotten or damaged) to remain as is.
