project  
WESTFIELD FARM  
Latton, Wiltshire GL7 5QQ

## Existing Elevations

| 251017-103 | rev |

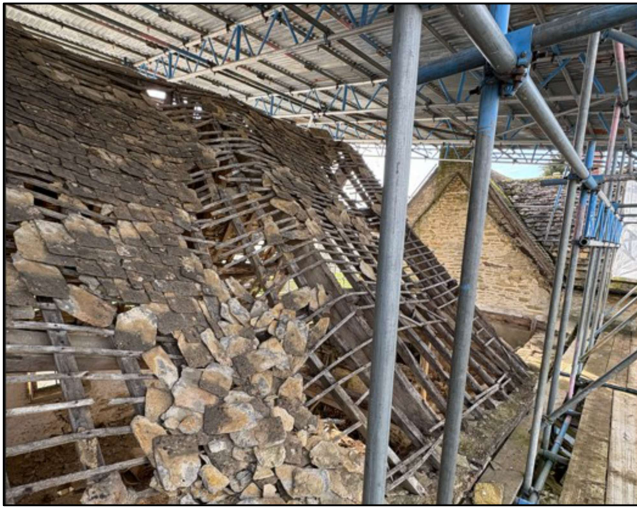
Section of existing roof with roof timbers and stone slates still in place. However, it appears that the roof timbers are starting to show signs of collapse.

Structural recommendation to remove stone slates to reduce weight load on existing timbers and prevent further damage in preparation for further structural review of existing structure.

Stone slates to be removed carefully and salvaged for reuse later on. Stone slates are to be store on site in a location to be agreed.

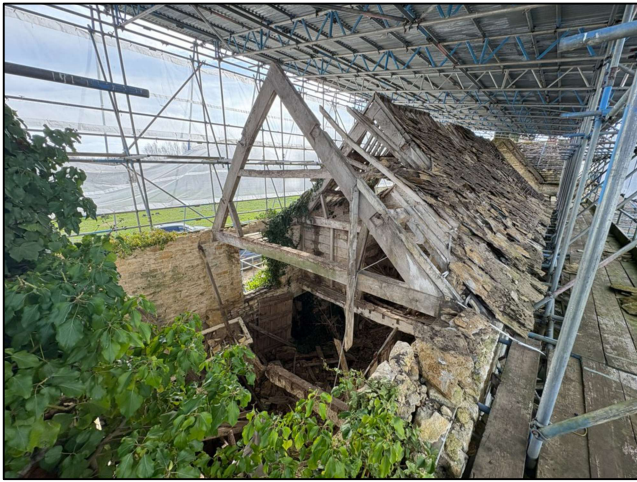
Section of existing roof with roof trusses and rafters in place.

Structural recommendation to remove loose stone slates and foliage from stonework and timbers in preparation for full structure review of building.

Any loose timbers are to also be removed, with significant pieces to be stored in safe place.

Stone slates to be removed carefully and salvaged for reuse later on. Stone slates are to be store on site in a location to be agreed.

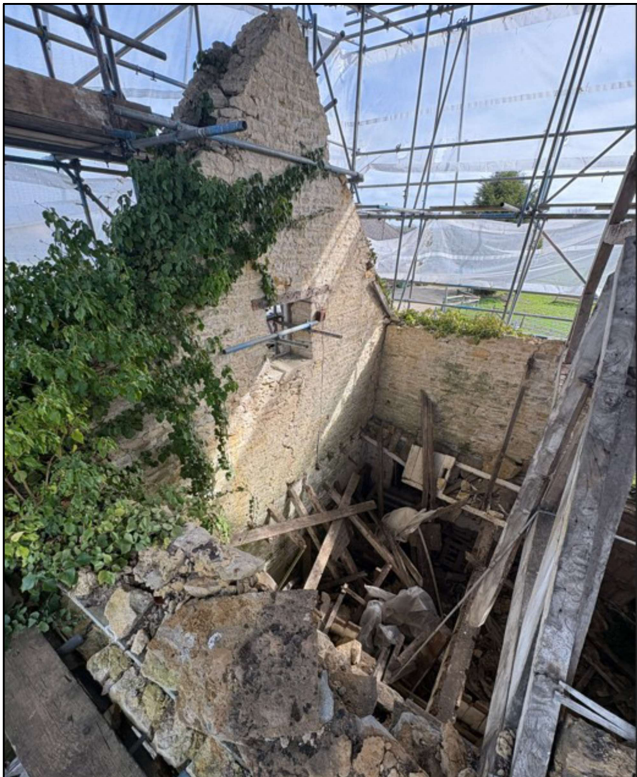
Significant amount of debris within the building, which appears to be roof structure material that has fallen in on the first floor that has further collapsed onto the ground floor. The build up of debris that is leaning on the external walls are starting to push the walls out.

Structural recommendation to remove debris including foliage to reduce the load impact on the existing external walls. Further structural survey of the building to then take place.

All existing broken timbers to be removed, along with stone slates and other debris. Stone slates, significant pieces of timber and timber paneling to be salvaged and stored in safe place.

Any first floor structure that is still in original place (and not rotten or damaged) to remain as is.

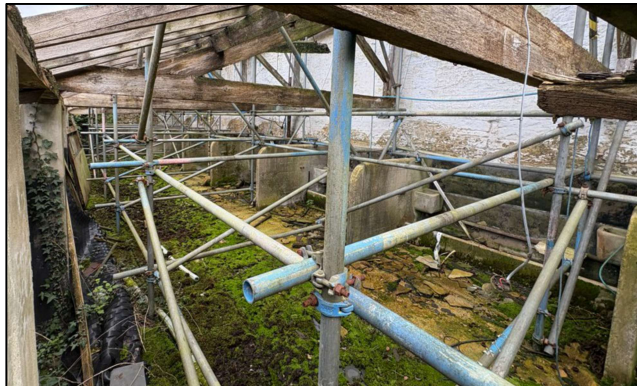
Debris within the lean-to building, which appears to be general stored materials.

Structural recommendation to remove debris to further structural survey of the building to take place.

If any significant pieces of timber and timber paneling and any other historic fabric to be salvaged and stored in safe place.

Any floor and partition structure that is still in original place (and not rotten or damaged) to remain as is.

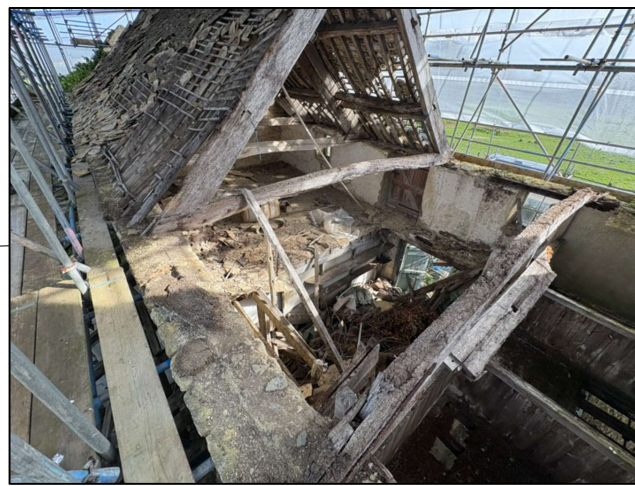
Significant amount of debris within the building, which appears to be roof structure material that has fallen in on the first floor that has further collapsed onto the ground floor. The build up of debris that is leaning on the external walls are starting to push the walls out.

Structural recommendation to remove debris to reduce the load impact on the existing external walls. Further structural survey of the building to then take place.

All existing broken timbers to be removed, along with stone slates and other debris. Stone slates, significant pieces of timber and timber paneling to be salvaged and stored in safe place.

Any first floor structure that is still in original place (and not rotten or damaged) to remain as is.

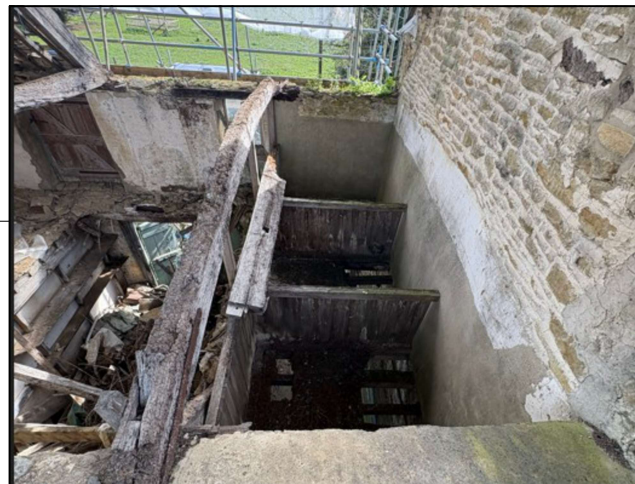
Debris within the building above passageway.

Structural recommendation to remove debris to reduce the load impact on the existing external walls. Further structural survey of the building to then take place.

All existing broken timbers and general debris to be removed. Significant pieces of timber and timber paneling to be salvaged and stored in safe place.

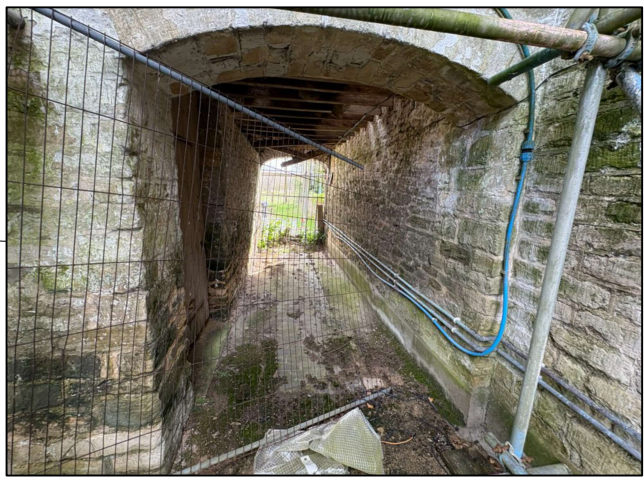
General view of passageway under listed building

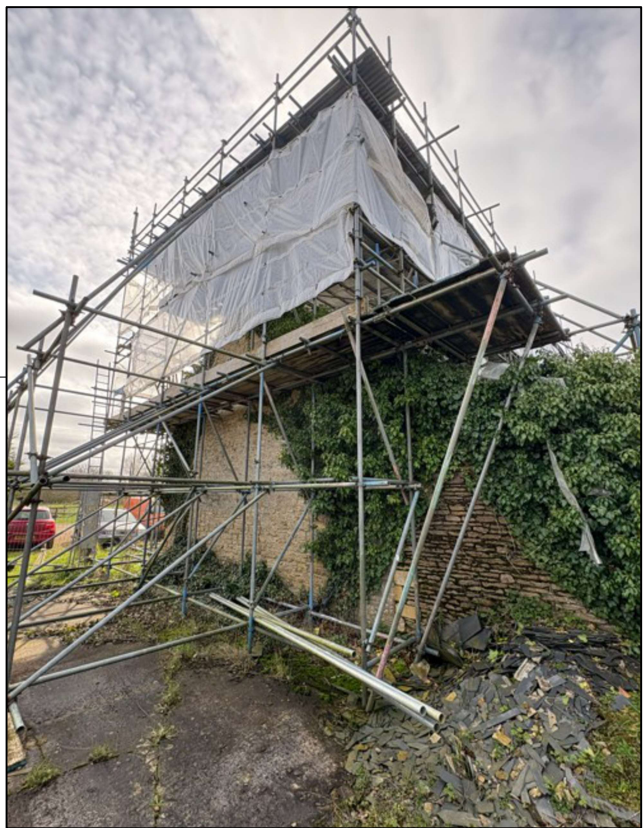
Significant amount of debris outside the building, which appears to be roof structure material that has fallen. The build up of debris that is leaning on the external walls are starting to push the walls inwards.

Structural recommendation to remove debris including foliage to reduce the load impact on the existing external walls. Further structural survey of the building to then take place.

All existing broken timbers to be removed, along with stone slates and other debris. Stone slates, significant pieces of timber and timber paneling to be salvaged and stored in safe place.
