# Outline Structural Condition Report & Schedule of Works

Front Barn At Westfield  
Farm, Ermin Street,  
Latton, Wilts, GL7 5QQ

| Project title | Front Barn at Westfield Farm, Ermin Street, Latton, Wilts, GL7 5QQ |
| Document title | Outline Structural Condition Report & Schedule of Works |

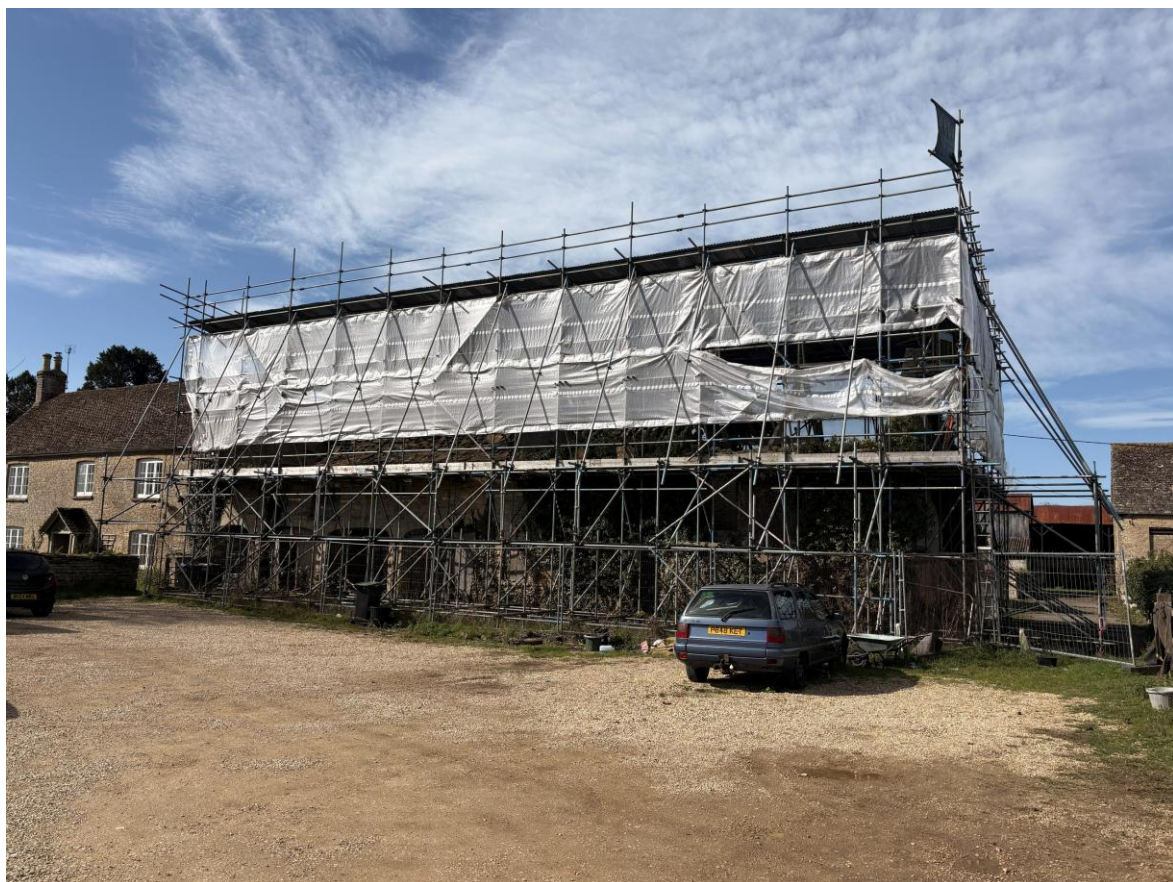
**General Current View of Building Front Elevation**

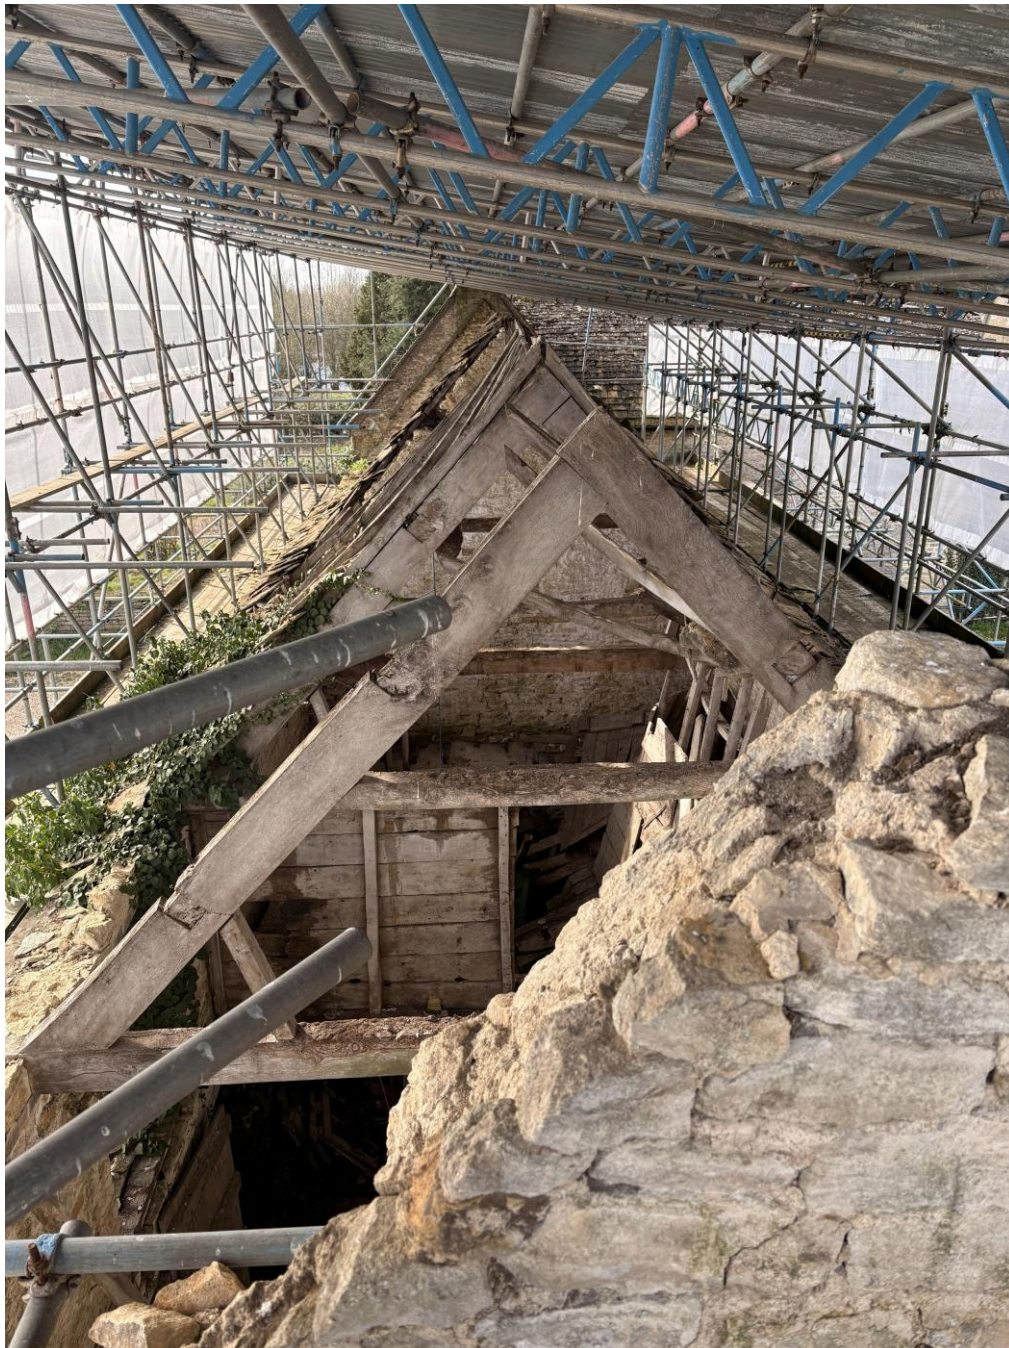
**General View of Current Roof Structure – Photograph Taken From East Gable Looking West**

The majority of the roof that can be seen is in poor condition, the effects of weather and exposure are visibly apparent. The principle rafters are visibly misaligned out of plane, and the purlins sagging.

It is likely that not only repair but strengthening too of the existing remaining timber members will be required, before the roof can safely again support the proposed stone slate roof covering.

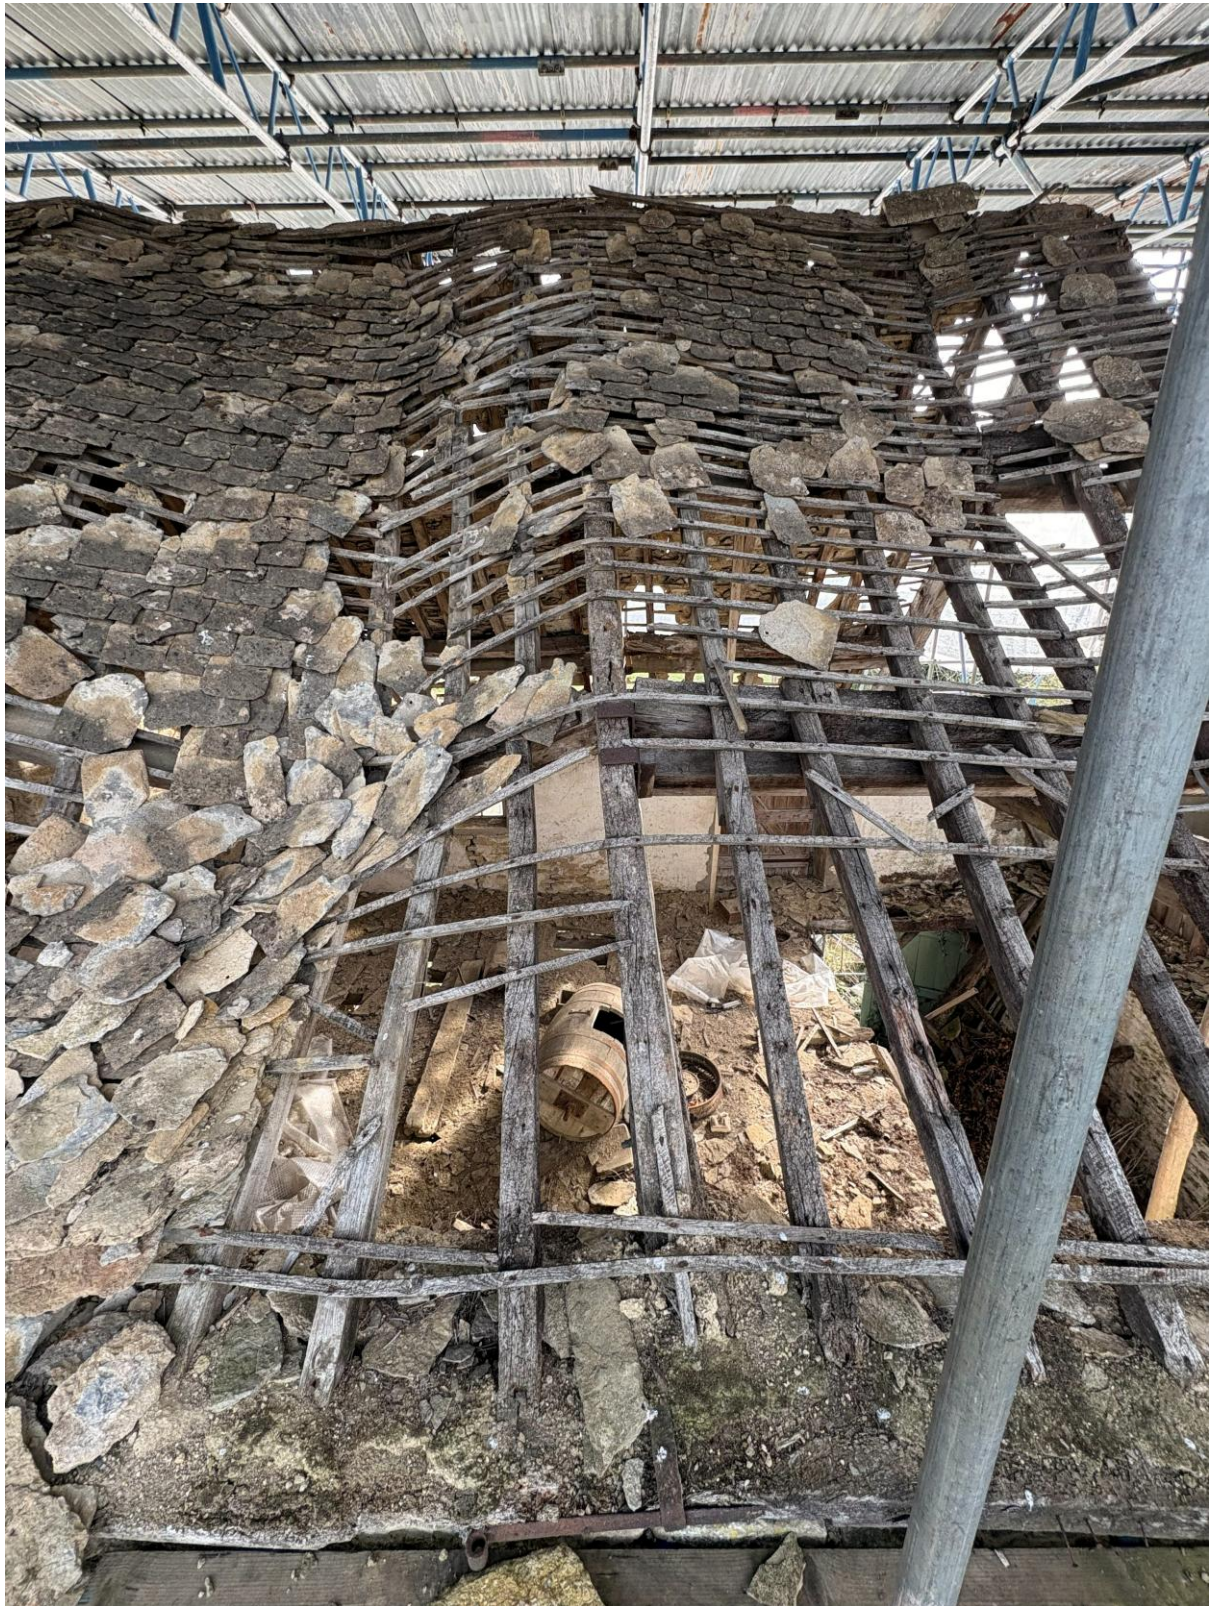
**View of Mid – Section of The Roof – Showing Deformed and Partially Collapsed State of The Roof Fabric – Note The Dislodged ‘Rivers’ of Stone Slates**

Perhaps only 20% of the roof covering, is intact and in place, the remainder dislodged, loose or fallen.

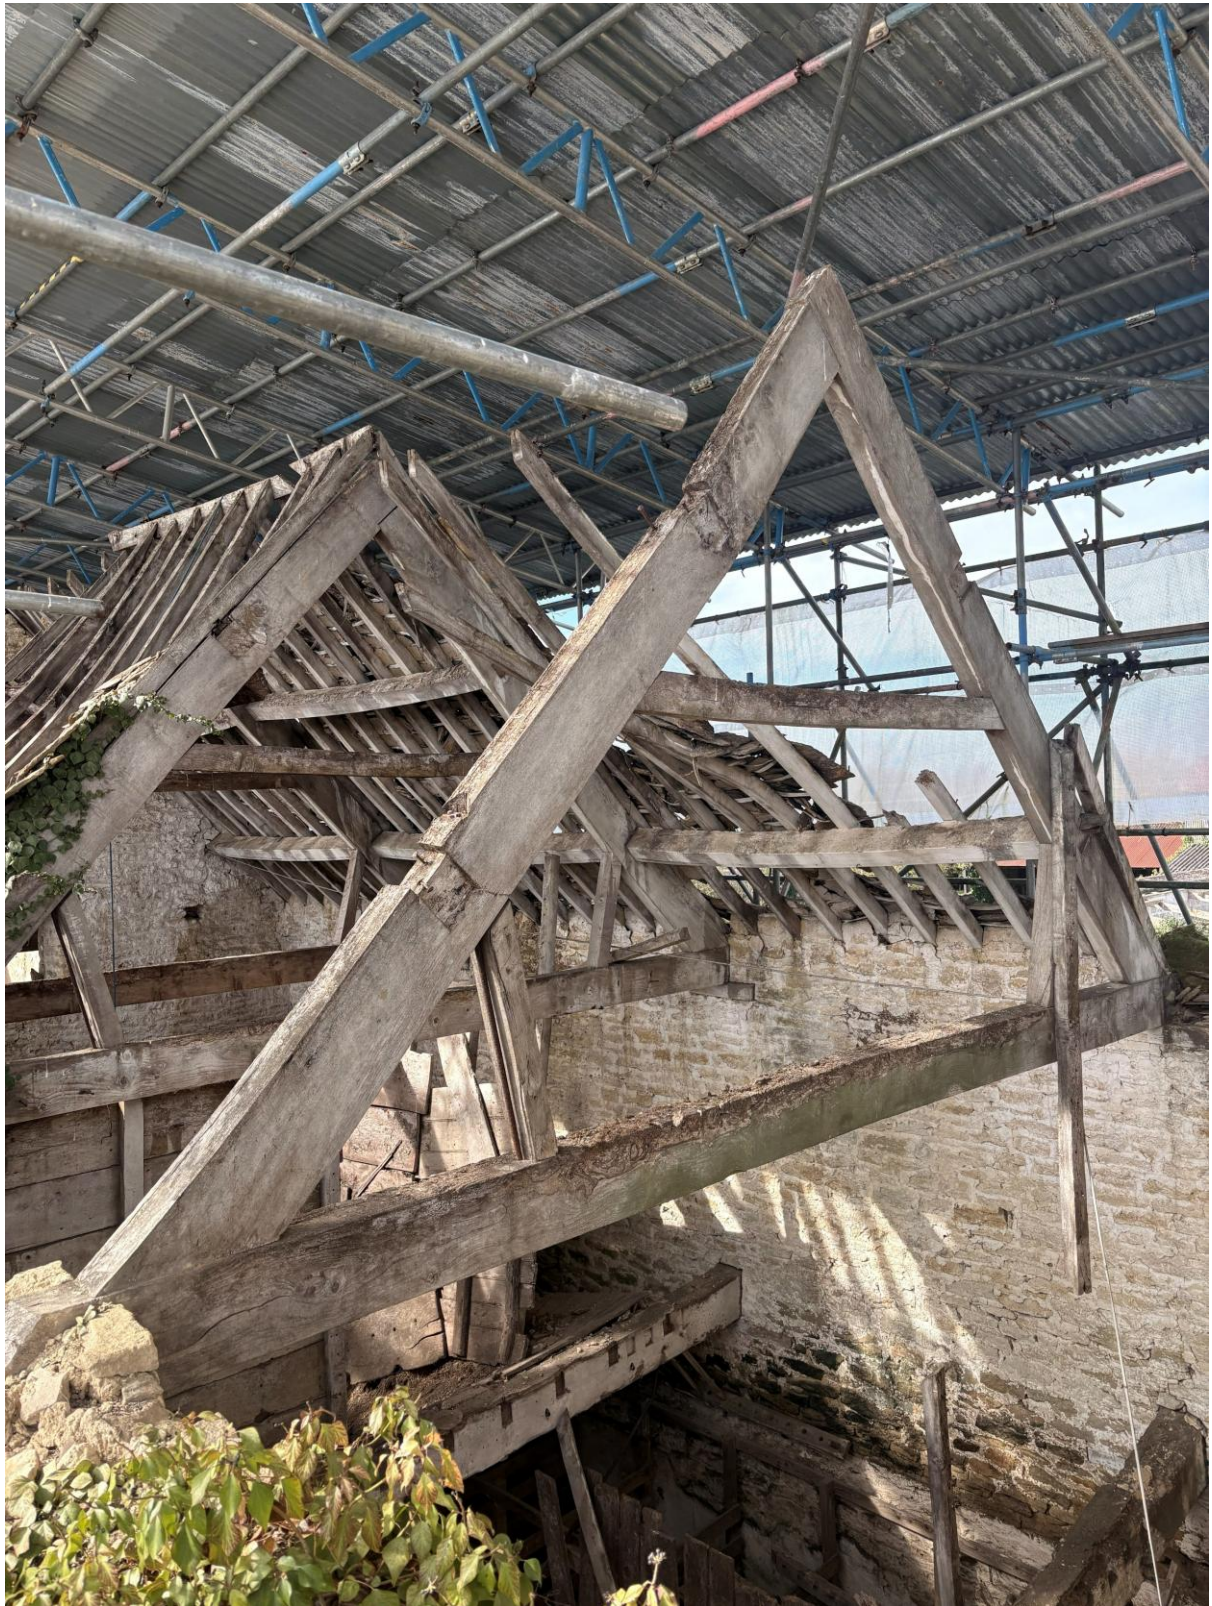
**View of Eastern End Section of Roof – Note Missing (Collapsed) Roof Slates, Rafters and Purlins**

The stone slate roof covering, common rafters and purlins are missing totally in the two eastern bays and the last western bay at the junction with the farm house, thus three out of seven bays are missing and have fallen onto the first floor.

From the last photograph, the elemental form of the typical roof truss can be seen – this being the two principle rafters and tie beam forming the triangulated A frame, the two lower queen struts under the lower purlin mortices, and the upper collar mid-way between the purlin mortices.

This is most likely achievable by removing the vertical polythene side sheeting at the front of the building and using a cherry picker access platform to remove loose stone slates, and dangerously loose timbers from the roof structure to prevent them from falling.

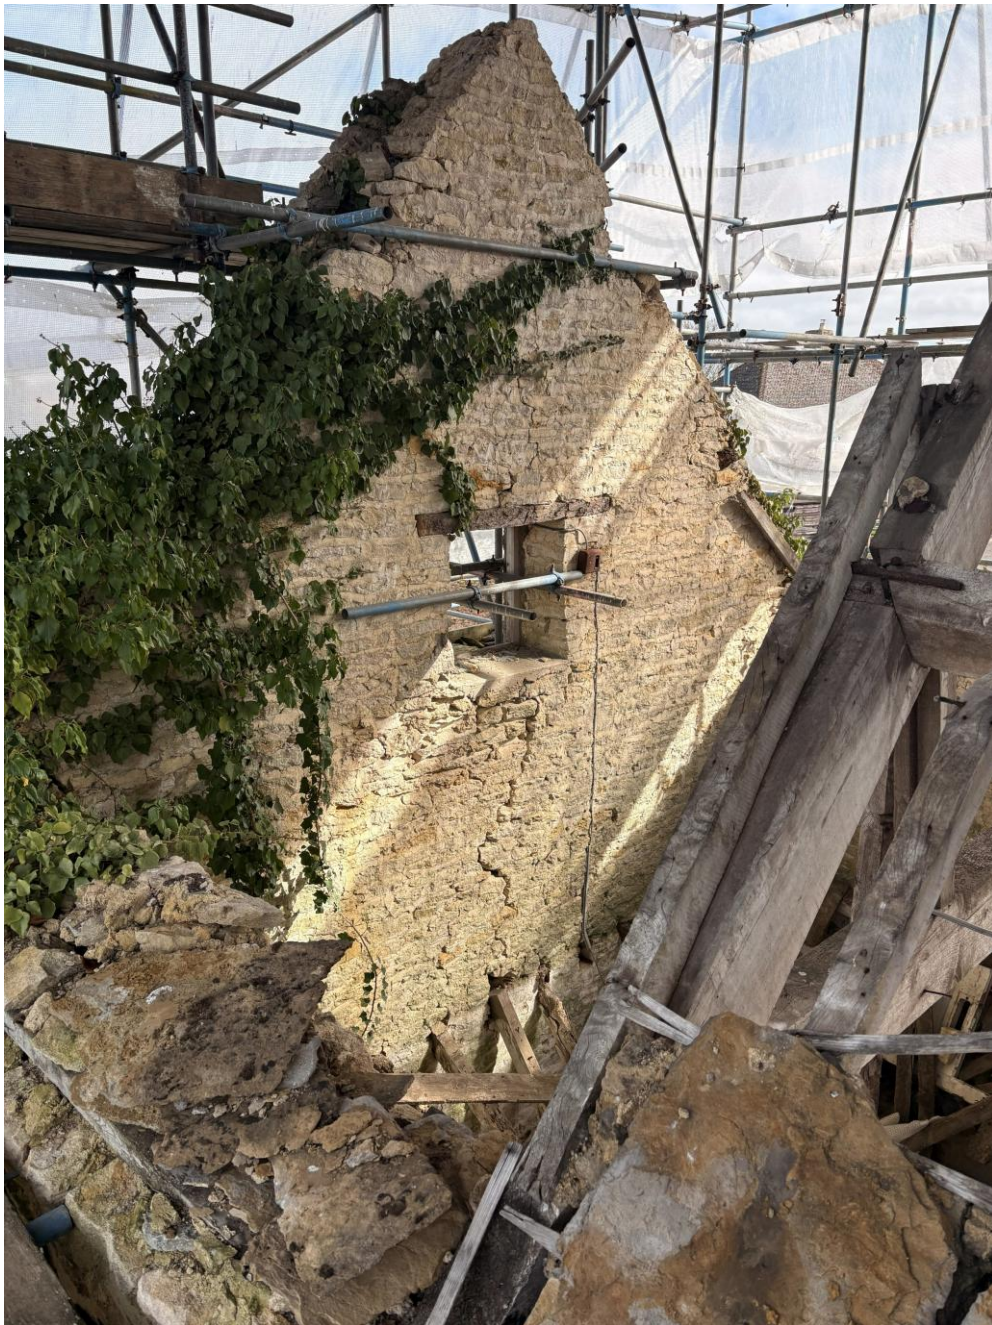
There is some evidence of vertical and stepped cracking caused by historic foundation movements.

**General View of Eastern Gable Wall – Note Vertical Cracking**

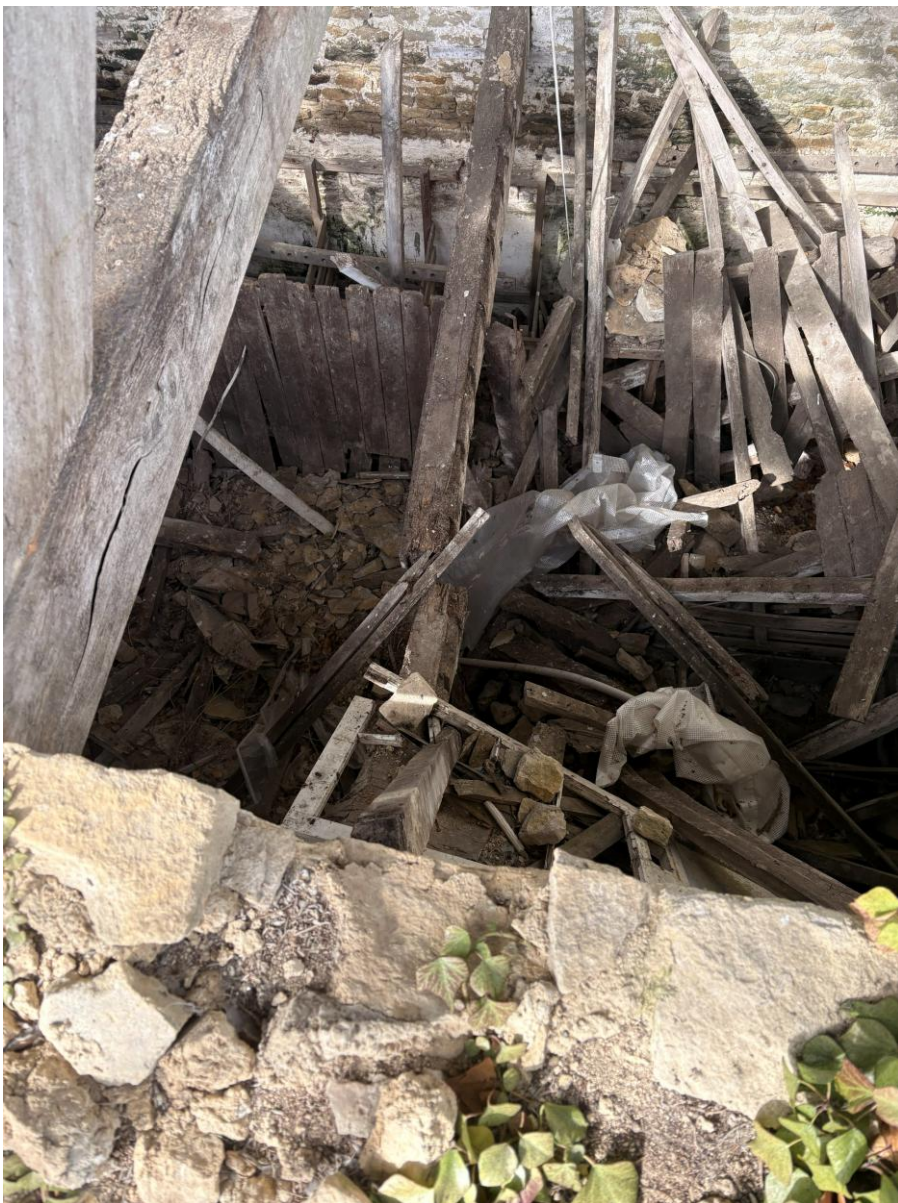
Fallen roof debris and timber first floor walls have collapsed onto the first floor structure and caused overload and damage, either in the form of destruction of the beams and joists or severe deformation.

**General View of Eastern Section Of Floor – Note Collapsed Beam and Missing Joists**

This element of the building requires clearance before any meaningful assessment can be made.

Once this has been completed and the principle roof structure stabilised by strapping or bracing, the internal first floor can then be tackled in a similar fashion to make it safe for inspection.
