**Record of Condition of 5 Windows at  
35 Temple Corsley Warminster Wilts**

**BA12 7QN**

**March 2026**

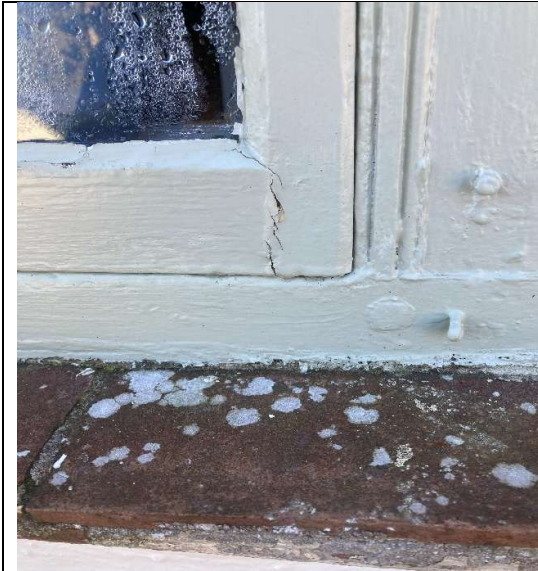
Window W1 Right hand bottom corner -  
Tiled cill – casement joints in poor  
condition

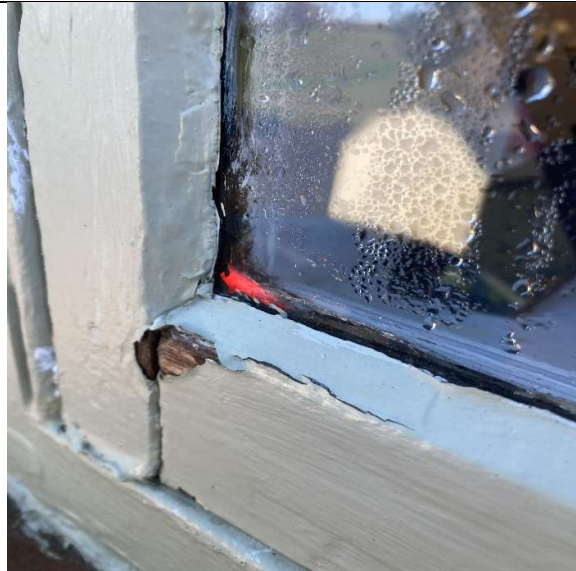
Window W1 left hand bottom corner- open  
casement joint and significant rot to frame

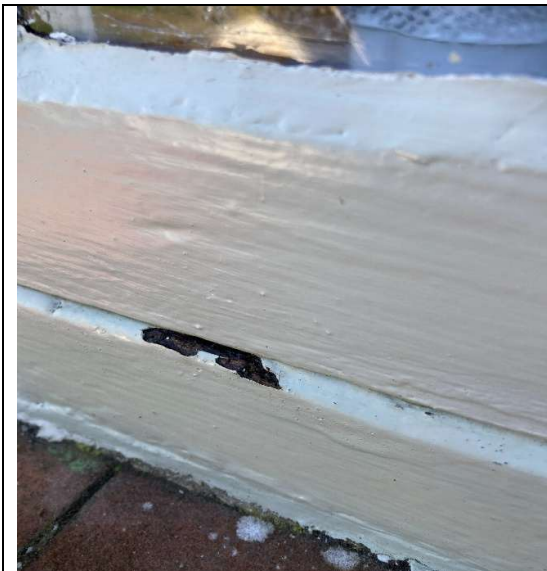
Window W1 centre of frame showing  
significant rot

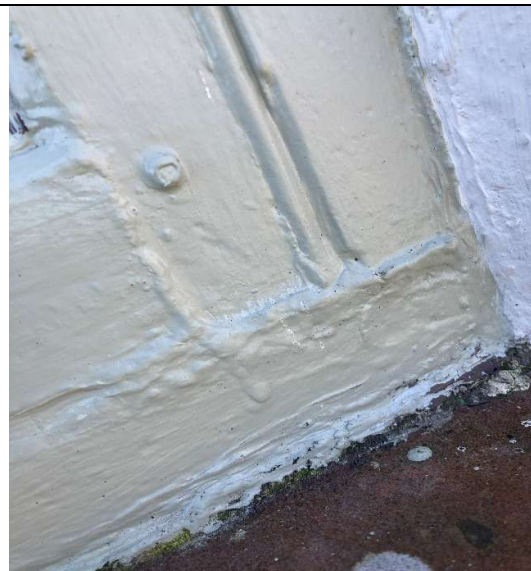
Window W1 right hand base of frame  
showing heavily filled and painted

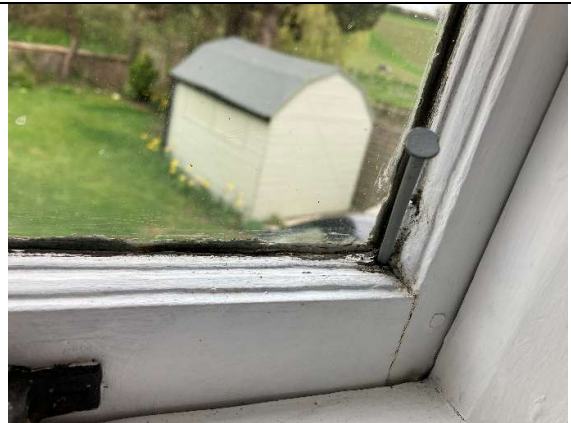
W1 note nail pressed into rotten wood in corner of casement

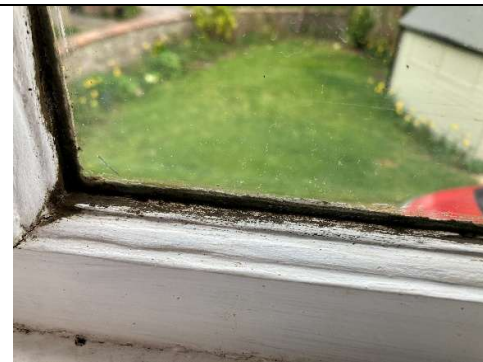
W1 note rot to casement

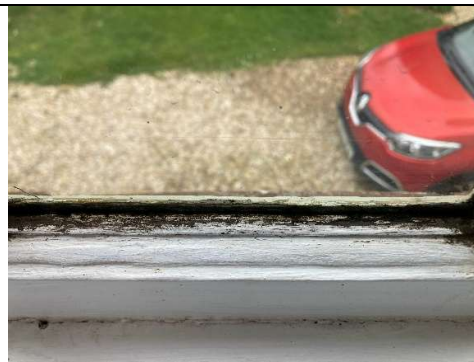
Note rot to bottom rail of casement

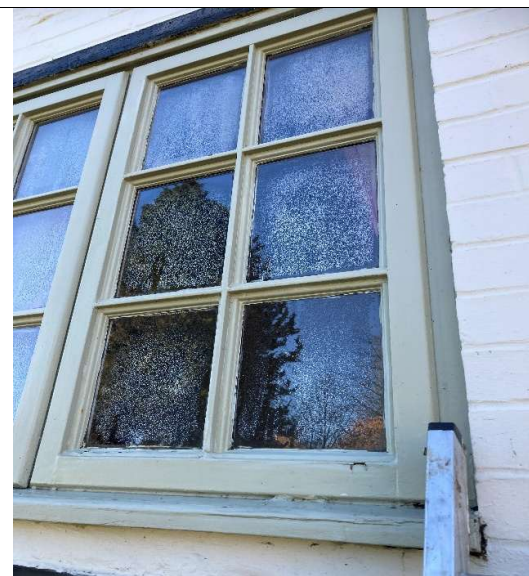
Window W3 showing projecting casements. Timber cill to be retained

Window W3 – recent window to be replaced to match style of windows W1 and W4

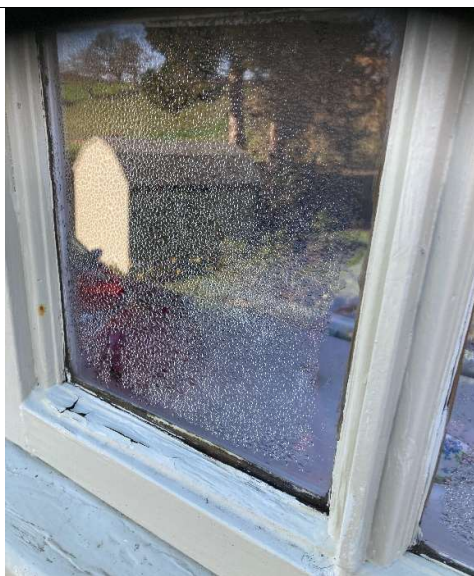
Significant rot to glazing bars

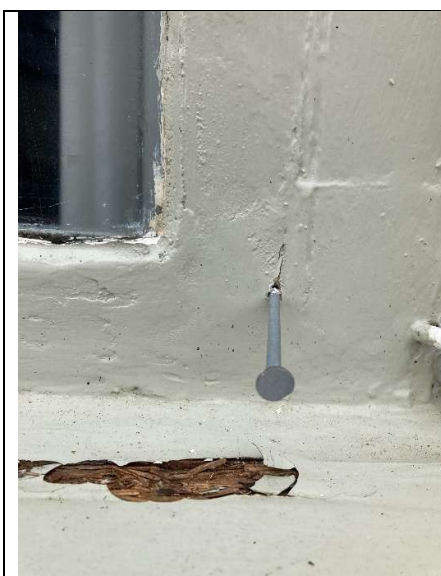
Rotten frame right side and note nail pressed into rotten frame

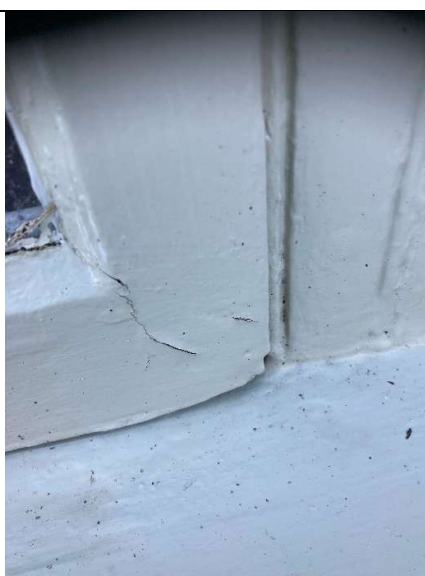
Cracked frame lower right side

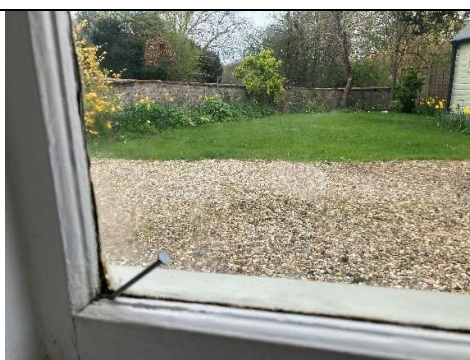
W2 note nail pressed into rotten casement frame

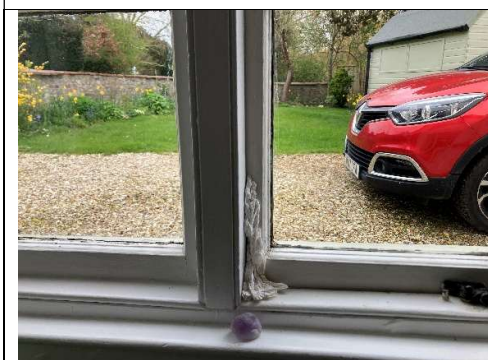
Note tissue paper to seal up hole in casement frame

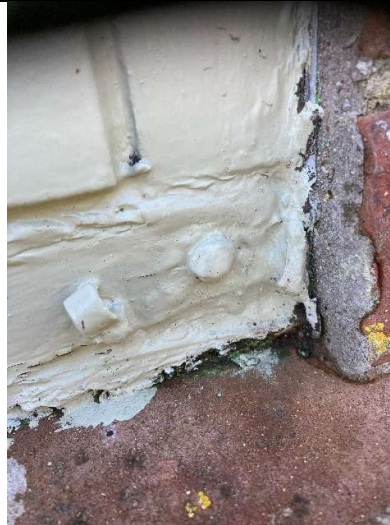
Detail on window frame lower left showing considerable rot to frame

The window is a close match to the window in the adjoining property and will be replaced as an exact single glazed replica

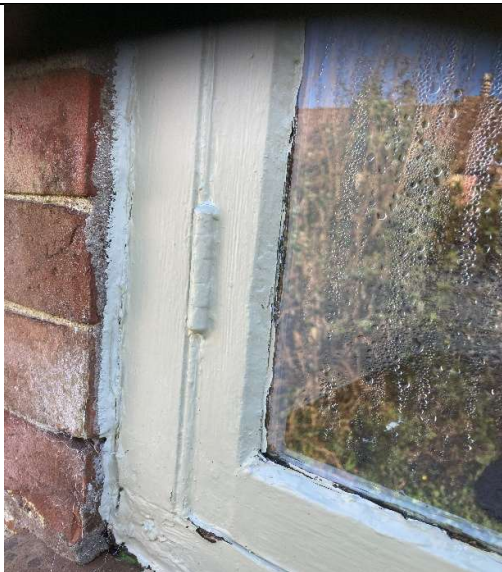
Detail lower left casement painted shut and rot to frame

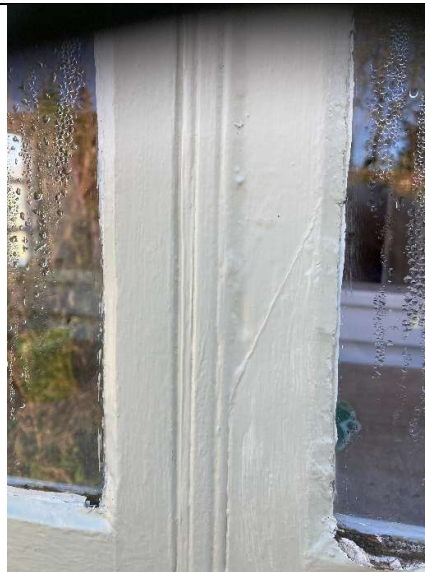
Centre mullion showing casement painted shut and rot to fixed casement frame

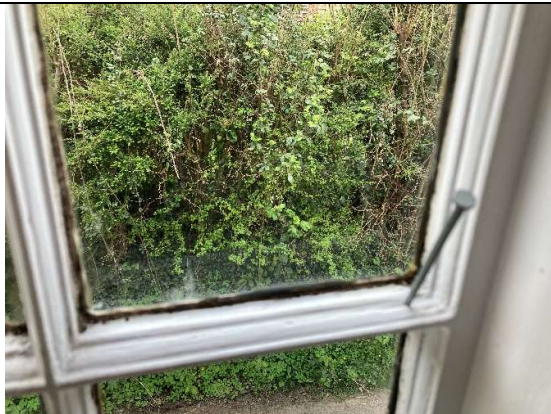
W4 note nail pressed into rotten glazing bar

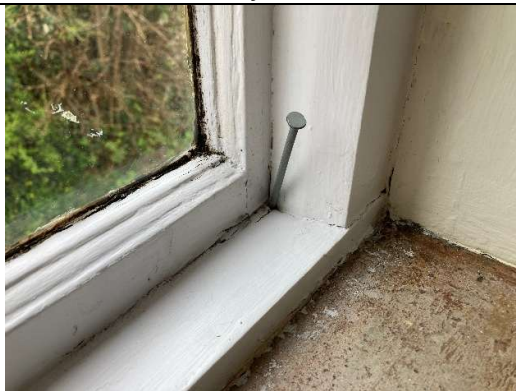
W4 Note nail pressed into rotten frame

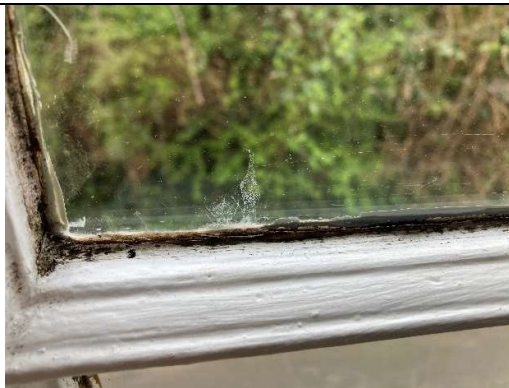
W4 note rot around casement frame
