# **3 Northgate Street, Devizes**

**A Historic Buildings Statement**

**February/March 2026**

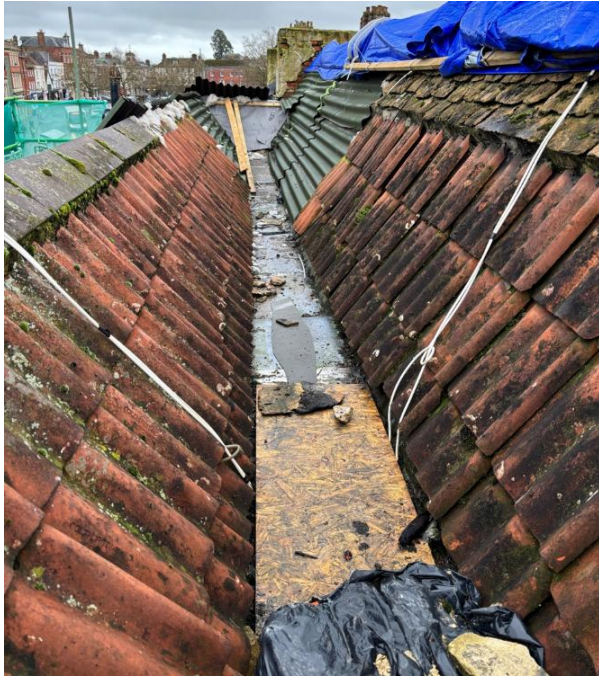
Due to the handy presence of scaffolding, the roof covering could be inspected in some detail. The higher, rear roof is primary, now covered in a mixture of stone tile, double roman tile and corrugated iron laid horizontally, all observed on the inner pitch (**fig.20**). Tarpaulin covers the apex of the roof, and is a recent addition.

**Fig.20 Valley between front and rear main roofs**

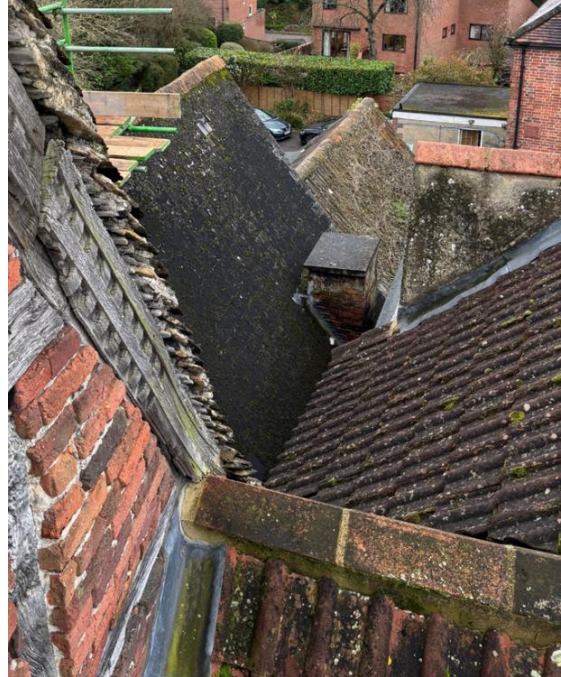
The rear range roofs visible from the scaffolding show slate tile on the steep pitched first extension, and a lower roman tile roof to the second extension (**fig.21**).

**Fig.21 View of rear range roofs**

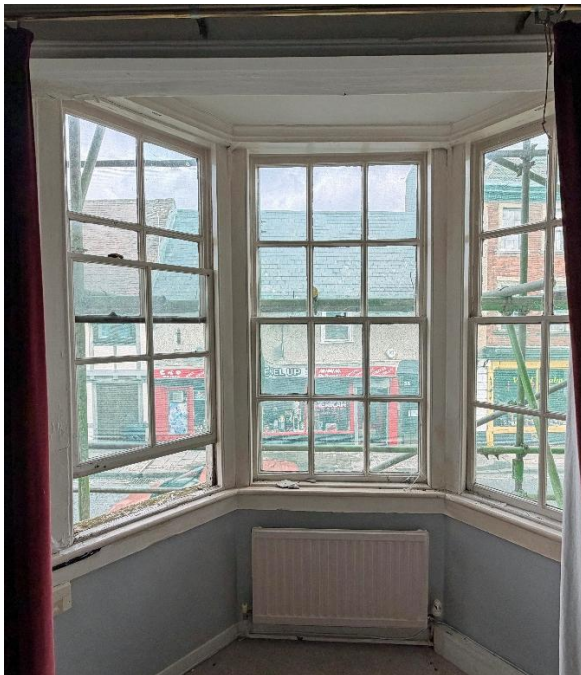
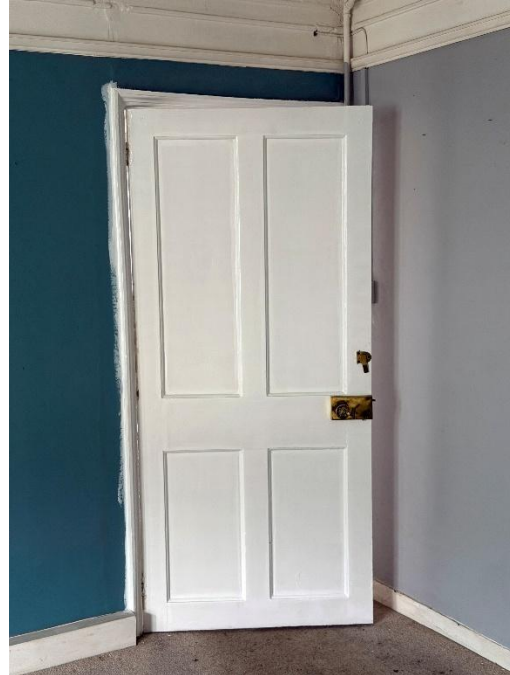
**Fig.47 Bay window retaining historic sashes with moulded glazing bars and moulded cornice**

**Fig.48 4-panel door**

Carpeted bedroom. Lath and plastered ceiling with plastered transverse beam. Later picture rail. Acanthus leaf cornice much overpainted with consequent loss of detail (**figs.46 & 49**). Exterior walls dry-lined with plain skirtings. Bay window with thick 1½" (4.5cm) moulded glazing bars, some repairs (**fig.47**). Floor covered with fitted carpet, so boards beneath not seen.

4-panel door with brass rim lock and knob handles on plain butt hinges. Flattened ogee architrave surround of the 19<sup>th</sup> century (**fig.48**).

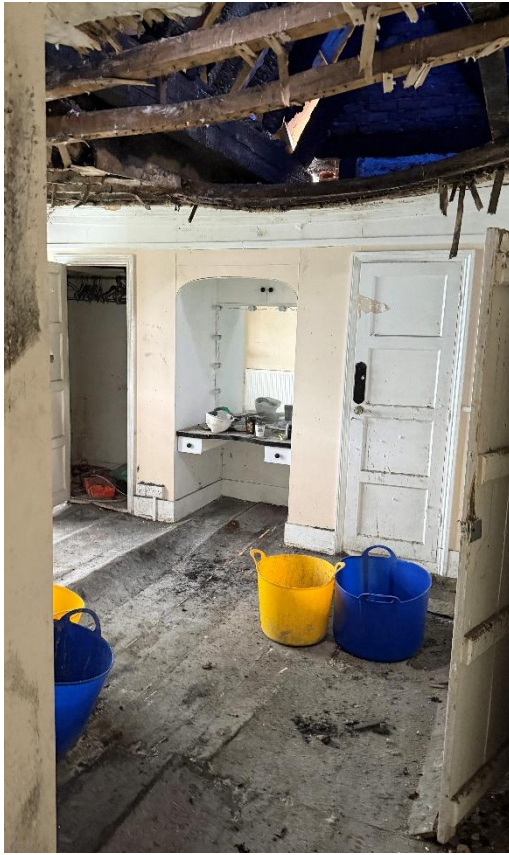
**Fig.63 South Attic Room from doorway**

Access to this room was restricted due to the amount of fire damage and subsequent water ingress damaging the historic floors which look to be 11" oak boards, as in the north room. The damaged ceiling shows a construction of riven lath and plaster. The decorative plastering of a transverse beam has come away from the beam, which is seen to be made up of two sections with plaster between. The cornice comprises two bands of decoration; an upper egg-and-dart band, and a wider, lower band of garlands with fleurons. This was carried on either side of the beam.

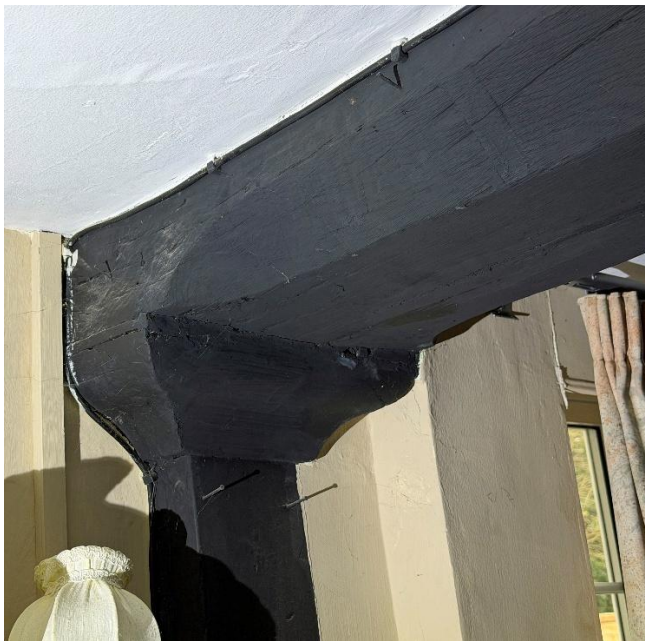
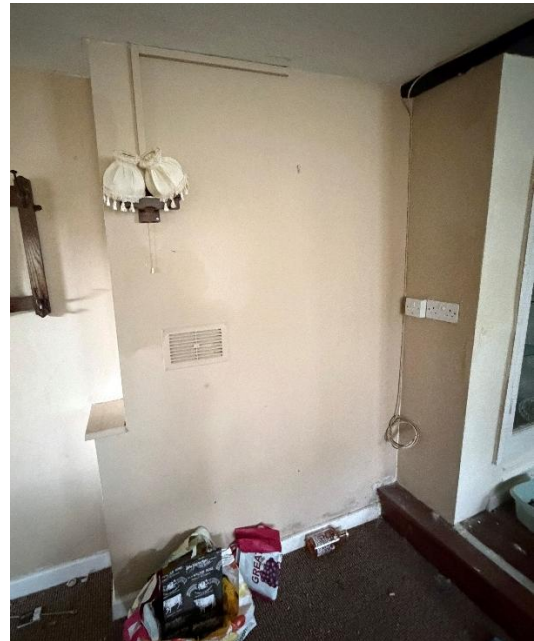
Entrance to the wing inside the back door involves 3 steps down. A domed cut-away facilitates the inwards door-swing, and mirrors the same arrangement on the first floor. The door is of 6 panels and hung on HL hinges (**fig.65**). The only example of this hinge type in the house, excepting the others being of 19<sup>th</sup> century date or later. The ceiling here is likewise stepped, with the eastern, upper part lath and plastered, the lower part at the west end being 49lasterboarded. One older reused beam has been identified, partly resting on a curved bracket and shallow pilaster at the south end. The beam has a wide chamfer indicating at least an early 17<sup>th</sup> century date. At the south end there is evidence that the decorative chamfer stops – apparently bars – have been cut away, perhaps to disguise it as a reuse from an older structure (**fig.66**).

**Fig.66 Reused mutilated 17<sup>th</sup> century beam    Fig.67 Blocked back kitchen fireplace**

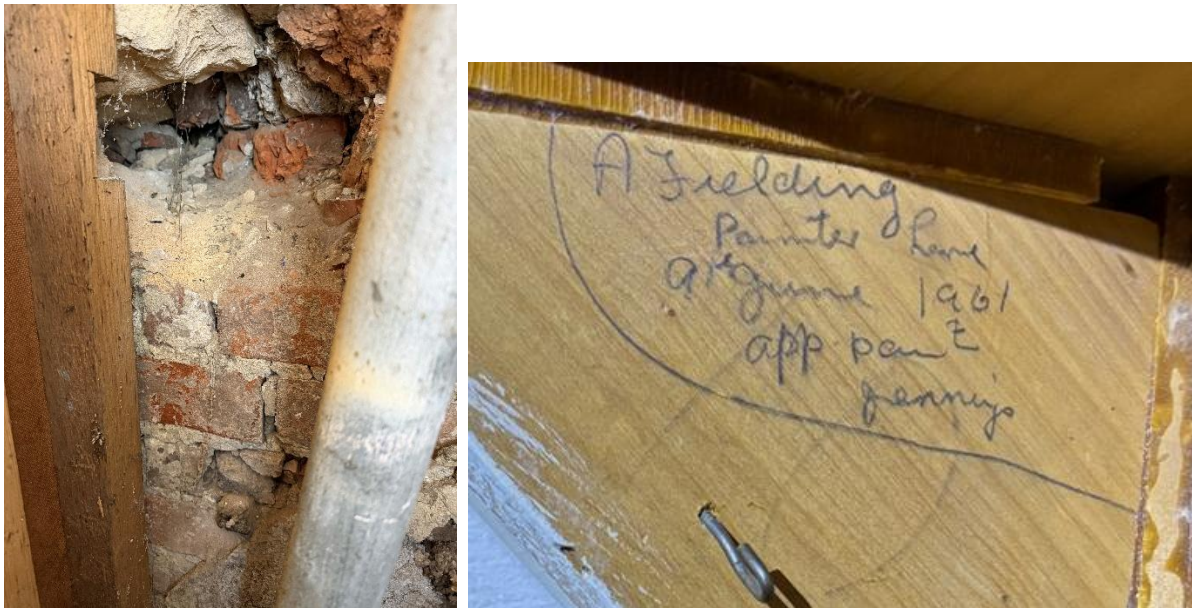
exposed remains of plastering over brickwork set in a lime mortar, and also part of an ashlar block visible – perhaps part of a fireplace surround (**fig.68**). This is further indicated by some evidence of smoke-blackening.

**Fig.68 Fireplace return seen in stair cupboard. Note stonework perhaps for an ashlar lintel, and smoke blackening**

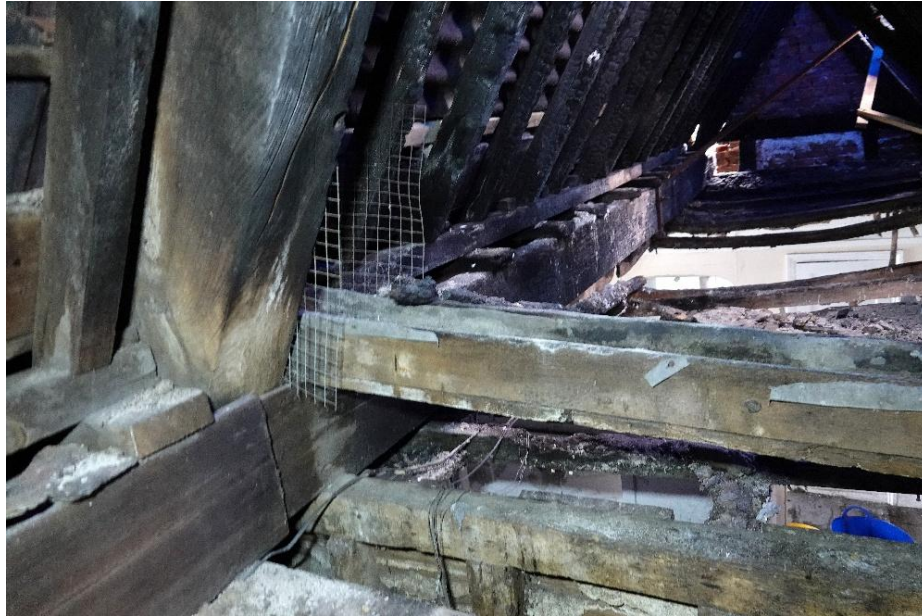
Returning to the main roof range, **Truss T2** is charred from the fire but otherwise survives. The whole truss cannot be shown in a single photograph but its individual elements are shown in **figs. 90-94** below. The principal rafter on the front slope is possibly a replacement, perhaps when the horizontal plate was added, and it is

possible the truss is a composite made from re-used elements from the primary build. However, the rear slope does still retain its primary principal rafter, 150 x 200mm in section, and this timber has some interesting features. There is an unusual carpenter's mark in the form of a chiselled double "V", see **fig. 10**. The truss apex detail is shown in **fig. 9**, and is a heavy yoke plate over a bridled joint, apparently primary, with a housing for a heavy diamond ridge piece, now replaced by a thin plank ridge.

***Figs. 91. Truss T2, showing on the left the principal rafter of the front slope. The internal gutter can be seen cutting across the centre of the image, and below it, the top of a framed lath-and-plaster partition. See also Fig. 97.***

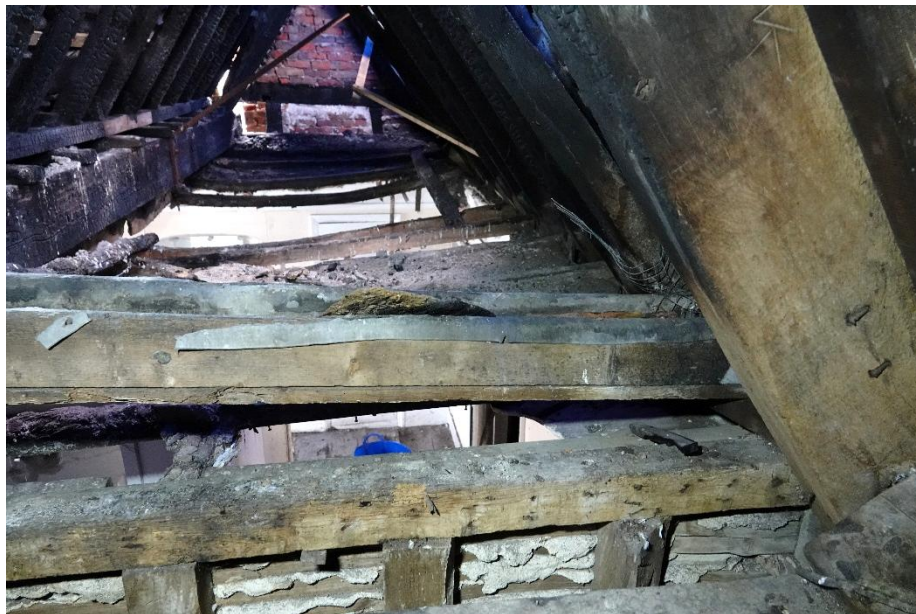
Adjacent to T2 is an internal gutter running through the roof space from front to rear. The gutter is an open box with a lead lining and clearly dates from the addition of the subsidiary front ridge roof. It discharges through the rear slope of the main roof (**fig 97**).

***Fig. 97. The lead-lined gutter cutting through the roof space by T2***
