30<sup>th</sup> March 2026

### 3 Northgate St, roof and elevation repairs - design statement

# JAMES MACKINTOSH ARCHITECTS

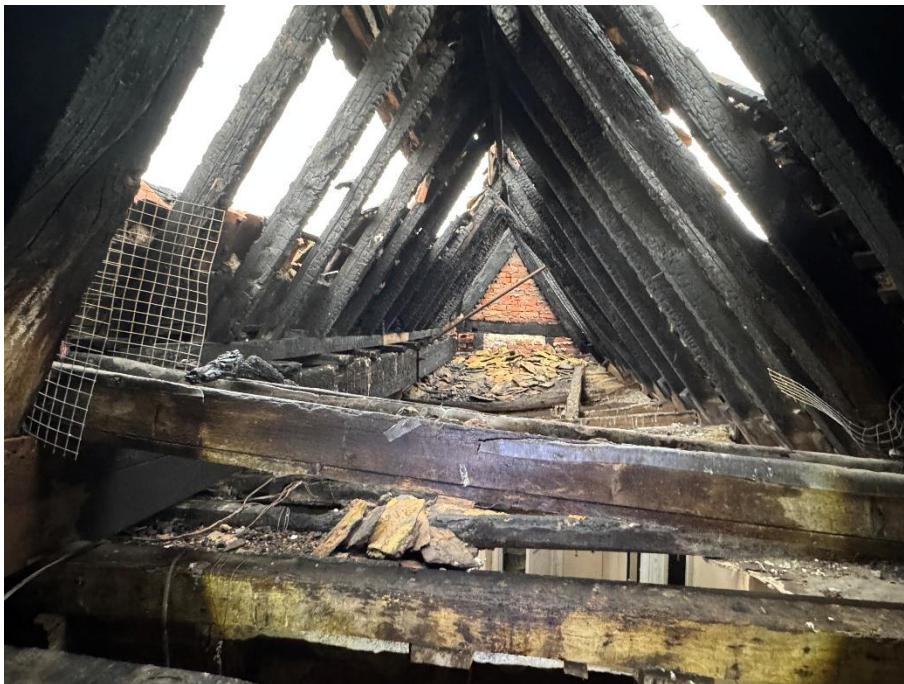
The works affect the eastern side of the building and involve replacement of approximately 80% of the existing rafters. This assessment is approximate due to the temporary roof covering, and every effort will be made to retain historic fabric where possible.

Fire damage to roof structure

Existing ceiling joists will be removed to allow access for repair works. The structural engineer has identified that the tying of the roof structure has been compromised over time due to previous alterations.

A large historic beam is no longer acting structurally but has been retained. It will be supported by new ceiling joists hung from 11" x 4" beams using steel straps at every third rafter.

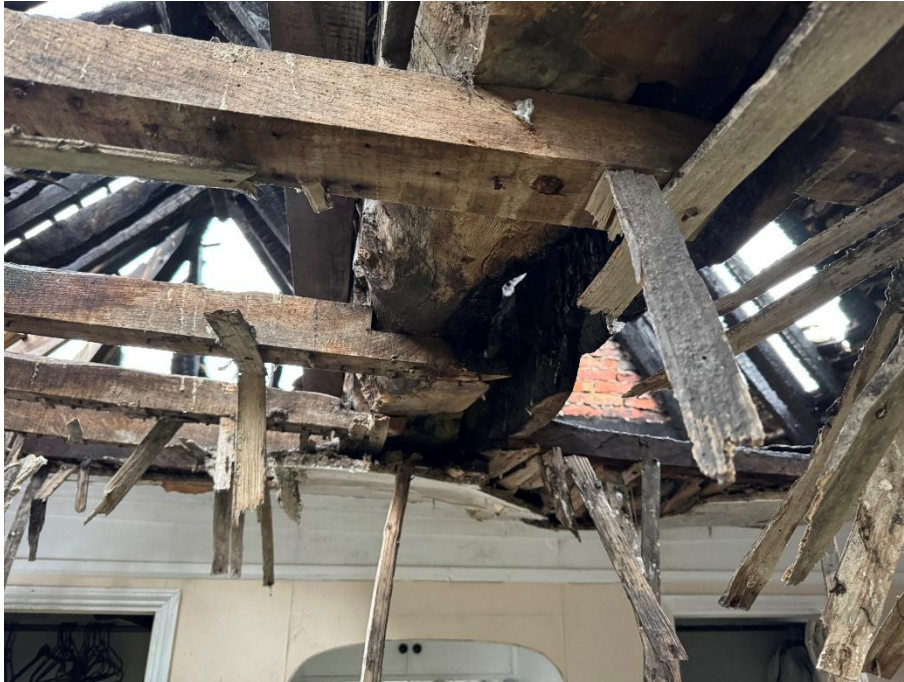
Historic beam and modern bearers either side.

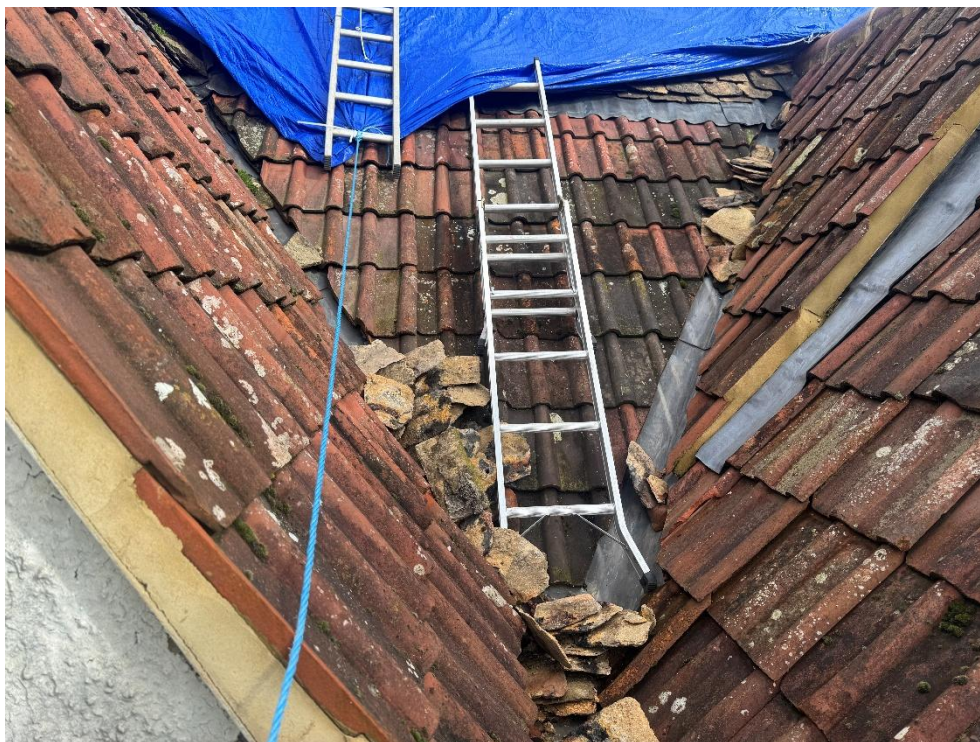
Modern interlocking tiles have been used on less visible areas, including the lower north-facing pitch within the valley and the south-facing pitch. A lead apron has been introduced at junctions between differing materials to prevent water ingress. The eastern return gable is also covered in modern interlocking pantiles.

Lead apron showing replacement of slate with modern interlocking pantiles.

New stone slates will be sourced locally to supplement existing materials and to re-cover areas currently finished in mixed materials. The February 2026 survey confirmed that the existing valleys are formed using the traditional Cotswold swept valley detail, which will be reinstated. Where the roof transitions to pantiles, lead valleys will be introduced.

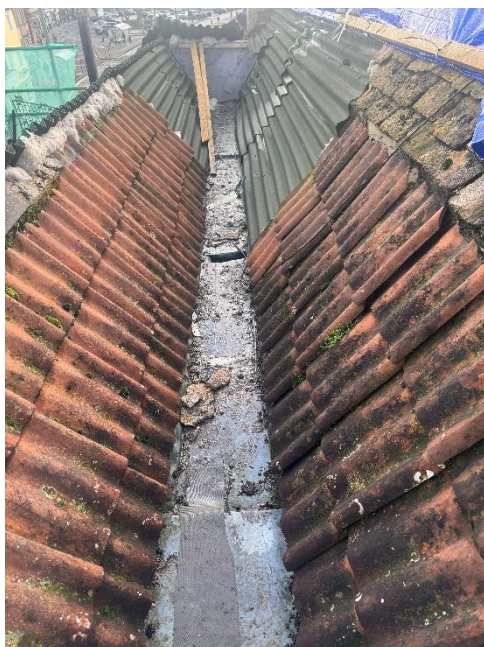
Valley showing lead gutter and pantile and slates in same roof pitch.

Due to limited access, and debris in the gutter at the time of the survey, the exact detailing of the existing lead valley gutter could not be fully recorded. The final detailing will be determined by the appointed roofer but will follow the established form shown on section 496/501 and roof

plan 105 to incorporate a new sump at the outlet location. The sump will discharge into the internal roof gutter and will be formed in minimum Code 6 lead.

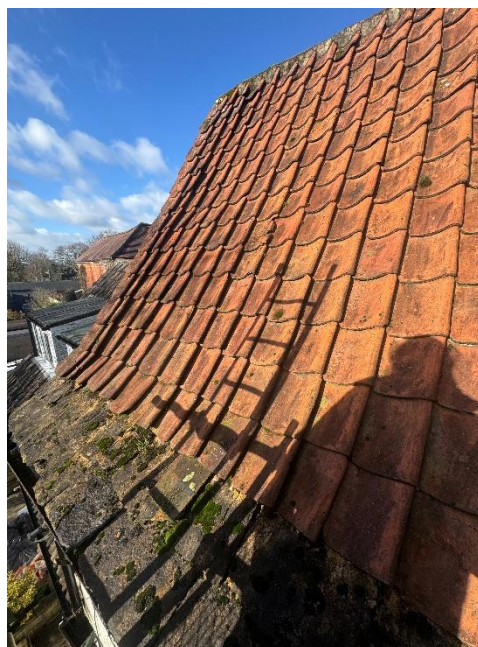
Traditional pantile roof – out of scope of repair

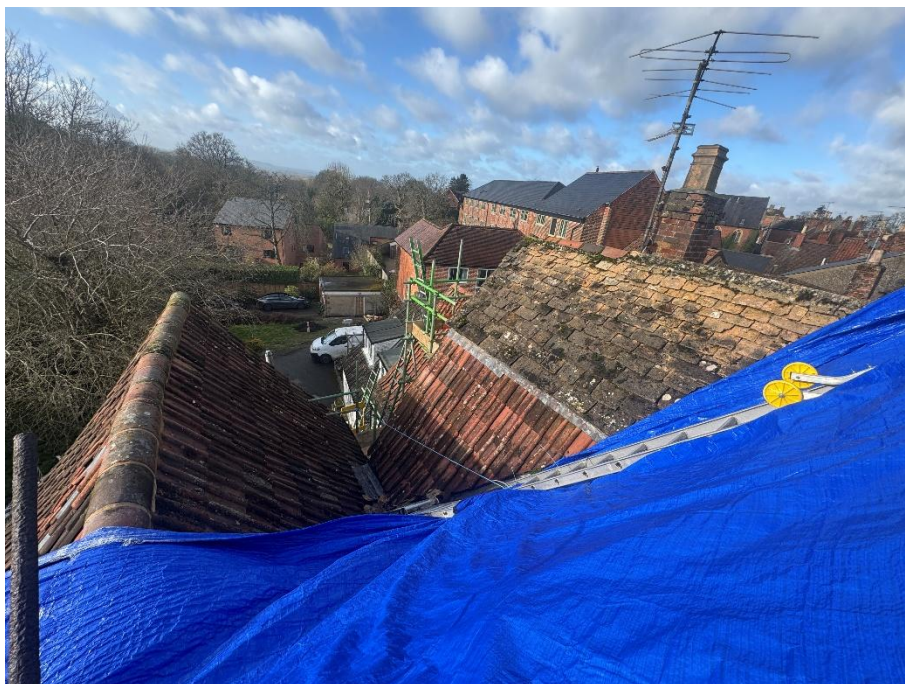
Right pitch- Part pantile, part stone slate roof to be replaced in stone slate

Traditional pantiles remain on the western return but are not affected by the current proposals. A condition assessment undertaken by a local roofer has informed the repair strategy. Despite thermal shock damage, a sufficient quantity of stone slates is considered salvageable for reuse on the principal front roof slope.

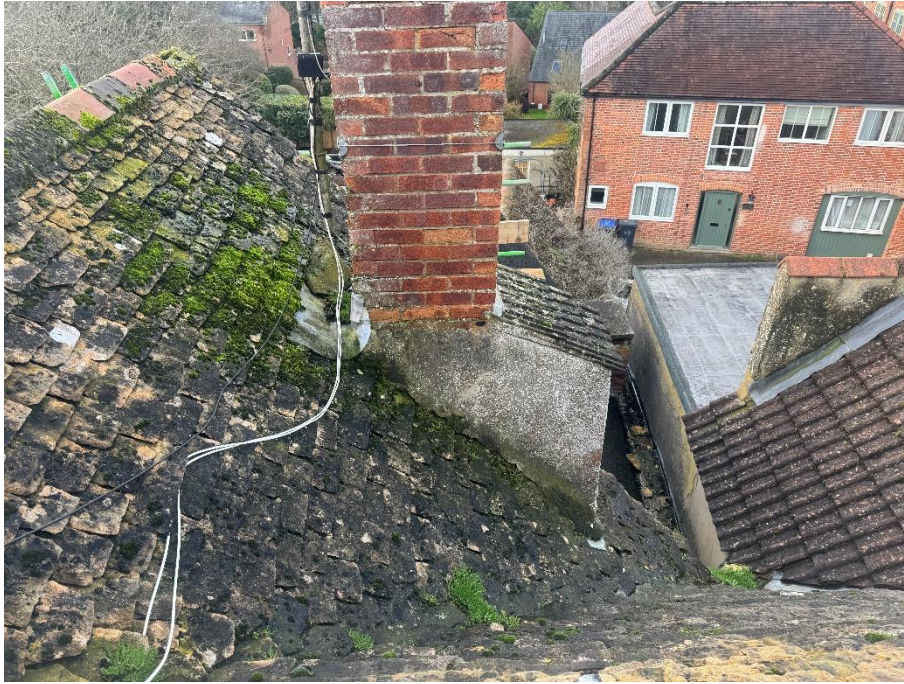
Swept tiles to valley

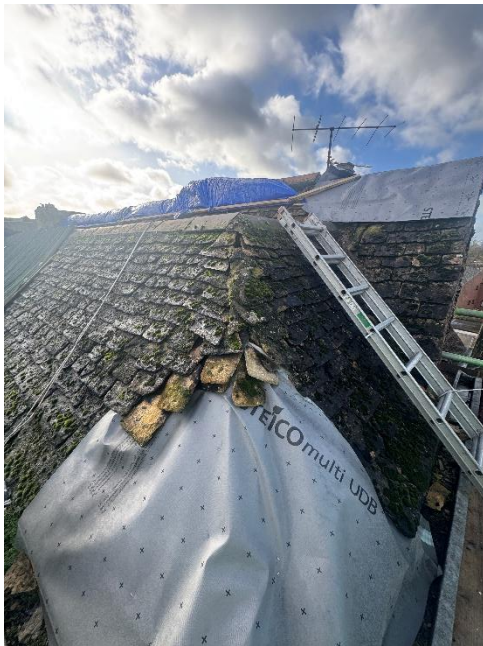
Mortared hips

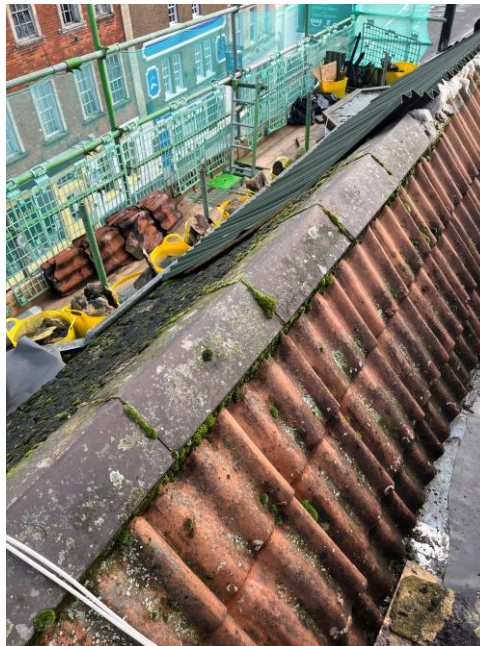
Inappropriate ridge tiles rto be replaced with stone ridges

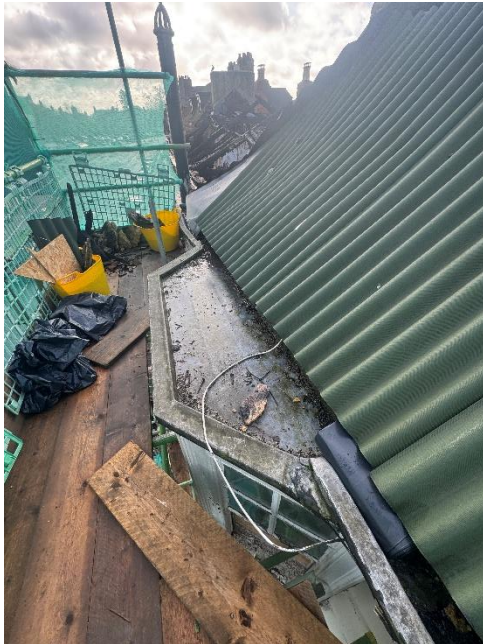
The front eaves gutter is a shallow timber construction lined with lead. The lead lining requires repair. Inspection in February confirmed that, although not compliant with modern standards, the gutter performs adequately except at corner junctions where cracking has occurred. It is therefore proposed to introduce lead T-pren joints at corners to accommodate movement and prevent future failure.

Flat lead roof with shallow upstand

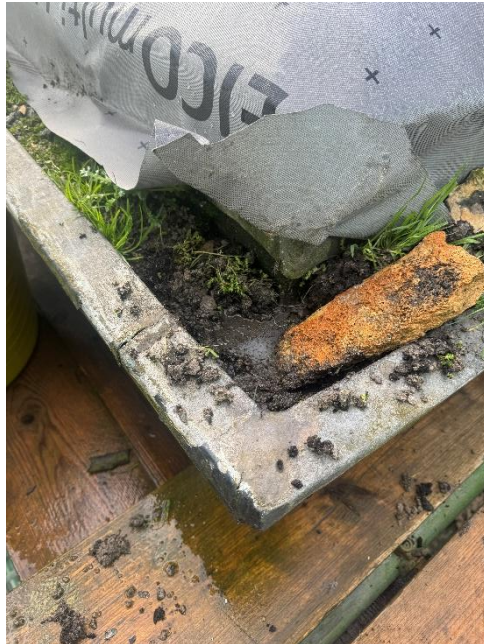
Failure at corners owing to expansion and contraction of lead around corners

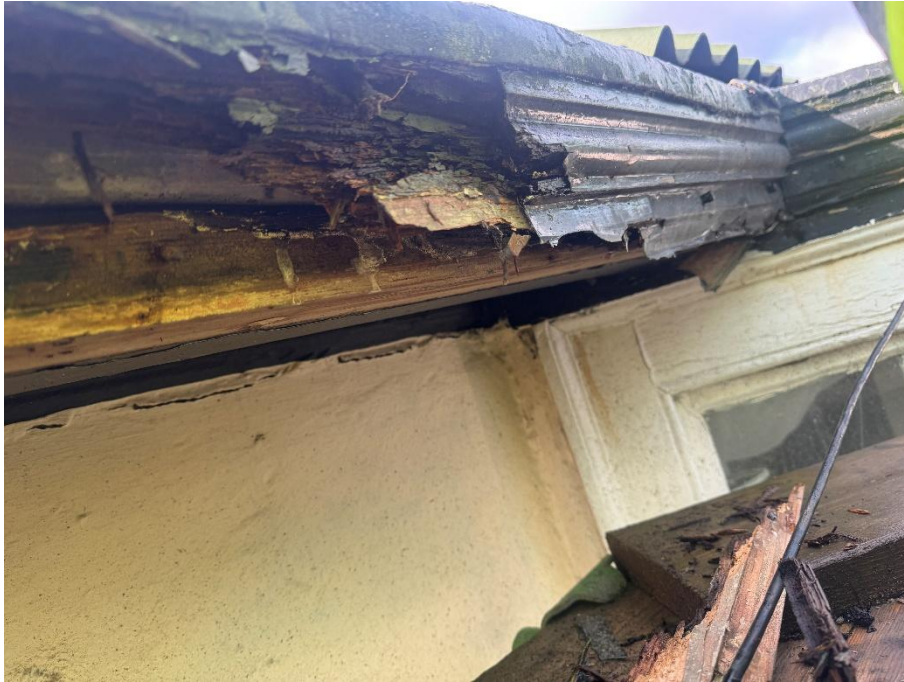
Failure of timber gutter east side of front elevation.

Defective timber sections will be replaced on a like-for-like basis using good-quality timber.

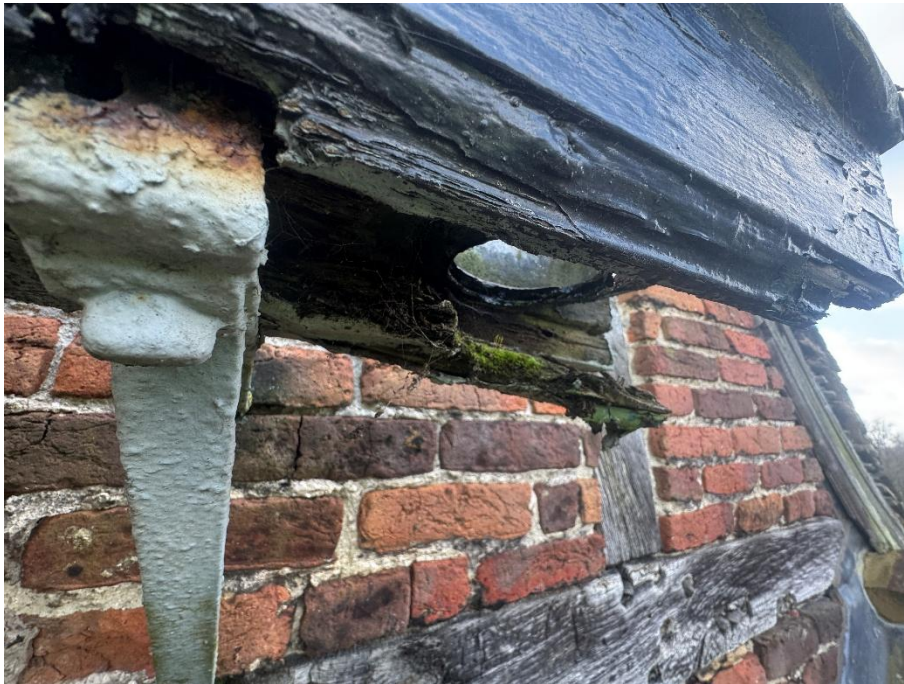
Failure of gutter west elevation

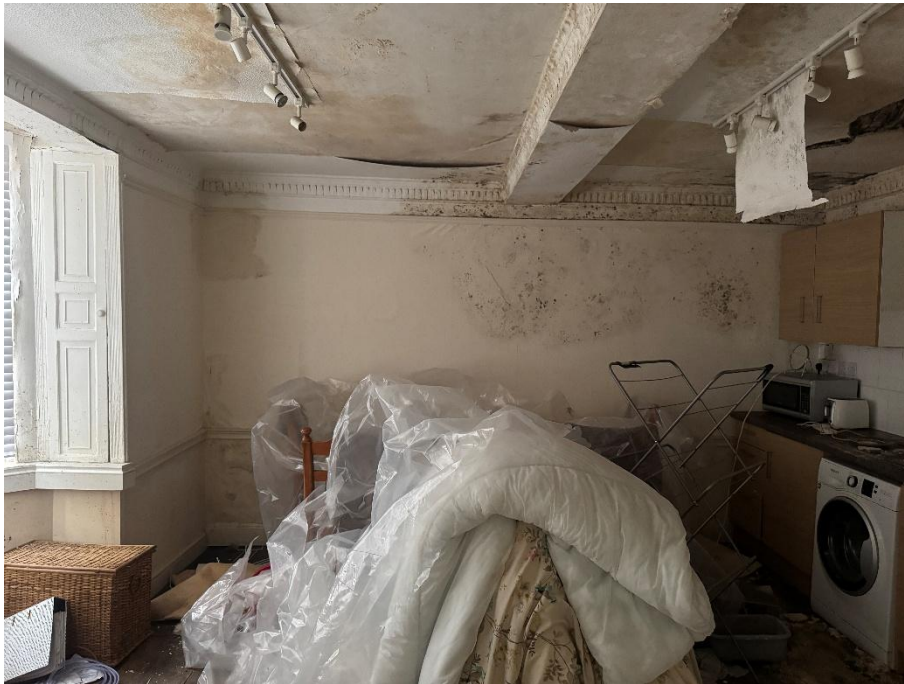
Ceiling plaster has failed in rooms on each floor, with lath failure evident. Ceilings will be replaced using traditional lath and plaster.

Ceiling damage ground floor. Dec 25

The extent of damage to cornices is not fully known, but partial replacement is anticipated. Existing paint will be removed to allow accurate moulds to be taken so that replacement sections match the original profiles.

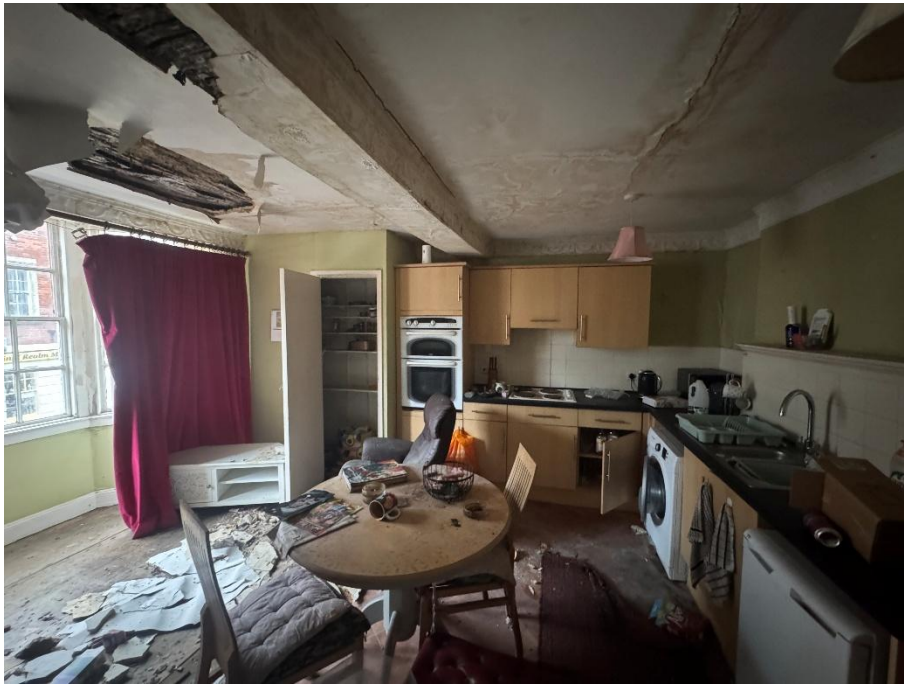
Ceiling damage first floor. Dec 25

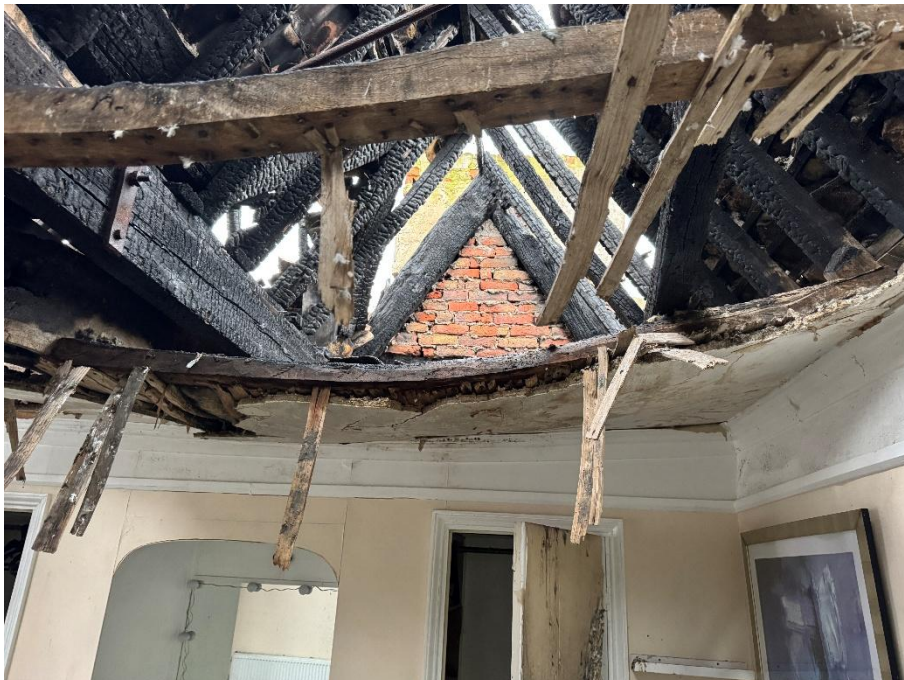
Ceiling damage second floor. Dec 25

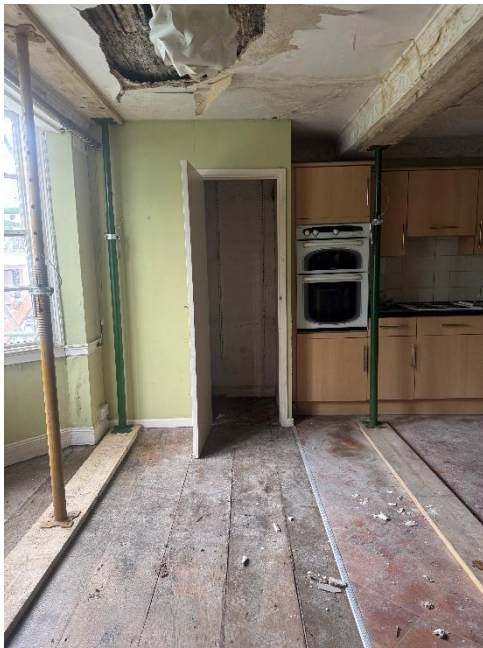
Floorboards are cupped and damaged due to prolonged moisture exposure. Replacement will be carried out on a room-by-room basis.

Cupped floorboards first floor. Feb26

- Upper floors: new larch boards (approx. 190mm wide)
- Ground and first floors: reclaimed boards to match existing dimensions

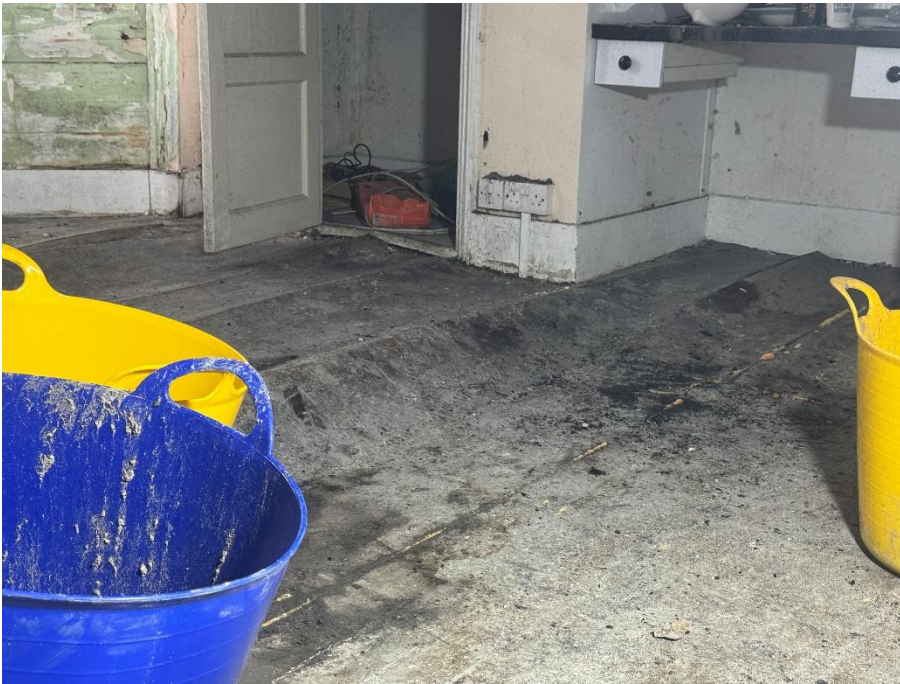
Damaged floorboards second floor Feb26
