PROJECT 3 Northgate Street

DRAWING STATUS Listed Building Consent

DRG TITLE Existing First Floor Plan  
Showing Repairs

JOB/DRG No. 496/103

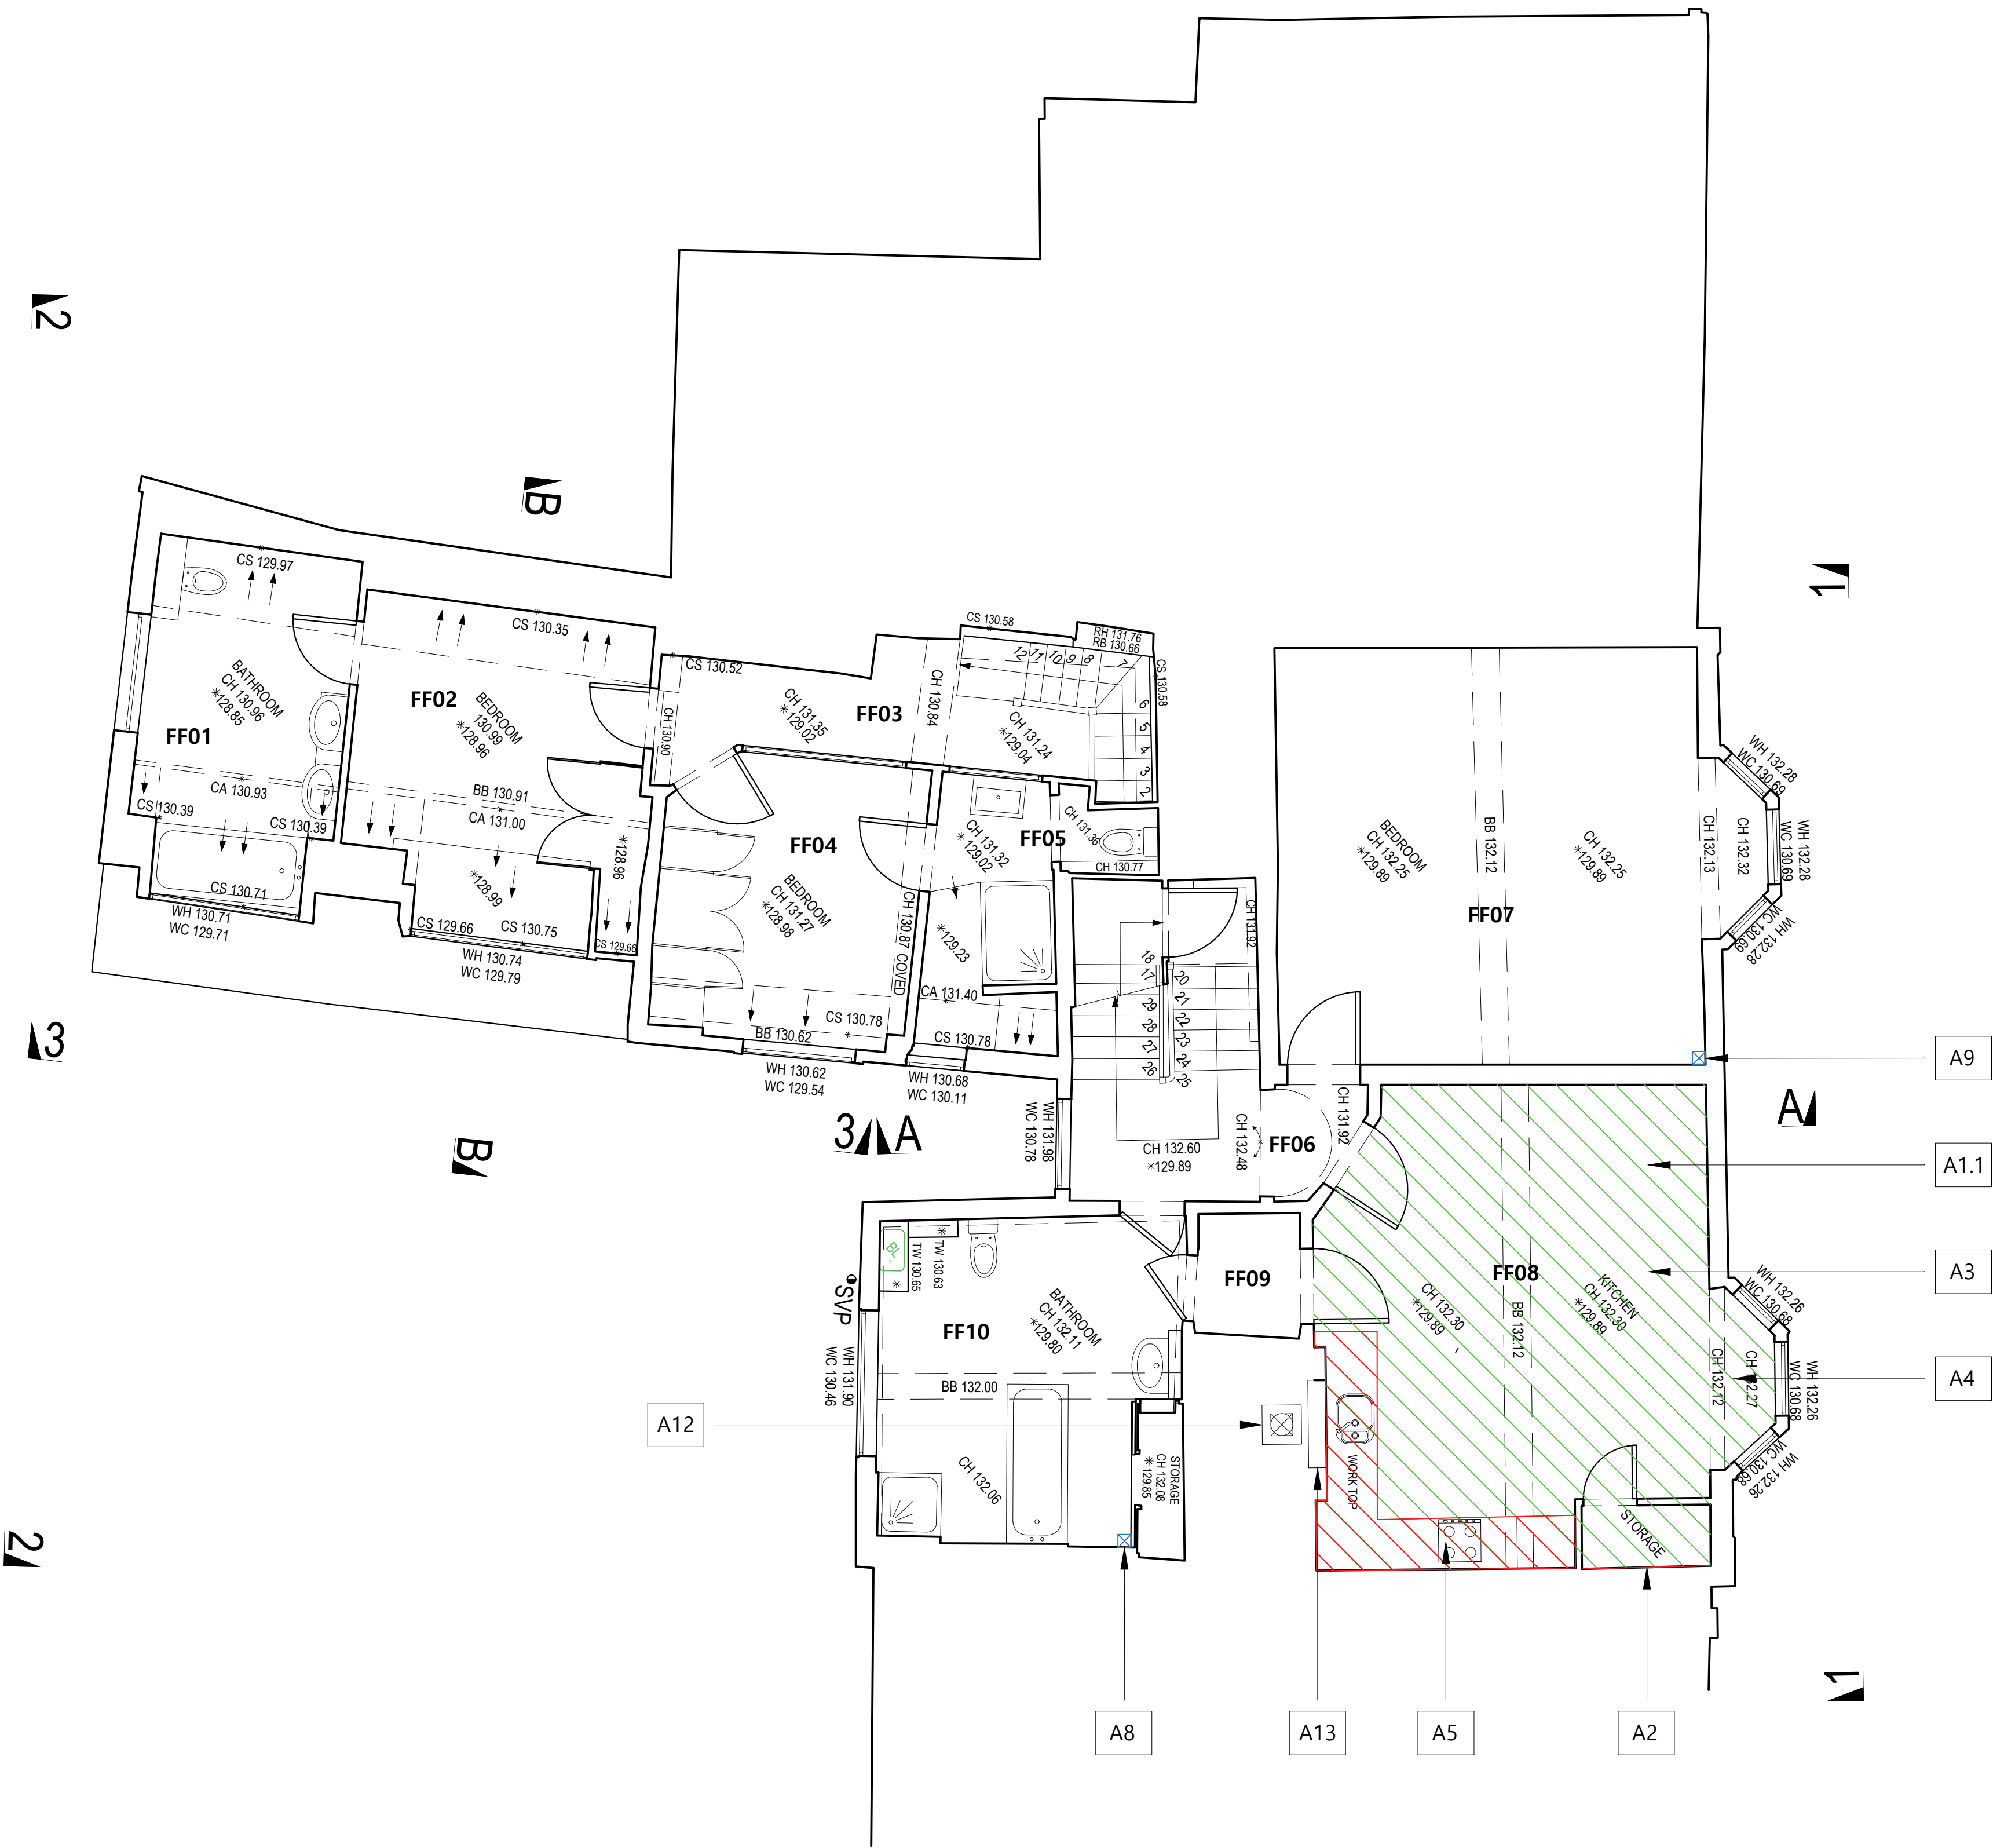
1.0 Existing First Floor Plan Showing Repairs

Subject to detailed survey carry out repairs to cupped and damaged boards. Allow for replacing 70% of boards owing to prolonged exposure to water ingress.
- A2

Remove plaster and existing laths to wall to inspect timber frame for repairs. Replace laths and replaster in lime.
- A3

Remove plaster and existing laths to ceiling and failed sections of cornice. Replace laths and replaster in lime.
- A4

Mould to be taken of all existing cornice. All cornice to be repaired following repairs to ceiling.
- A5

Remove kitchen units.
- A8

Provide new vents in ceiling. To vent to roof above.
- A9

New soil and vent pipe from SF. To vent to roof above.
- A12

Existing flue to be reused and reinstated.
- A13

Existing chimney opening to be reopened.
