**RE: OYSTER FARM BARNs, CATCH COMMON – EMERGING PROPOSAL FOR RESTORATION OF THE BARNs AND CHANGE OF USE**

**RE: OYSTER FARM; GUTCH COMMON  
WORKS TO FARM BUILDINGS-STRUCTURAL ENGINEERING SERVICES**

**BARN A (read with SP25.R01; R02 and R03)**

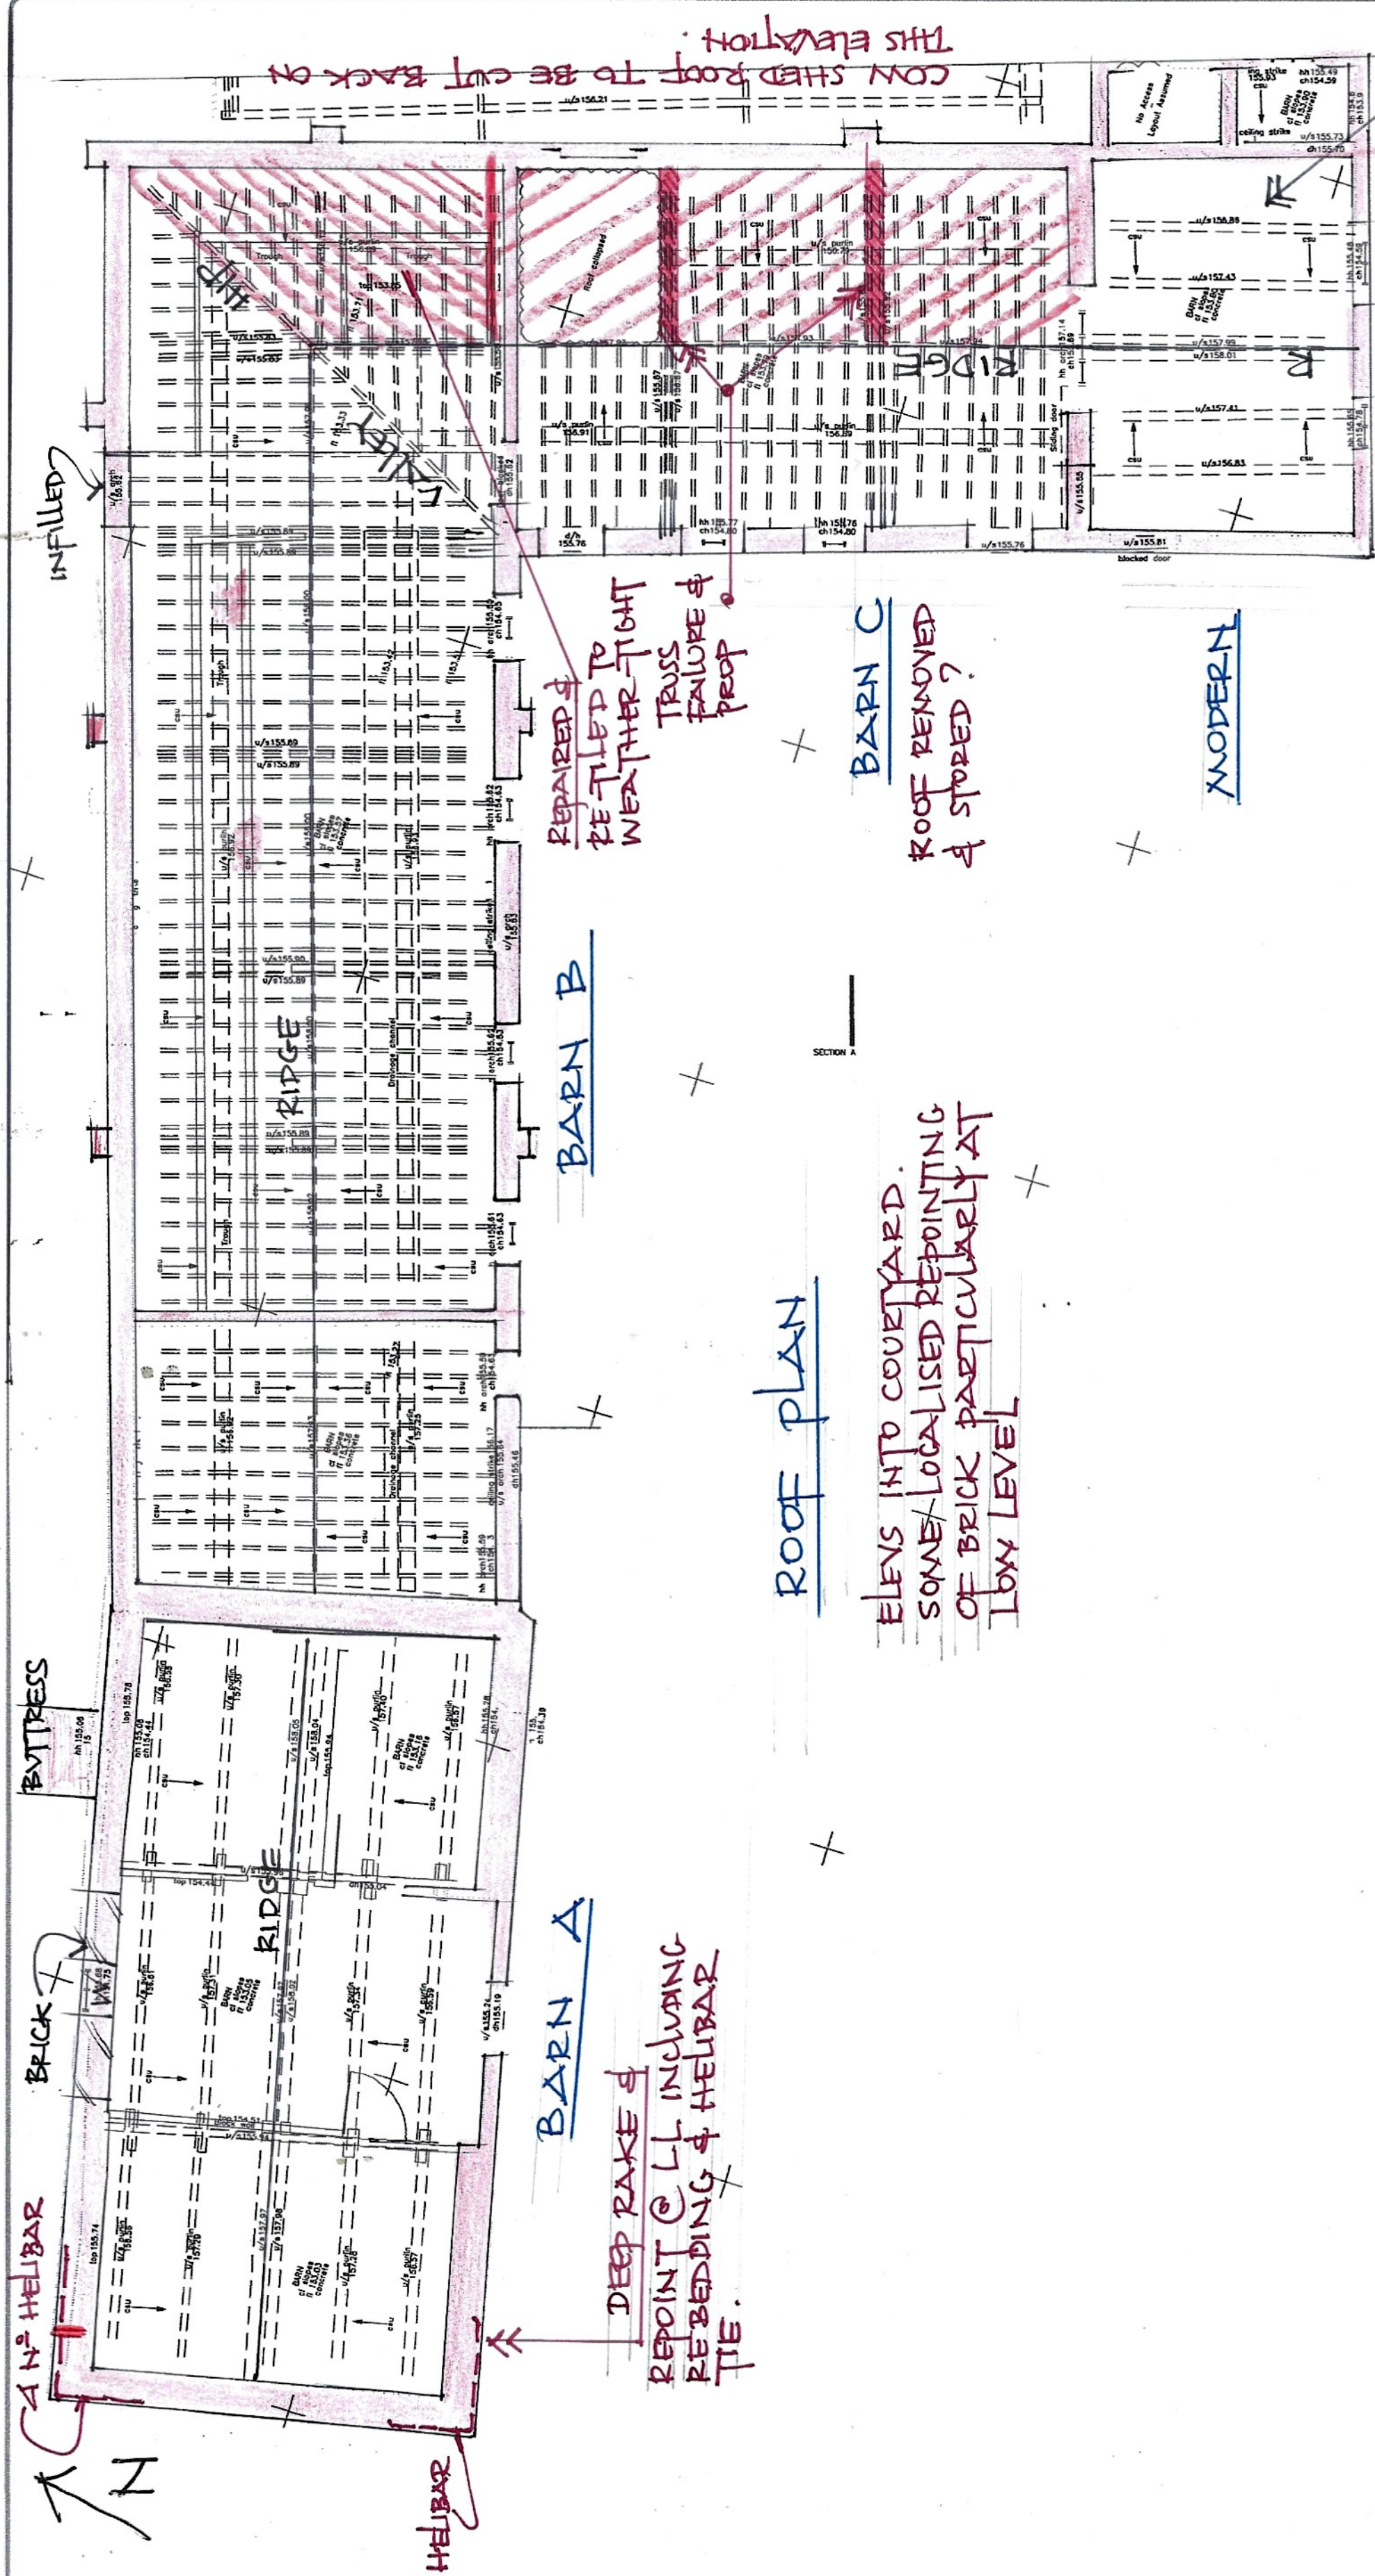
SP 25. R01

MODERN EXTENSION - FIBRE CEMENT BOARD ROOF SHEETS ONTO CURRENTLY WEATHER-TIGHT.

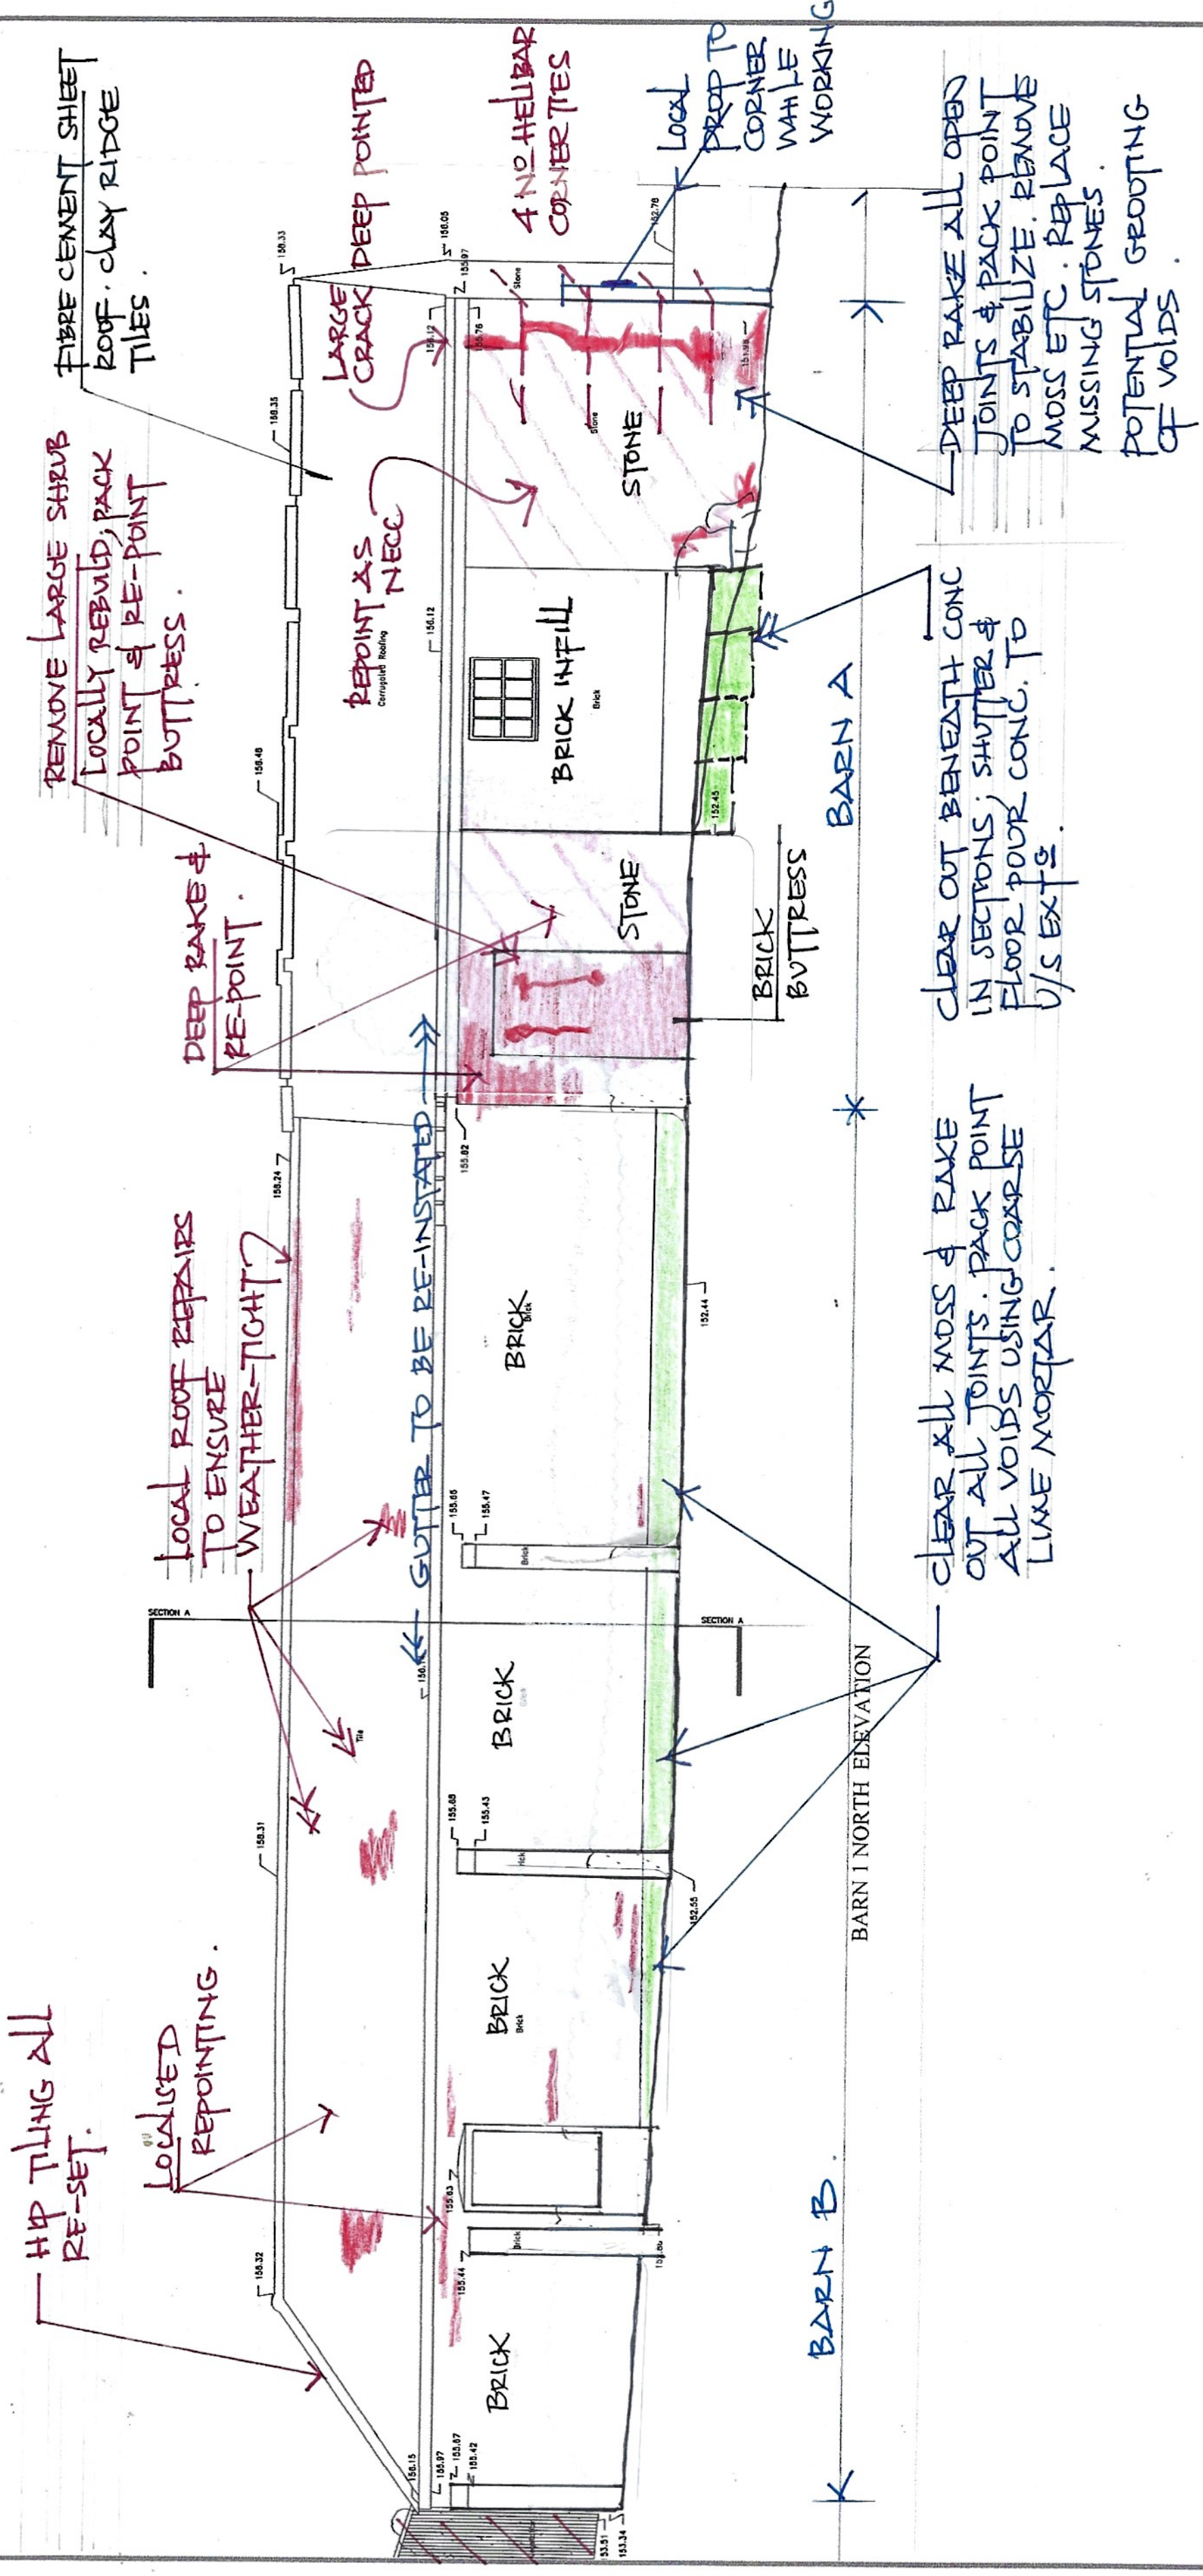
| DRG. NO | | SP 25. R02 | | REV. | | | | | |

The stonework is in a reasonable condition with the three main wall panels all in reasonable order. However, the western gable appears to have settled slightly relative to the adjacent side walls resulting in cracking at the corners, most significantly in the NW corner, and some stones have become loose or displaced. The increased movement is due, in some part, to the lower ground levels to the NW of the building. A section of the north wall has been re-built in brickwork, or an opening infilled, and a substantial brick buttress constructed to prevent movement. Even so, there is evidence of further movement by way of cracking to the masonry. At low level, in particular, there are large cracks and voids in the foundation stones. Unchecked invasive plant growth has also resulted in further damage due to shrub / tree roots in the masonry.

On the north side and north-west corner, the wall should be repaired at low level with sections carefully rebuilt re-setting displaced stones and infilling voids.

The significant corner cracking to both NW and NE should be carefully repaired including insertion of helibar ties. In the NW corner at low level some localised grouting may be beneficial to fill voids.

The whole north wall should have any displaced stones reset and be repointed where open joints are present. At low level moss should be removed and all open joints re-pointed.

ALL MORTAR LIME BASED.  
GROUT TO BE LIME BASED  
FREE FLOW.
