# HERITAGE STATEMENT

## PROPOSED REPLACEMENT WINDOWS at THE OLD VICARAGE, BRITTFORD SP5 4DX

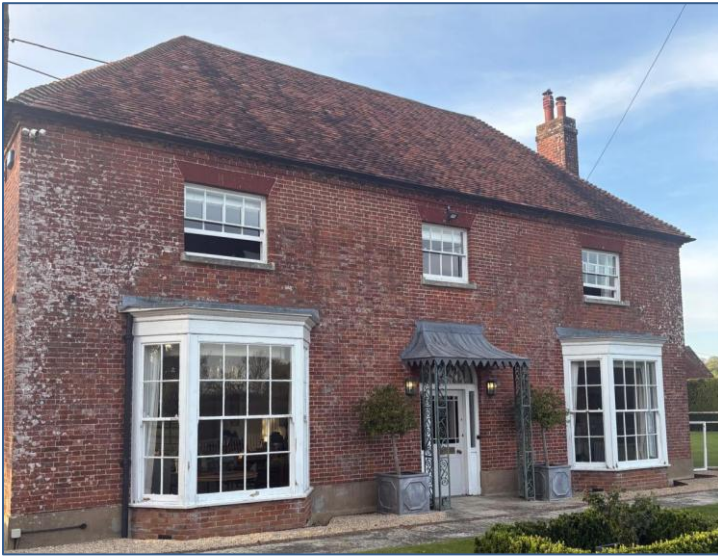
South Elevation showing bays and short sashes over

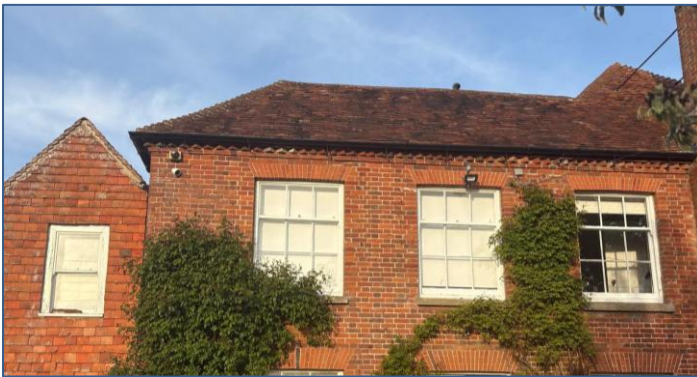
West Elevation first floor sashes in brick and tile hung elevations

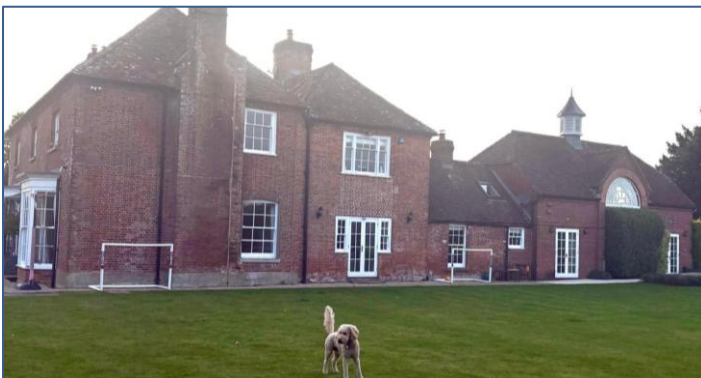
East Elevation showing French Doors and Sidelights

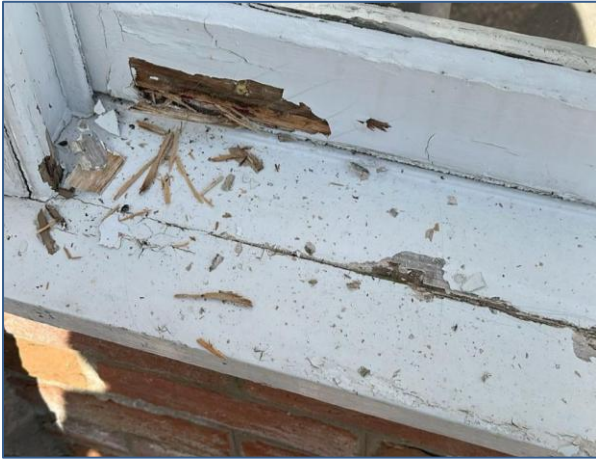
Issues – water ingress from above, wet rot in rails, cill and sash box.

Bay window bottom rail rot

Proposal – Replace bay sashes, fascia and cornice and reroof. Adequately seal the perimeter to make weathertight, sashes also include new draughtproofing measures.

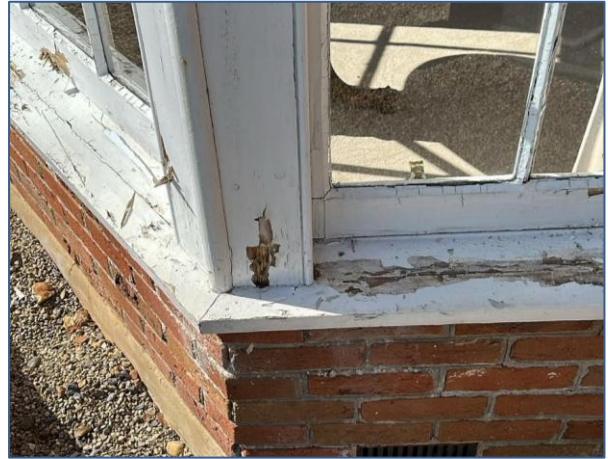
Bay window corner sash box

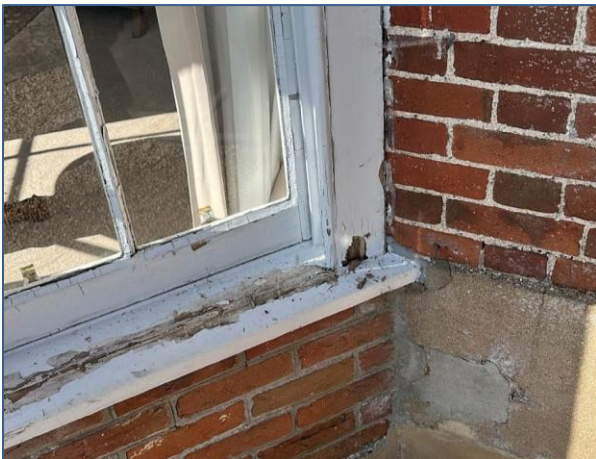
Bay window sash box rot and wall junction

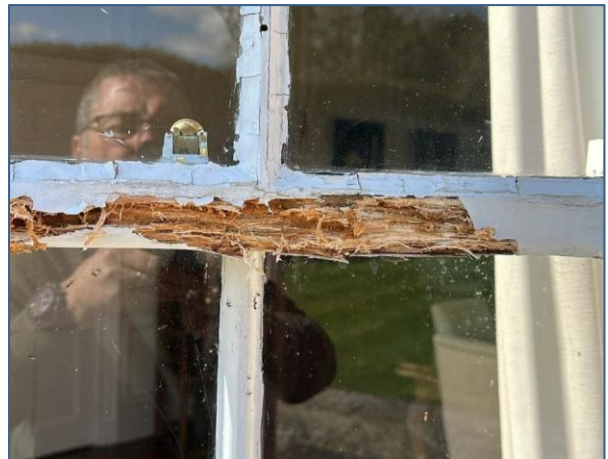
Wet rot to glazing bar

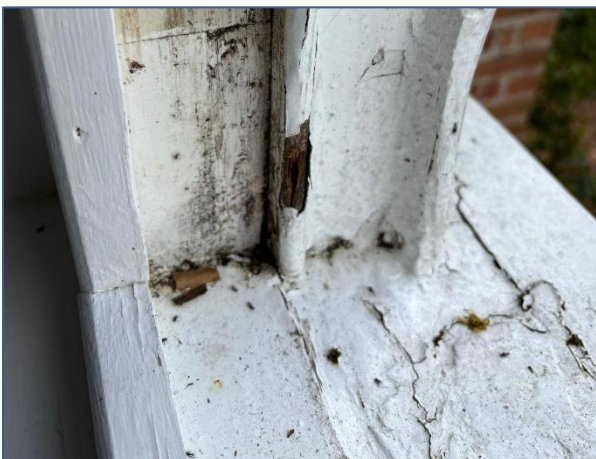
First floor sash box deterioration

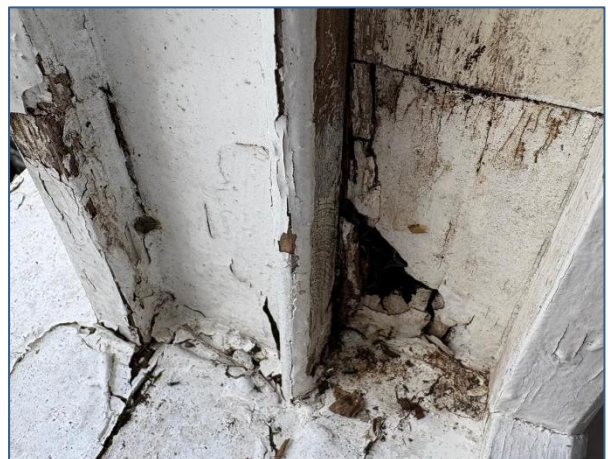
First floor sash box failure

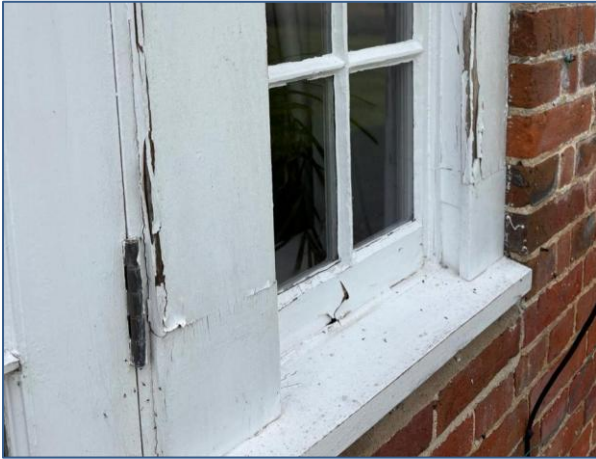
Issues - Evidence of scarf repairs and rot on windows doors

Sidelight sash repair

Proposal – Replace doors and sashes in existing opening. Adequately seal the perimeter to make weathertight, sashes also include new draughtproofing measures. Check lintel over opening to establish soundness and replace if found to be inadequate.

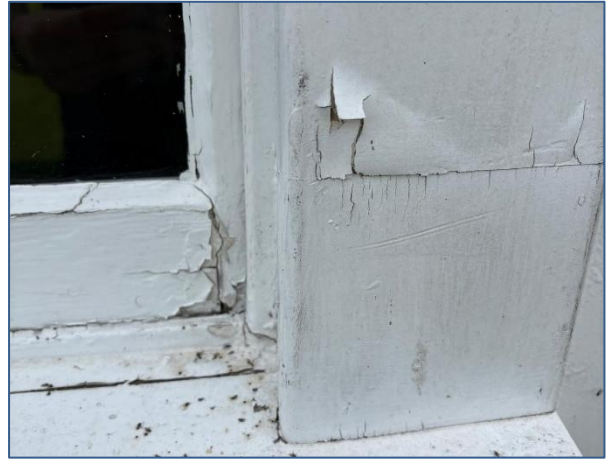
Sash box scarf repair

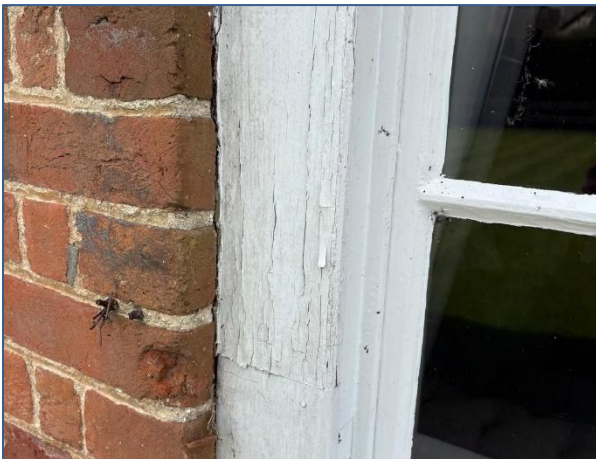
Original to repair junction

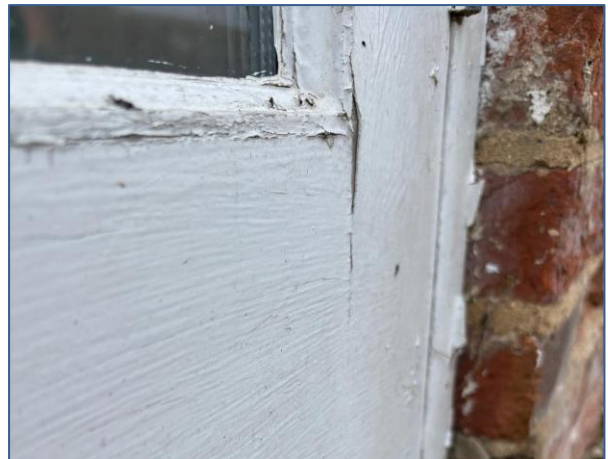
Door bottom rail in poor condition
