# Tree Assessment Report: Malmesbury Ambulance Station 2026

# TREE CONDITION SURVEY AND RISK ASSESSMENTS

| <b>SITE ADDRESS (THE SITE):</b> | Malmesbury Ambulance Station, Station Road, Malmesbury, SN16 9JS |

| <b>SURVEYED &amp; PREPARED BY:</b> | James Worsley | <b>DATE:</b> | 9 <sup>th</sup> March 2026 |

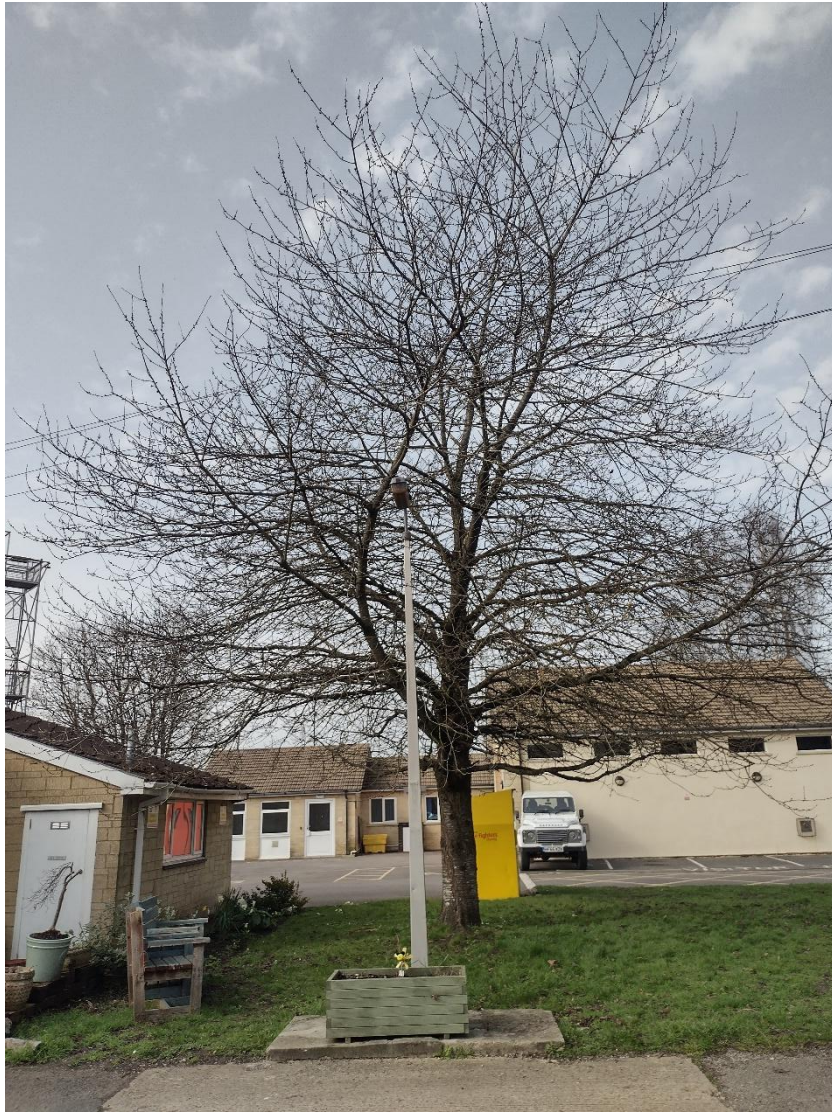
| Ref. | Species | Height | Dia | Crown Radius | Age Class | Target Description | Survey Notes | Condition | What 3 Words | Inspect Period | Target Range | Size | PoF | RoH |
|---|---|---|---|---|---|---|---|---|---|---|---|---|---|---|
| T001 | Wild Cherry<br><i>Prunus avium</i> | 8 | 40 | 6 | Early Mature | Owned by the estate.<br>Target - building and seating area | 2022: Minor deadwood, mower damage to surface roots, leggy growth, BT line resting on branches, street light under canopy, sub optimal branch unions at 4m<br><br>16.10.2024:Good vitality; since reduced as per recommendations.<br><br><b>2026:</b> No new significant risk features observed. Crown growing in contact with the overhead telecom wires and the security light. | Fair | ///suspect.betrayal.backtrack | 2 Years | Property(4)<br>£2,000 - £200 | Property | PoF(4)<br>1/1K - 1/10K | <1/1M |

**T001:** Wild cherry growing in contact with wires and light

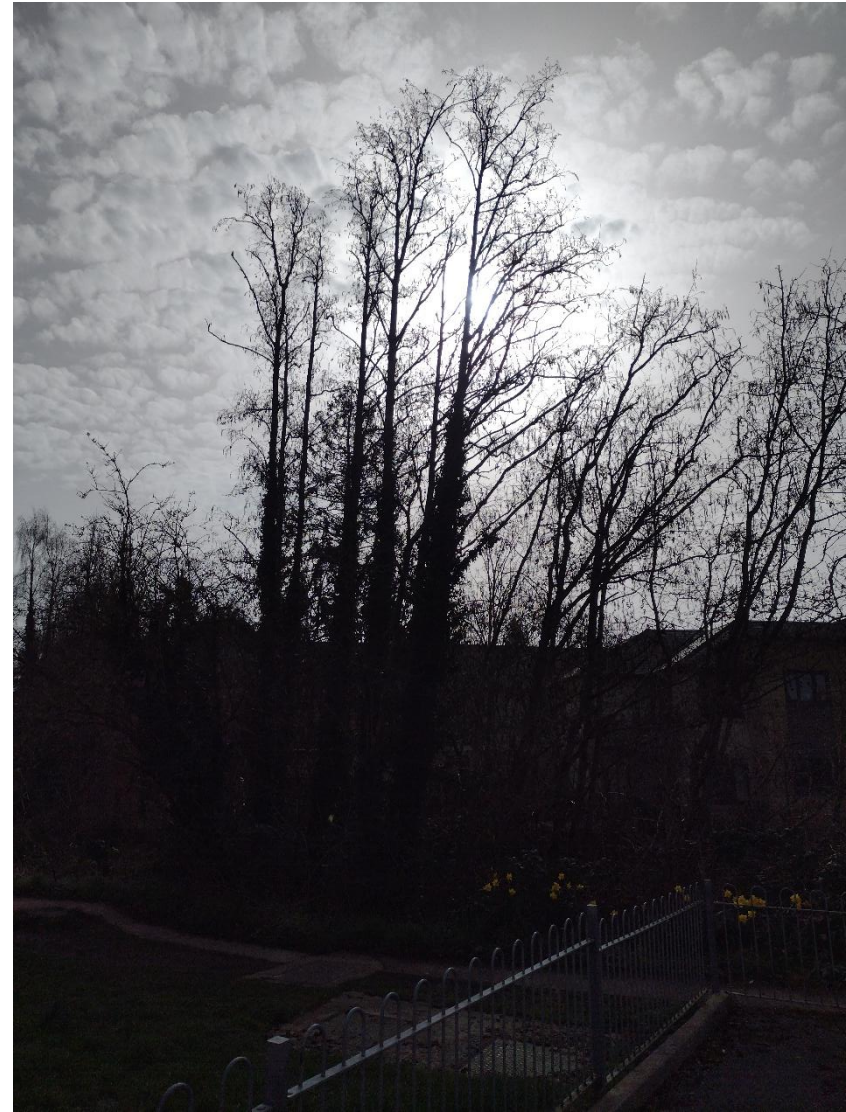
| Ref. | Species | Height | Dia | Crown Radius | Age Class | Target Description | Survey Notes | Condition | What 3 Words | Inspect Period | Target Range | Size | PoF | RoH |
|---|---|---|---|---|---|---|---|---|---|---|---|---|---|---|
| G1 | Common Alder<br>x8<br><i>Alnus glutinosa</i> | 8 | 20 | 3 | Semi Mature | Unclear on ownership<br>Target - car park | 2022: Slight decline in vitality, stems mainly biased away from fire station parking<br><br>16.10.2024:One tree in group since declined considerably. Confirm ownership before removal. Ivy obscures stems, and steep banking above deep water<br><br><b>2026:</b> Group in poor physiological condition, likely owed to infection from Phytophthora alni. Group has a slight lean away from site. Ownership ambiguous. | Fair | ///tried.sock.fallback | 1 Year | Property(3)<br>£20,000 - £2,000 | Property | PoF(5) | <1/1M |

**G1:** Alder in poor physiological condition

| ID: | Species | Management Recommendations: | Priority: |
|---|---|---|---|
| G1 | Common Alder x8 | Confirm tree group ownership and coppice group if SWAST ownership | 5 |
