5 February 2026

**Inspection to GALES COTTAGE, 56-58 HIGH STREET, STEEPLE ASHTON, BA14 6EU**

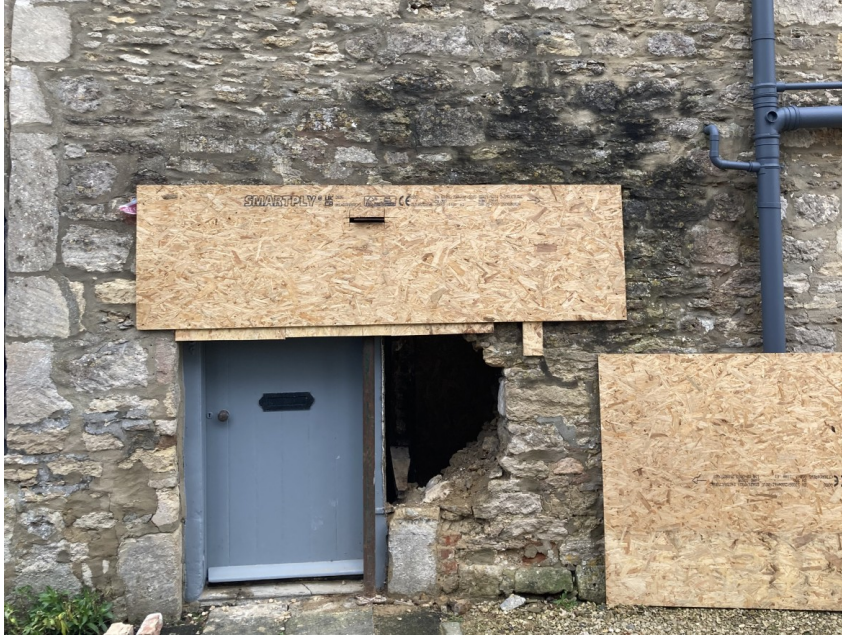
The damage has been caused by a point loading resulting from an impact by a passenger vehicle. The vehicle struck the side elevation of the building adjacent to the entrance door. As reported by the property owner, the initial damage was not clearly visible externally, other than localised cracking to the stonework. However, the damage was significantly more evident internally, where the inner skin of the stone wall collapsed into the room. Temporary propping was installed immediately following the incident to support the first-floor joists bearing onto the damaged wall. Over time, loose sections of masonry detached, resulting in the formation of a substantial opening and further cracking, as shown on the photographs provided.

It should also be noted that localised areas of dark staining and weathering are present on parts of the external masonry, located directly above the area of the impact damage. These observations relate to the existing condition of the wall fabric only and are not associated with the vehicle impact damage forming the basis of this report. The scope of this inspection and report is limited solely to the assessment of visible damage attributable to the reported impact. No investigation has been undertaken into the cause, extent, or significance of the staining in terms of structural performance, material condition, or future behaviour of the masonry, and no reliance should be placed on this report in that regard. Any reference to such existing conditions is provided for context only and should be considered separately from the damage assessment and repair recommendations set out within this report. It is recommended that these areas are reviewed and addressed in a timely manner as part of routine maintenance.

*1. Collapsed section of the side wall with visible black mould and staining.*

We recommend that the damaged section of the external stone wall is demolished and reinstated. Due to the extent of cracking and localised failure within the stonework, we recommend that the affected section of wall is demolished and rebuilt rather than undertaking localised repairs.

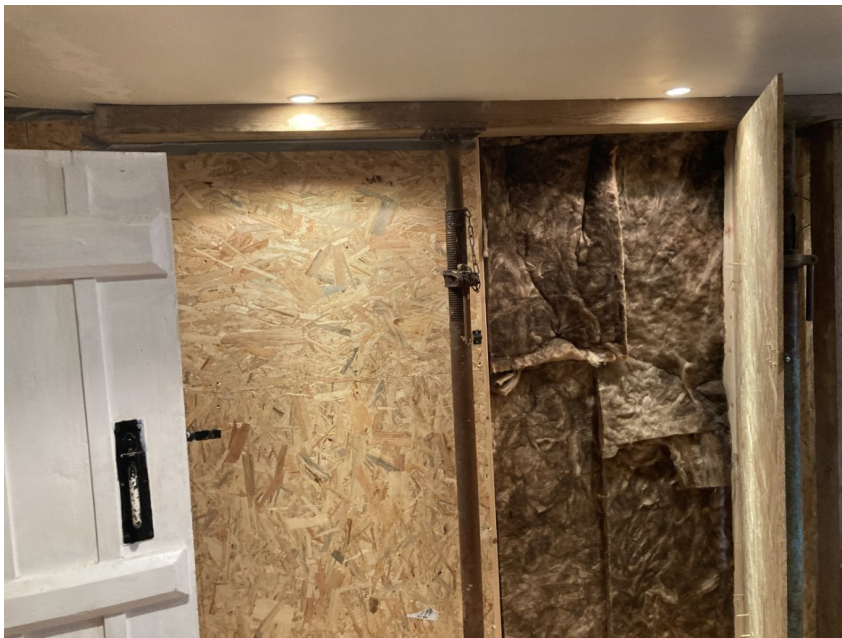
*2. Temporary propping installed internally.*

The crack to the internal face of the external front wall should be further inspected by the main contractor on site to confirm whether it is limited to surface finishes only or penetrates deeper into the stone wall construction. The findings should be reported back to MG Structures to allow an appropriate repair methodology to be advised. The new wall panel should be adequately tied back to the remaining section of the side wall. The lintel over the entrance door should be inspected and assessed for suitability for reuse; if found to be damaged or inadequate, it should be replaced on a like-for-like basis. Temporary propping must be provided to support the existing first-floor structure for the full duration of the construction works.

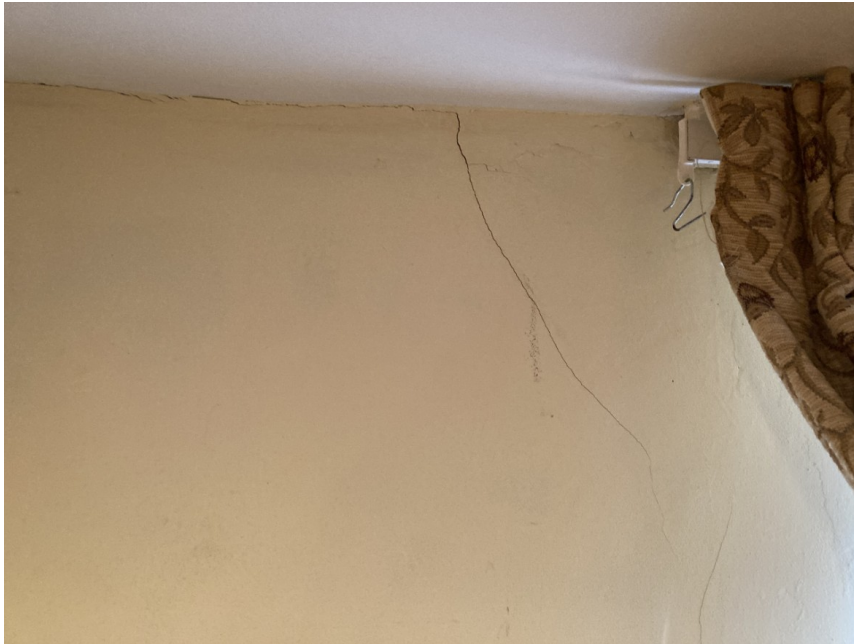
The adjacent external wall forming the front elevation exhibits a diagonal crack extending from the top corner of the window opening. In addition, a minor horizontal crack is visible internally along the ceiling line. We inspected the first-floor rooms located directly above the point of impact and found no visible cracks or signs of structural movement. All wall and ceiling finishes were intact, with no evidence of distress. It is noted that these rooms have been recently renovated, and therefore any cracking or movement would be clearly apparent.

*3. Diagonal crack on the internal face of the external front wall*
