**RE: MARLBOROUGH COLLEGE - 2 PEWSEY ROAD  
SURVEY OF SUBSIDENCE DAMAGE**

Further to our inspection of the crack damage to the external walls of the above property in November 2024, I can summarise our findings below.

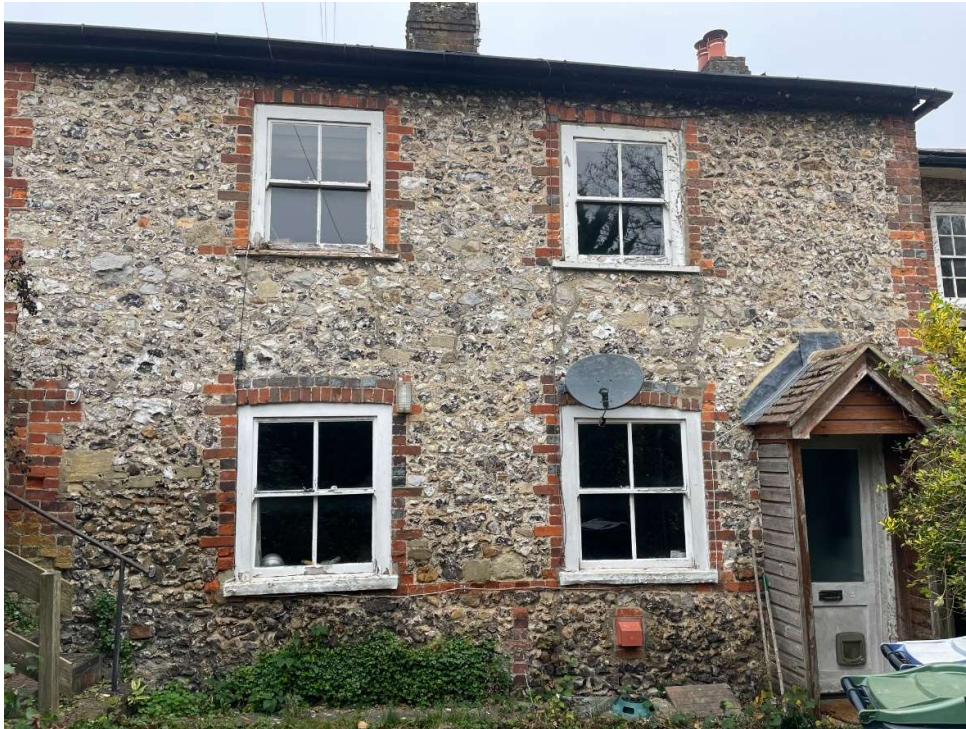
The external loadbearing masonry walls of the house are flint faced and have several historic cracks visible to the front elevation (see photograph above) which have been infilled with mortar.

These cracks also appear internally in the front rooms of the house with clear visual evidence of distortion in the window frames that suggest that there has been on-going settlement of the foundations towards the right hand flank return facing 3 Pewsey Road.

Following a three-month period after underpinning the wall cracks should be re-stitched, exposing the base masonry on internal walls and installing Helifix stitching bars before re-plastering.

The external cracked render can also be repaired using a sand lime mortar.

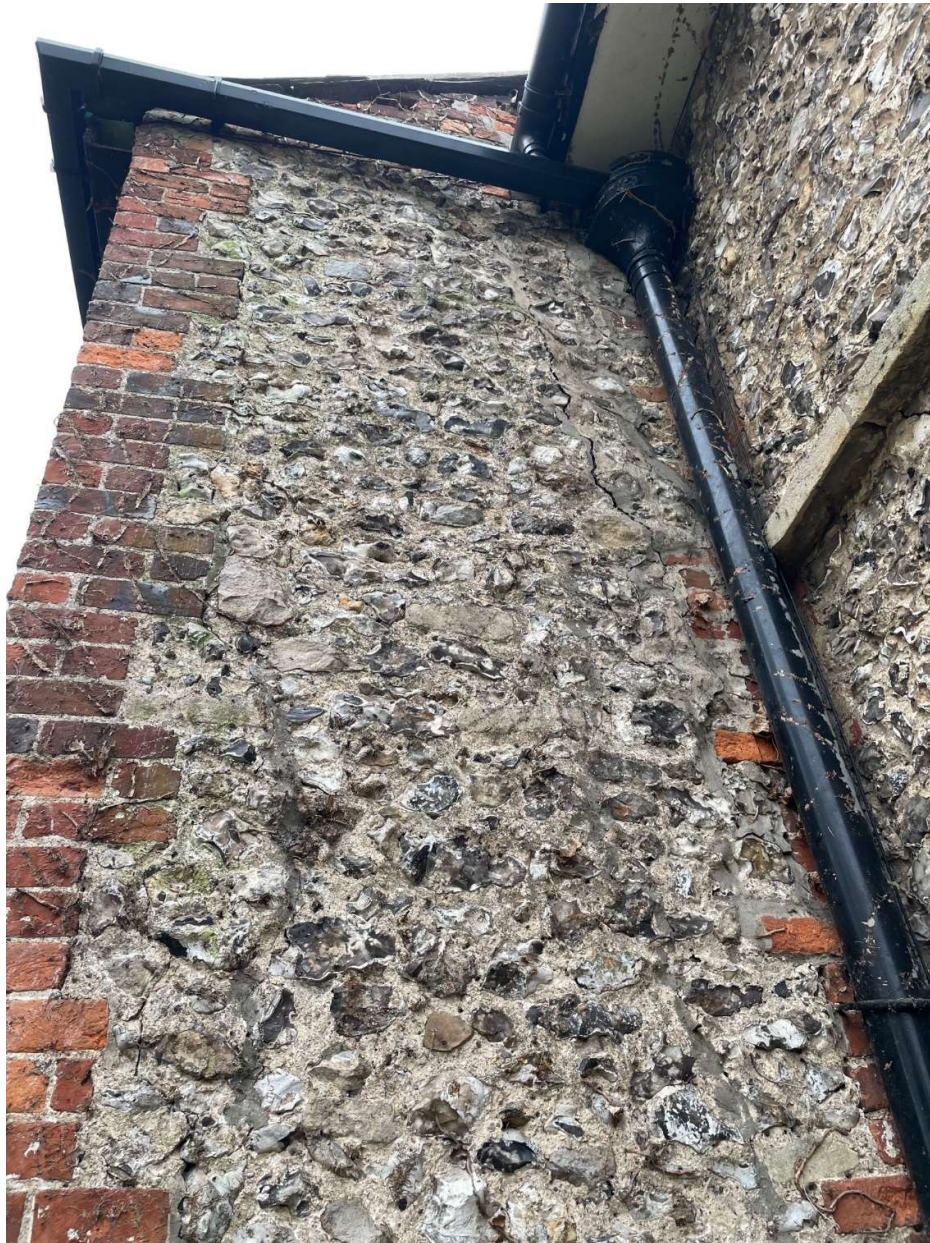
Recent significant cracks have manifested on this flank return, externally and internally in the first floor front bedroom see photographs below.

Previous trial pit investigations at 4 Pewsey Road found very shallow footings which required underpinning. This is likely to be the case at 2 Pewsey Road.

It was also noted that the roof rainwater downpipe which is likely to discharge into a soakaway in the rear garden could also have defects that have washed away fines in the soil below the footing which has made matters worse in terms of the wall subsidence viewed.

Expose the base of the roof rainwater downpipe to ascertain if there are cracks in the pipe at its' junction leading to the soakaway. A CCTV survey may be required to confirm the extent of repairs required.

Traditional hit and miss mass concrete underpinning to a depth of 1.2m below ground level is required to the front wall and return of the house. The underpinning should ideally be also continued along the entire walls of the adjoining houses to avoid the likelihood of future differential settlement of footings across the rear walls.

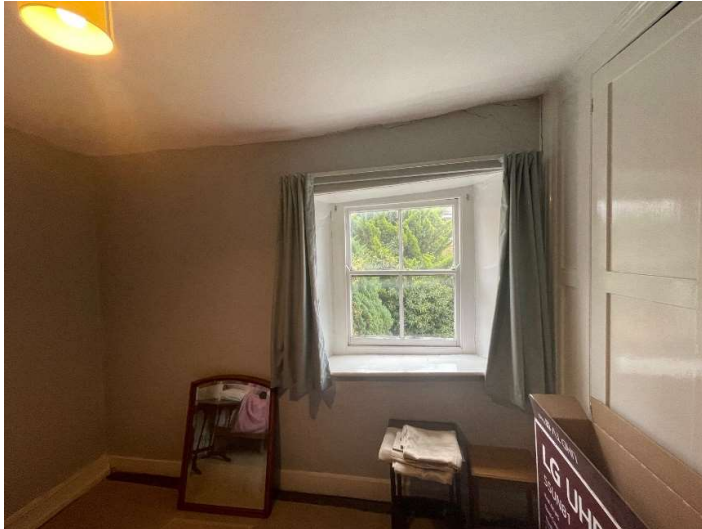
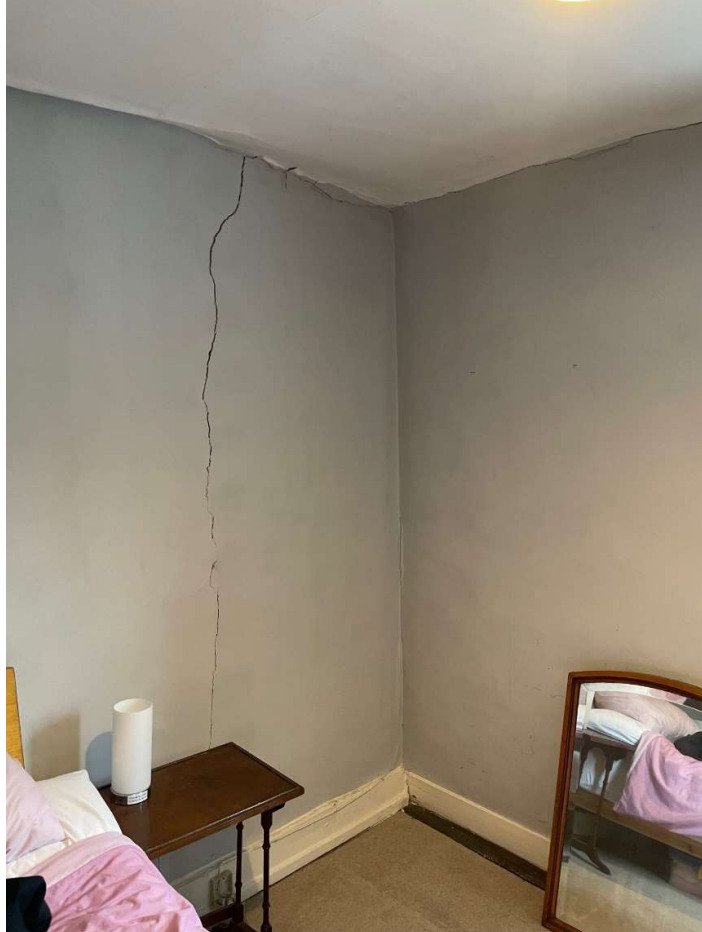
Historic distortion to front elevation window opening at first floor
