8332-06-0101

## INSPECTION REPORT

THE RATTLEBONE INN, CHURCH STREET, MALMESBURY, SN16 0LR

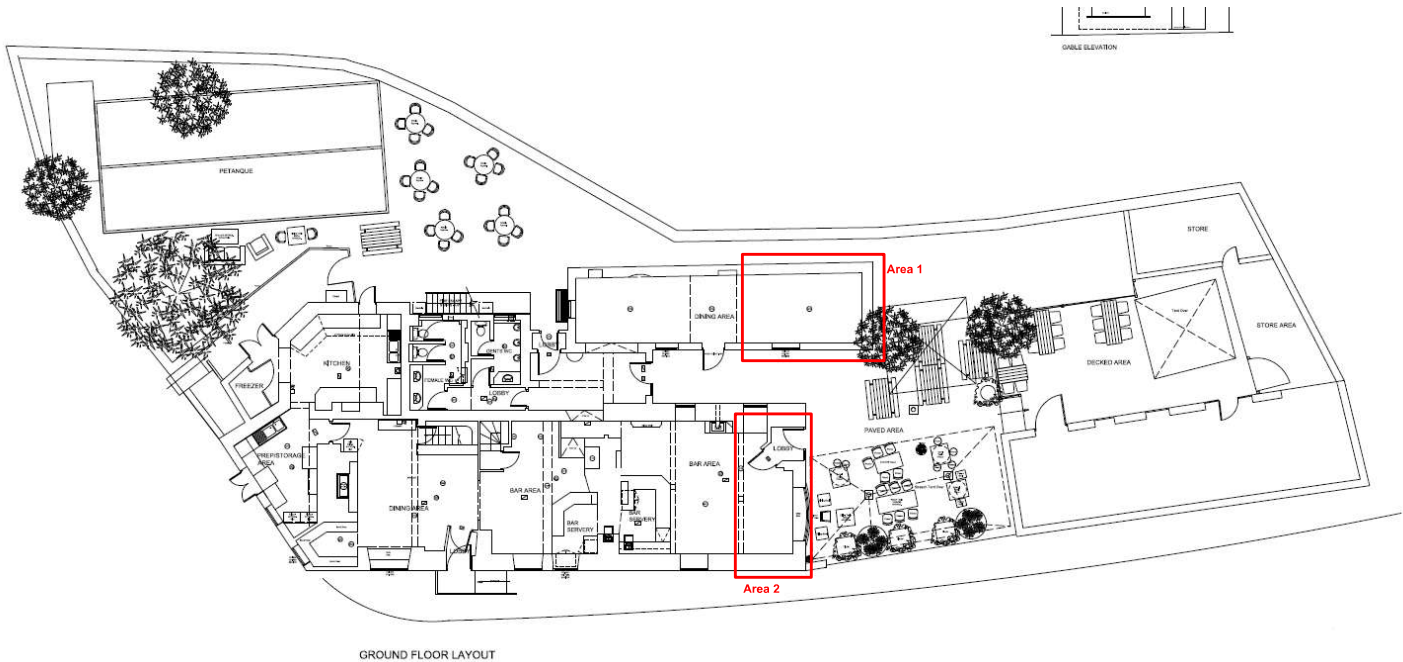
Figure 1 - Location Plan of Observed Defects

- 2.3. The main focus of the inspection was to report on the defect reported to the wall of the dining area, however, the other defects observed will be included in the report and see Figure 1 for reference location of defects.

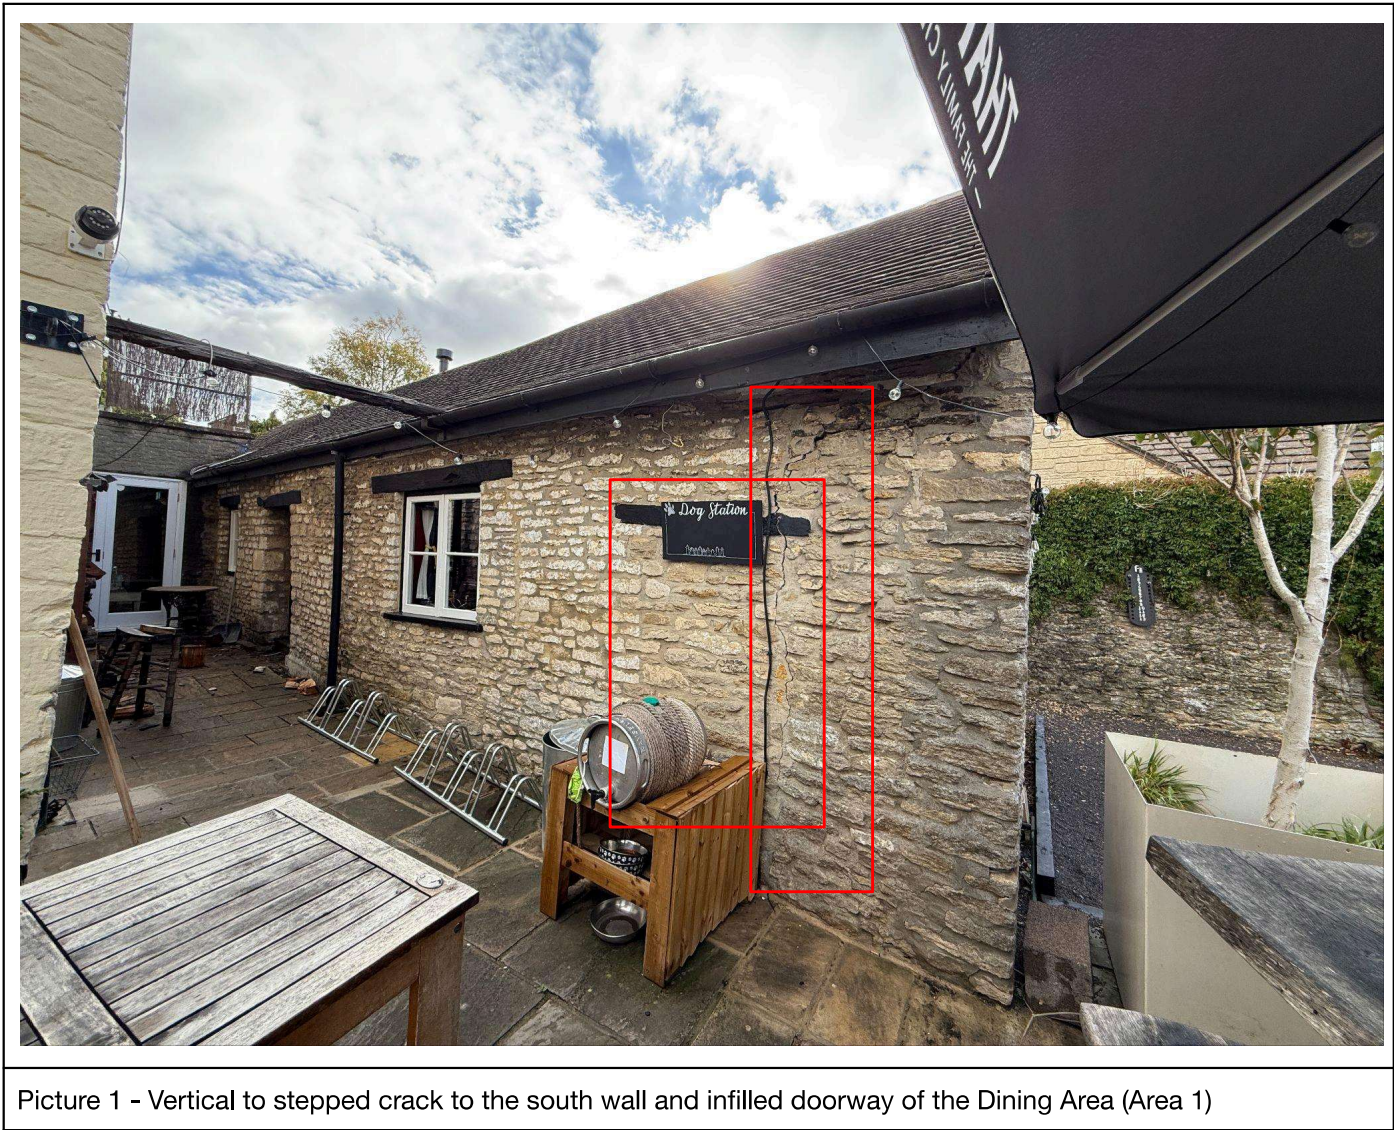
- 4.1. The external defects observed will be referenced according to the areas noted in Figure 1.
- 4.2. Within Area 1; the front elevation of the dining area contained a stepped to vertical crack with a maximum width of 30mm to the top and 1mm towards the bottom of the crack. The crack was located on the south side 1m in from the gable end.

- 4.5. An infilled doorway was located adjacent to the observation above. A timber lintel above the infill was 500mm from the eaves level of the property.

- 6.4. In addition, the cause of the 30mm external crack observed on the south wall 1m from the gable cannot be fully determined based on one visit and a monitoring regime. However, based on the observations possible causes include settlement due to poor soil or a lack of adequate footings. According to BRE Digest a crack exceeding 25mm warrants structural repair.

Picture 1 - Vertical to stepped crack to the south wall and infilled doorway of the Dining Area (Area 1)

- 6.5. Therefore, there are two options. Option 1 is stitching the cracks to the corners internally and the external crack near to the gable end via Helix ties and monitoring the defects for potential future movement. Within this option future underpinning cannot be fully ruled out. Option 2 is conducting three trial holes to assess the conditions of the soil and footings to determine if the movement observed is ongoing, the trial holes will need to be located on the corner where the external crack had been observed and underneath the damp stonework. Following Option 2 it is possible underpinning may be required should condition of the soil and/or footings prove to be inadequate and stitching and repointing to the defects will be required.

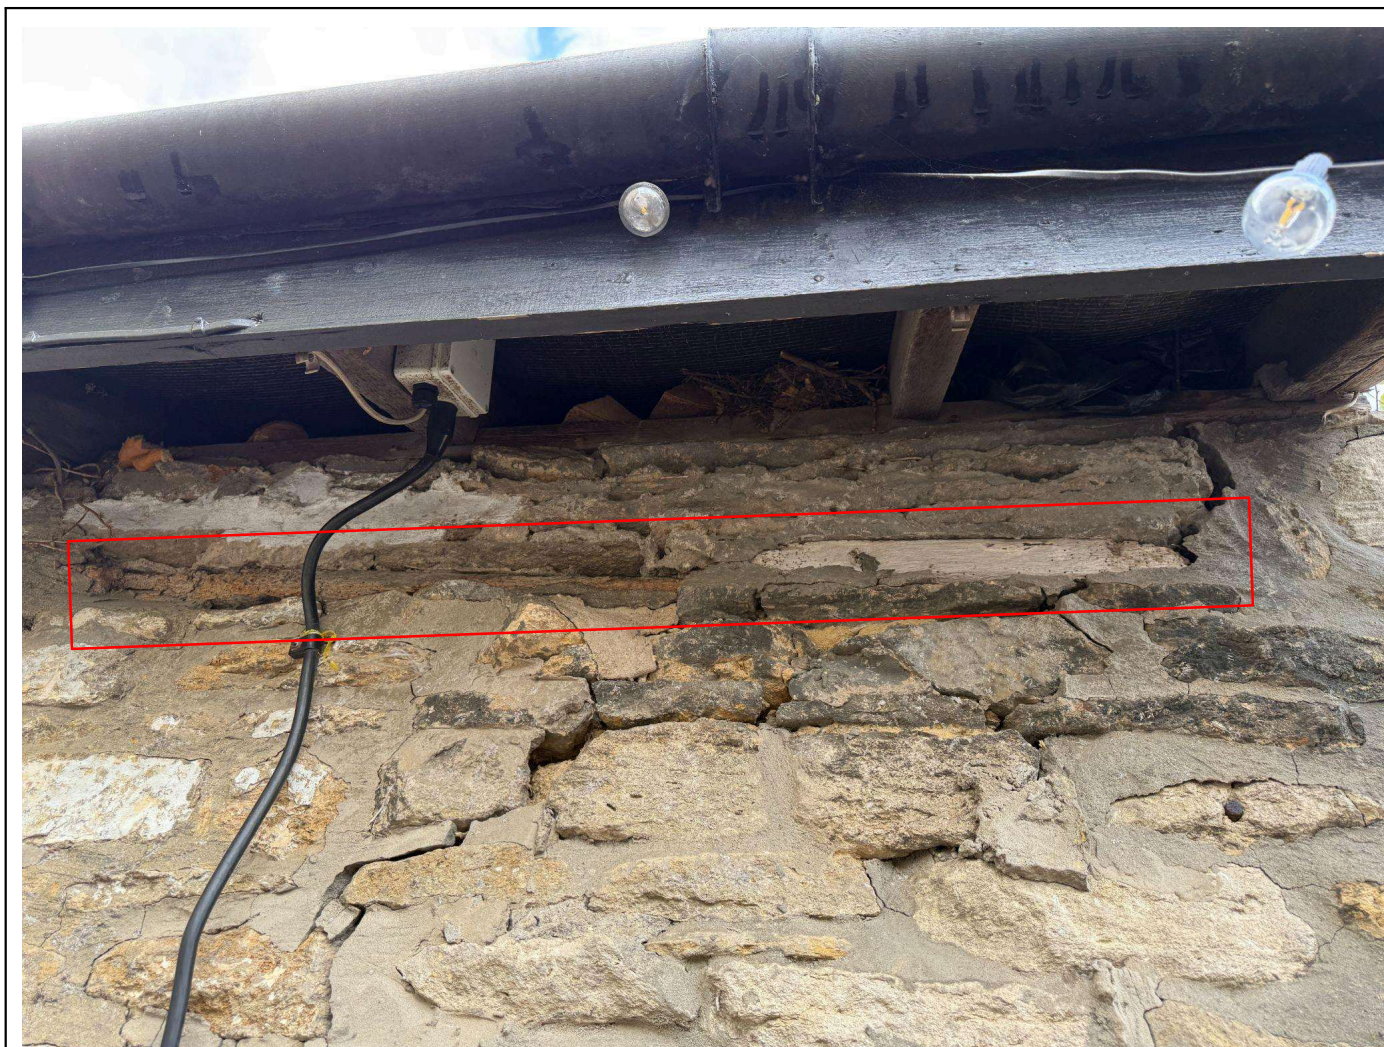
- 4.3. The stonework had deteriorated towards the eaves level above the crack observed above.
- 4.4. Within the deteriorated stonework, an exposed timber beam was observed embedded within the stonework that had signs of rot. The wall plate for the rafters could also be observed above the exposed timber beam.

Picture 2 - Deteriorated stonework to the eaves level and exposed timber beam

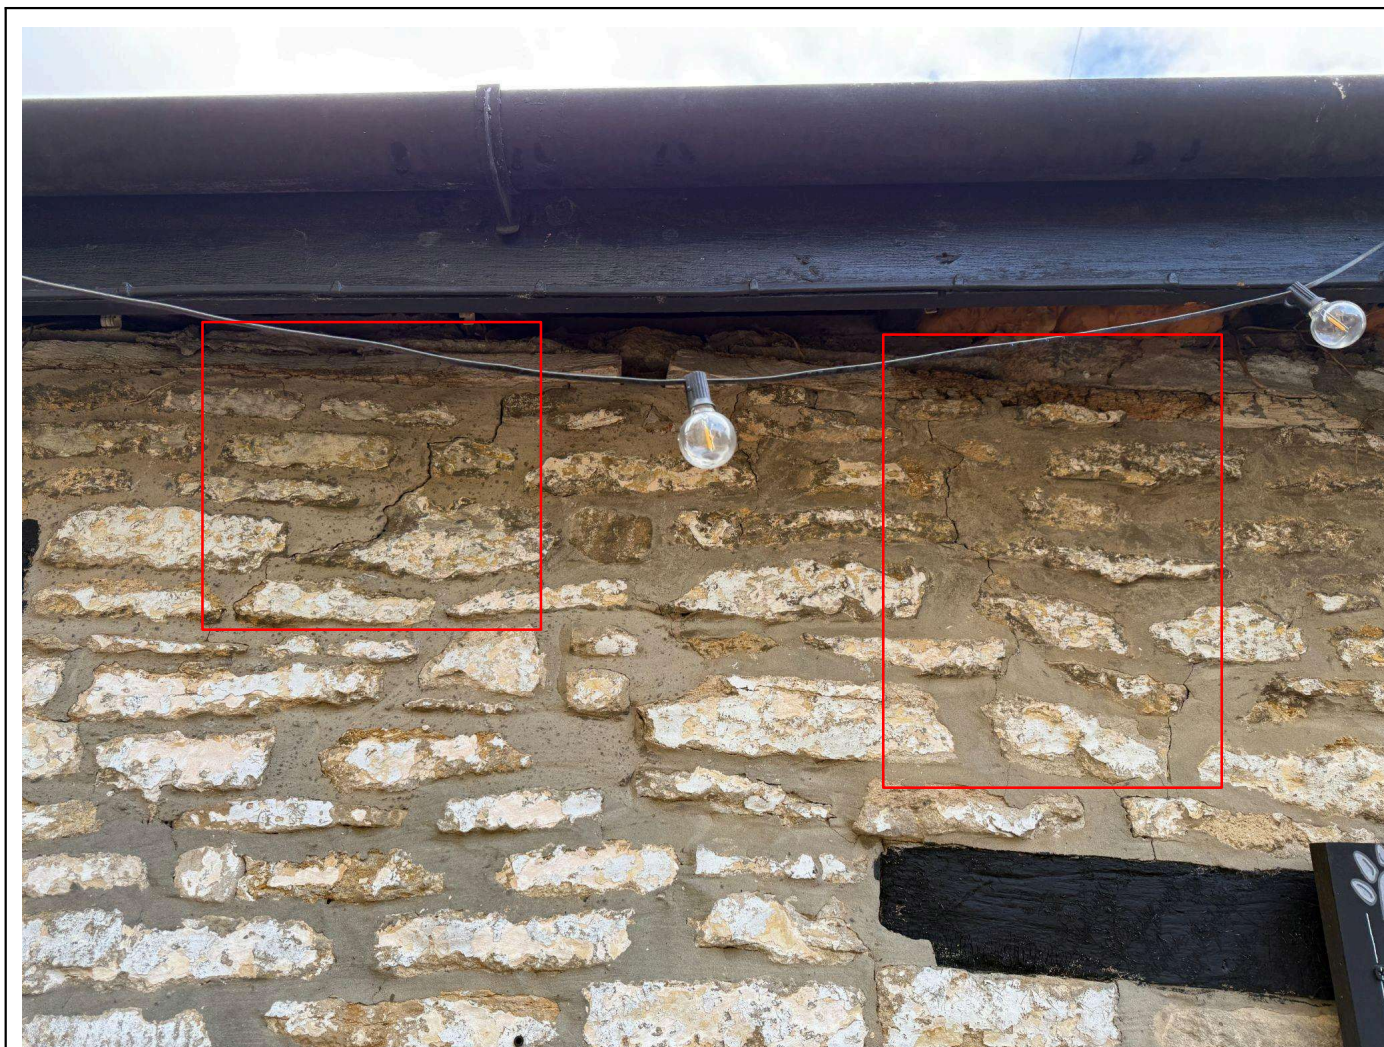
- 4.6. Above the timber lintel observed above a 1mm vertical crack was observed starting from the eaves level.
- 4.7. Similar cracks to the above were observed adjacent to the crack above further away from the gable end.

Picture 3 - Vertical cracks above the timber lintel

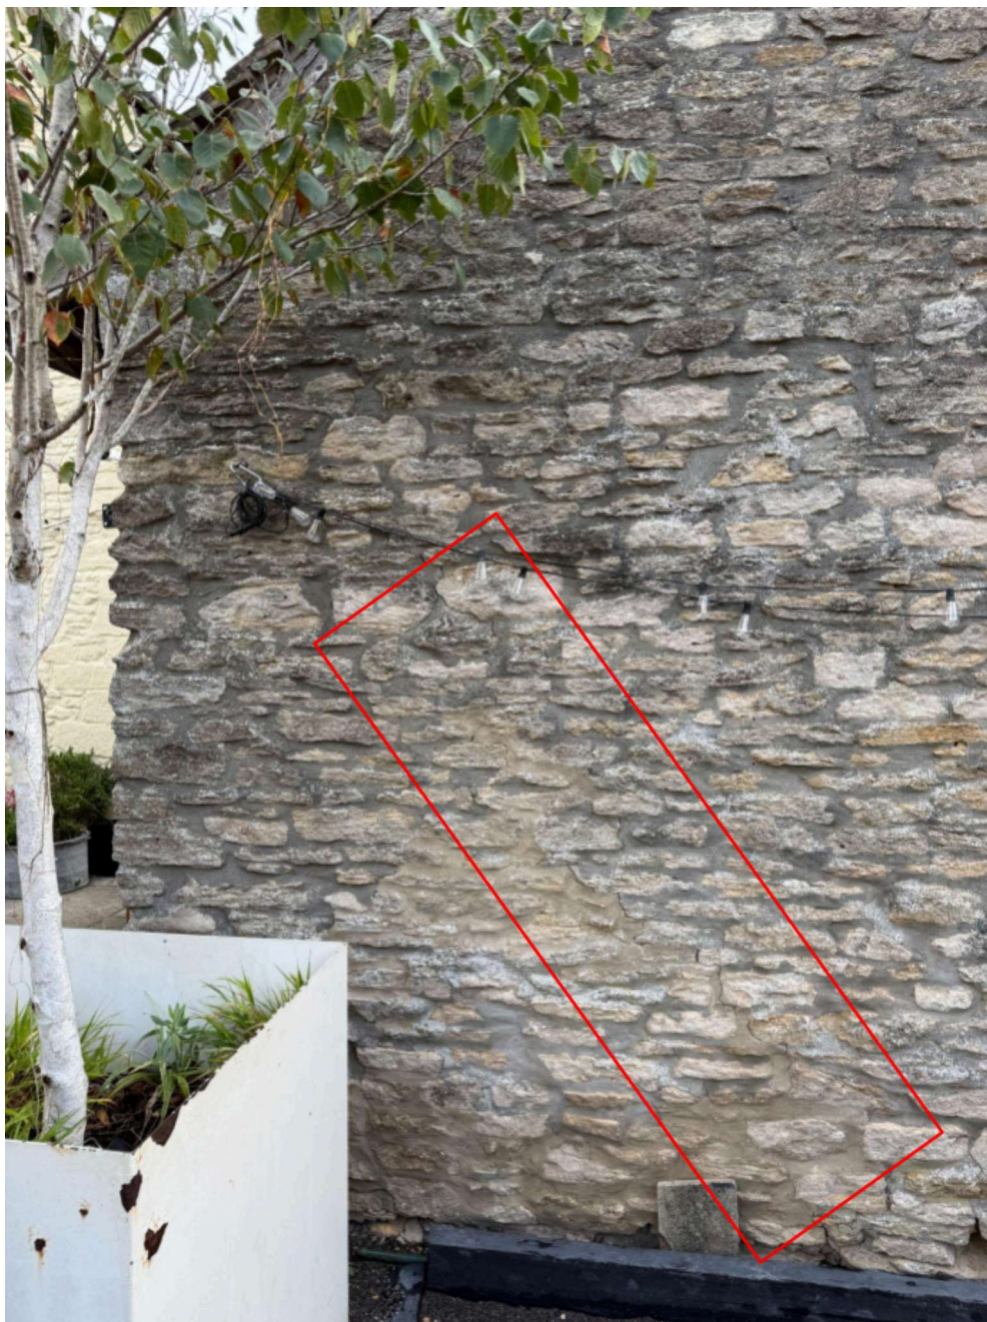
- 4.8. To the lefthand side of the gable end a hairline to 1mm stepped to vertical cracks were observed from the bottom of the roof line to the ground level.

Picture 4 - Vertical to stepped crack of the lefthand side of the gable wall

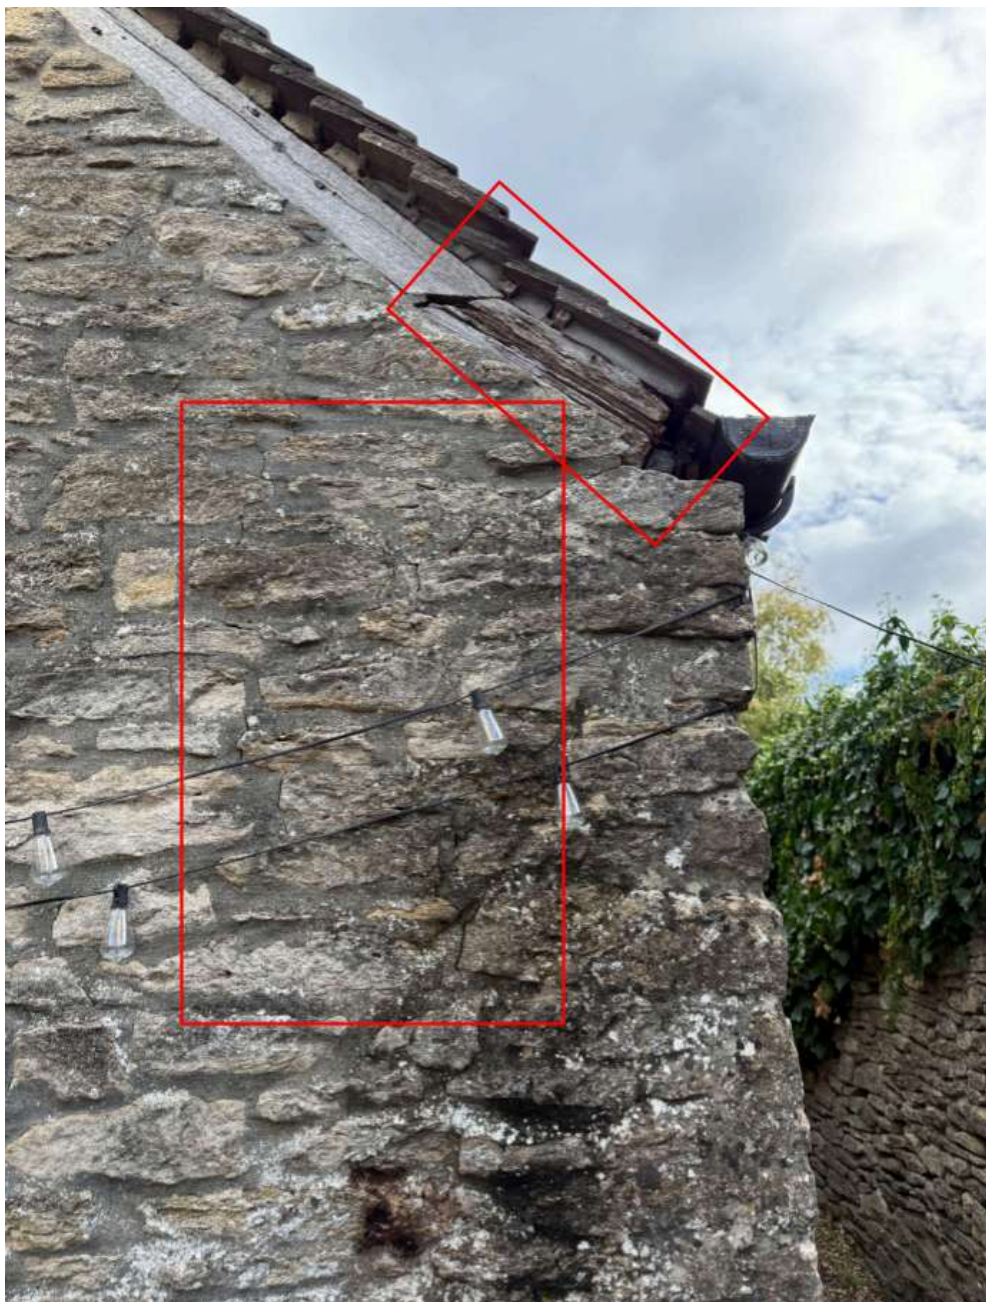
- 4.9. To the righthand side of the gable damp stonework was observed from the bottom of the roof line to the ground level.
- 4.10. Several hairline cracks were observed starting from the roof line and continued to a 1mm vertical crack following the damp stonework.

- 4.11. A timber facade was observed on the gable end with timber to the bottom righthand side containing signs of rot near to the guttering.
- 4.12. To the north side the gutter spanned for a length of approximately 10.2m to the downpipe and contained little to no fall.

Picture 5 - Righthand side of gable wall damp stonework with hairline cracks and timber rot

- 6.1. The following are the conclusions and recommendations to the defects observed.
- 6.2. The lack of an adequate fall of the guttering to the north wall of the dining area (see Figure 1) had likely resulted in water leaking from the guttering causing the damp stonework and rotted timber observed. Typically, issues with a damp proof course would occur a maximum 1 meter from the ground level and the damp to the stonework occurred from eaves level to the ground level. Therefore, it is recommended to prevent possible future issues the gutter should be reinstalled to ensure suitable fall in accordance with Building Regulations.

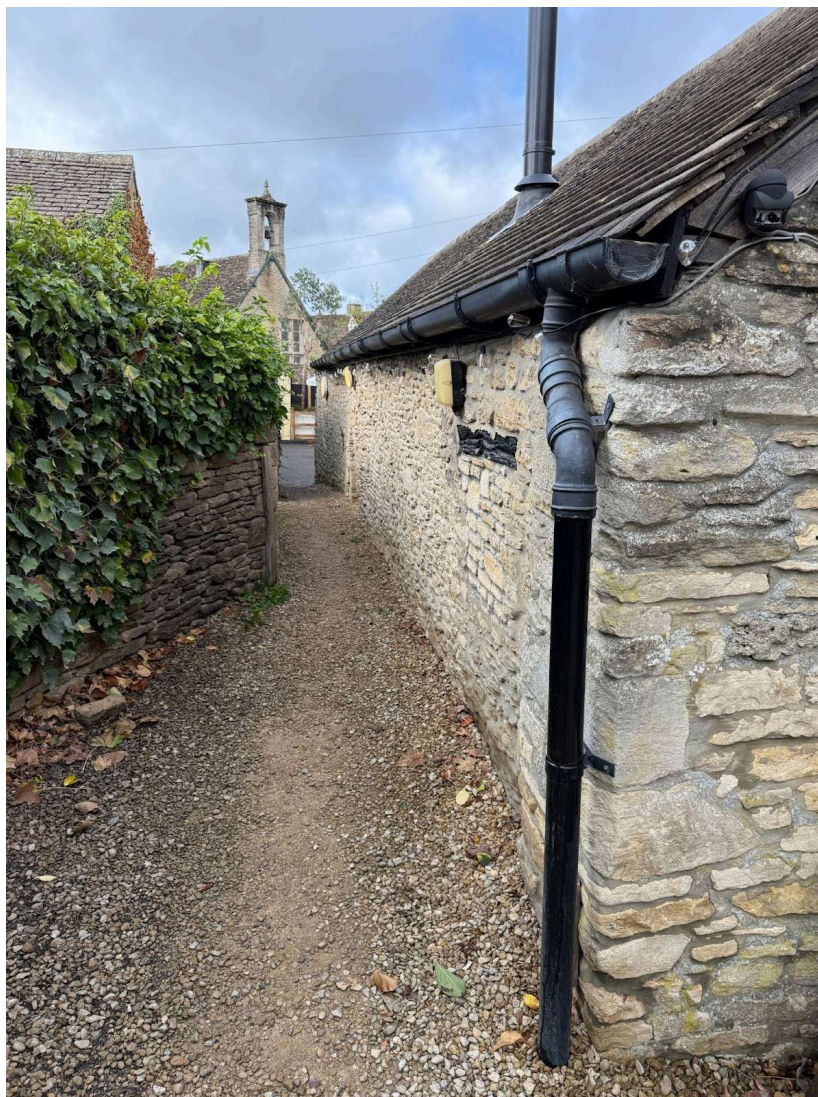
Picture 6 - North wall guttering to Dining Area

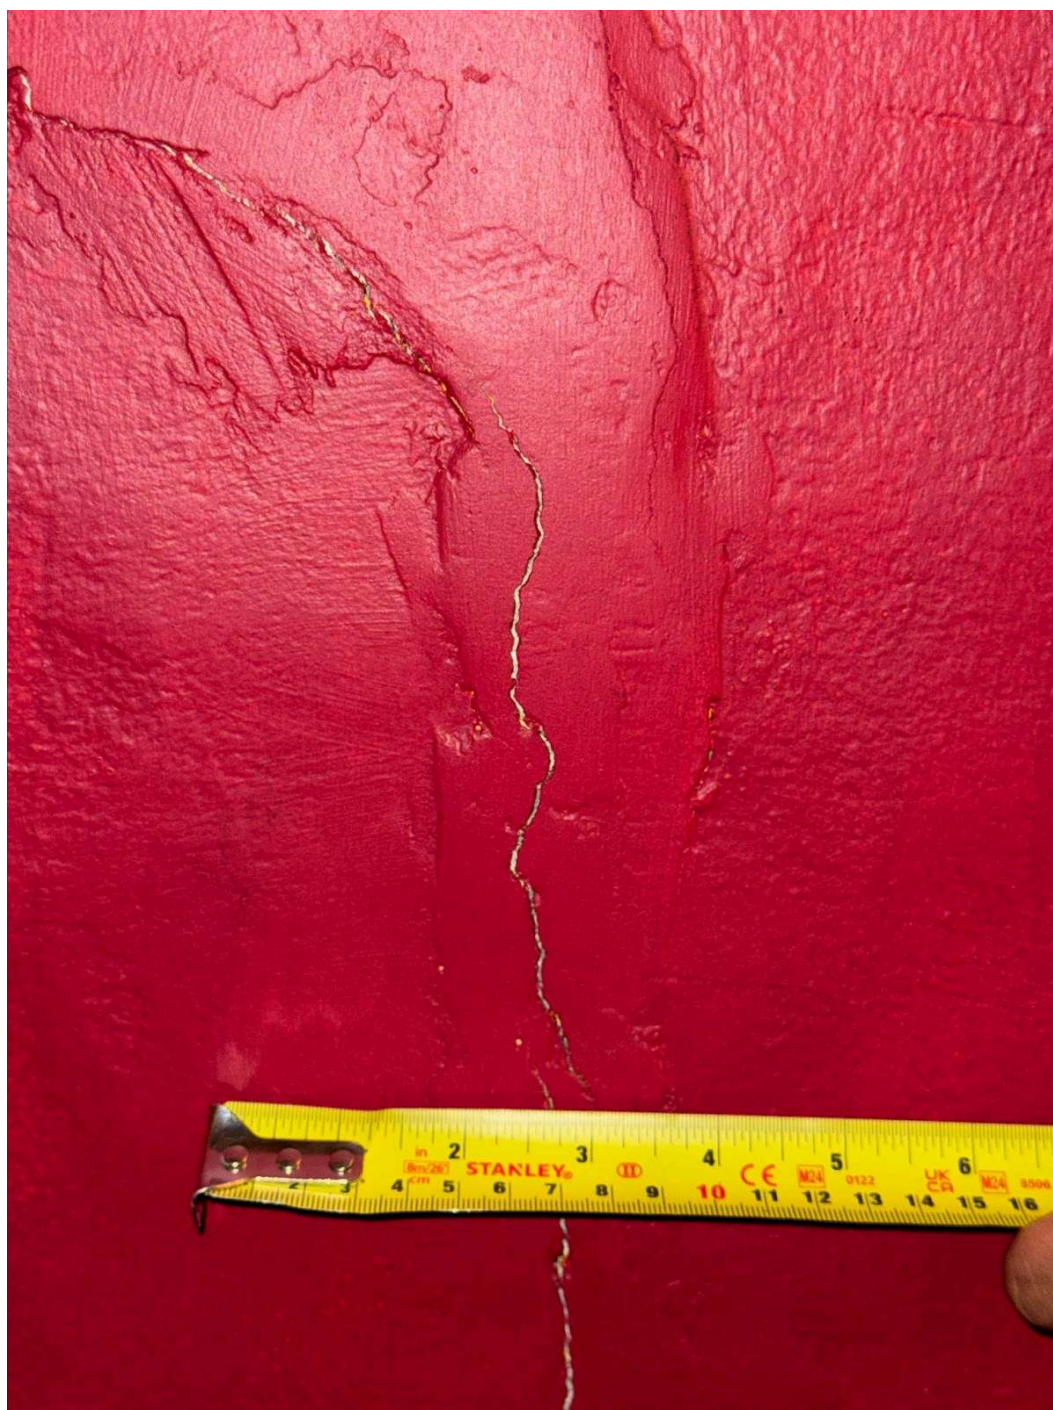
- 5.1. Within the dining area to the north (see Figure 1), to the south wall near to the gable end a repair of a defect was observed. The repair did contain a 1mm vertical to stepped crack.

Picture 7 - Repair of a defect on the south wall of the Dining Area with vertical crack

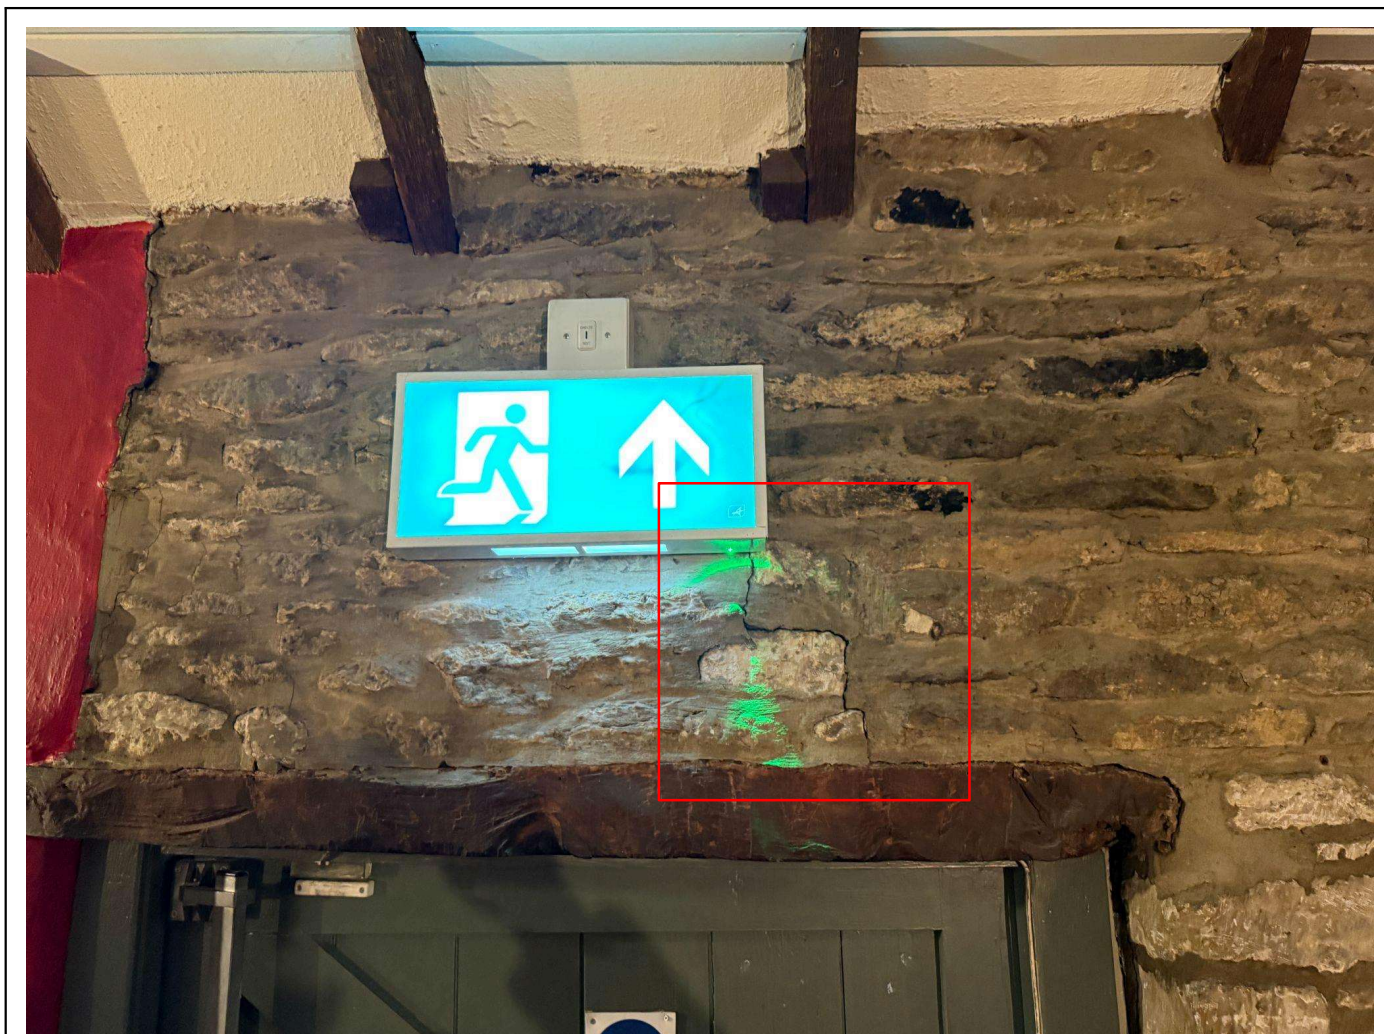
- 5.2. On the same wall below the fire exit sign a 1mm stepped crack was observed from the corner of the sign to the top of the timber lintel.
- 5.3. In both corners of the gable end a vertical crack with a maximum width of 25mm was observed from eaves to the ground floor.

Picture 8 - Stepped crack below the fire exit sign on the south wall of the Dining Area

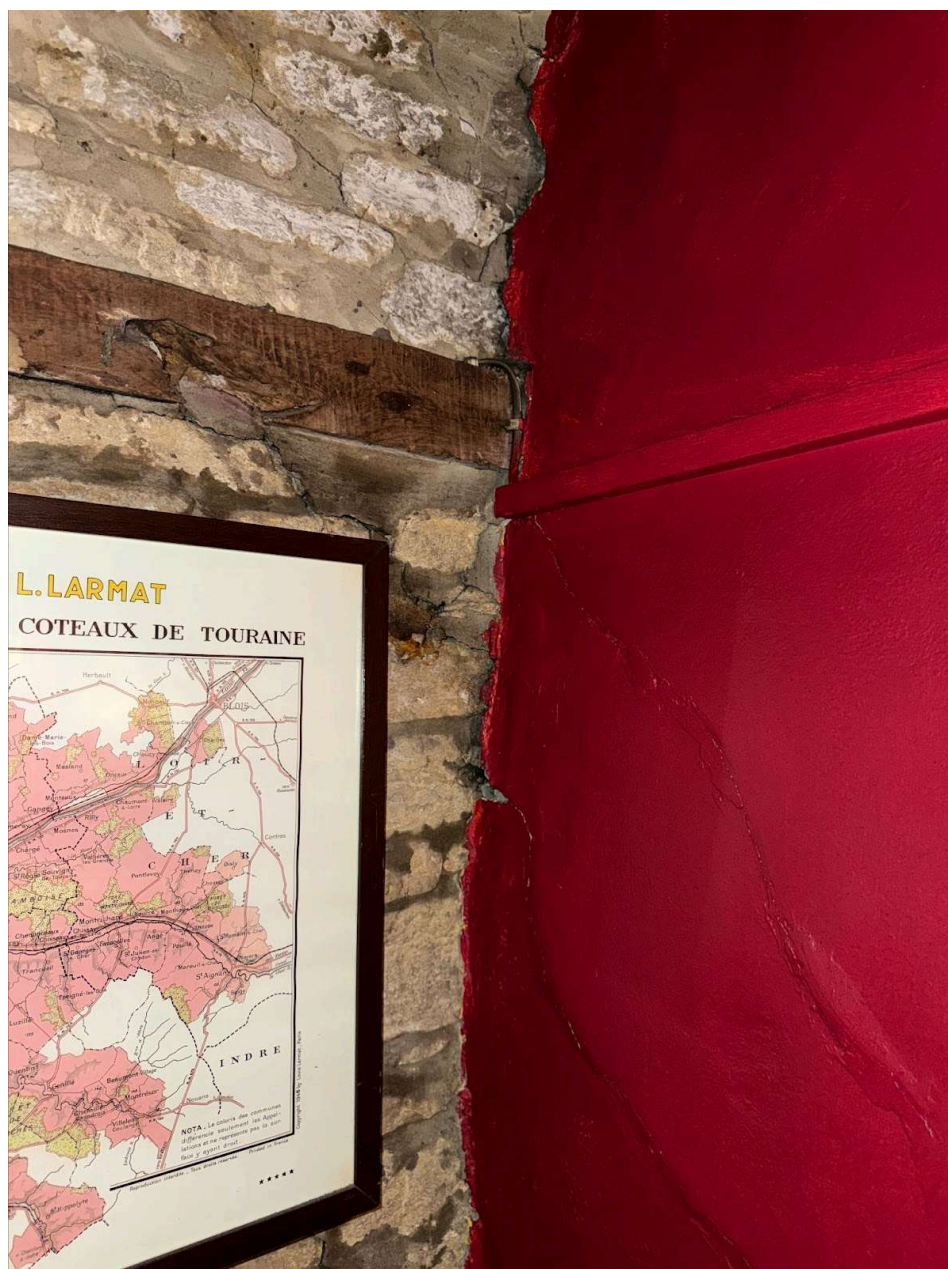
- 6.3. The vertical cracks observed to the corners of the gable wall in the dining area indicate the gable wall was leaning outwards. From the observed roof structure it appeared that the 'A' frames were not connected to the gable through a purlin and no diagonal bracing was observed, this could be a possible cause for the defects observed. However, based on a single visit the cause cannot be fully determine and as a result it is difficult to provide a recommendation for a suitable repair.

Picture 9 - Vertical cracks to the right hand corner of the gable wall

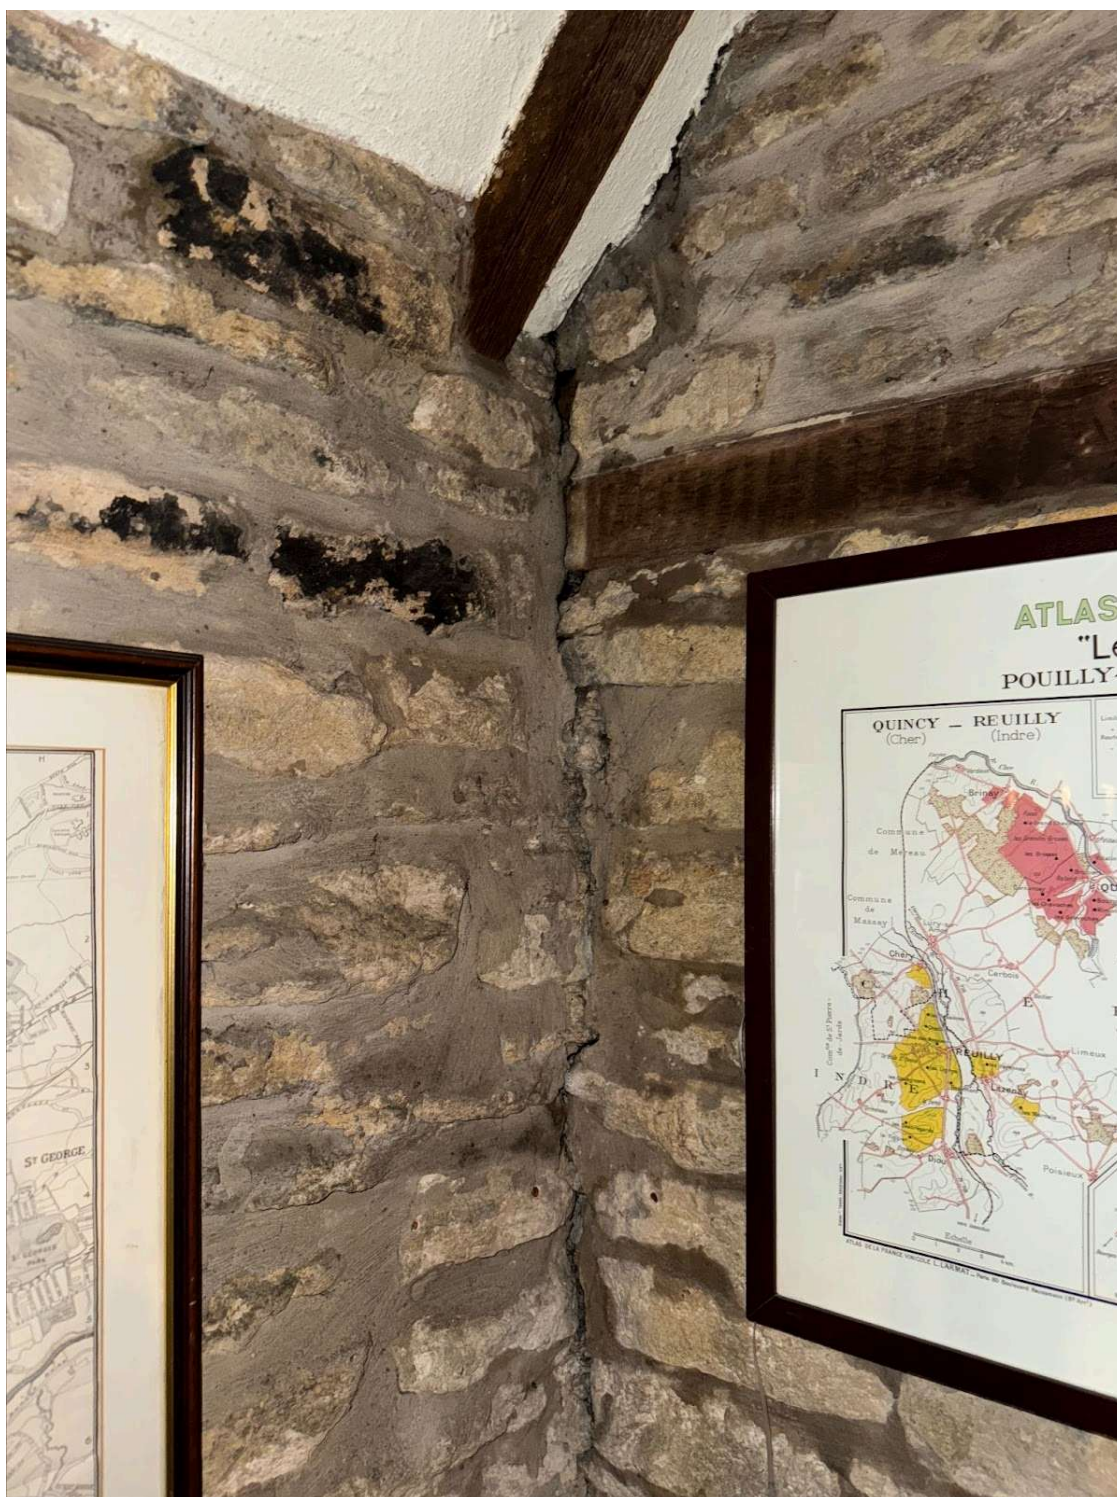
Picture 10 - Vertical cracks to the lefthand corner of the gable wall

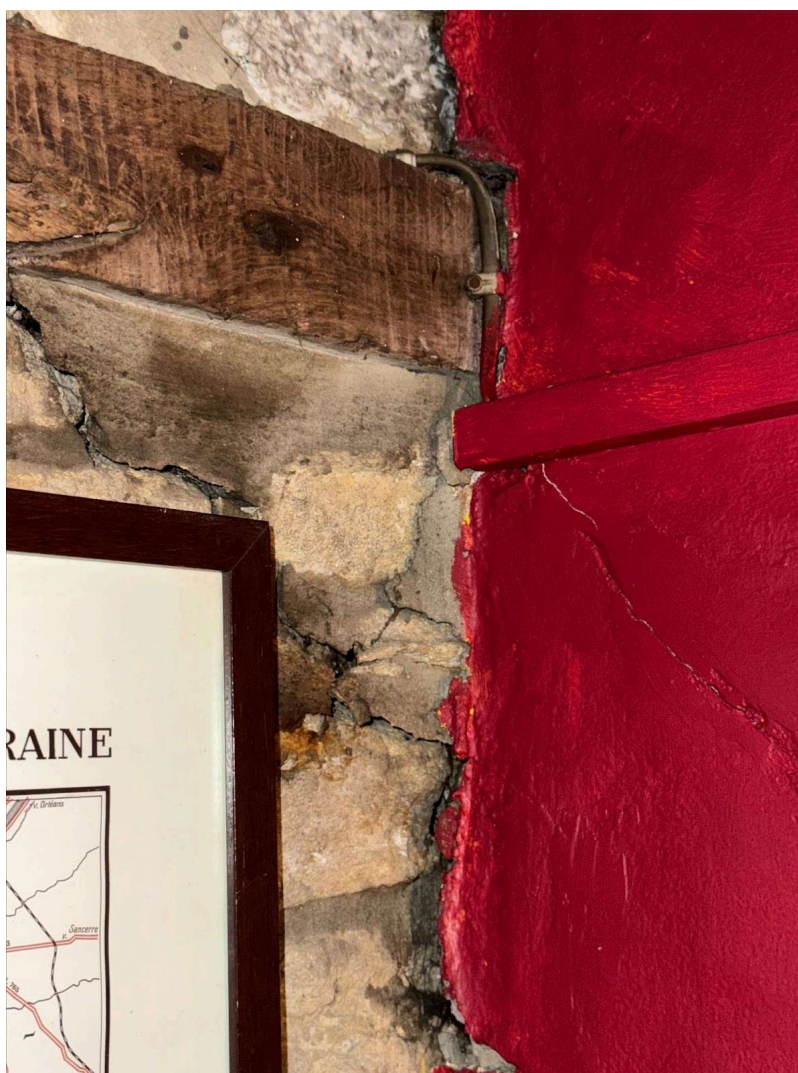
- 5.4. A 2mm to 1mm stepped crack was observed below the righthand timber strap on the gable wall and continued as a vertical crack to the ground level.

Picture 11 - Stepped crack below the righthand timber strap in the gable wall

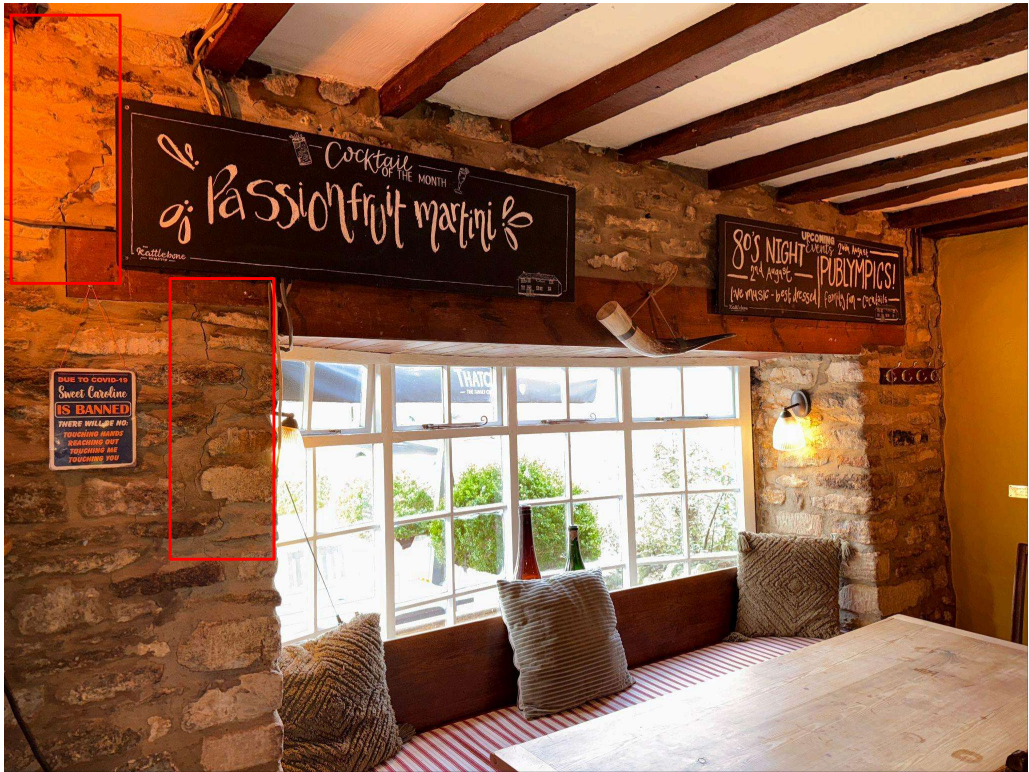
- 5.5. Within the main property (highlighted Area 2) a 2mm vertical to stepped crack was observed to the lefthand side of timber lintel on the window located to the east side (see Figure 1). The crack started from the underside of the timber joist to the top of the lintel. The crack then continues from the underside of the timber lintel as a stepped crack for approximately 500mm depth.

Picture 12 - Vertical to stepped crack below the timber lintel to Area 2 on the main property

- 6.6. According to BRE digest the vertical cracks observed to the lefthand side and righthand side of the timber lintel within the main property (see Picture 12 and 13) does not warrant significant structural repairs, therefore, the cracks should be stitched together with Helifix ties according to manufactures specifications and monitored for possible future movement.

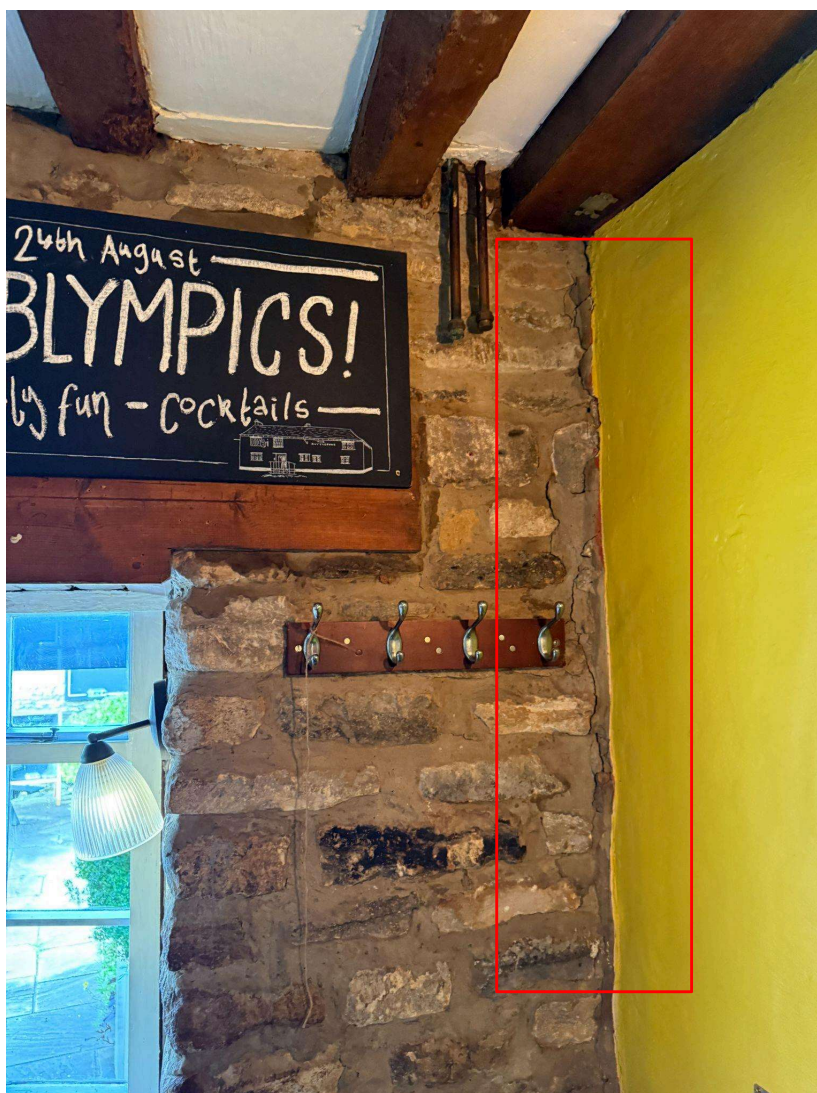
- 5.6. To the righthand side of the same timber lintel a 1mm vertical crack was observed near to the end of the wall. The crack started from the exposed timber floor joists and continued for approximately 600mm.

Picture 13 - Vertical crack adjacent to the timber lintel to Area 2 on the main property.
