# ASBESTOS 2GO LIMITED

On behalf of:  
The Ramsbury Manor Foundation

Asbestos Refurbishment and Demolition Survey  
To Specific Locations Only

@  
Ramsbury Manor  
Ramsbury  
Marlborough  
Wiltshire  
SN8 2RG

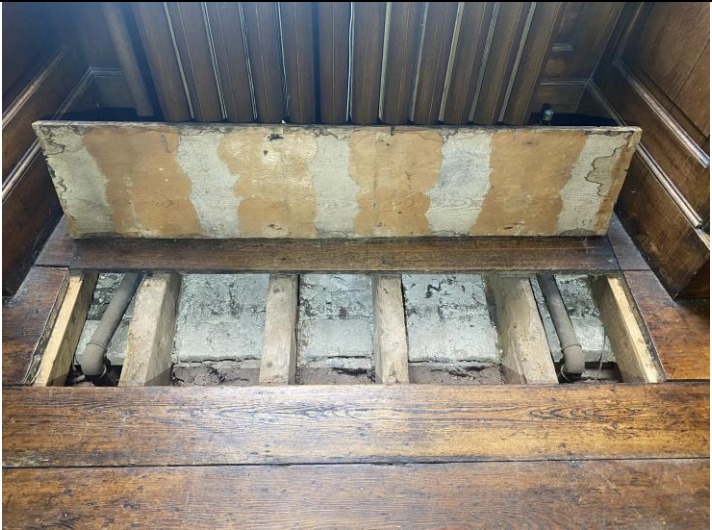
| <b>Other Recommended Action:</b> | Asbestos has been found within the floor voids at all levels within the building, these materials were found during a restricted access inspection; leaving much of the floor voids uninspected. Further ACM's may be present & widespread within the uninspected parts of the floor voids.<br>We recommend to restrict all access into the floor voids, pending licensed asbestos removal works to decontaminate the voids. | | | |

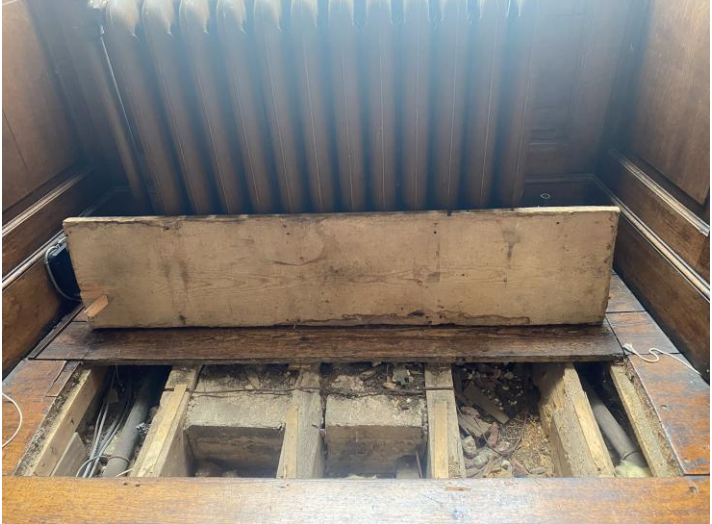
| <b>Other Recommended Action:</b> | Asbestos has been found within the floor voids at all levels within the building, these materials were found during a restricted access inspection; leaving much of the floor voids uninspected. Further ACM's may be present & widespread within the uninspected parts of the floor voids.<br>We recommend to restrict all access into the floor voids, pending licensed asbestos removal works to decontaminate the voids. | | |

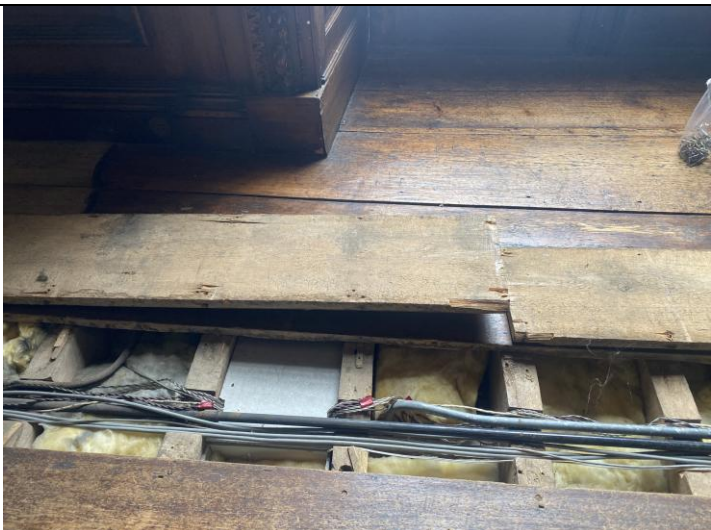
| <b>Other Recommended Action:</b> | | Asbestos has been found within the floor voids at all levels within the building, these materials were found during a restricted access inspection; leaving much of the floor voids uninspected. Further ACM's may be present & widespread within the uninspected parts of the floor voids.<br>We recommend to restrict all access into the floor voids, pending licensed asbestos removal works to decontaminate the voids. | | |

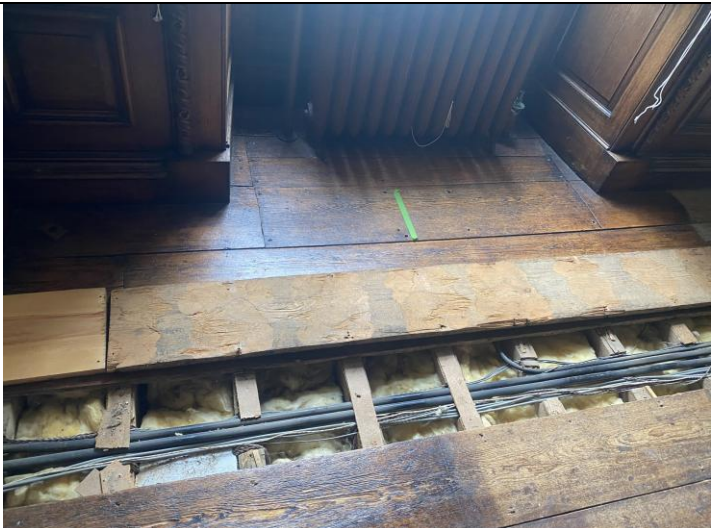
| <b>Other Recommended Action:</b> | | Asbestos has been found within the floor voids at all levels within the building, these materials were found during a restricted access inspection; leaving much of the floor voids uninspected. Further ACM's may be present & widespread within the uninspected parts of the floor voids.<br>We recommend to restrict all access into the floor voids, pending licensed asbestos removal works to decontaminate the voids. | | |

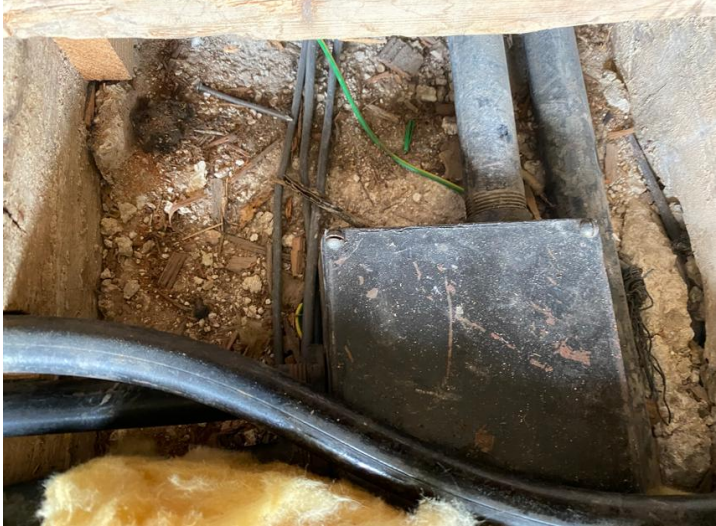
| <b>Other Recommended Action:</b> | Asbestos has been found within the floor voids at all levels within the building, these materials were found during a restricted access inspection; leaving much of the floor voids uninspected. Further ACM's may be present & widespread within the uninspected parts of the floor voids.<br>We recommend to restrict all access into the floor voids, pending licensed asbestos removal works to decontaminate the voids. | | |

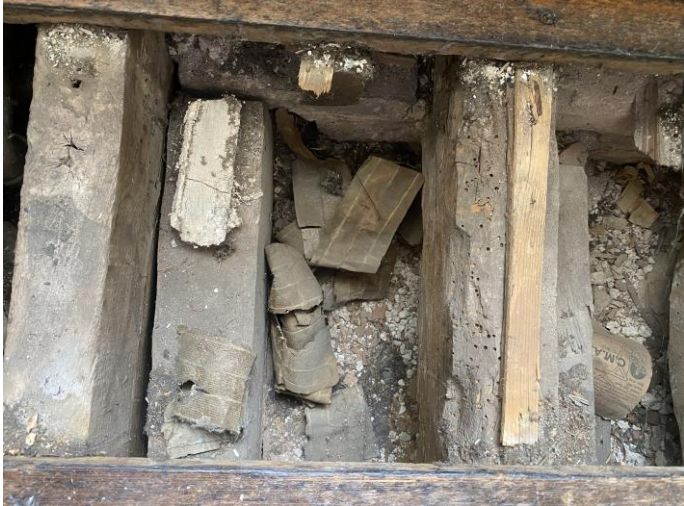
| <b>Other Recommended Action:</b> | Asbestos has been found within the floor voids at all levels within the building, these materials were found during a restricted access inspection; leaving much of the floor voids uninspected. Further ACM's may be present & widespread within the uninspected parts of the floor voids.<br>We recommend to restrict all access into the floor voids, pending licensed asbestos removal works to decontaminate the voids. | | |

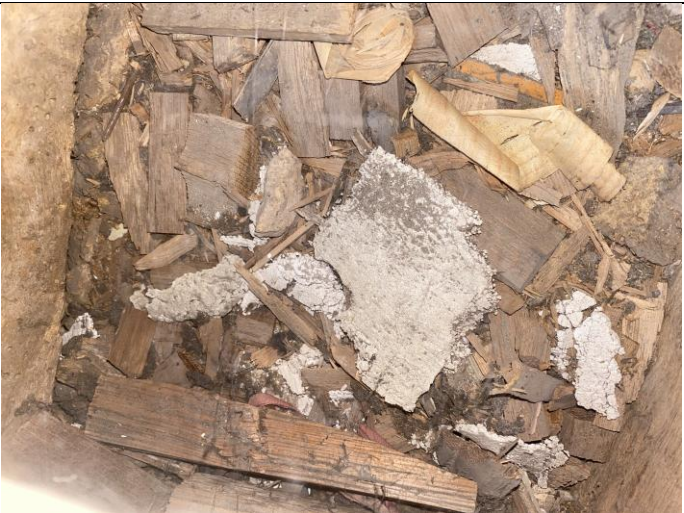
| <b>Other Recommended Action:</b> | Asbestos has been found within the floor voids at all levels within the building, these materials were found during a restricted access inspection; leaving much of the floor voids uninspected. Further ACM's may be present & widespread within the uninspected parts of the floor voids.<br>We recommend to restrict all access into the floor voids, pending licensed asbestos removal works to decontaminate the voids. | | | |

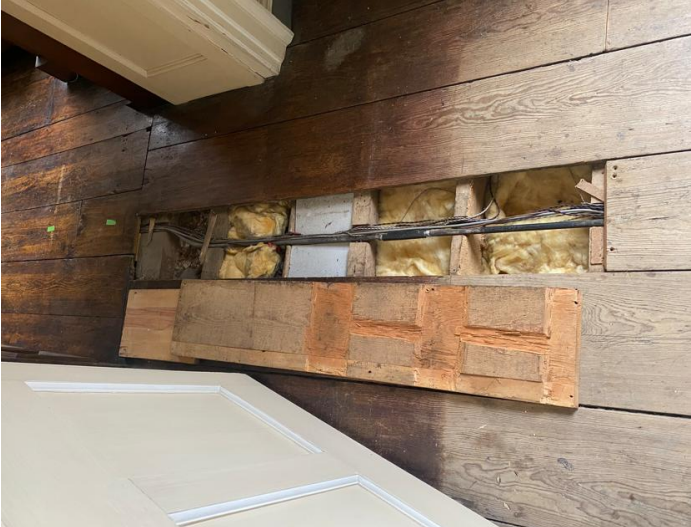
| <b>Other Recommended Action:</b> | | Asbestos has been found within the floor voids at all levels within the building, these materials were found during a restricted access inspection; leaving much of the floor voids uninspected. Further ACM's may be present & widespread within the uninspected parts of the floor voids.<br>We recommend to restrict all access into the floor voids, pending licensed asbestos removal works to decontaminate the voids. | | |

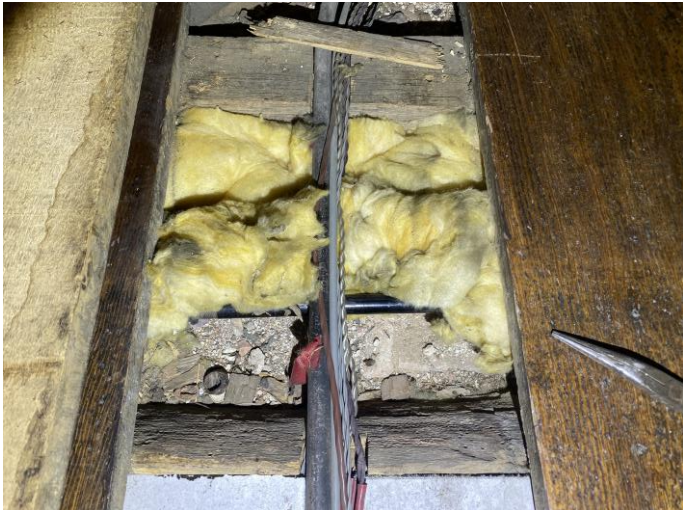
| <b>Other Recommended Action:</b> | | Asbestos has been found within the floor voids at all levels within the building, these materials were found during a restricted access inspection; leaving much of the floor voids uninspected. Further ACM's may be present & widespread within the uninspected parts of the floor voids.<br>We recommend to restrict all access into the floor voids, pending licensed asbestos removal works to decontaminate the voids. | | | |

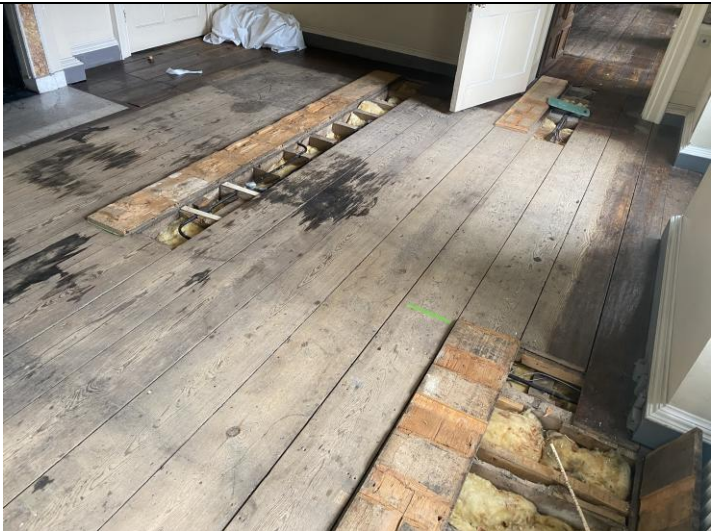
| <b>Other Recommended Action:</b> | Asbestos has been found within the floor voids at all levels within the building, these materials were found during a restricted access inspection; leaving much of the floor voids uninspected. Further ACM's may be present & widespread within the uninspected parts of the floor voids.<br>We recommend to restrict all access into the floor voids, pending licensed asbestos removal works to decontaminate the voids. | | |

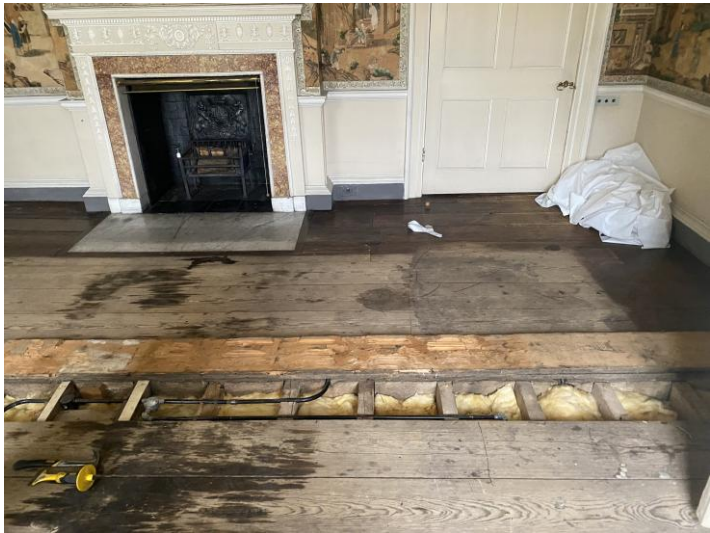
| <b>Other Recommended Action:</b> | Asbestos has been found within the floor voids at all levels within the building, these materials were found during a restricted access inspection; leaving much of the floor voids uninspected. Further ACM's may be present & widespread within the uninspected parts of the floor voids.<br>We recommend to restrict all access into the floor voids, pending licensed asbestos removal works to decontaminate the voids. | | |

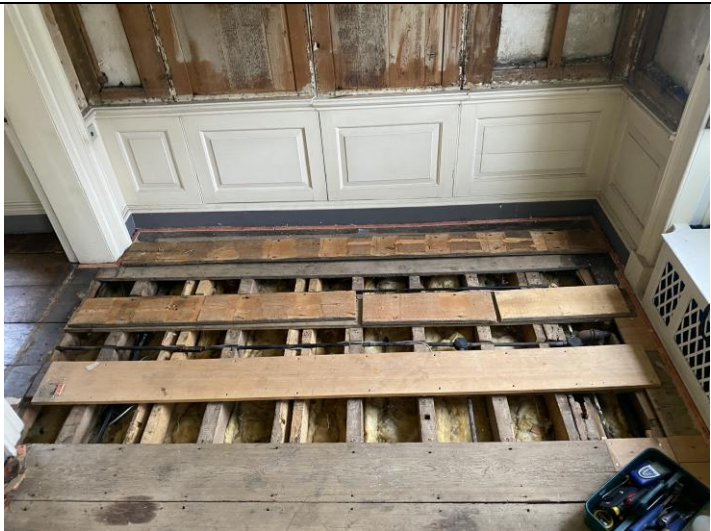
| <b>Other Recommended Action:</b> | Asbestos has been found within the floor voids at all levels within the building, these materials were found during a restricted access inspection; leaving much of the floor voids uninspected. Further ACM's may be present & widespread within the uninspected parts of the floor voids.<br>We recommend to restrict all access into the floor voids, pending licensed asbestos removal works to decontaminate the voids. | | |

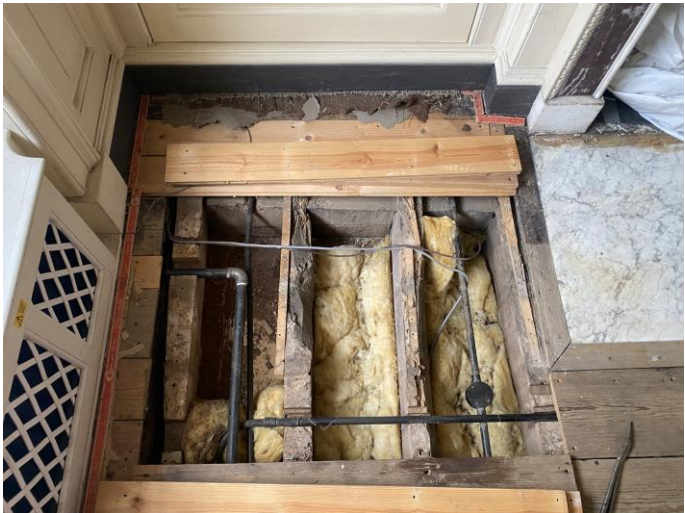
| <b>Other Recommended Action:</b> | Asbestos has been found within the floor voids at all levels within the building, these materials were found during a restricted access inspection; leaving much of the floor voids uninspected. Further ACM's may be present & widespread within the uninspected parts of the floor voids.<br>We recommend to restrict all access into the floor voids, pending licensed asbestos removal works to decontaminate the voids. | | |

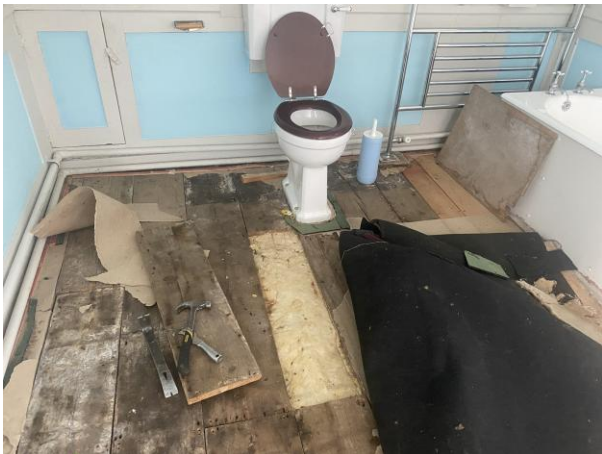
Deep fill fibreglass insulation

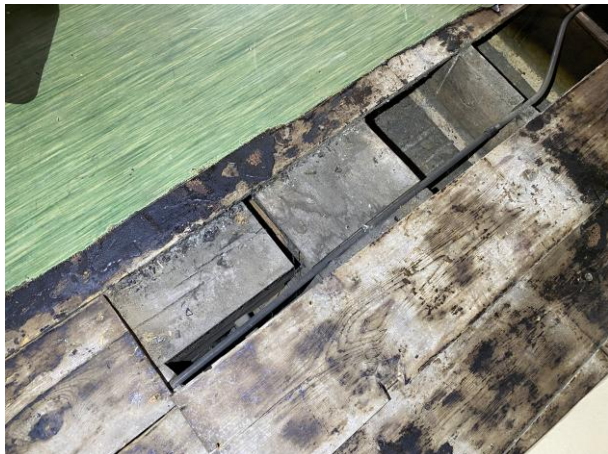
Large beams

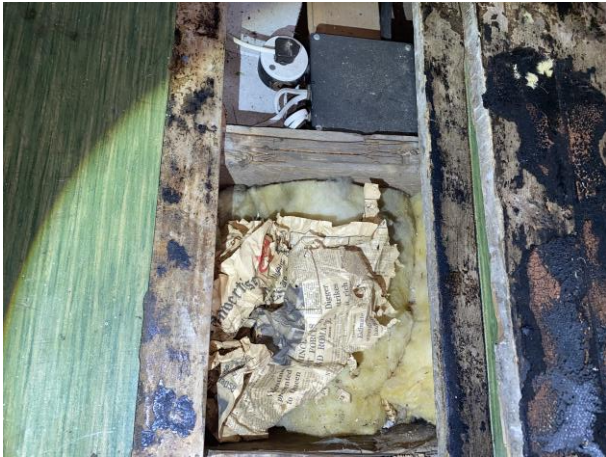
Deep fill fibreglass insulation

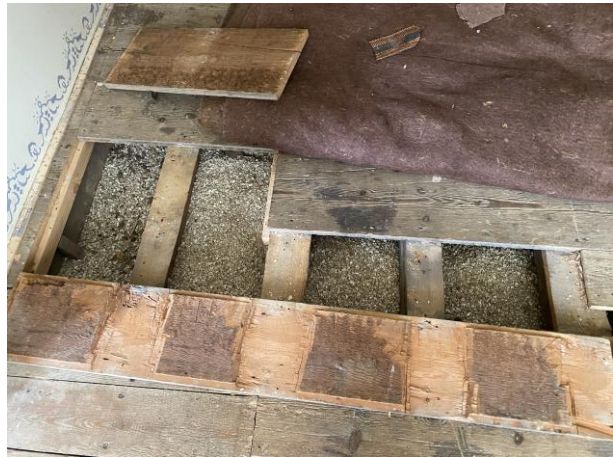
Loose fill vermiculite insulation

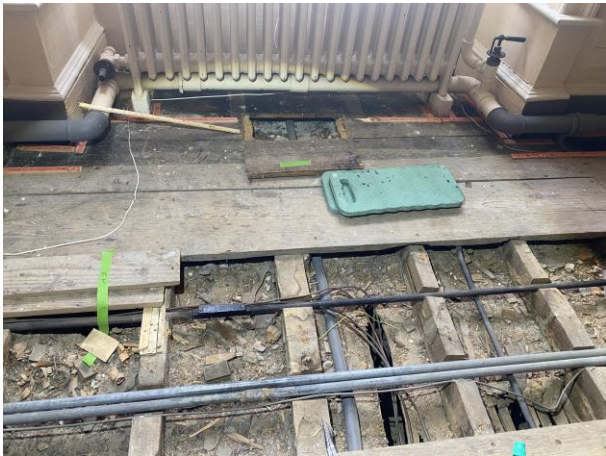
Clay & straw pugging insulation conceals dropped void

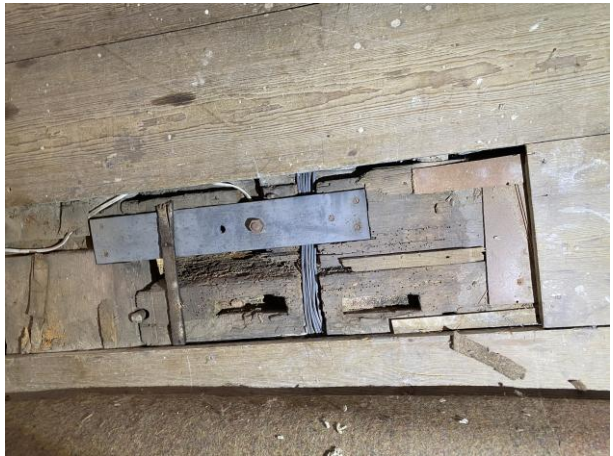
Large beams

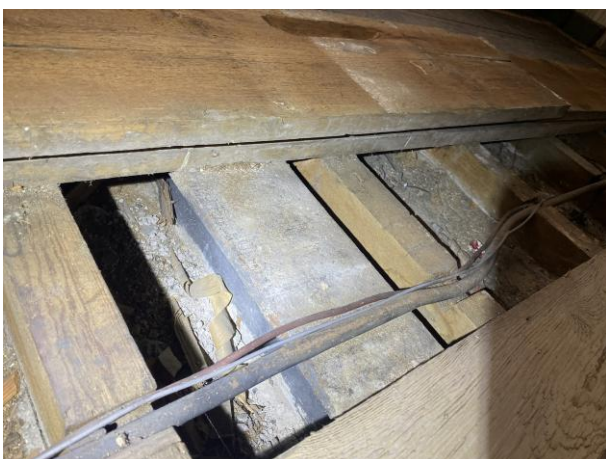
Rolled steel joist / clay & straw pugging insulation

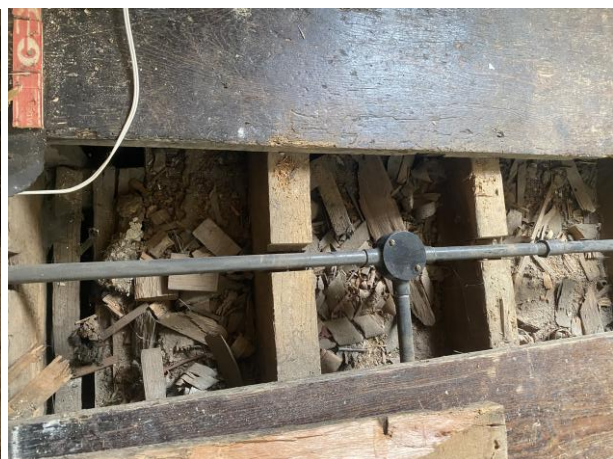
Clay & straw pugging insulation conceals dropped void
